Cala Homes (Chiltern) Limited

Asbestos Demolition Survey

Stable Buildings on land at Fritwell  
Off Fritwell Road

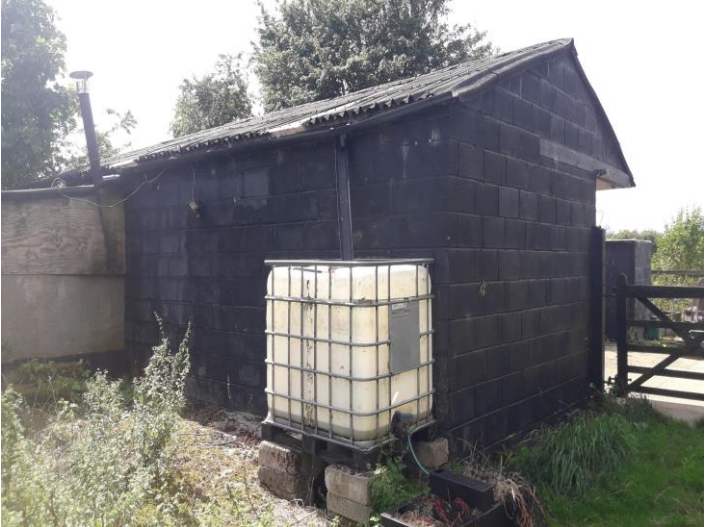
<b>Sample Reference:</b>	S01		
<b>Sample Location:</b>	Stable building 1 (left on entry)		
<b>Sample Position:</b>	Roof		
<b>Sample Description:</b>	Bituminous corrugated sheeting		
<b>Material Risk Assessment Algorithm (MA):</b>			
<b>Product type/debris:</b>	N/A	<b>Accessibility:</b>	N/A
<b>Surface Treatment:</b>	N/A		
<b>Extent of damage:</b>	N/A	<b>Approximate Extent/Quantity:</b>	N/A
<b>Asbestos Type:</b>	NADIS	<b>Priority Risk Assessment</b> Where a duty to manage applies the Duty Holder must add all positive asbestos locations to an asbestos register. We recommend the Duty Holder use the priority risk assessment algorithm within this document to calculate the priority risk rating for each positive instance & prioritise the recommended action noted for each instance starting with the highest risk to the lowest to ensure each risk is reduced to as low as reasonably practicable within an agreed timeframe. For more advice contact our offices or visit the Health & Safety Executive website: <a href="https://www.hse.gov.uk/asbestos/managing/index.htm">https://www.hse.gov.uk/asbestos/managing/index.htm</a>

<b>Material assessment score:</b>	N/A		
<b>Material Risk Assessment</b>	N/A		
<b>Recommended Management Action:</b>	N/A		
<b>Recommended Remedial Action:</b>	N/A		
<b>Recommended Removal Action:</b>	N/A		
<b>Other Recommended Action:</b>	N/A

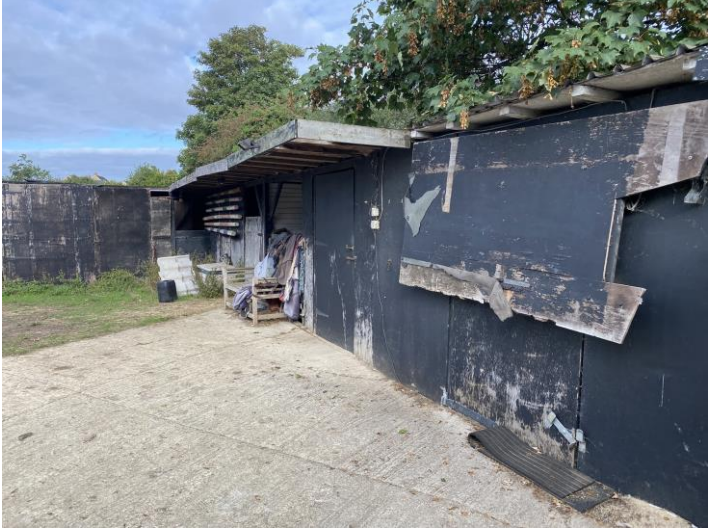
<b>Sample Reference:</b>	S02		
<b>Sample Location:</b>	Stable building 2 (left on entry)		
<b>Sample Position:</b>	Roof lining		
<b>Sample Description:</b>	Bituminous mineral felt		
<b>Material Risk Assessment Algorithm (MA):</b>			
<b>Product type/debris:</b>	N/A		<b>Accessibility:</b> N/A
<b>Surface Treatment:</b>	N/A		
<b>Extent of damage:</b>	N/A		<b>Approximate Extent/Quantity:</b> N/A
<b>Asbestos Type:</b>	NADIS		<b>Priority Risk Assessment</b> Where a duty to manage applies the Duty Holder must add all positive asbestos locations to an asbestos register. We recommend the Duty Holder use the priority risk assessment algorithm within this document to calculate the priority risk rating for each positive instance & prioritise the recommended action noted for each instance starting with the highest risk to the lowest to ensure each risk is reduced to as low as reasonably practicable within an agreed timeframe. For more advice contact our offices or visit the Health & Safety Executive website: <a href="https://www.hse.gov.uk/asbestos/managing/index.htm">https://www.hse.gov.uk/asbestos/managing/index.htm</a>

<b>Material assessment score:</b>	N/A		
<b>Material Risk Assessment</b>	N/A		
<b>Recommended Management Action:</b>	N/A		
<b>Recommended Remedial Action:</b>	N/A		
<b>Recommended Removal Action:</b>	N/A		
<b>Other Recommended Action:</b>	N/A
