HAYWOOD HOMES
BERRY HILL ROAD, ADDERBURY, OXON
SECTION 278 AND 38 WORKS
STAGE 1 ROAD SAFETY AUDIT

SA 3808
September 2022

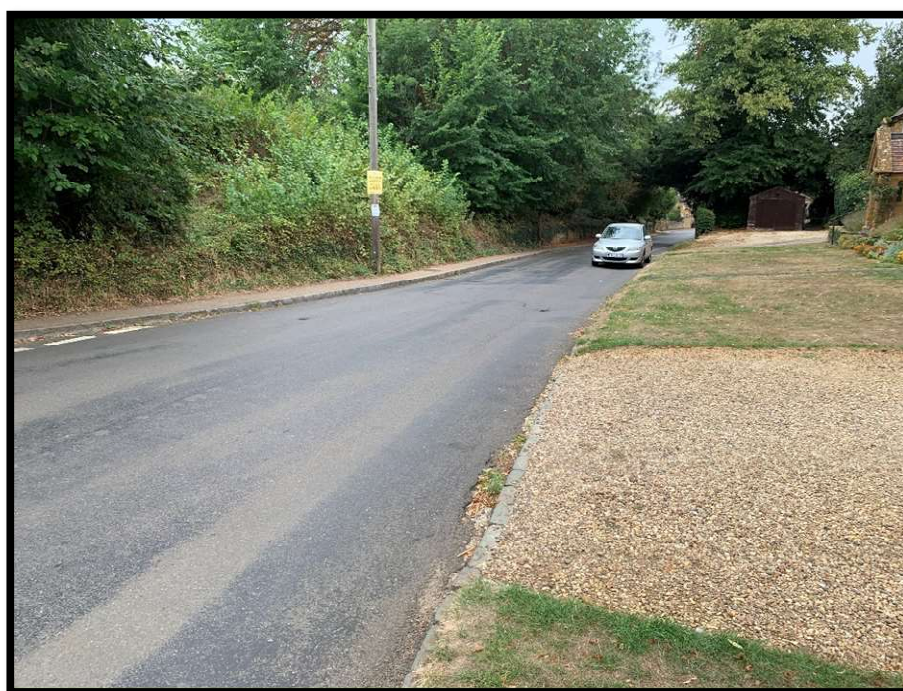
Image Nr 1

Location: Outside numbers

Summary: Risk of pedestrian/vehicle conflict

The drawings show a proposed inset uncontrolled pedestrian crossing point at the northern end of the proposed footway at the start of Horn Hill Road. Image number 1 above shows the approximate location of the crossing. However, as mentioned in Problem 6.1 above, the width of the proposed footway is inappropriate. It may be seen in the image above that the existing footway on the west side of Horn Hill Road also appears to be substandard as it is too narrow by current standards. This would become a particular issue when more than two pedestrians, especially those with buggies are crossing from east to west. This situation may result in collisions between vehicles and pedestrians, with injuries occurring.

Recommendation

It is recommended either that the crossing point is relocated to a safer site, or that more landing width is provided for pedestrians when using this crossing

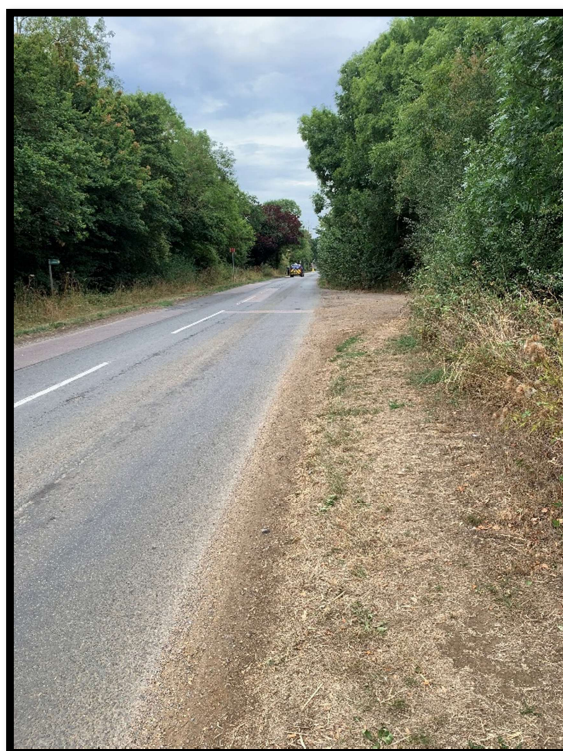
Image Nr 2

Location: Berry Hill Road between "Last House" and A4460 Oxford Road

Summary: Risk of pedestrian/vehicle conflict

The Audit Team observed on their site visit that the trees and hedges were at their full growth, some of which were overhanging the carriageway. Currently pedestrians have to walk either on the verge or on the carriageway. There is an increased risk of collisions between vehicles and pedestrians, especially during the hours of darkness as pedestrians may not be seen resulting in injuries occurring.

Recommendation

It is recommended that the trees and hedges adjacent to the Berry Hill Road carriageway and verge are cut back so that there is sufficient visibility for drivers using this route. This is particular important as there is no street lighting system in place.

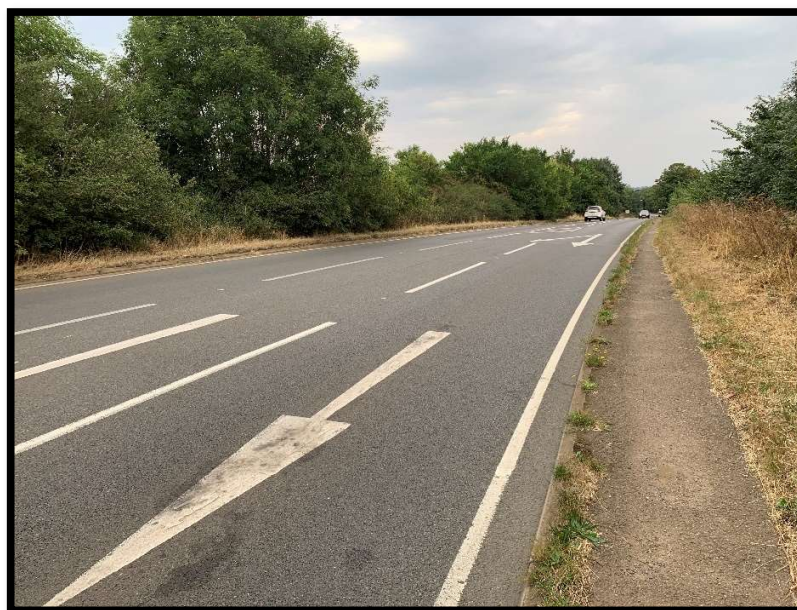
Image Nr 3

Location: Proposed Bus Stops north of Berry Hill Road / A4460 Oxford Road Junction

Summary: Risk of head-on and side impact type of vehicle conflict

The drawings submitted for audit show a proposed pedestrian central refuge located approximately at the start of the ghosted right turn from Oxford Road into Berry Hill Road, as seen in image number 3 above. Also included are two bus stops and their 'cages', one for a northbound bus and one for the southbound bus. The Audit Team are concerned with the location and configuration of the proposal as it could lead to vehicle collisions, in the following circumstances; if a bus had stopped at the southbound bus stop it is likely that a queue of traffic may occur behind it, wishing to overtake. However, because of the vertical alignment of Oxford Road, it is highly probable that the southbound driver would not be able to see either any northbound vehicles or pedestrians on the crossing. This situation may result in head-on or side impact collisions, with injuries occurring.

Recommendation

It is recommended that the designer ensures that there is adequate forward visibility when a bus has stopped in either of the bus cages and that southbound vehicles are able to see any pedestrians either waiting to cross or crossing Oxford Road.

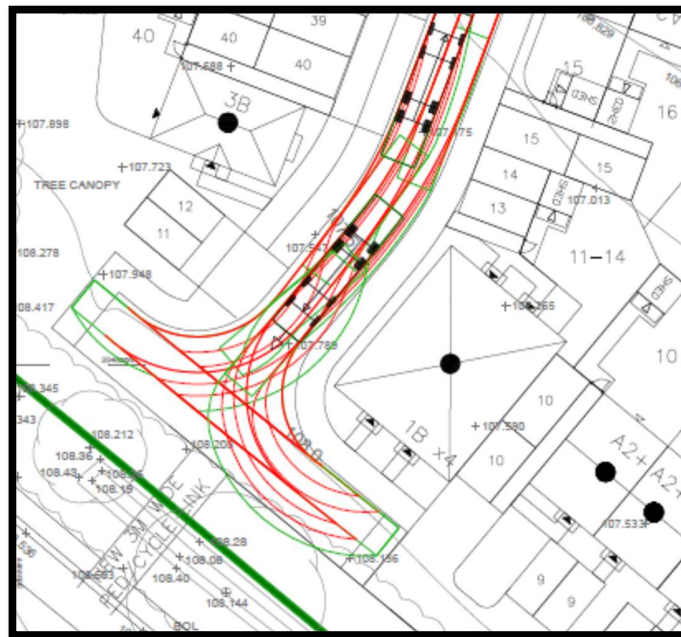
Image Nr 4

Location: Turning head at the southern end of Road 2

Summary: Risk of collisions between pedestrians and vehicles

Drawings for vehicle swept paths for a 4-axle refuse vehicle and a fire appliance have been submitted for analysis. An extract of the swept path for a 4-axle refuse vehicle is shown in image number 4 above. The swept path shows how the vehicle will carry out a 180° manoeuvre to leave the turning head in a forward gear. Unfortunately, the swept path shows that the vehicle has to mount the eastern kerb in order to carry out this manoeuvre, with the risk of colliding with a pedestrian walking along the path. This situation may result in injuries.

Recommendation

It is recommended that the design of the turning head is adjusted to ensure that the swept path for a 4 axle refuse vehicle does not mount any kerbs and therefore prevents potential conflicts with pedestrians.

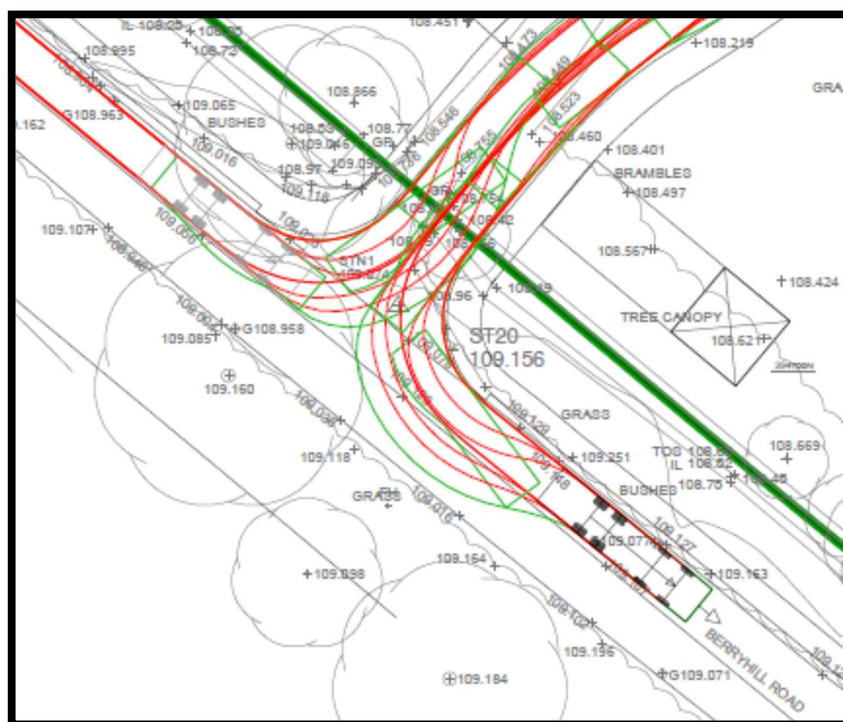
Image Nr 5

Location: Junction of development access (Road 1) and Berry Hill Road

Summary: Risk of side impact vehicle collisions

An extract of the swept path for a 4 axle refuse vehicle is shown in image number 5 above. The swept path shows how the vehicle will enter and leave the development Road 1. It also shows that when the vehicle leaves the site, it has to use the opposing lane in order to continue its journey eastwards. As Berry Hill Road is a very well used road, there is the risk of vehicle collisions between the refuse vehicles and other road users. This may result in injuries.

Recommendation

It is recommended that the design of the radii at the junction is amended to ensure that the swept path for the vehicle does not enter the opposing lane.
