MERSEYSIDE
FIRE & RESCUE
SERVICE

SIGNIFICANT INCIDENT REPORT

Incident: 018965 - 15092020

Address: Orsted BESS, Carnegie Road, Liverpool, L137HY

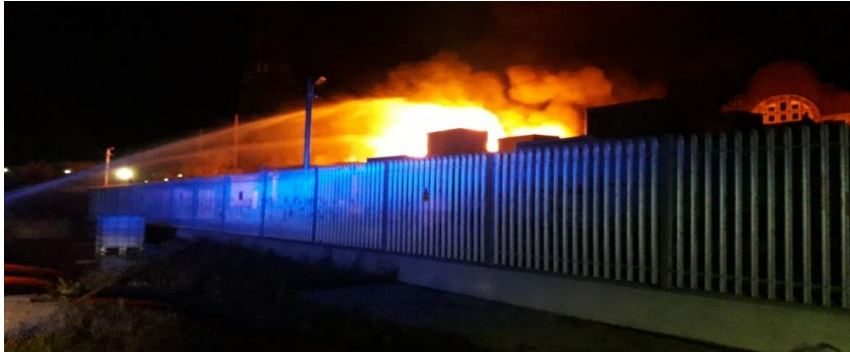
Firefighting action from Sector 1.

2 ground monitors at work.

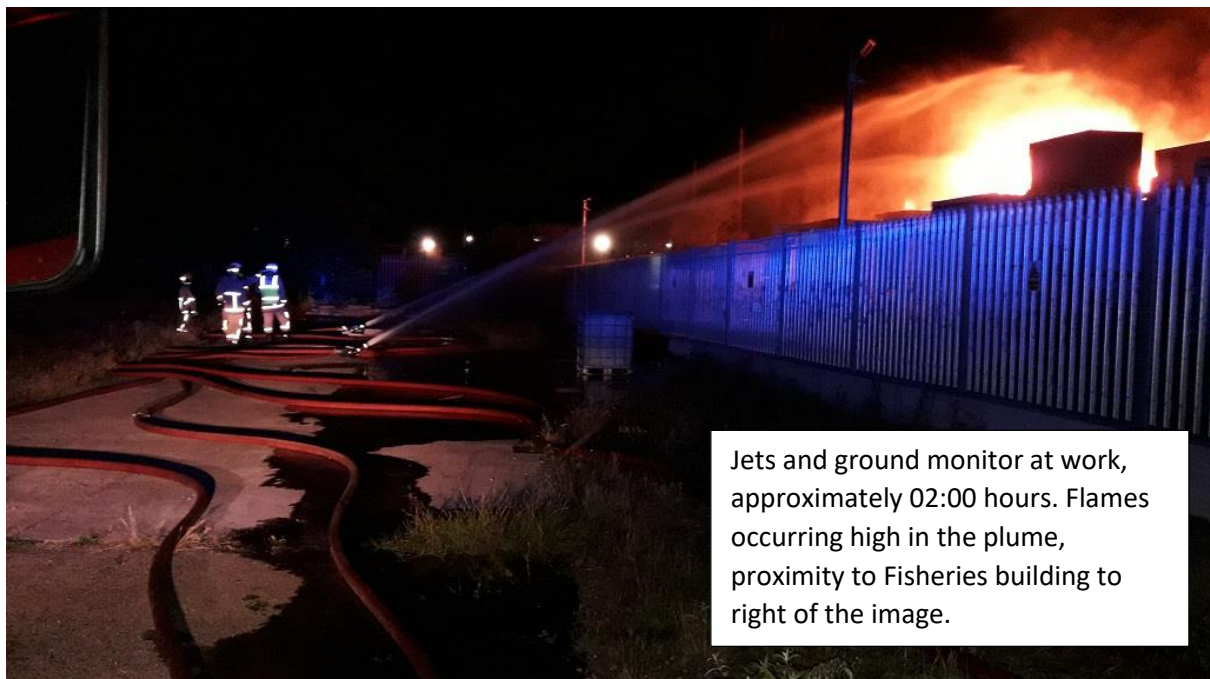
Jets and ground monitor at work, approximately 02:00 hours. Flames occurring high in the plume, proximity to Fisheries building to right of the image.

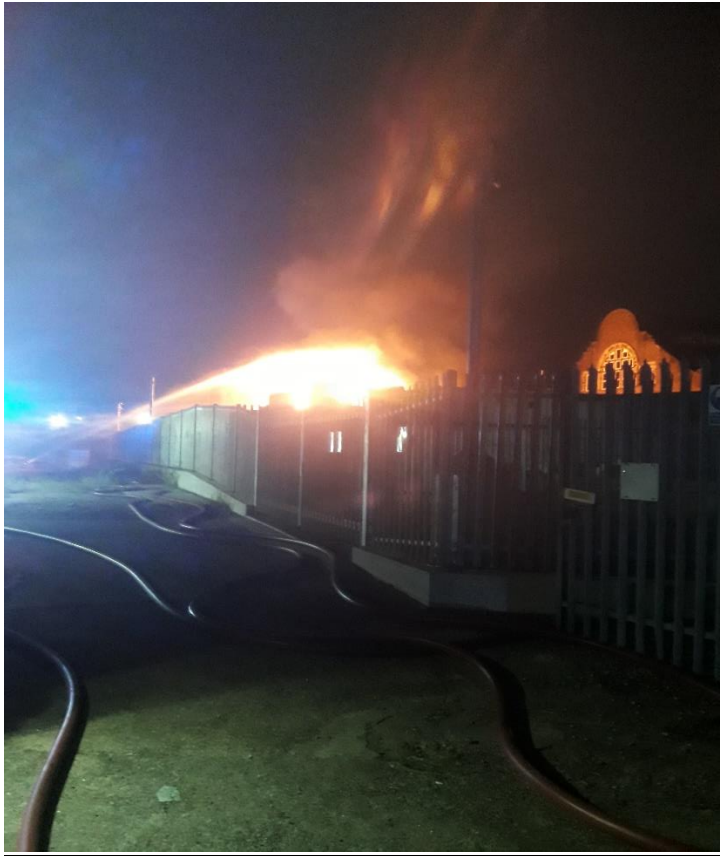
Ground monitors in use and personnel upwind of plume approximately 03:00 hours.

Information on plume toxicity gained at this point.

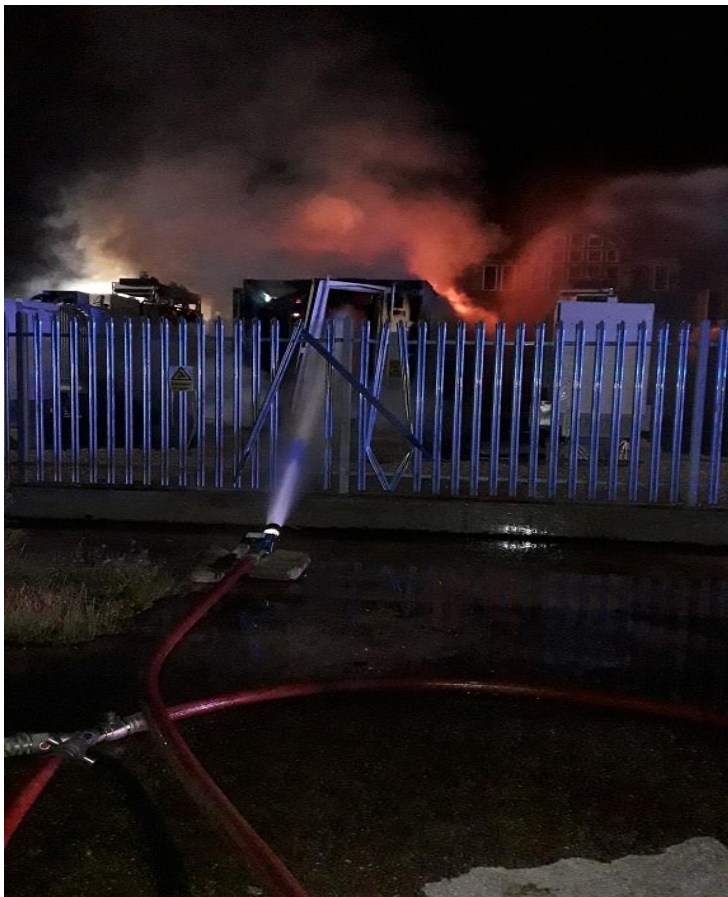
Ground monitor in use at approximately 05:15hrs.

Note sections of railings opened by MFRS to allow straight play of monitor jet.

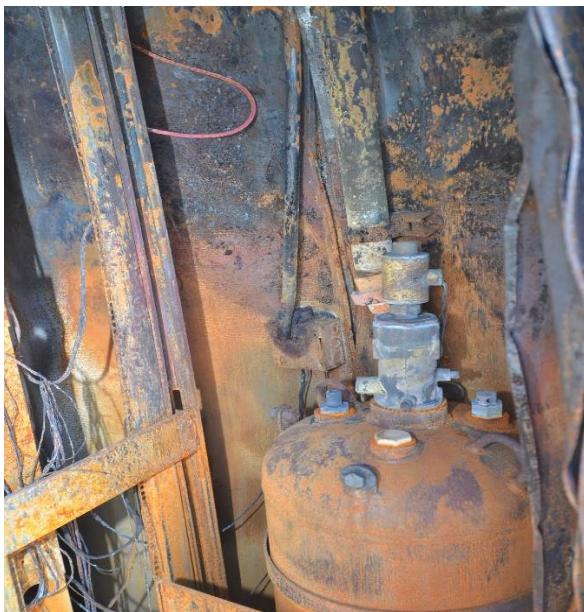
Image below left: Fire damaged NOVEC 1230 unit.

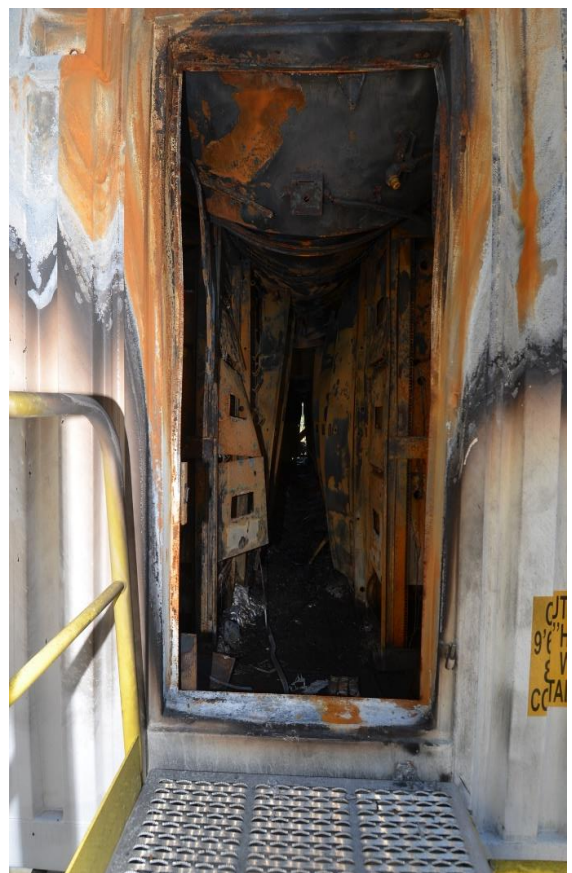
Image below right: Internal view of modules.
