# Asbestos Survey Report (Demolition Survey)

**Bodicote Flyover Farm Shop  
White Post Road  
Bodicote  
Banbury  
OX15 4BN**

Date	30/11/2021
Surveyor(s)	Steve Yells and Assistant
Version	1

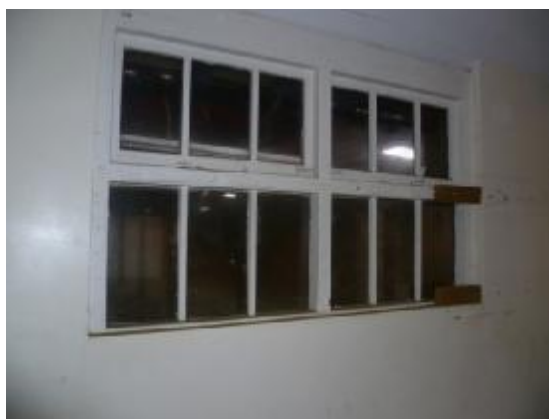
**Location:** Bodicote Flyover Farm Shop OX15 4BN  
**Observation No:** 1  
**Survey Means:** Visual Inspection  
**Photo:**

**Risk Category\*:** D  
**Floor:** Ground Floor  
**Area:** Large Storage Office  
**Material:** Putty to Metal Window Frames  
**Surface Treatment:** Sealed  
**Condition\*:** Fair  
**Accessibility\*:** Occasionally Disturbed  
**Extent:** 2 LM  
**Asbestos Type:**  
**Access Precaution:** None  
**Recommended Labelling:** None  
**Recommended Action:** No Further Action Required  
**Identification Level:** Verified  
**Additional Detail:** Sample No BFS/SY/111/001

**Analysis Result:** No Asbestos Detected  
**Notes:**

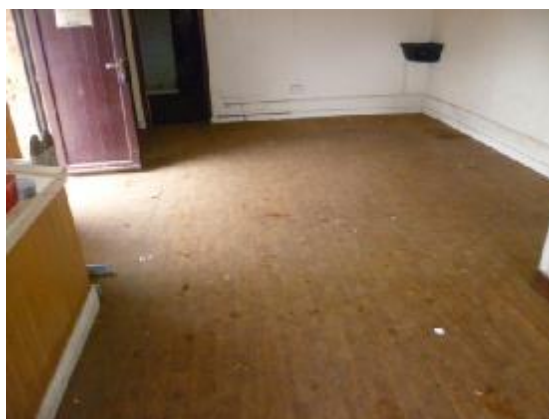
**Location:** Bodicote Flyover Farm Shop OX15 4BN  
**Observation No:** 2  
**Survey Means:** Visual Inspection  
**Photo:**

**Risk Category\*:** D  
**Floor:** Ground Floor  
**Area:** Shop  
**Material:** Vinyl Flooring & Adhesive (under more modern vinyl sheets)  
**Surface Treatment:** Sealed  
**Condition\*:** Fair  
**Accessibility\*:** Occasionally Disturbed  
**Extent:** 45 m2  
**Asbestos Type:**  
**Access Precaution:** None  
**Recommended Labelling:** None  
**Recommended Action:** No Further Action Required  
**Identification Level:** Verified  
**Additional Detail:** Sample No BFS/SY/111/002

**Analysis Result:** No Asbestos Detected  
**Notes:**

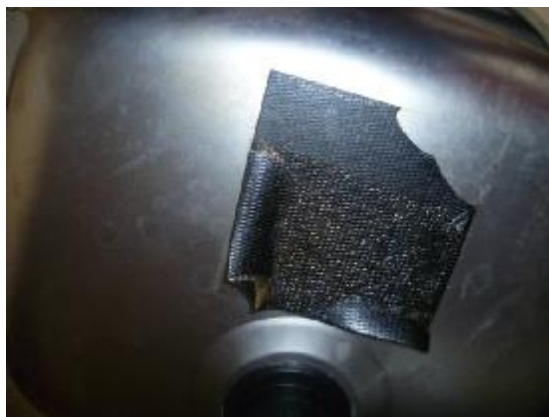
**Location:** Bodicote Flyover Farm Shop OX15 4BN  
**Observation No:** 3  
**Survey Means:** Visual Inspection  
**Photo:**

**Risk Category\*:** D  
**Floor:** Ground Floor  
**Area:** Kitchen  
**Material:** Mastic Pad to Sink Unit  
**Surface Treatment:** Sealed  
**Condition\*:** Fair  
**Accessibility\*:** Occasionally Disturbed  
**Extent:** 1 no  
**Asbestos Type:**  
**Access Precaution:** None  
**Recommended Labelling:** None  
**Recommended Action:** No Further Action Required  
**Identification Level:** Verified  
**Additional Detail:** Sample No BFS/SY/111/003

**Analysis Result:** No Asbestos Detected  
**Notes:**

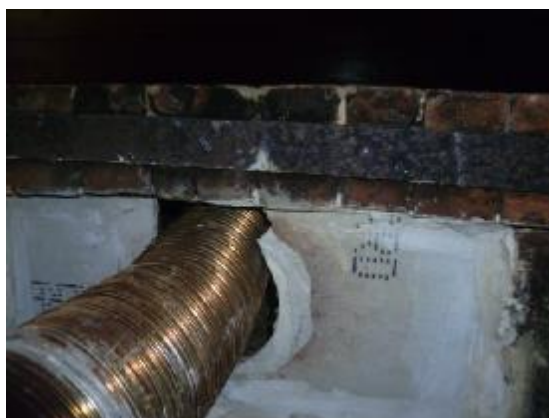
**Location:** Bodicote Flyover Farm Shop OX15 4BN  
**Observation No:** 4  
**Survey Means:** Visual Inspection  
**Photo:**

**Risk Category\*:** D  
**Floor:** Ground Floor  
**Area:** Office  
**Material:** Fire Register Plate  
**Surface Treatment:** Sealed  
**Condition\*:** Fair  
**Accessibility\*:** Occasionally Disturbed  
**Extent:** 10 m2  
**Asbestos Type:**  
**Access Precaution:** None  
**Recommended Labelling:** None  
**Recommended Action:** No Further Action Required  
**Identification Level:** Verified  
**Additional Detail:** Sample No BFS/SY/111/004

**Analysis Result:** No Asbestos Detected  
**Notes:**

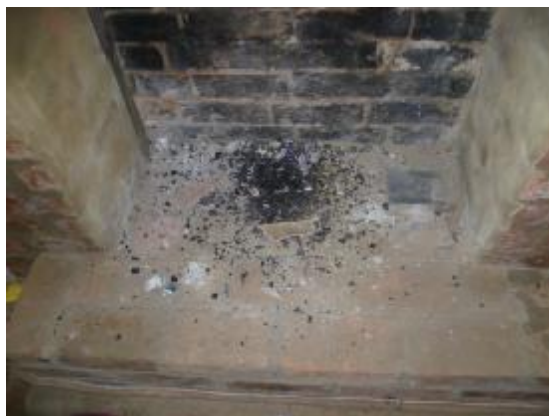
**Location:** Bodicote Flyover Farm Shop OX15 4BN  
**Observation No:** 5  
**Survey Means:** Visual Inspection  
**Photo:**

**Risk Category\*:** D  
**Floor:** Ground Floor  
**Area:** Office  
**Material:** Debris in Fire Place  
**Surface Treatment:** Unsealed  
**Condition\*:** Poor  
**Accessibility\*:** Occasionally Disturbed  
**Extent:** 1 m2  
**Asbestos Type:**  
**Access Precaution:** None  
**Recommended Labelling:** None  
**Recommended Action:** No Further Action Required  
**Identification Level:** Verified  
**Additional Detail:** AS per sample No BFS/SY/111/004

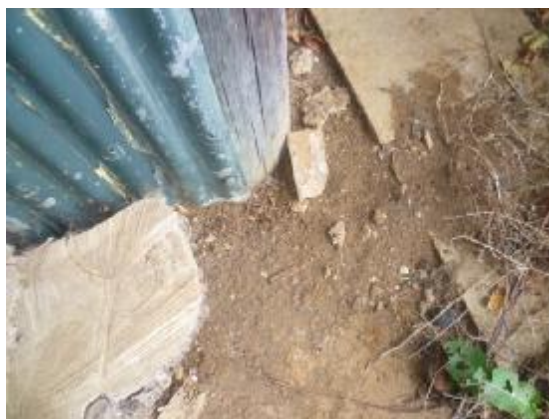
**Location:** Bodicote Flyover Farm Shop OX15 4BN  
**Observation No:** 6  
**Survey Means:** Visual Inspection  
**Photo:**

**Risk Category\*:** B  
**Floor:** Ground Floor  
**Area:** Log Shed  
**Material:** Debris  
**Surface Treatment:** Unsealed  
**Condition\*:** Poor  
**Accessibility\*:** Occasionally Disturbed  
**Extent:** NQ  
**Asbestos Type:** Cement  
**Access Precaution:** None  
**Recommended Labelling:** None  
**Recommended Action:** Remove following ACoP and dispose of as special waste prior to works commencing  
**Identification Level:** Verified  
**Additional Detail:** Sample No BFS/SY/111/005

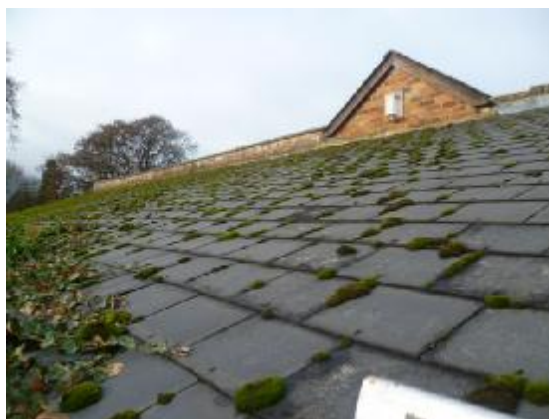
**Location:** Bodicote Flyover Farm Shop OX15 4BN  
**Observation No:** 7  
**Survey Means:** Visual Inspection  
**Photo:**

**Risk Category\*:** C  
**Floor:** Roof Level  
**Area:** Rear Store  
**Material:** Roof Slates  
**Surface Treatment:** Unsealed  
**Condition\*:** Fair  
**Accessibility\*:** Occasionally Disturbed  
**Extent:** 150 m2  
**Asbestos Type:** Cement  
**Access Precaution:** None  
**Recommended Labelling:** None  
**Recommended Action:** Remove following ACoP and dispose of as special waste prior to works comm  
**Identification Level:** Verified  
**Additional Detail:** Sample No BFS/SY/111/006

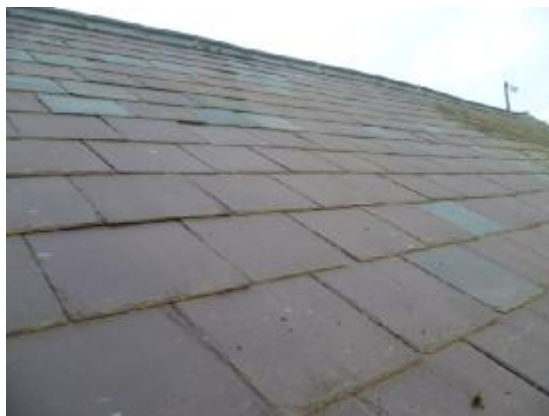
**Location:** Bodicote Flyover Farm Shop OX15 4BN  
**Observation No:** 8  
**Survey Means:** Visual Inspection  
**Photo:**

**Risk Category\*:** D  
**Floor:** Roof Level  
**Area:** Office Roof  
**Material:** Roof Slates  
**Surface Treatment:** Unsealed  
**Condition\*:** Fair  
**Accessibility\*:** Occasionally Disturbed  
**Extent:** 35 m2  
**Asbestos Type:**  
**Access Precaution:** None  
**Recommended Labelling:** None  
**Recommended Action:** No Further Action Required  
**Identification Level:** Verified  
**Additional Detail:** Sample No BFS/SY/111/007

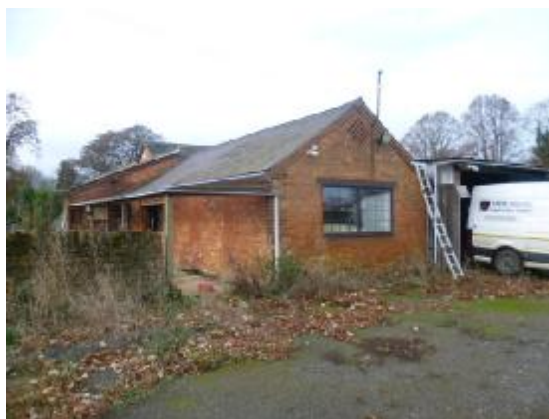
**Location:** Bodicote Flyover Farm Shop OX15 4BN  
**Observation No:** 9  
**Survey Means:** Visual Inspection  
**Photo:**

18	C	Roof Level Shop Roof	Roof Slates	Verified	Chrysotile Asbestos Detected	Remove following ACoP and dispose of as special waste

**Risk Category\*:** C  
**Floor:** Roof Level  
**Area:** Shop Roof  
**Material:** Roof Slates  
**Surface Treatment:** Unsealed  
**Condition\*:** Fair  
**Accessibility\*:** Occasionally Disturbed  
**Extent:** 70 m2  
**Asbestos Type:** Cement  
**Access Precaution:** None  
**Recommended Labelling:** None  
**Recommended Action:** Remove following ACoP and dispose of as special waste prior to works comm  
**Identification Level:** Verified  
**Additional Detail:** Sample No BFS/SY/111/008
