CEDAR LODGE NORTH SIDE STEEPLE ASTON BICESTER OX25 4SE

CONVERSION OF EXISING OUTBUILDINGS TO PROVIDE POOL AREA CHANGING / POOL PLANT. IN ADDITION - UPGRADE EXISTING ANCILLARY ACCOMMODATION.

OUTLINE SCHEDULE OF WORKS

September 2023

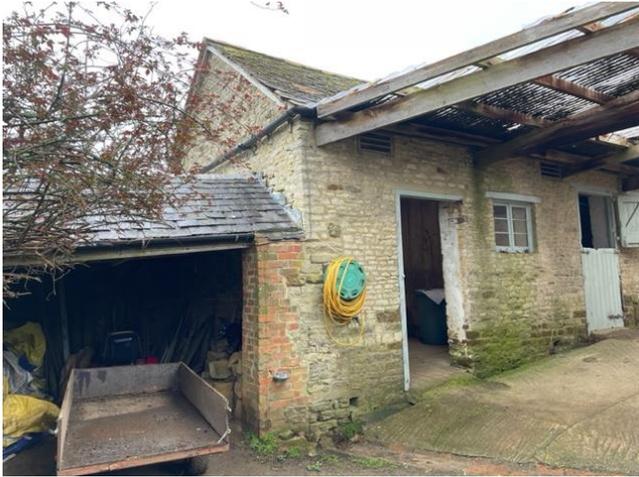
1 Single storey out-building with infill pole barn

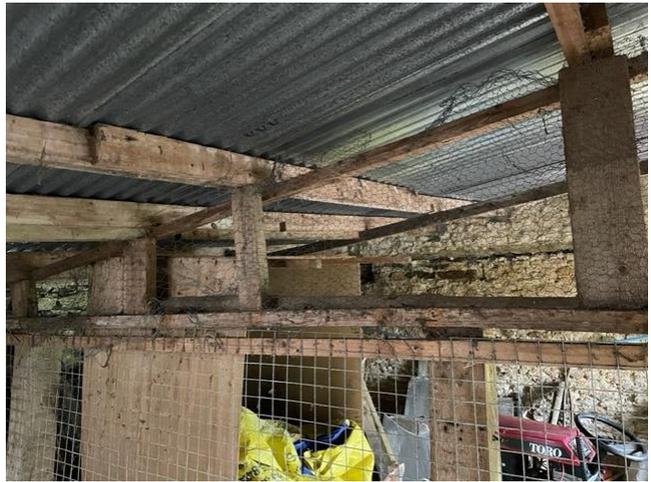
2 Interior of attached pole barn with metal corrugated roofing

2.1 Garden Lounge : Demolish existing pole barn structure between retained masonry gable walls. Remove roof structure and corrugated metal roof-coverings. Carefully remove rear stone walling and set aside good sound squared stones for re-use in repaired walling.

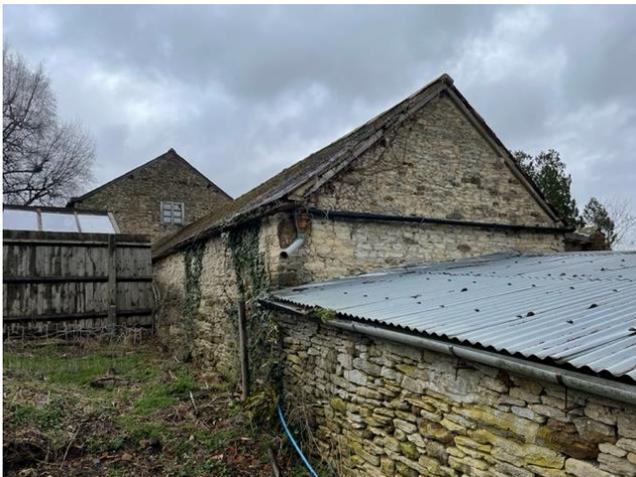
3 / 4 rear wall of out-building – poolside

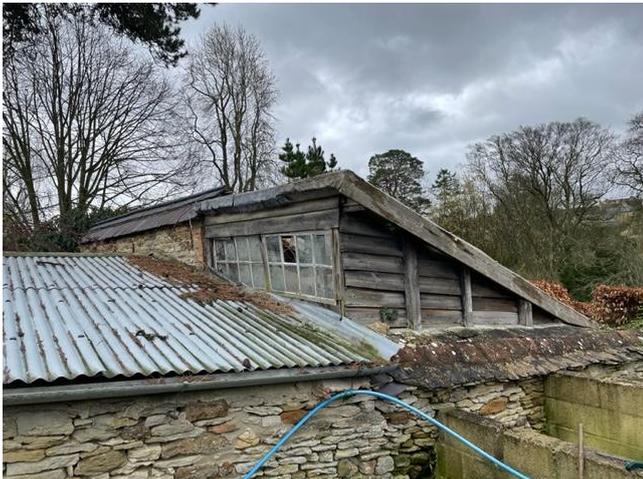
5 Corrugated metal roof / Timber over-build

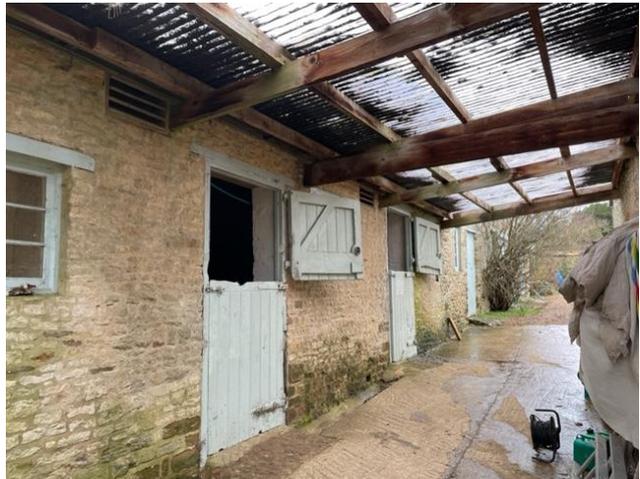
6 Single storey out-building (East) with canopy

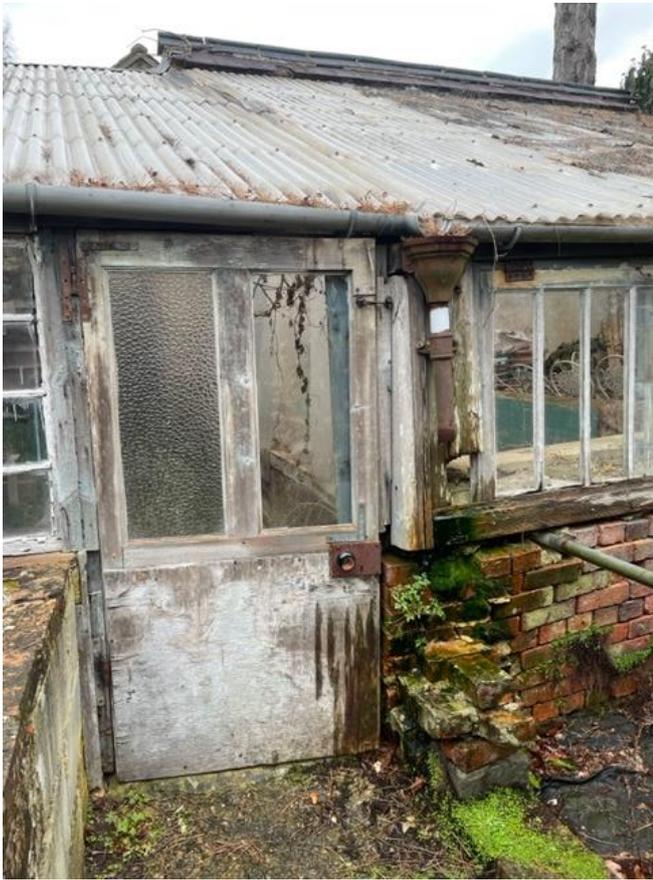
2.7 Glasshouse : This building is derelict – built as a lean-to off a large masonry cross wall – the timber rafters are severely defective and support an existing corrugated uPvc roofing which will be replaced with like profile 175 x 63mm hardwood sections for overlapping safety glass panels in the traditional glass house method. The glasshouse hosts a concrete tank which will be retained thoroughly cleaned and over-coated with a waterproof seal coat. Water supply and filtration will be supplied to facilitate the instatement of the tank as a lily pond.

7 Glass house with uPvc translucent roofing

8 Derelict condition of glass house

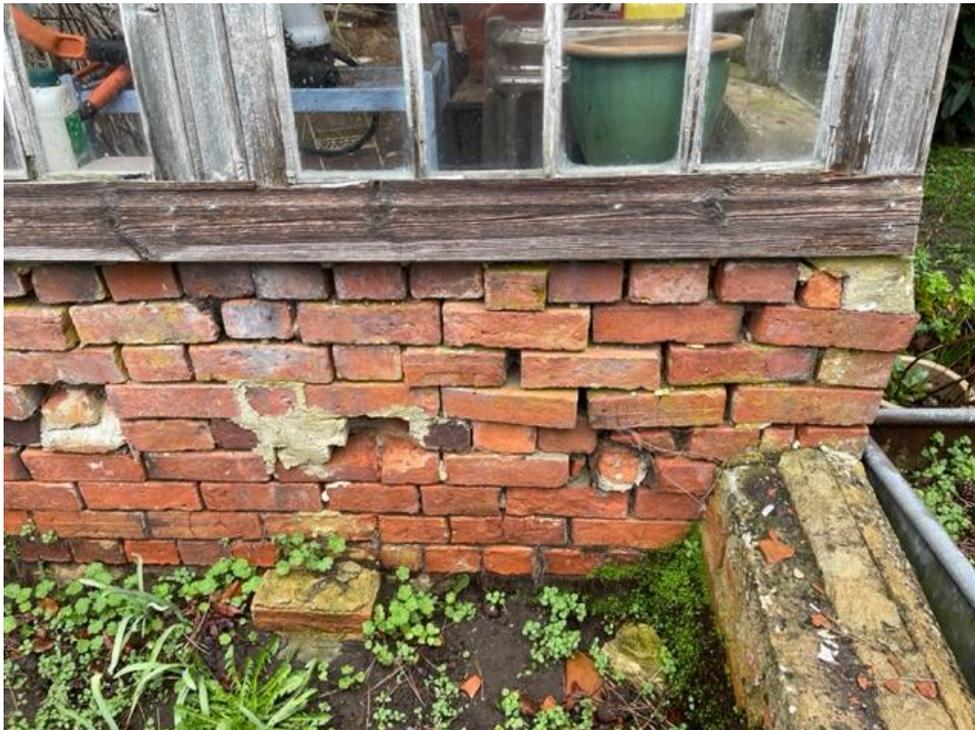
9 Defective brick plinth to glass house

The defective plinth walls to be removed and re-constructed with salvaged red stock clay bricks built off a new concrete strip foundation which will provide support for the replaced glazed timber wall frames and new glass roof.

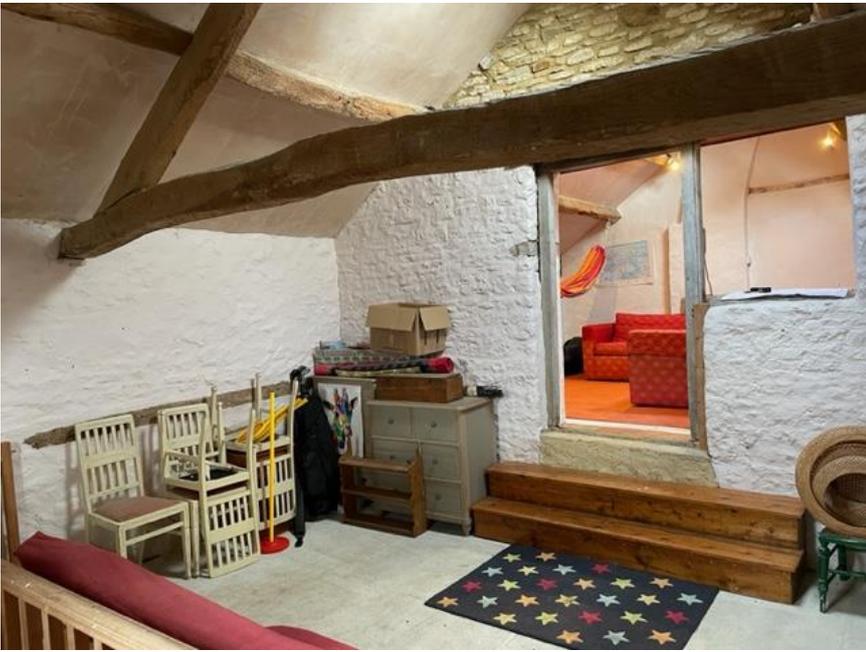
10/11/12 Upper rooms in out-building

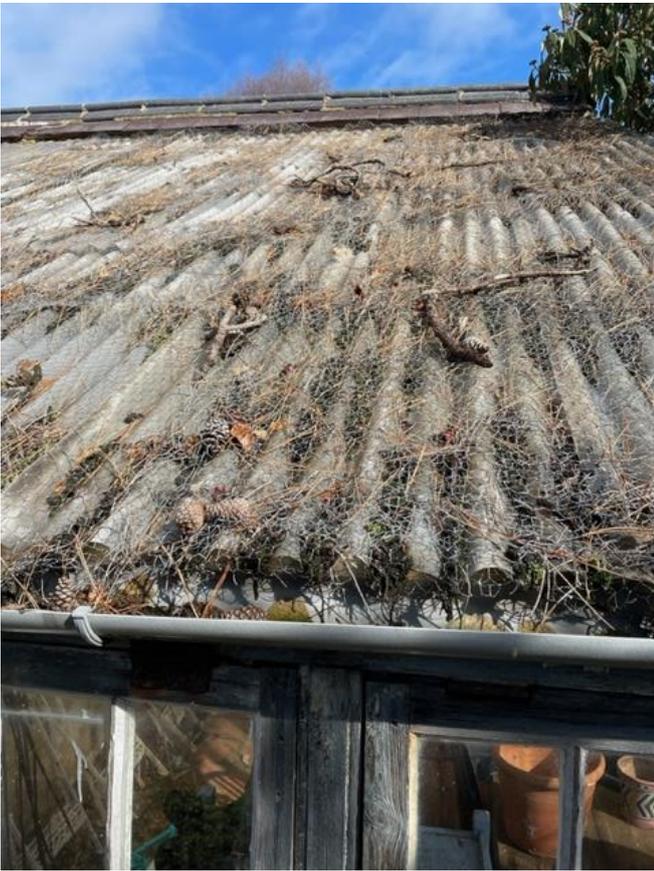
13 Translucent uPvc roof over glass house

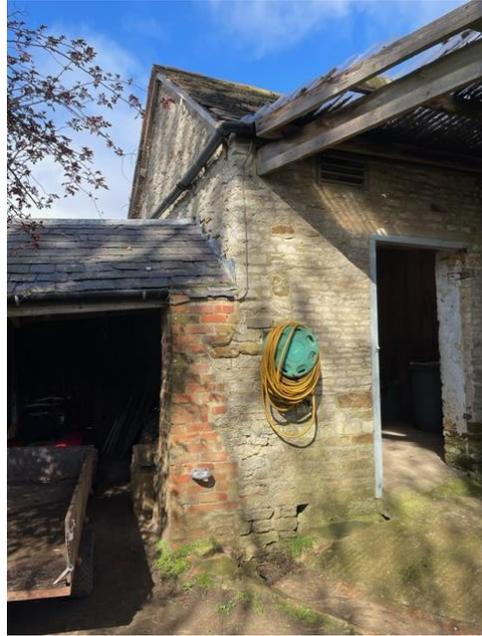
14 Abutment of open lean-to

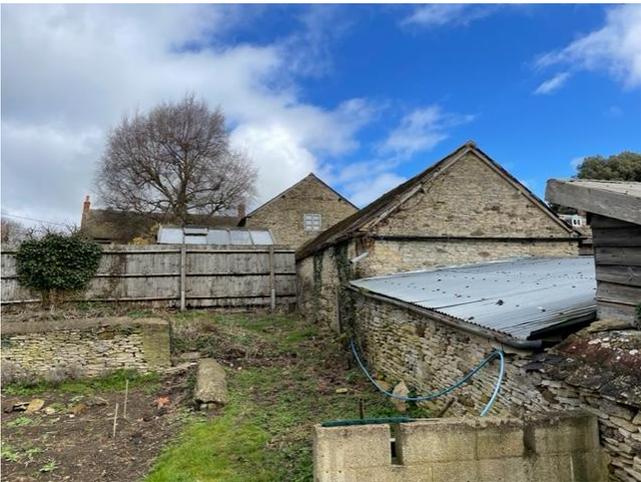
15 View of rear outbuildings - poolside

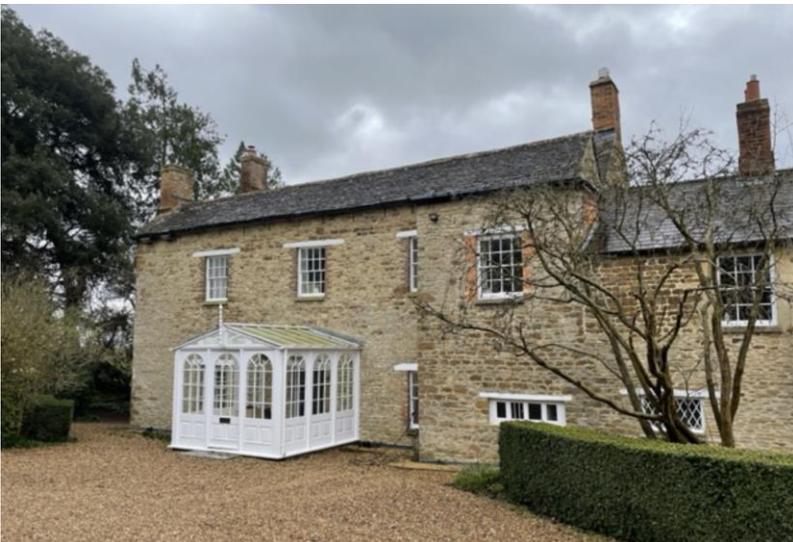
16 Cedar Lodge North Elevation
