## Detailed UXO Risk Assessment

FIL Reference: 2979R

The site is located at Launton on the former airfield, RAF Bicester in Oxfordshire. The site is centered on the coordinates 459673 E and 223945 N and is approx. 52,000m<sup>2</sup> in size.

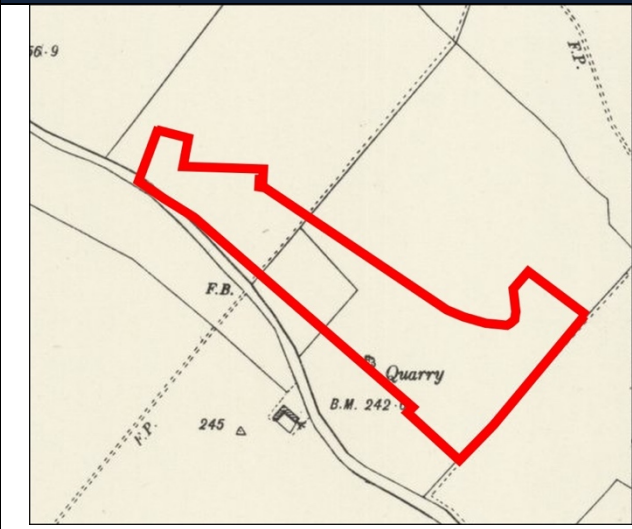
| OS Map | |
|---|---|
| <p>Showing a section of 1896 OS mapping. Showing the site as farmland, with a small quarry.</p> | <p>Showing a section of the 2020 revision of OS mapping. The airfield construction can be seen.</p> |

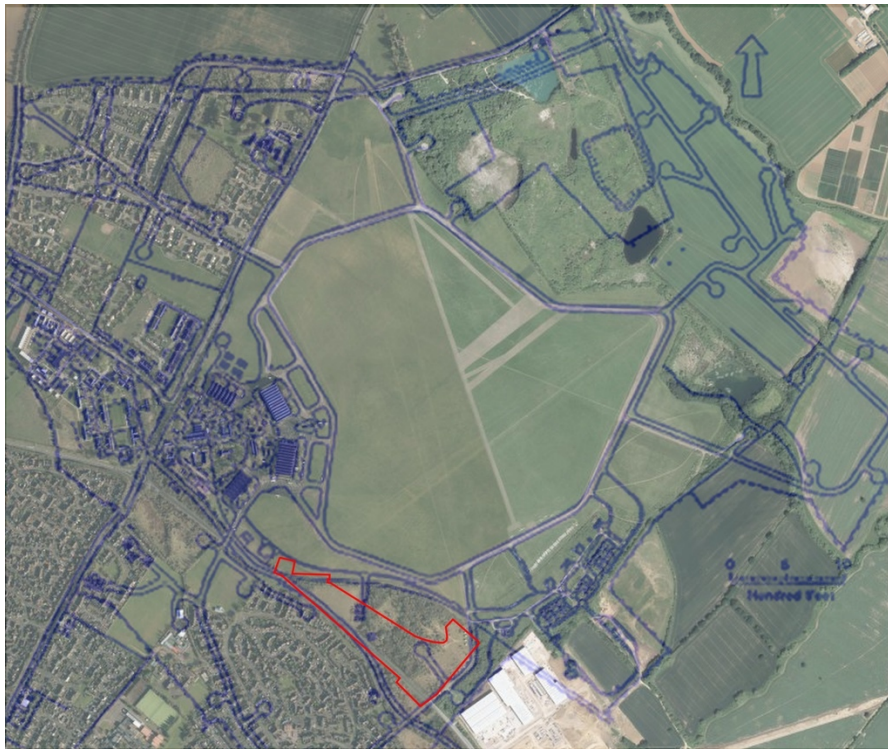
Figure 2. Showing Satellite Imagery with airfield map overlaid

The site resides within the boundary of the ex-RAF airfield - RAF BICESTER. The site is adjacent to the airfield bomb store. The southern part of the site is within the bomb store boundary and includes a bomb fuzing point building.
