H. Site walkover technical note

Project:	Oxford United Stadium		
Our reference:	100111993	Your reference:	-
Prepared by:	P Fitt / C Evans	Date:	20/07/23
Approved by:	-	Checked by:	M Webb
Subject:	Site walkover key observations

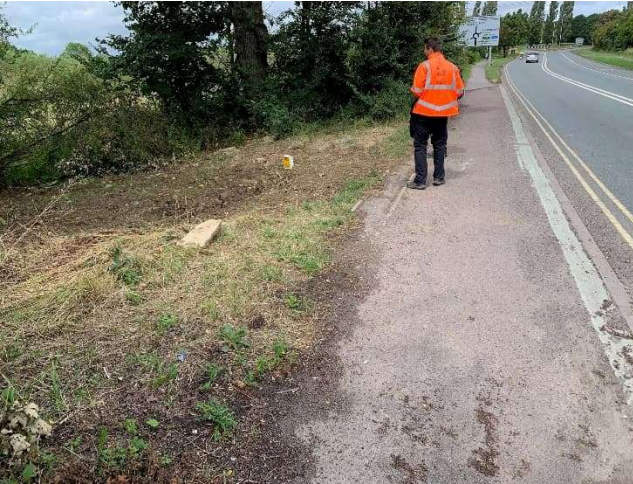
Figure A.1: Ground disturbance potentially associated with gas main, eastern site boundary

Ground disturbance noted on site perimeter, potentially associated with a gas main. See **Figure A.1** within Site Walkover Note.

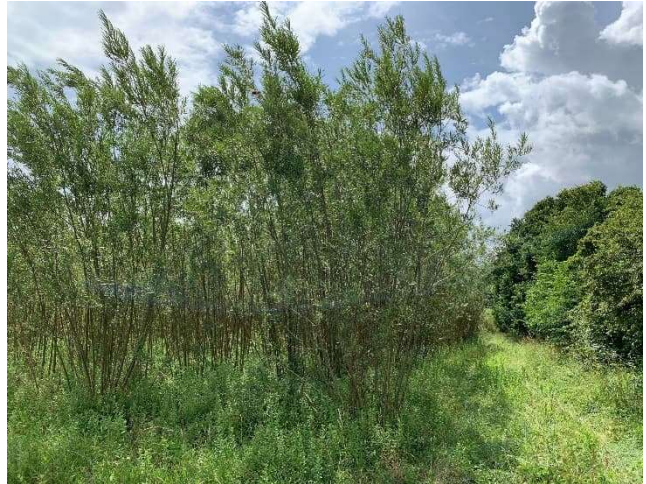
Figure A.2: Site condition in north-west area (facing south) – Willow farm

See **Figure A.2** within Site Walkover Note.

- Traffic management – it is anticipated that some form of traffic management would be required to access the site, due to the narrow entrance from a 40mph road (Figure A.8)
- It is likely that vegetation clearance of various degrees would be required to access most of the locations (e.g., see Figure A.2). This is likely to require consultation with an appropriately qualified ecologist.
- As part of the GI tender, we would recommend that allowance is made for a site walkover with the successful GI Contractor. This would be to confirm access arrangements, exploratory hole locations and any ground preparation required due to the restrictions at the site

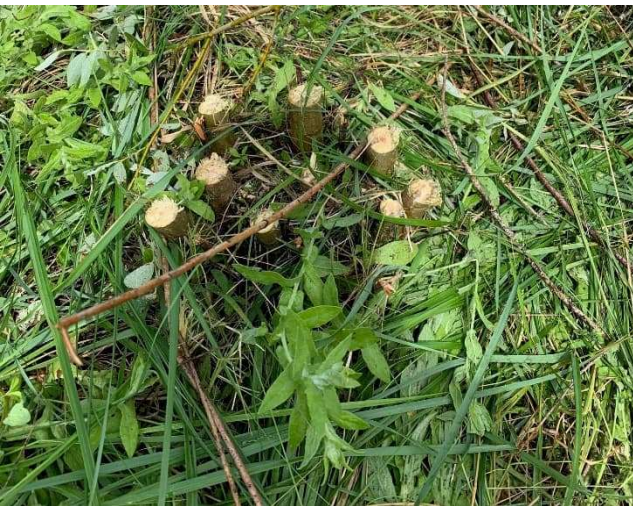
- The willow is coppiced to ground level every 3 – 4 years (on average), this appeared to be at c. 4- 5m height. (see Figures A.2 to A.4).
- On the day of the walkover the site was at its driest during the year.

Figure A.3: Coppiced Willow at ground level

Willow being coppiced during walkover. See **Figure A.3** within Site Walkover Note.

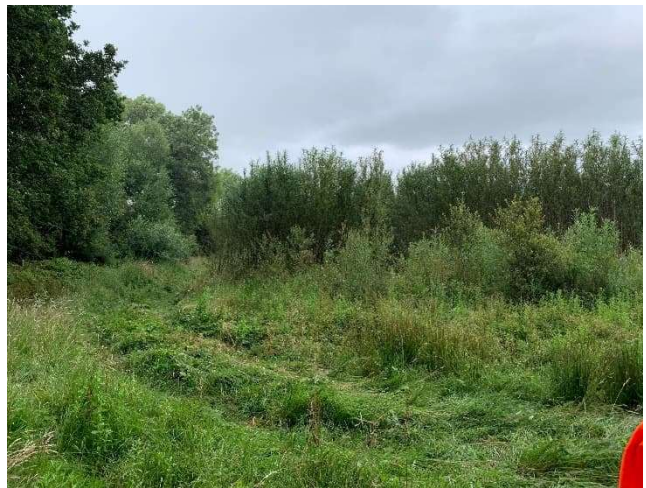
Figure A.4: Site condition in south-western corner (facing north). Access track overgrown

Overgrown access tracks. See **Figure A.4** within Site Walkover Note.

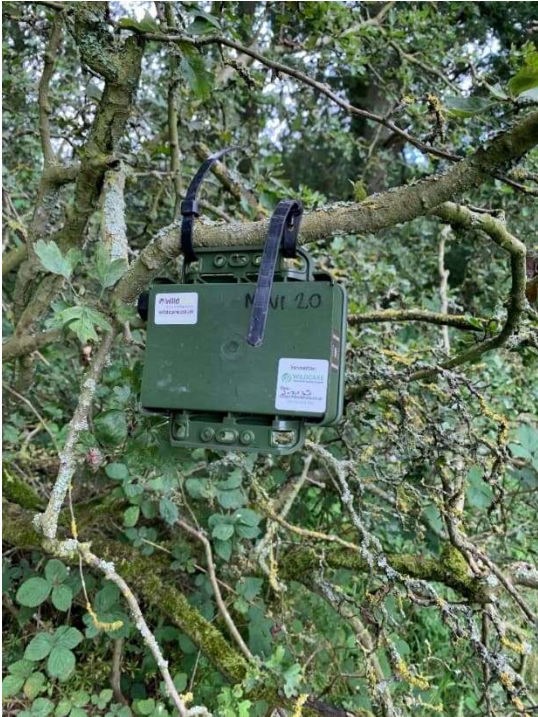
- Ecological features were noted including an ultrasonic recording device (Figure A.5) which may potentially suggest recording of bat activity at Stratfield Brake.

Figure A.5: Evidence of ecological monitoring (ultrasonic) at the edge of Stratfield Brake

Evidence of environmental monitoring (ultrasonic device). See **Figure A.5** within Site Walkover Note.

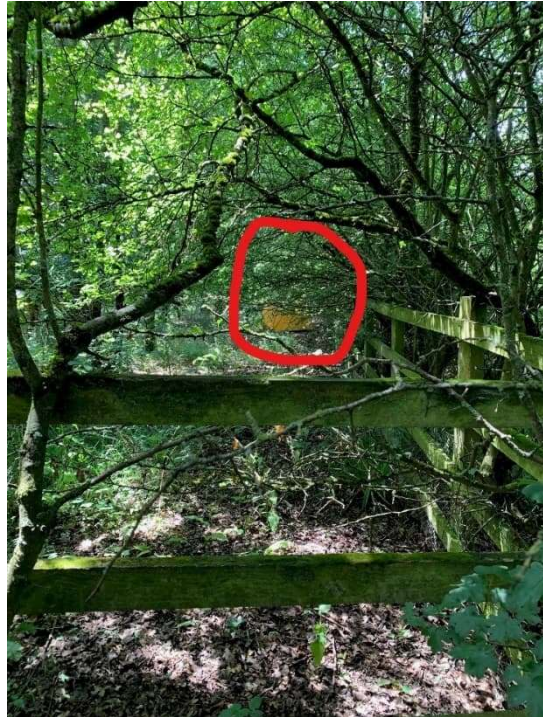
- In the south-east area of Stratfield Brake potential signs of squatting were observed – there was an old, damaged tent, drinks cans/glass and one tent which was up and looked relatively unscathed (Figure A.6). The tenant's also suggested people were previously accessing the site through the gate. On the walkover after observing this we avoided this area to reduce the chance of any potential confrontation.

Figure A.6: Evidence of squatting in Stratfield Brake (south-eastern corner of the site)

Evidence of squatting (erected tent). See **Figure A.6** within Site Walkover Note.

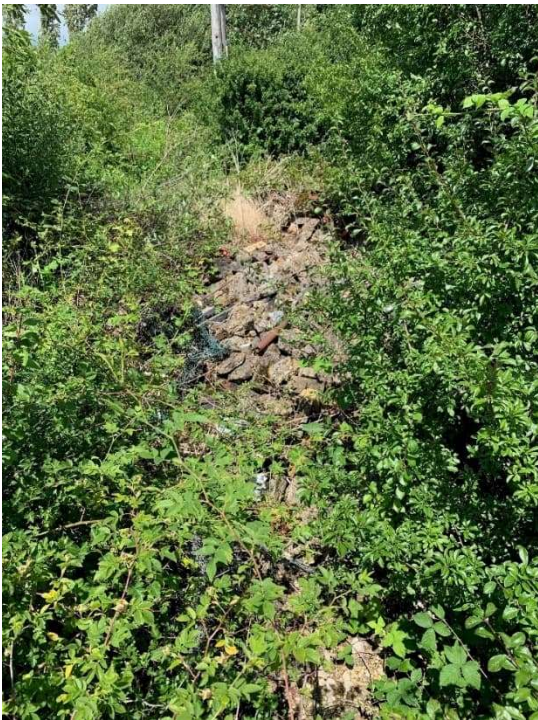
Figure A.7: Construction rubble north of gated entrance

Evidence of construction rubble north of site entrance. See **Figure A.7** within Site Walkover Note.

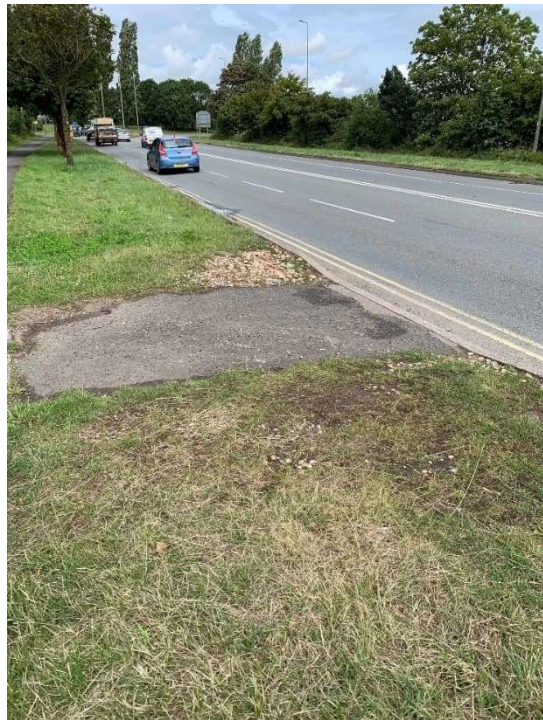
Figure A.8: Site access from Oxford Road (facing north-east)

Site access from Oxford Road. See **Figure A.8** within Site Walkover Note.

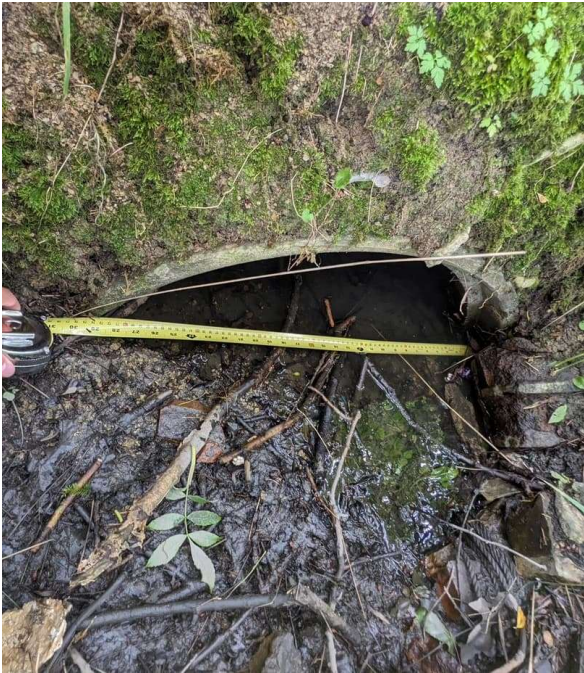
Figure A.9: Existing silted culvert

Existing culvert unmaintained and is ~85% blocked with debris/silt. Approximate diameter of culvert ~825mm. Culvert construction is concrete. Further investigation required however initial findings suggest true invert level is ~600mm lower than recorded on topo if cleared of debris/silt i.e. Topo suggested invert level = 62.9mAOD True invert level = 62.3mAOD. See **Figure A.9** within Site Walkover Note.

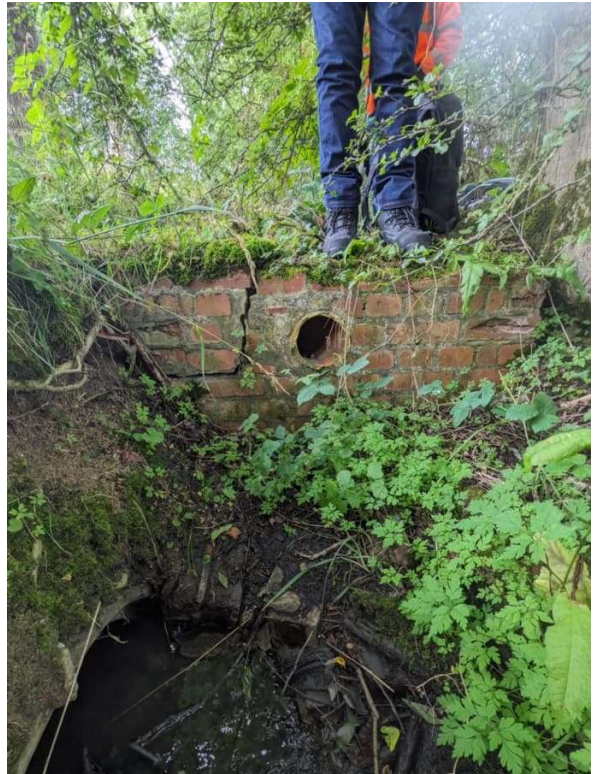
Figure A.10: Outlet within wall adjacent culvert

North face of ditch brick wall construction. Outlet pipe within wall, however unable to located upstream inlet within walled section of upstream ditch. Inlet pipe angles from east to west, which may suggest that ditch receives flow from highway filter drain. See **Figure A.10** within Site Walkover Note.

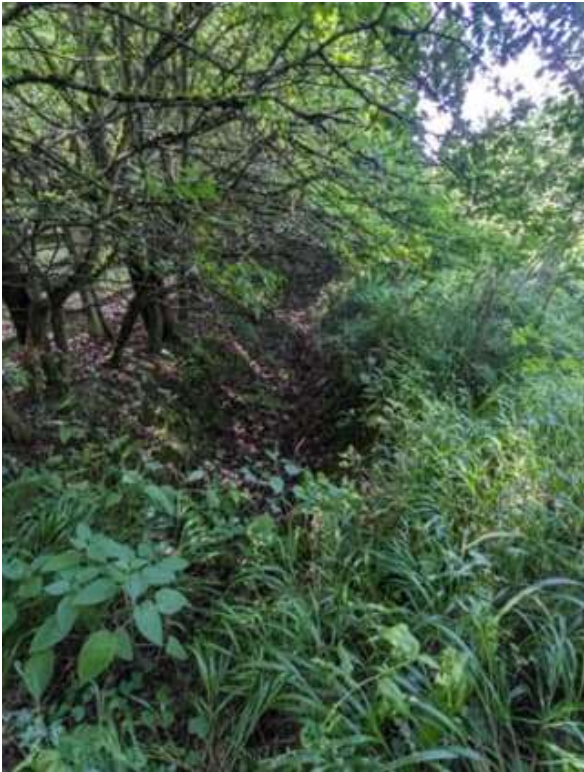
Figure A.11: Head of existing ditch south of proposed OUFC site

Confirmed that the ditch starts here i.e. no connection from southern site ditch. Condition of ditch appeared unmaintained and overgrown. See **Figure A.11** within Site Walkover Note.

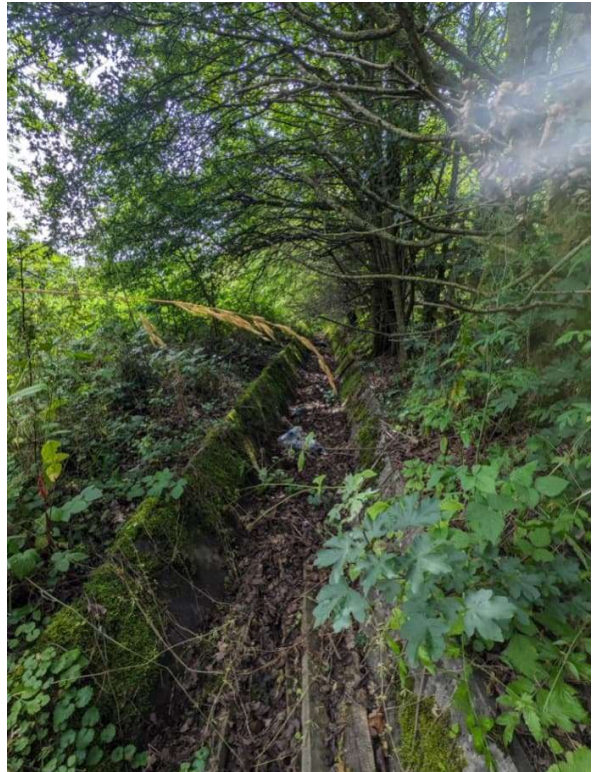
Figure A.12: Existing ditch east of southern site

Observed ditch on southern face of site. Ditch construction appeared to be a lined base with concrete pavers/section forming the sides. Area was too overgrown to determine where the ditch originated, however looking upstream the ditch continued for a hundred metres or so. Fall of ditch is from south-west to north-east (as indicated by arrow). Condition of ditch appeared fair, however unmaintained with debris and leaves within base of ditch. See **Figure A.12** within Site Walkover Note.

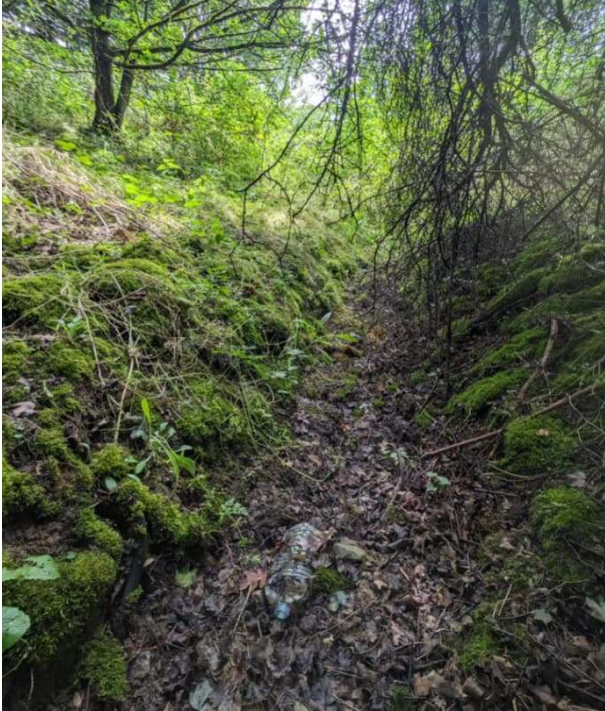
Figure A.13: Existing ditch east of proposed OUFC site

Observed ditch on eastern face of site (at the foot of the 1:2 slope from road level to site level). Area was too overgrown to determine where the ditch originated. Fall of ditch is from north-west to south-east (as indicated by arrow). Condition of ditch appeared fair, however unmaintained with debris and leaves within base of ditch. See **Figure A.13** within Site Walkover Note.

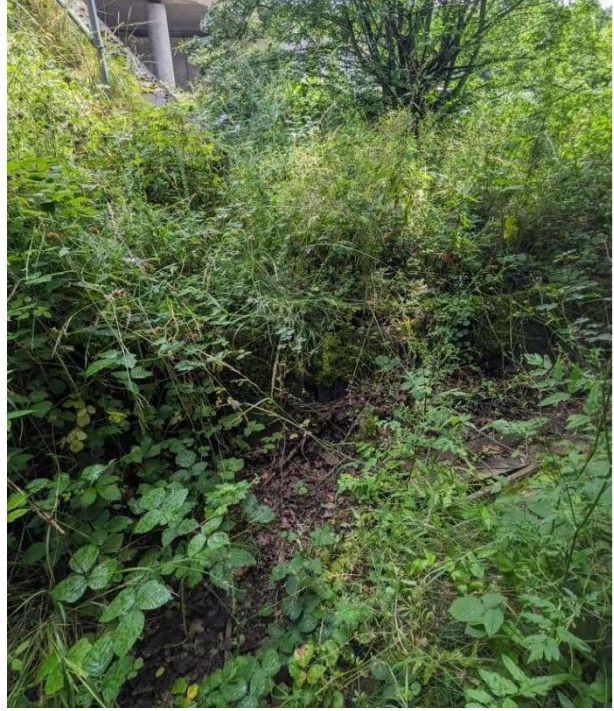
Figure A.14: Convergence of east ditch within proposed OUFC site and east ditch within southern site

Both ditches intercept at a low spot as indicated. No obvious discharge feature from this low spot and convergence of ditches. Ground levels within ditch appeared to be considerably lower than the southern ditch serving the proposed OUFC site. See **Figure A.14** within Site Walkover Note.

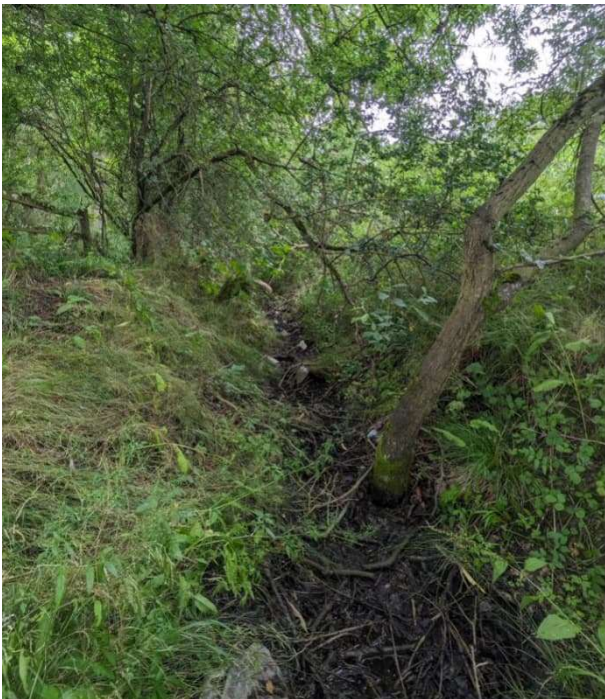
Figure A.15: Existing ditch west of proposed OUFC site (ditch adjacent Frieze Way carriageway)

Unable to observe ditch further upstream due to area overgrown. See **Figure A.15** within Site Walkover Note.

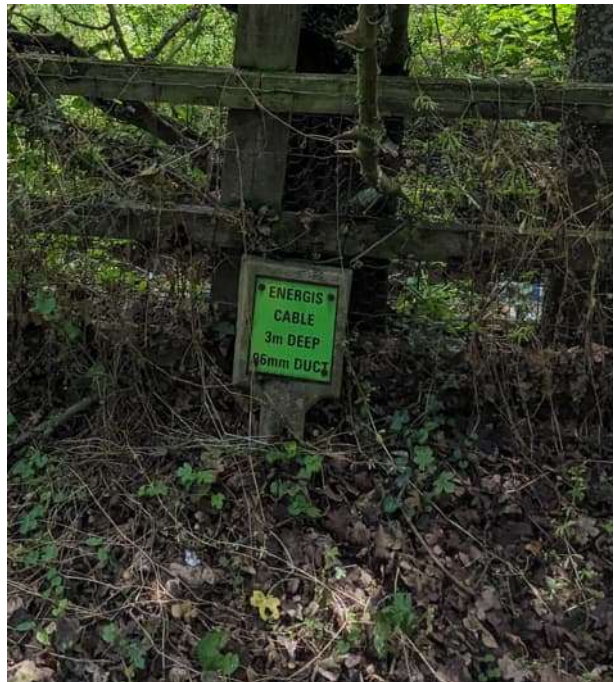
- Existing utility marker post located in the southeast corner that read 'ENERGIS CABLE 3m DEEP 96mm DUCT'. From review of the C2 results this appears to be the existing telecoms cable that runs south to north. See Figure A.16.

Figure A.16: Existing utility marker post located in southeast corner of site
