Operational Inspection

Banbury Longford Park Development Phase 1

Inspection Ref: 1919439

Operational Inspection - 16-January-2023 - 10:04 Inspector Mark Perkins

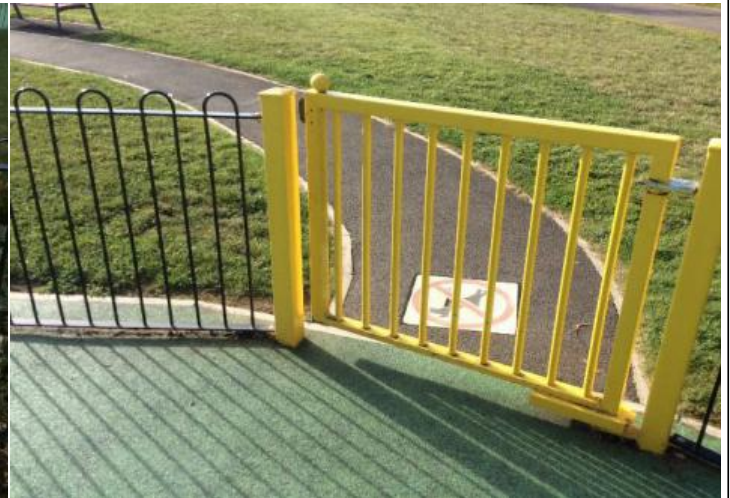
Finding: All the gates are closing too quickly (less than 4 seconds)

Action: All Gates operating correctly

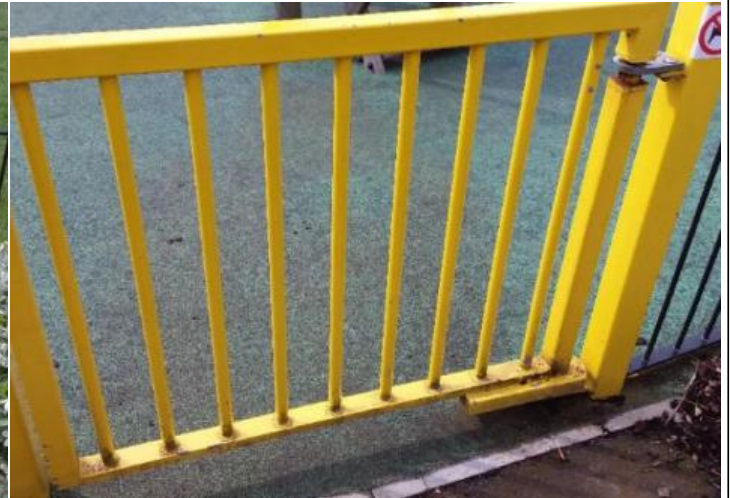
Finding: Gates noisy

Action: Lubricate gates

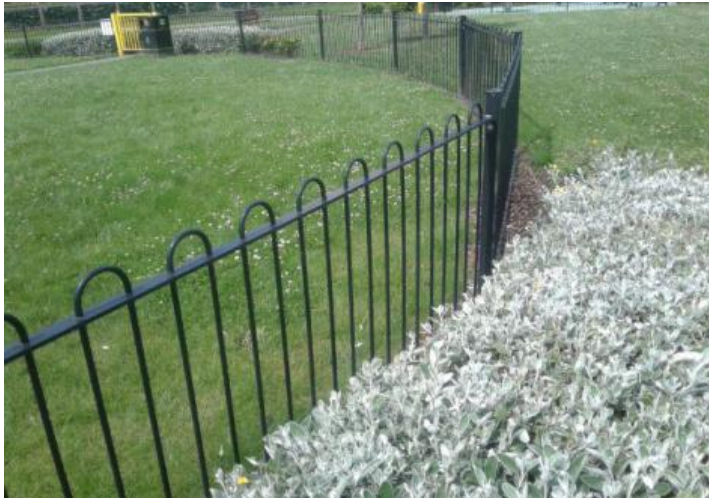
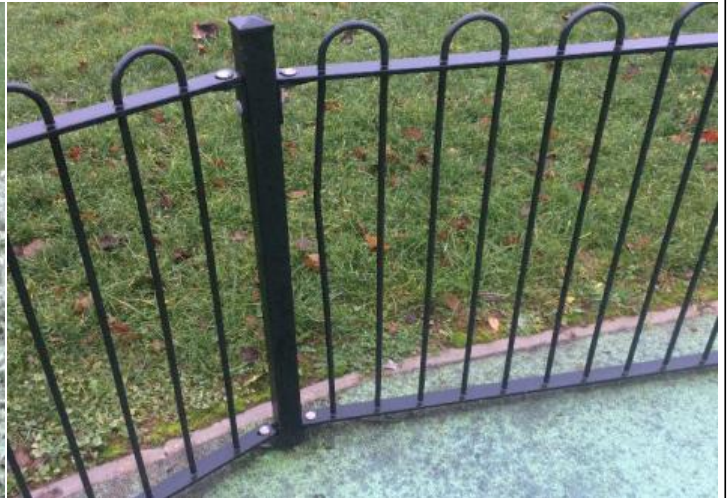
Finding: There is some damage to the fence sections

Action: Monitor for any further deterioration and repair as required

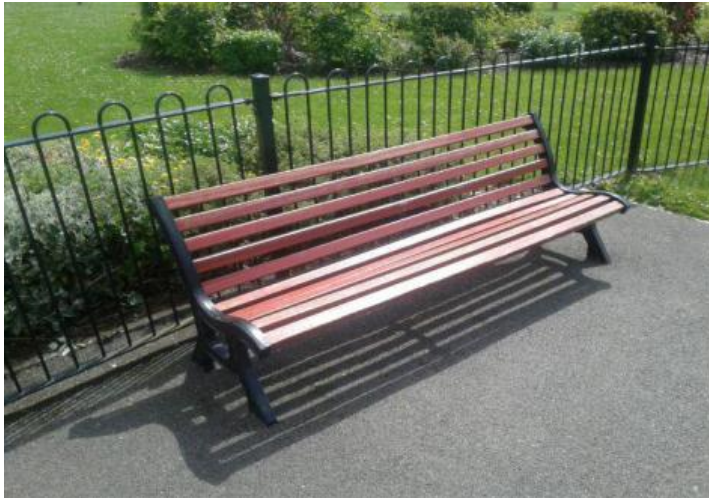
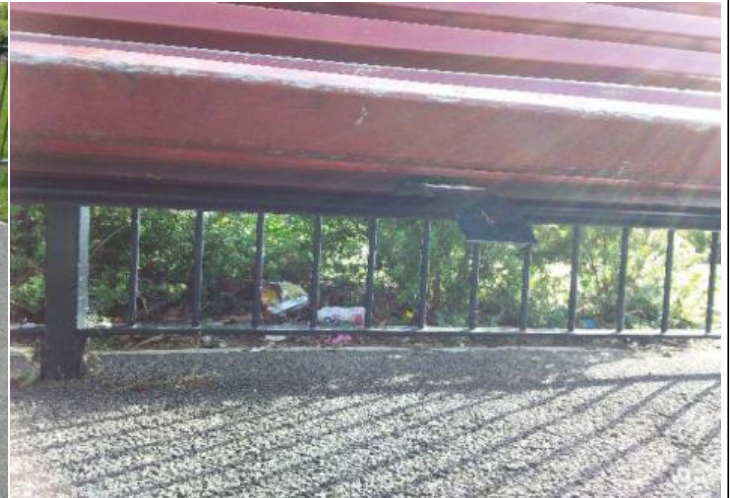
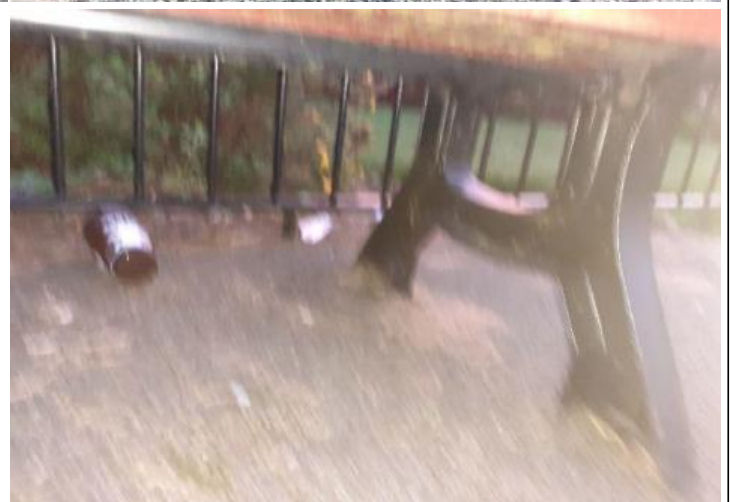
Finding: A number of fixing(s) have worked loose

Action: Fixings secured

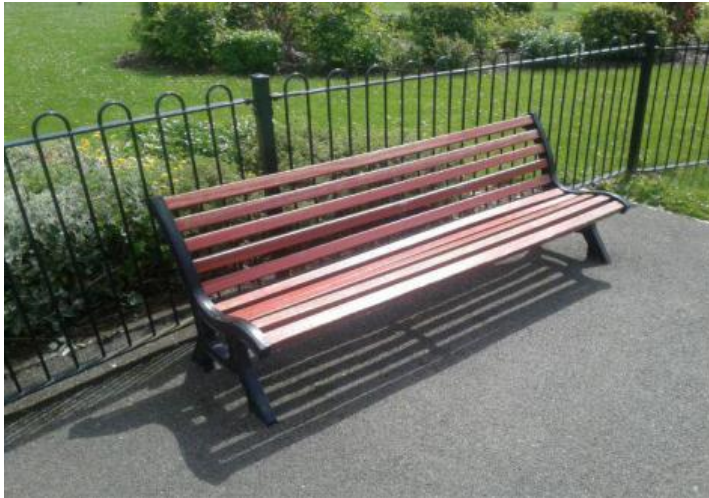
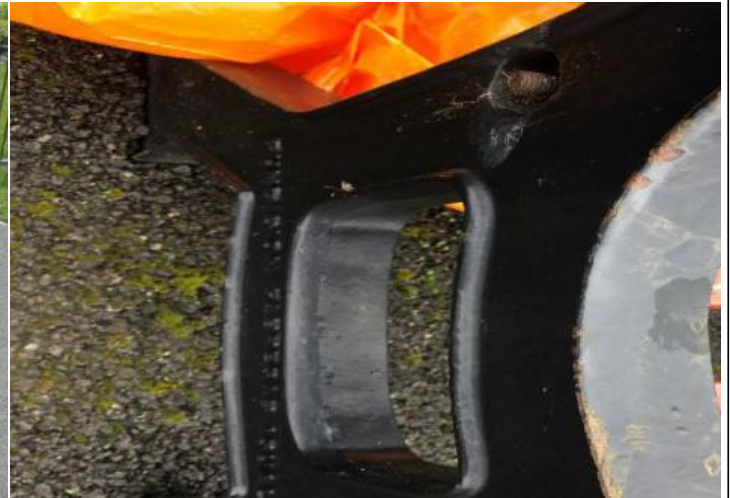
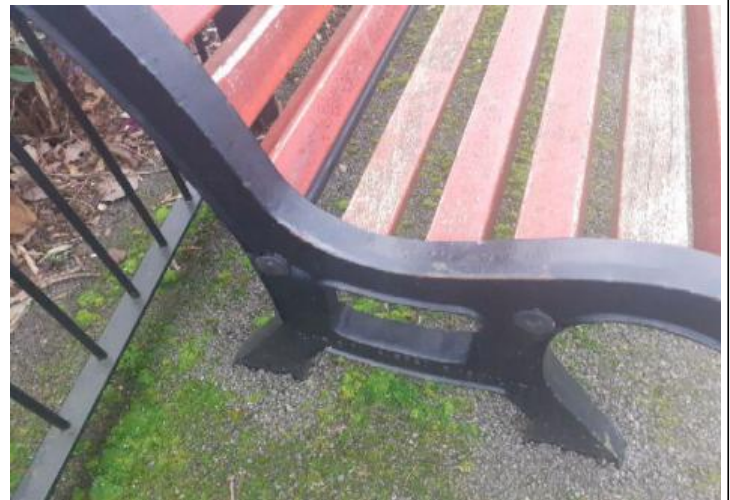
Finding: Caps missing

Action: Caps replaced

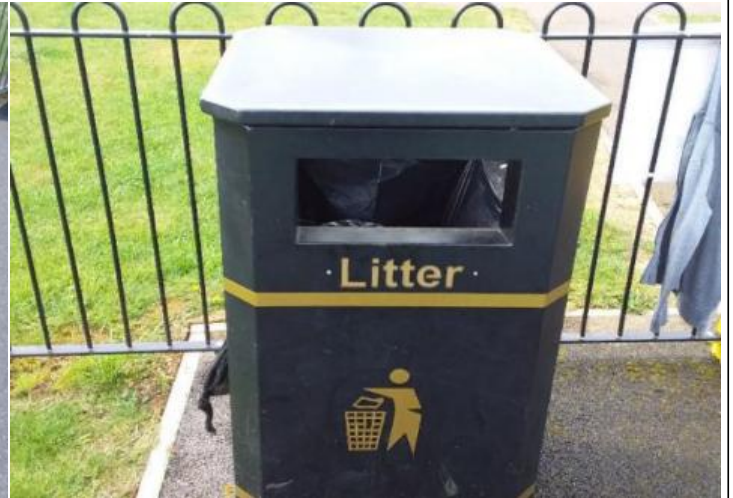
Finding: Bin

Action: Bin emptied

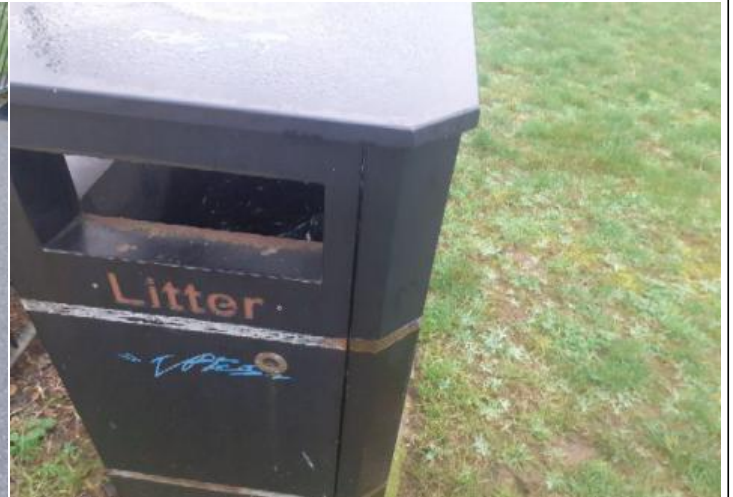
Finding: Bin has graffiti

Action: Remove graffiti

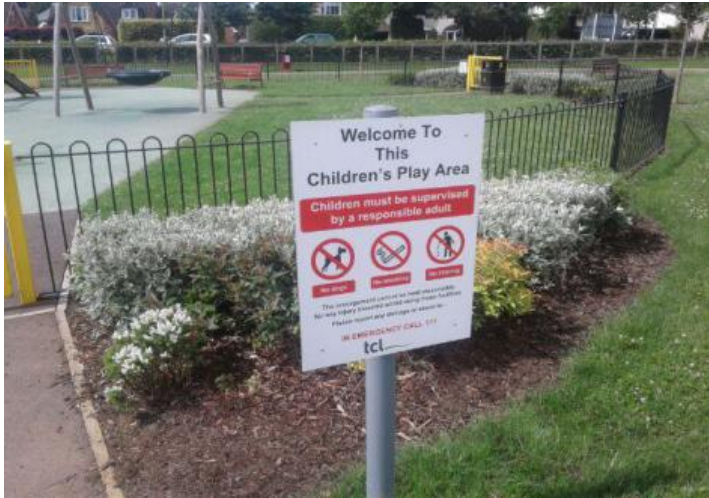
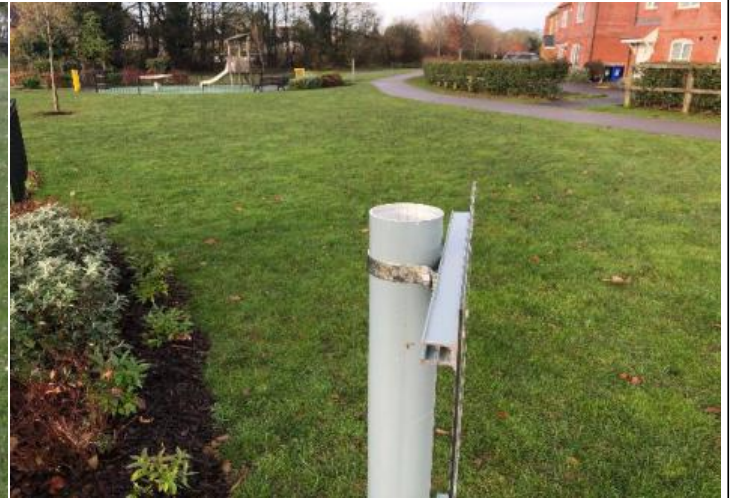
Finding: Cap missing

Action: Replace cap

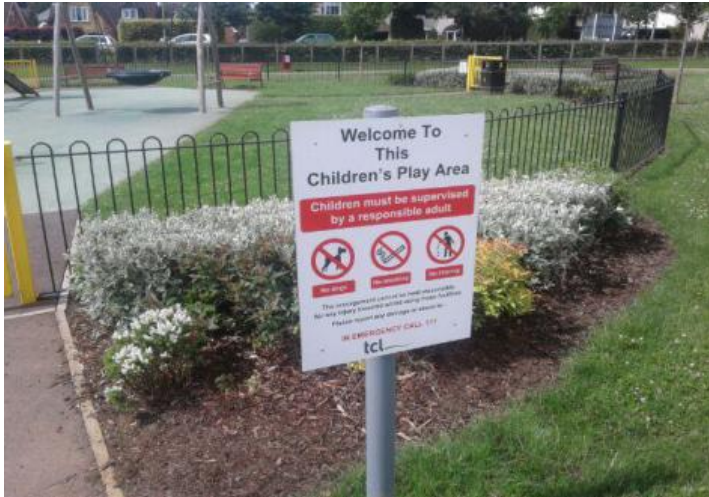
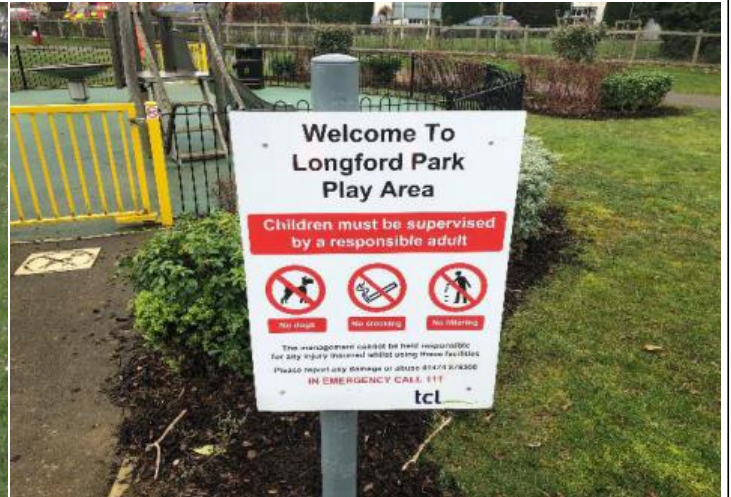
Finding: Sign loose

Action: Tighten sign

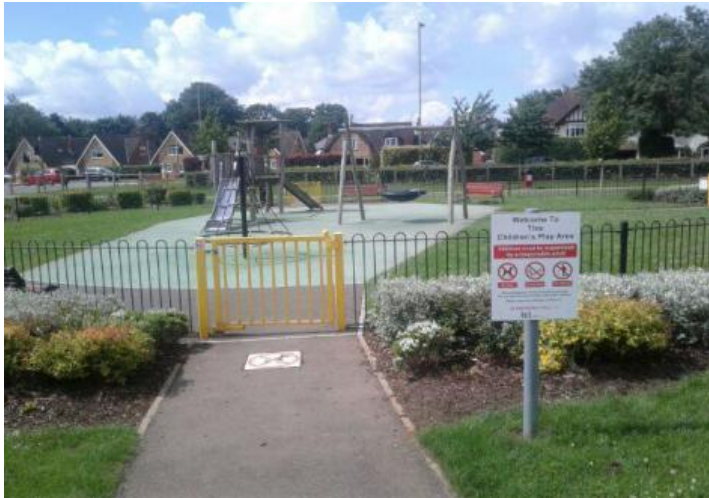
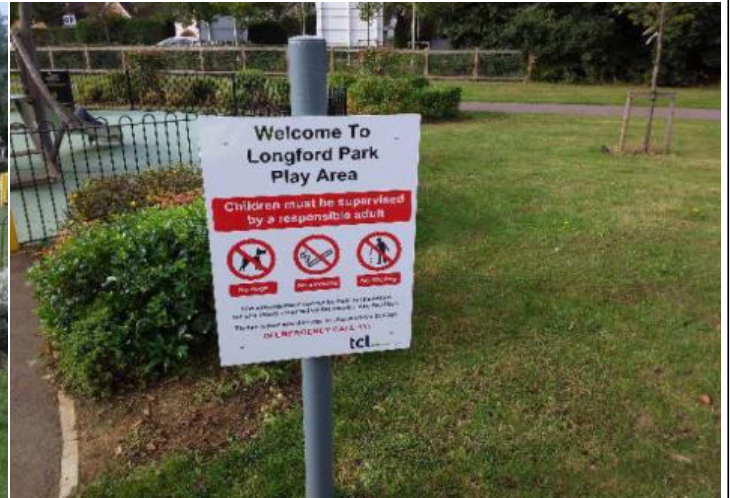
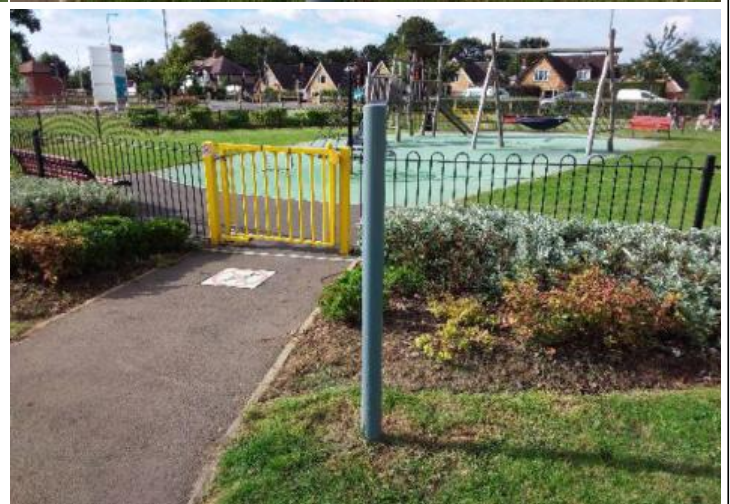
Finding: It is recommended that information signs with emergency contact details are installed at each entrance/exit point to the playground

Action: Provide in accordance with the recommendations set out in BS EN 1176

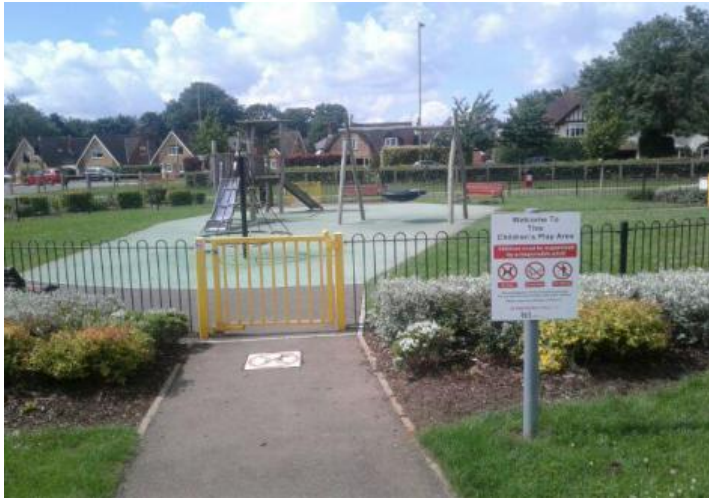
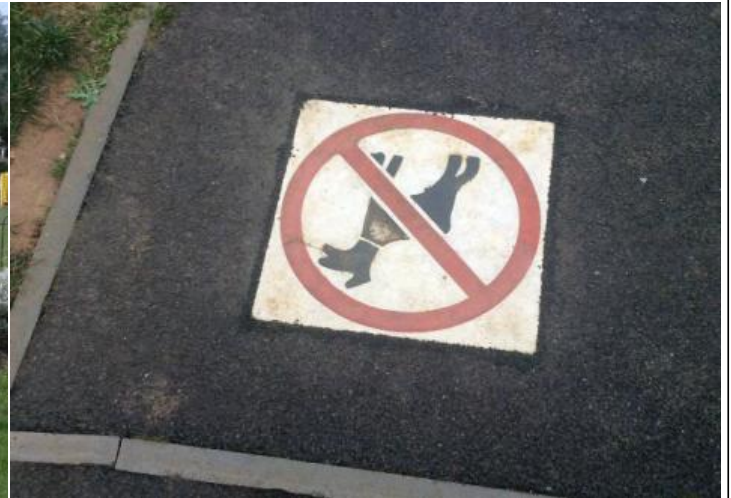
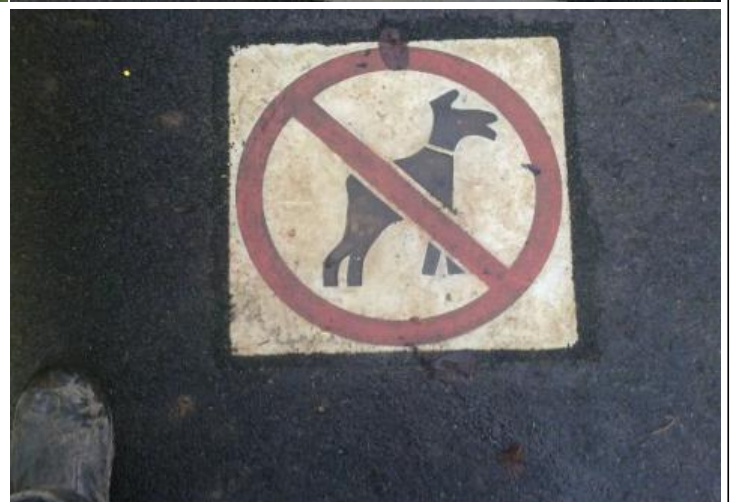
Finding: Part of the no dog sign is missing creating a potential trip hazard.

Action: Reinstate sign.

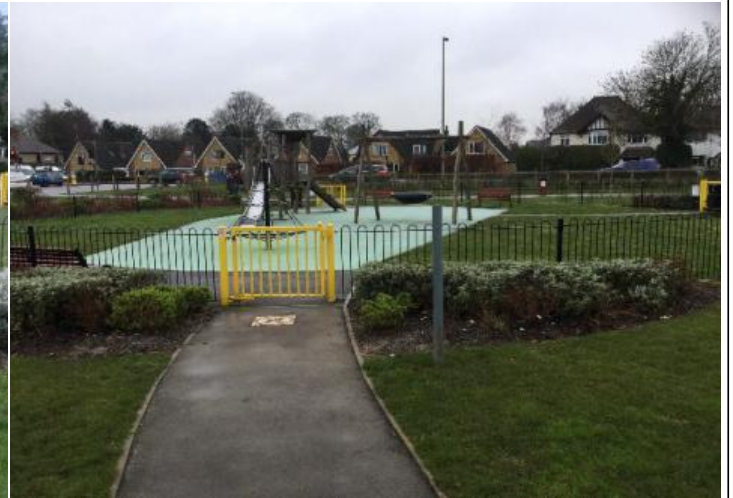
Finding: The site is accessible to the public during the COVID 19 pandemic. The government have released guidelines for safely re-opening these types of facilities which is available on the government website.

Action: Ensure there is an appropriate risk assessment in place and review regularly

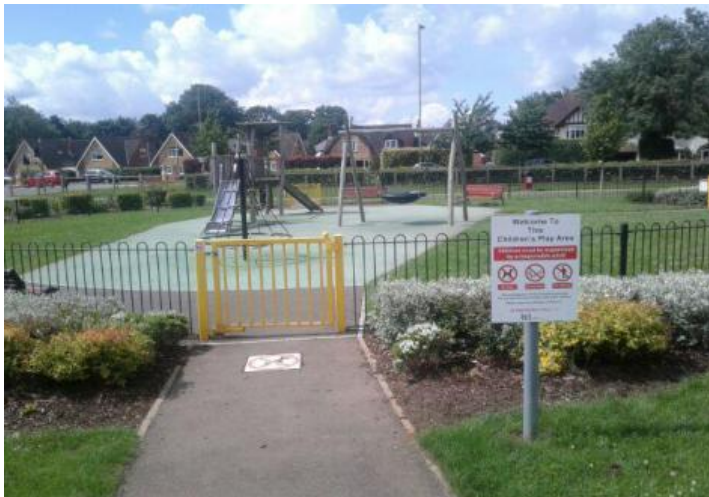
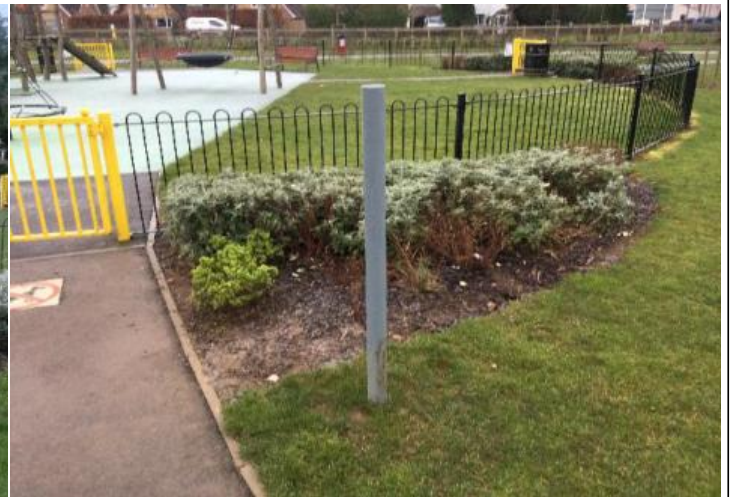
Finding: The signage is damaged or missing

Action: Replace signage

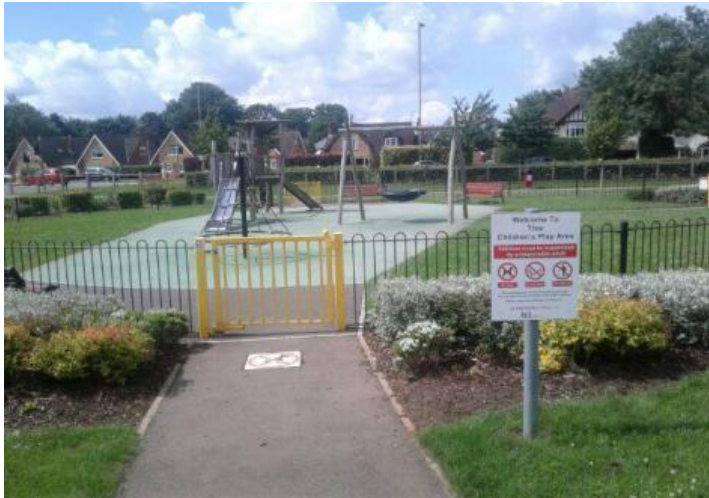
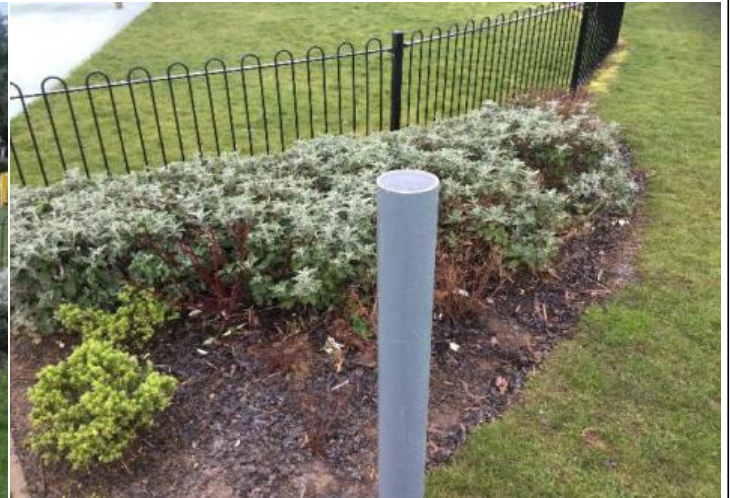
Finding: There are post / end caps missing from the item

Action: Replace missing post caps

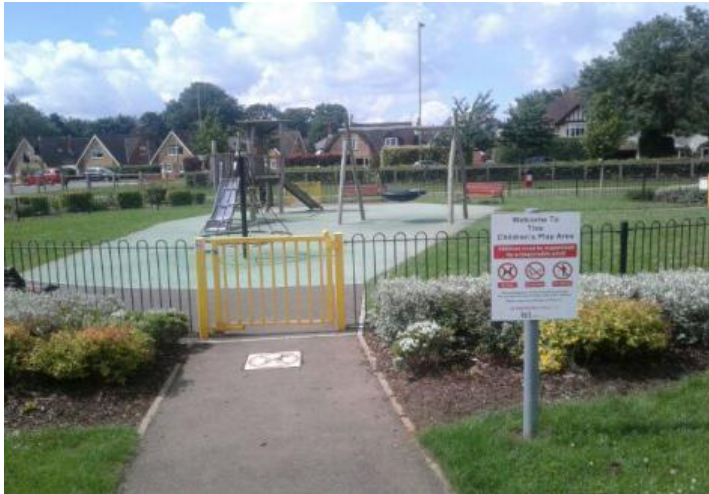
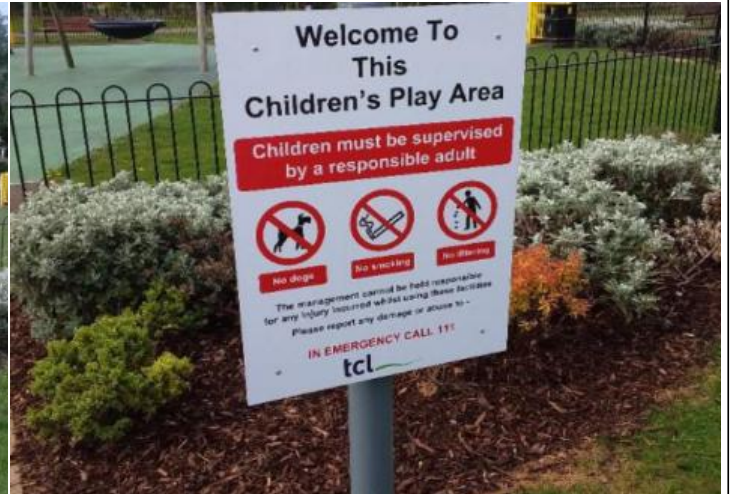
Finding: Sign

Action: Sign replaced

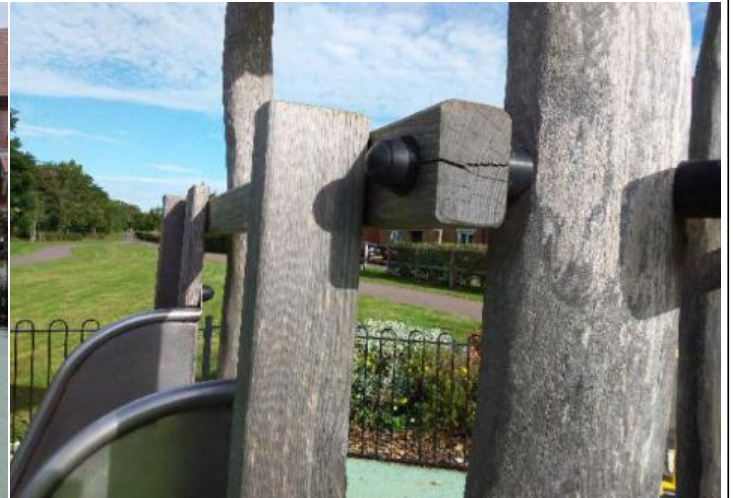
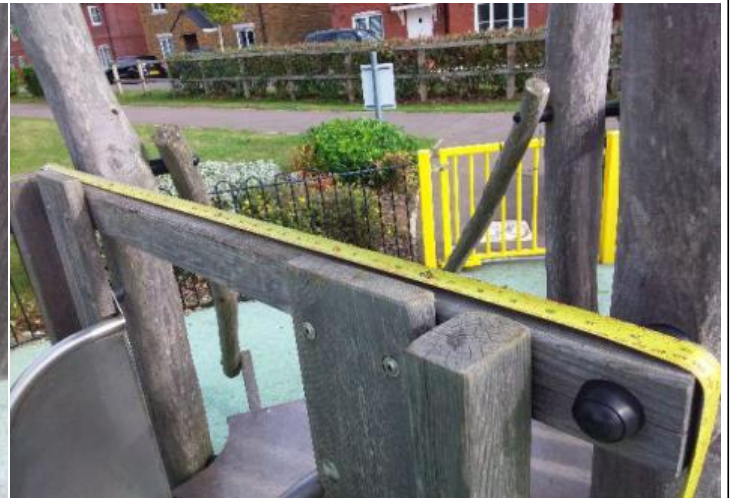
Finding: There are splits in the timber running through fixing point,
Action: monitor to ensure this does not create instability in the structure

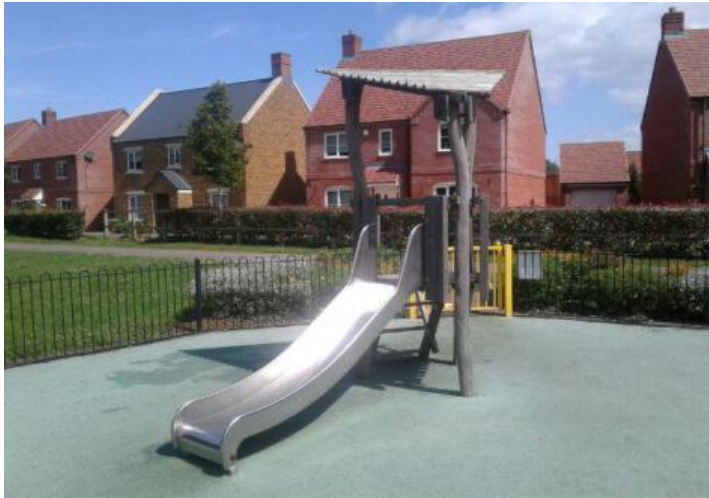
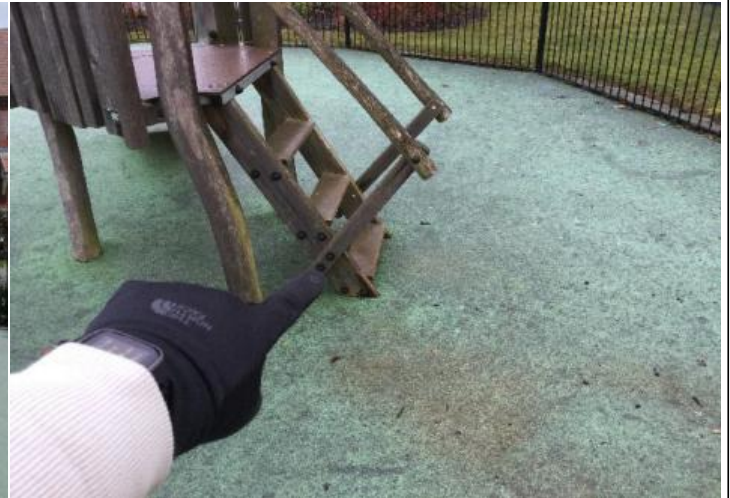
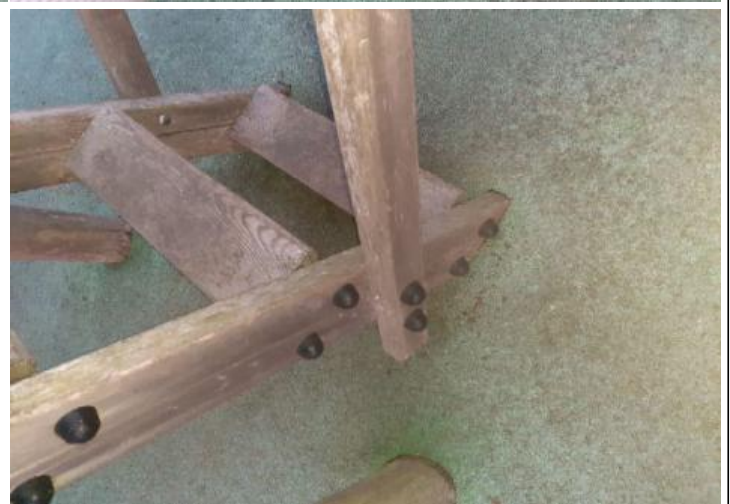
Finding: A number of fixing(s) have worked loose

Action: Fixings tightened

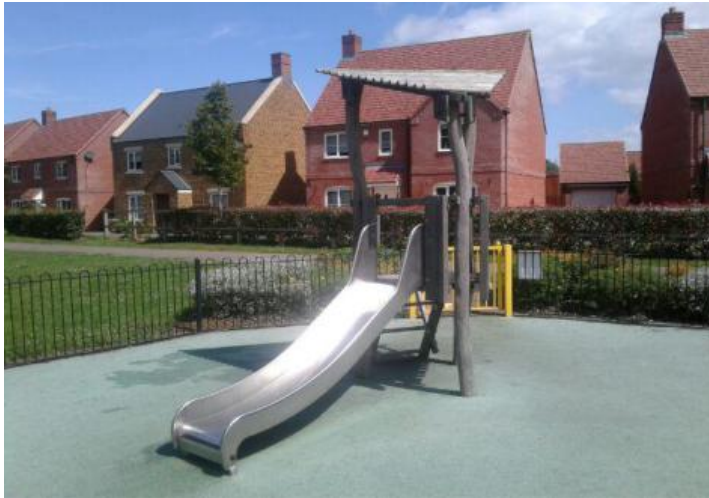
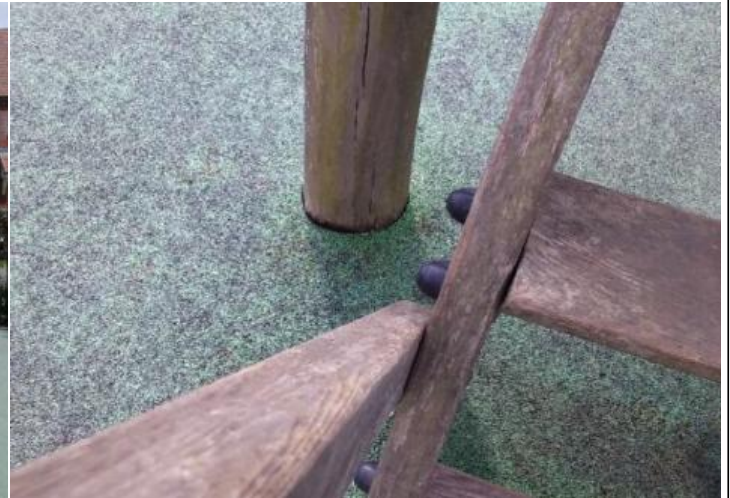
Finding: Loose fixings

Action: Tighten fixings on steps and handrail

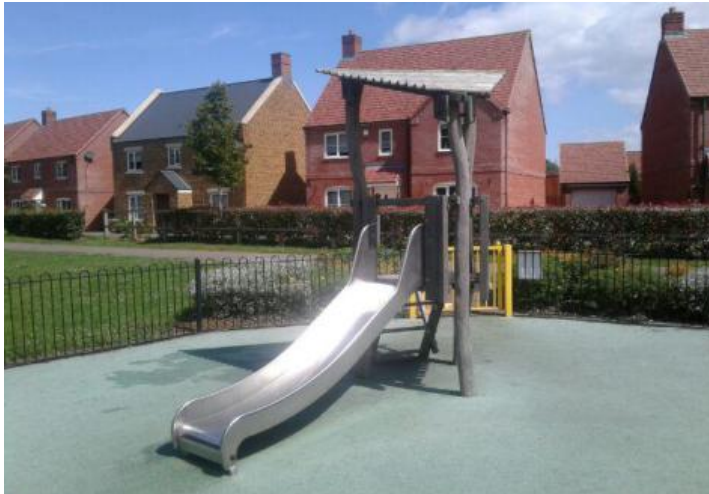
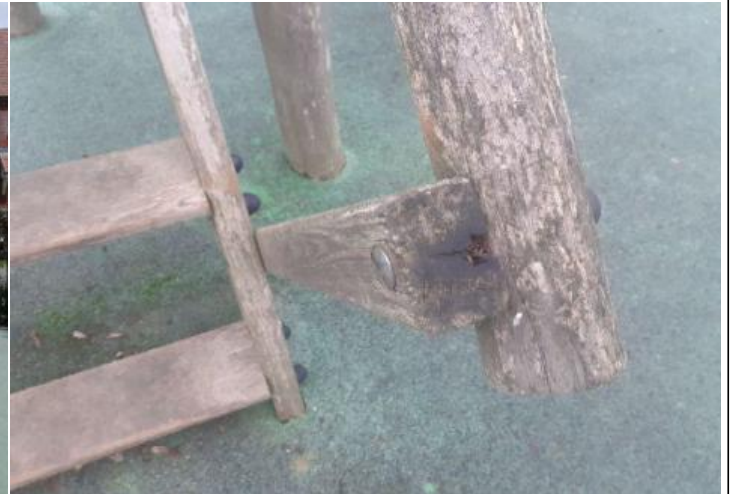
Finding: Timber starting to show signs of rot

Action: Replace timber

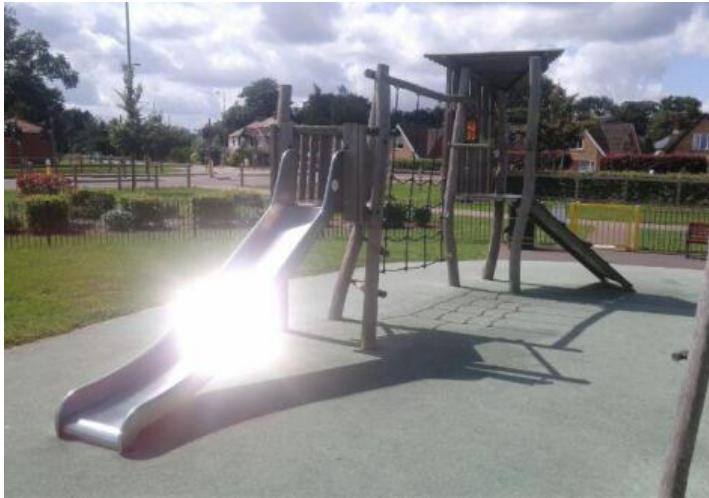
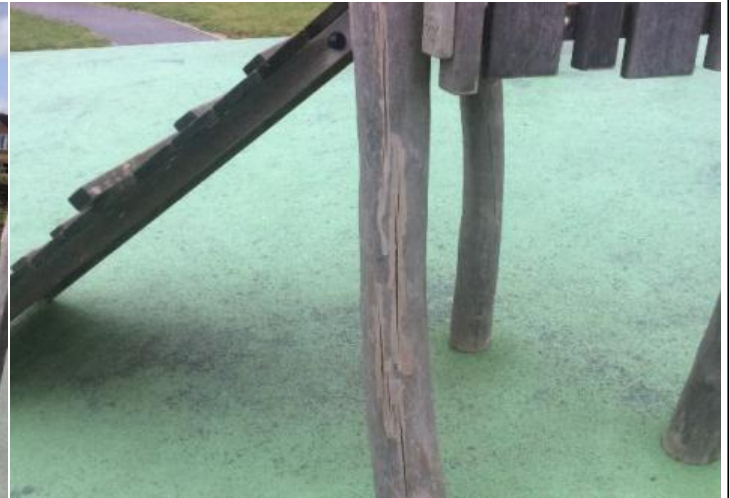
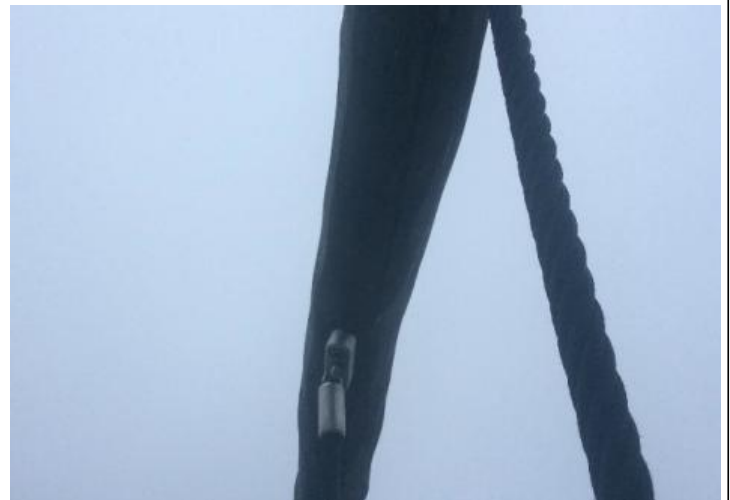
Finding: The timber has a number of splits (shakes) although these are not considered to be a problem at present

Action: Monitor to ensure the splits do not cross through fixing points of the structure and cause any instability

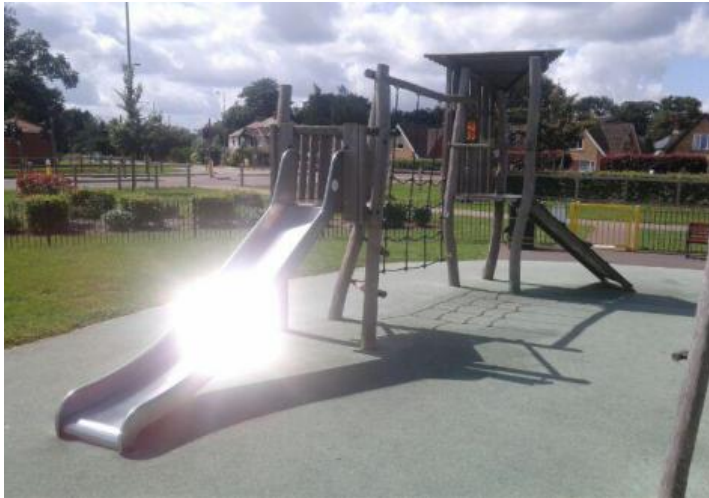
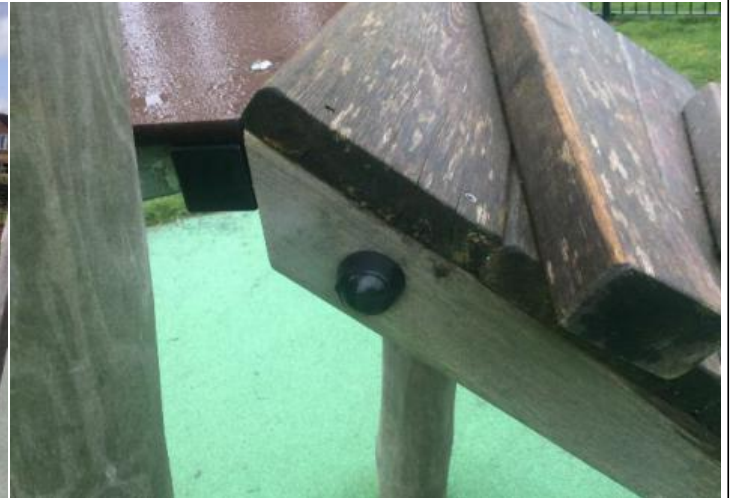
Finding: Fungus was found on site (see photos)

Action: Identify fungus type and remove if poisonous; if classified as non-harmful leave on site

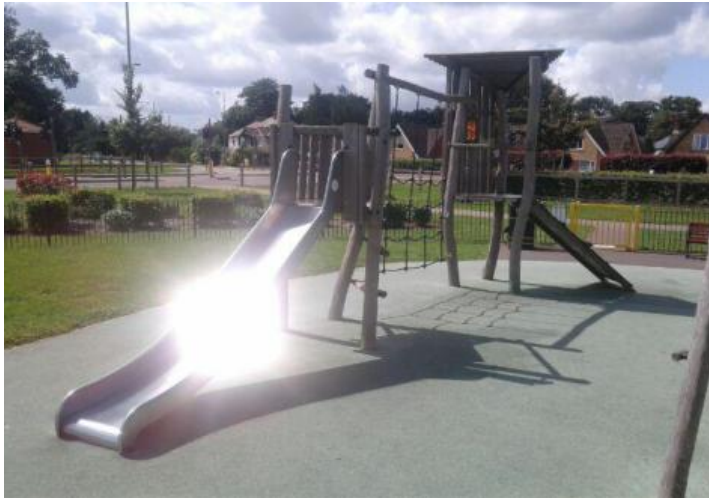
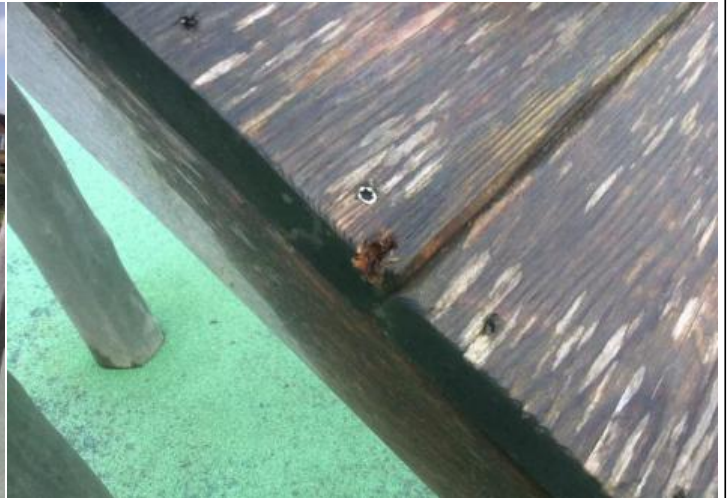
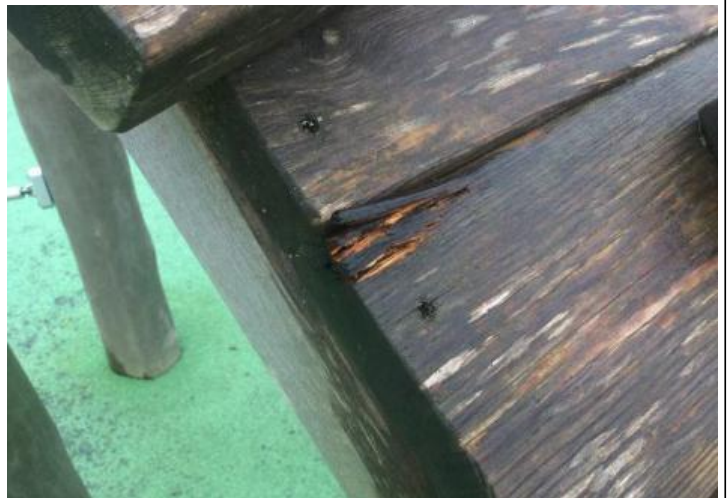
Finding: There is some evidence of rot in the timber

Action: Monitor for any further deterioration and replace as required

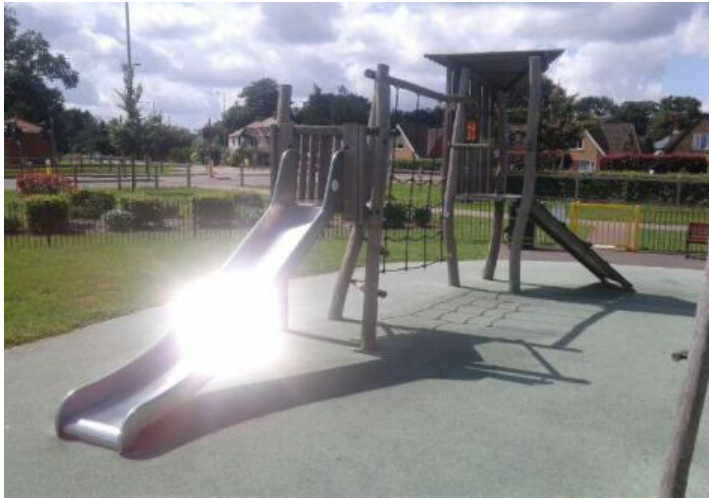
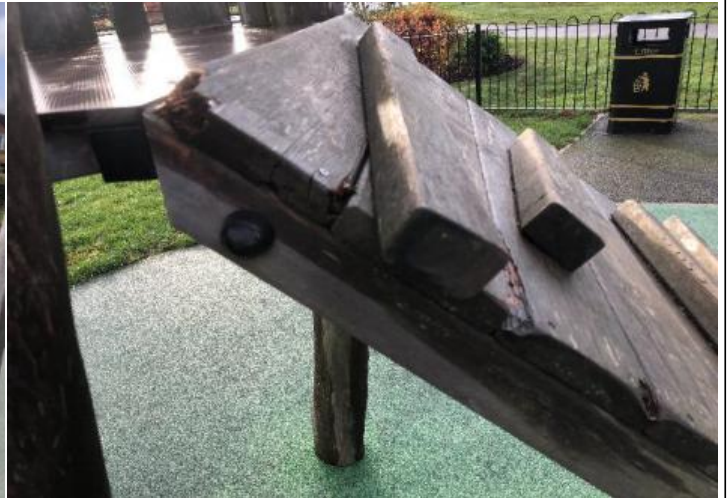
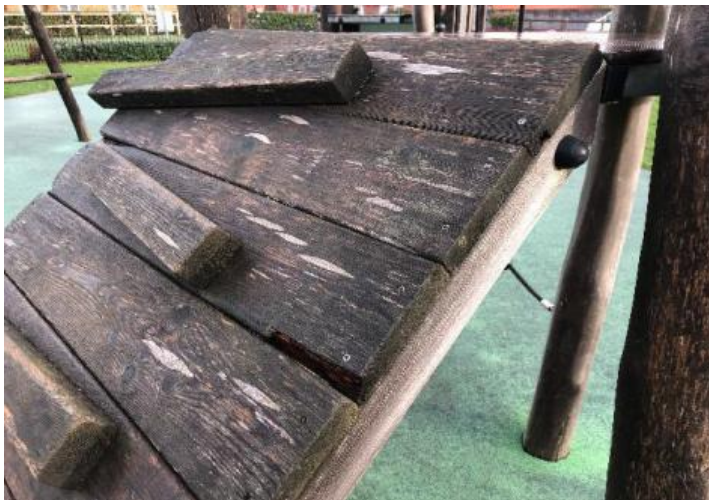
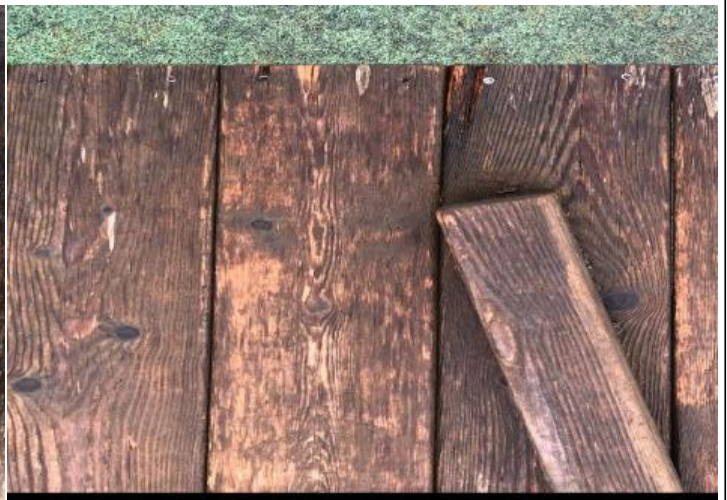
Finding: Timber slats rotted on ramp

Action: Replace slats

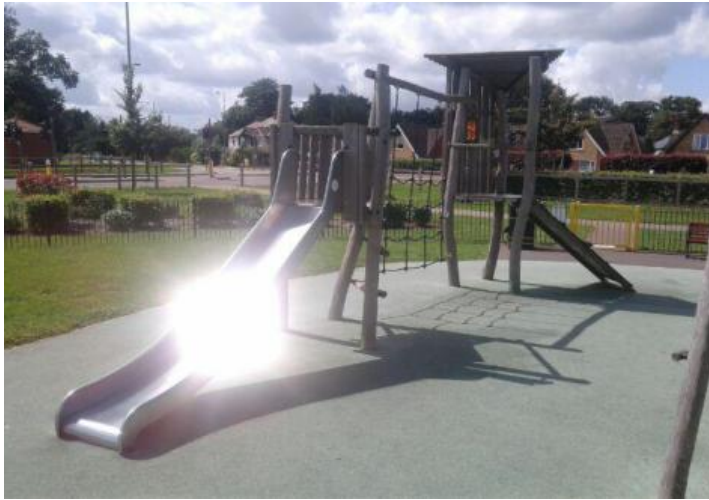
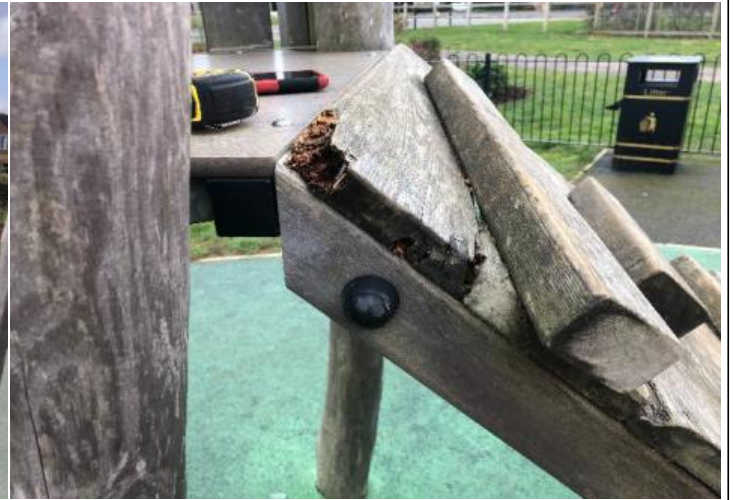
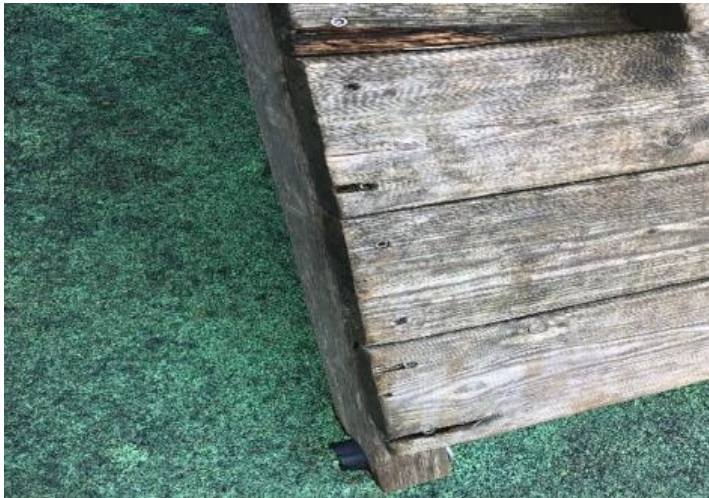
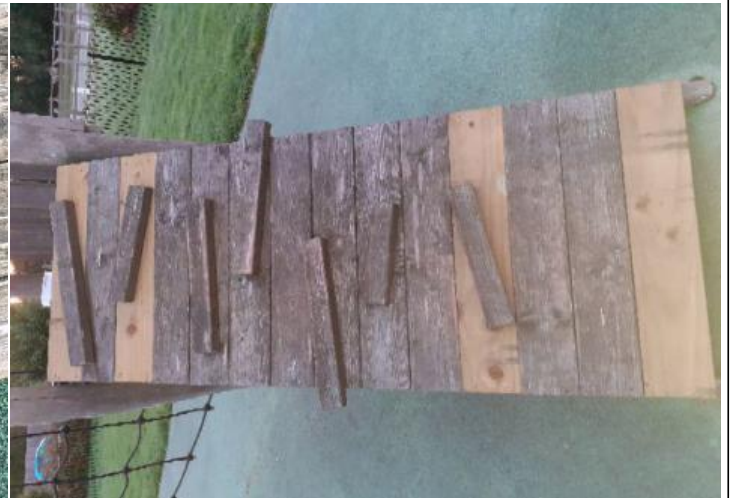
Finding: Slats rotting

Action: Slats replaced

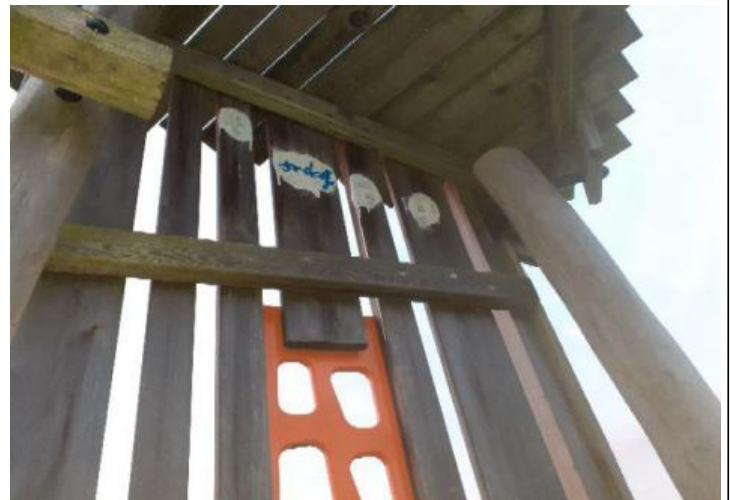
Finding: Item has graffiti

Action: Remove graffiti

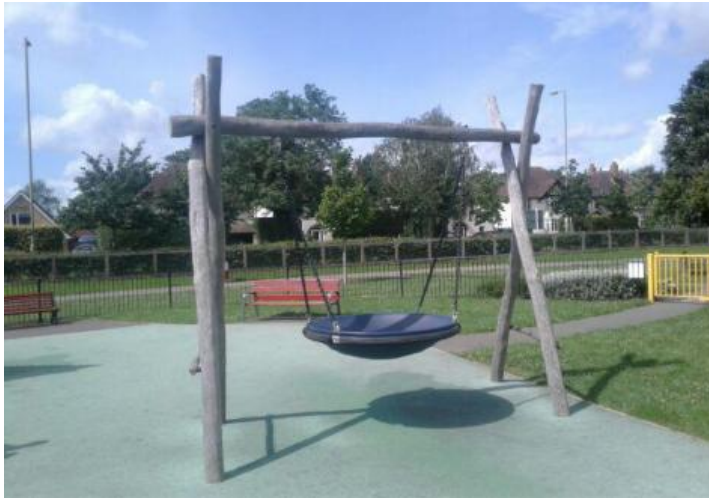
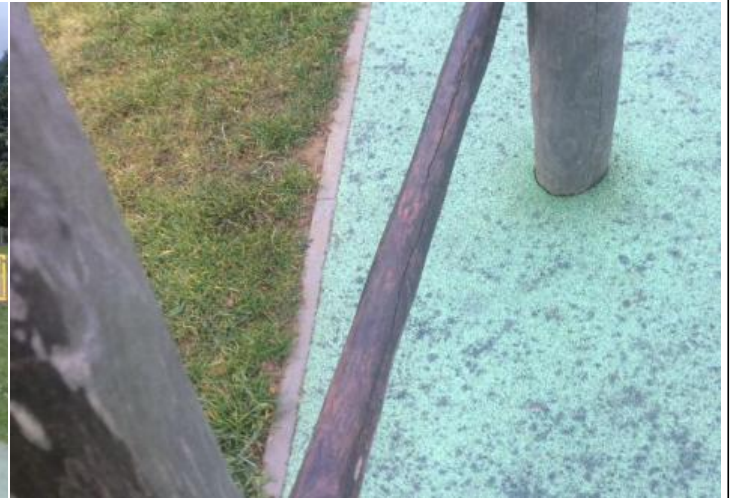
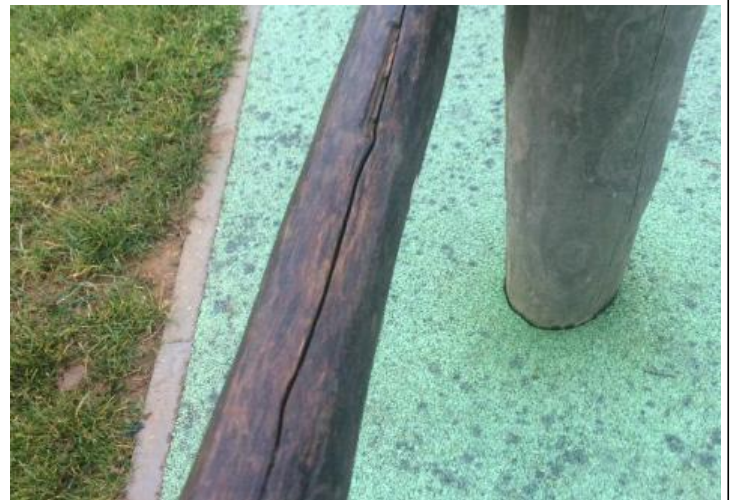
Finding: The timber has a number of splits (shakes) although these are not considered to be a problem at present

Action: Monitor to ensure the splits do not cross through fixing points of the structure and cause any instability

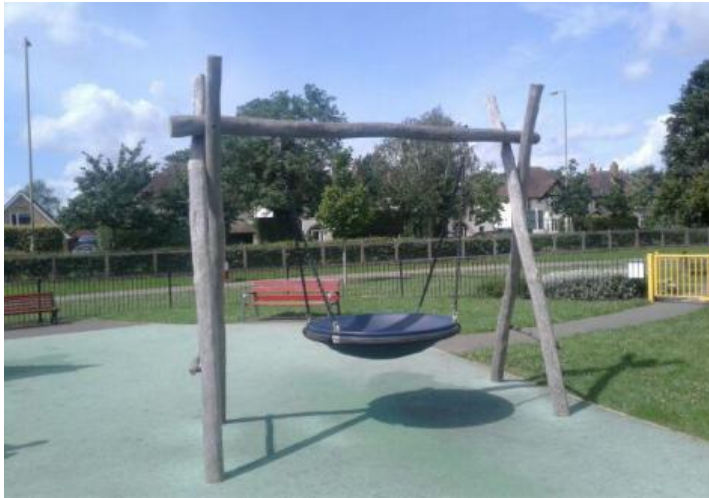
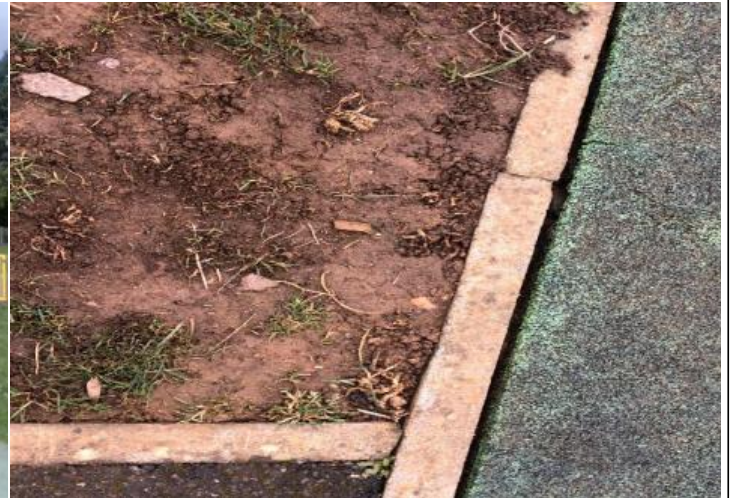
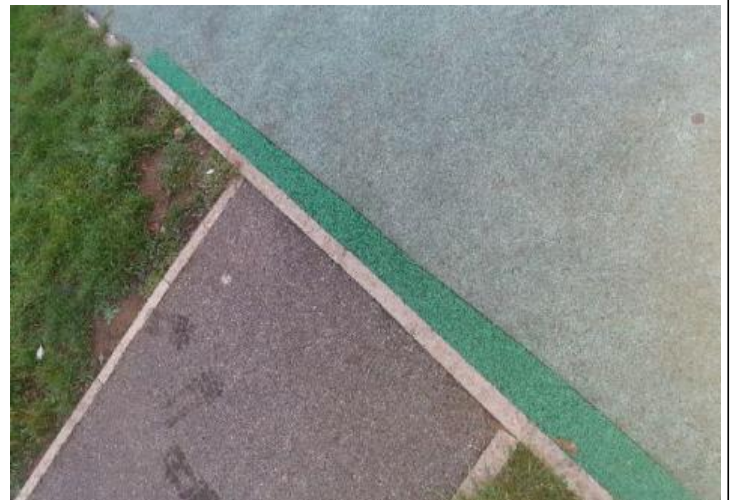
Finding: Wet pour raising

Action: Wet pour repaired
