Operational Inspection

Banbury Longford Park Development Phase 1

Inspection Ref: 1919439

Operational Inspection - 16-January-2023 - 10:04 Inspector Mark Perkins

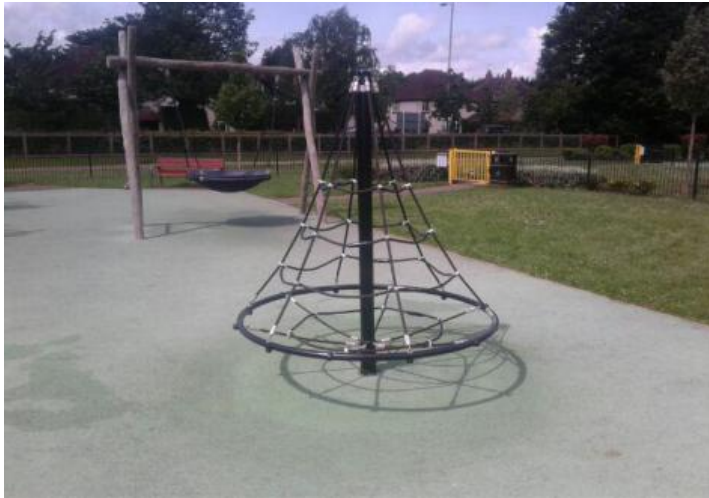
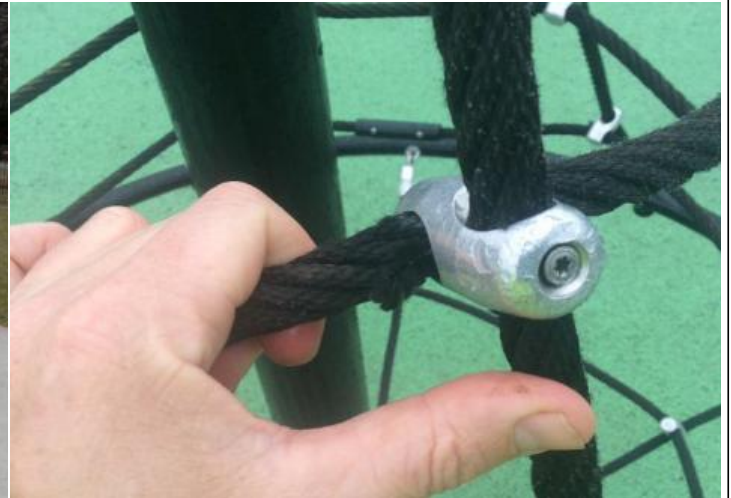
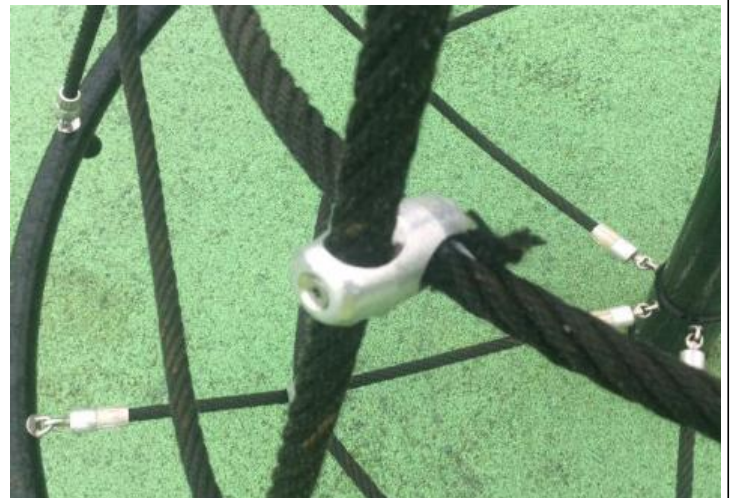
Finding: The ropes/nets are worn/damaged in places

Action: Monitor for any further deterioration and repair or replace as required

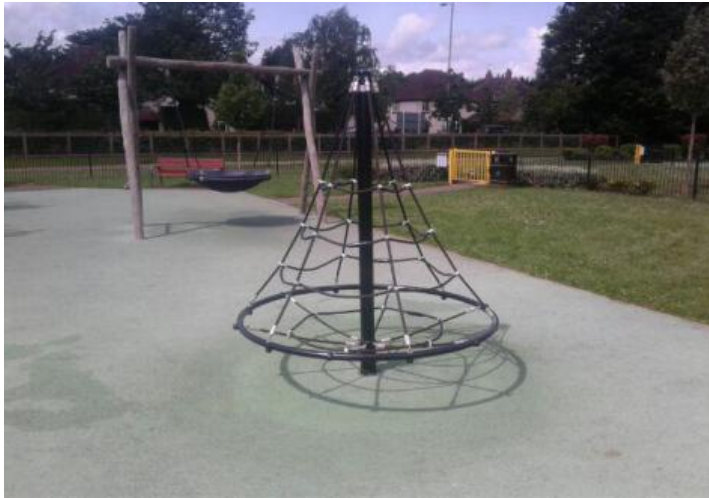
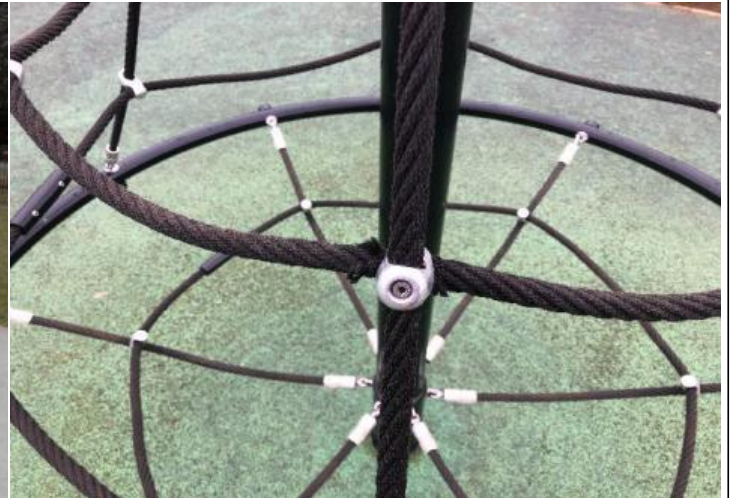
Finding: Net fixings loose

Action: Tighten fixings
