heyford park

BUILDING APPRAISAL

ROGER EVANS ASSOCIATES LTD FOR NORTH OXFORDSHIRE CONSORTIUM LTD

Issued : July 2006

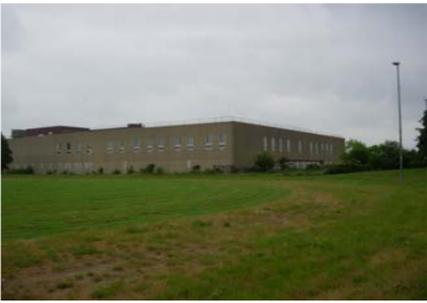
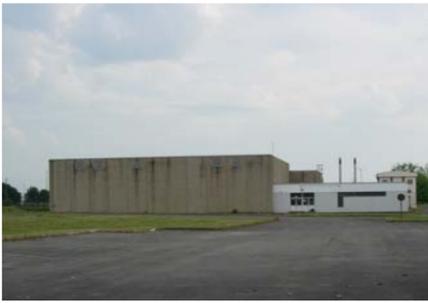
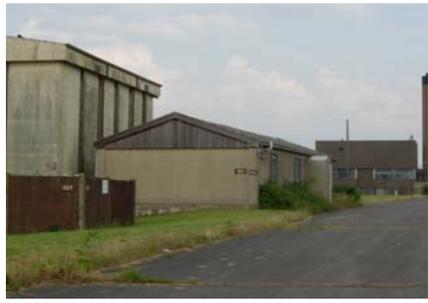
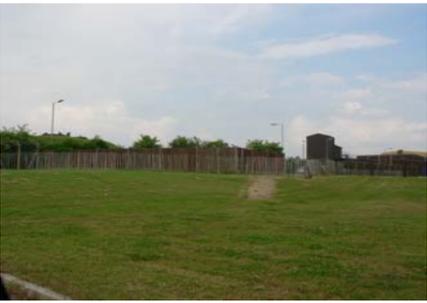
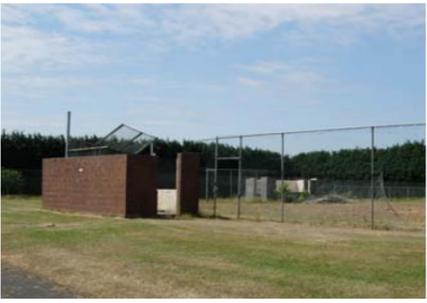
Building No.	582	583	584	590	595
Current Use	Disused - former hospital (60 bed)	Gymnasium	Store	Waste disposal pit	Disused - baseball dugouts
Date of Construction (NB: info from asset register)	1982	1976	1982	1940	
Floor Area/Volume m ² /m ³ (NB: info from asset register)	9042	2302	116		
Number of Floors	2	1	1		1
Building Height (Eaves, Ridge) m, estimated	9	8; 4.5; 7, 7.5	2.4, 4	1.8	2.2, 2.4
Construction/Structure	Concrete precast pebble dash panel walls. Flat roof with metal capping. Metal windows. Large metal plant housings on roof.	Pebble dash concrete walls to main volume (8m high) with flat roof and metal capping. Concrete base to lower entrance volume (4.5m high) with plastic weather boarding to walls. Metal windows & doors with timber subframes. 2 No. volumes (7.5m high) adjacent gym clad with timber shingles on plywood background. Timber boxing forms piers on walls. Shallow pitch roof with metal flashing. Boiler-house to rear has rendered walls with flat roof (4.5m high).	Concrete plinth & structure with pebble dashed walls. Timber weather boarding to gable ends. Metal windows behind wire mesh with timber cills. Possible corrugated asbestos roof with plastic fascia. Plastic roof to porch. Asbestos internal walls.	Pit surrounded by 1.8m high timber fence panels supported by concrete posts.	Blockwork walls with metal monopitch roof. Timber frames to openings covered by chicken wire.

Building/Setting Features & Characteristics of Note					Adjacent to baseball field.
Potential Uses		Still in use			
Status/Condition	3 fair	3 fair	3 fair	2 good	4 poor

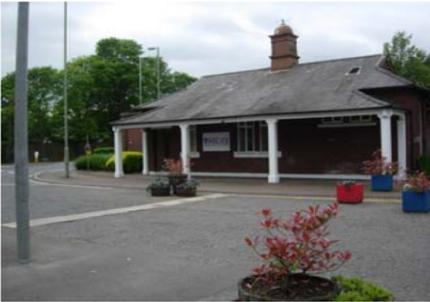
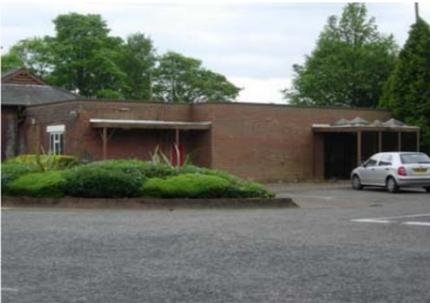
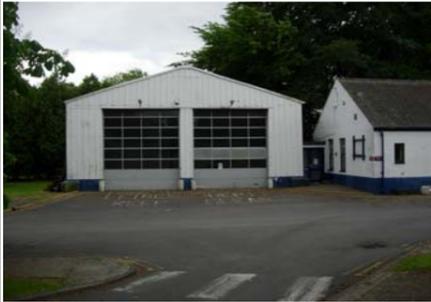
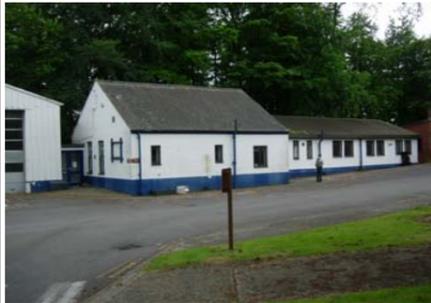
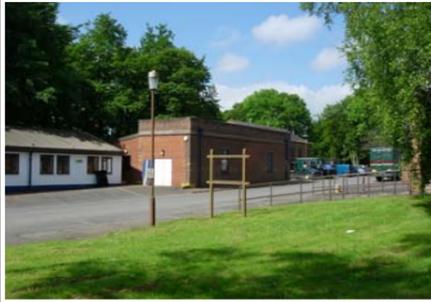
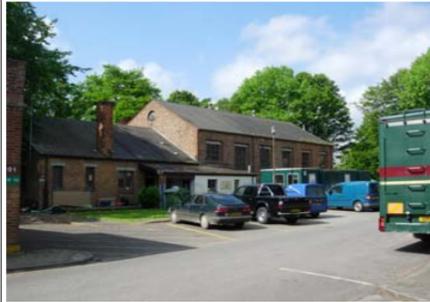
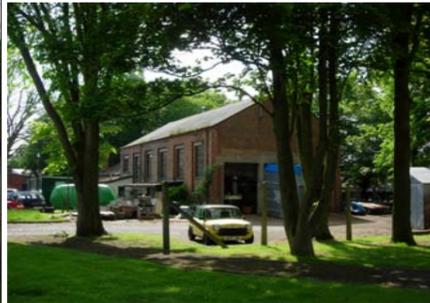
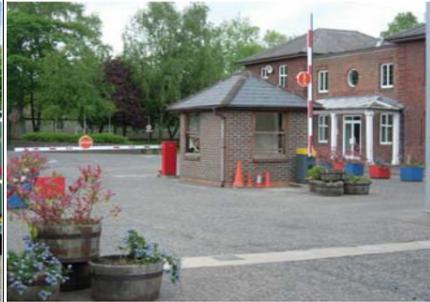
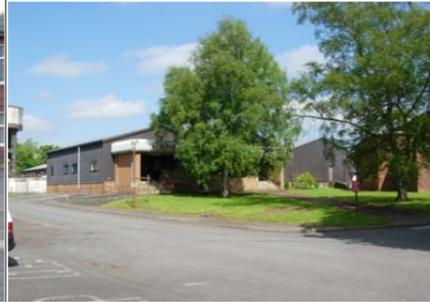
Building No.	100	101/102	103	104	106
Current Use	Thames Valley Police / NOC / Security	Disused - offices / workshop	Workshop - 'Kingsground' narrow boats	Gatehouse	Storage - 'Pride'
Date of Construction (NB: info from asset register)	1925	1939	1940	1990	1940
Floor Area/Volume m ² /m ³ (NB: info from asset register)	557	543	340	8	2166
Number of Floors	1 (higher at front)	1	1 double height space with single storey addition	1	1 double height
Building Height (Eaves, Ridge) m, estimated	2.1, 5	4, 5.5; 3, 6; 2.2, 4; 5	2.5, 5 & 5, 7	2.1, 3	5, 7.5
Construction/Structure	Main building brick with pitched, tiled roof. Roof extends to form entrance canopy which rests on concrete pillars. Bare blockwork internally. Brick side extension with flat roof & metal entrance canopy. Rear extension rendered with leaded metal windows and metal pitched roof.	4 No. linked buildings: 1) 1.5 storey high brick building with external metal cladding. Large metal & glazed doors at front; 2) Brick painted walls with steep pitched, tiled roof & metal windows; 3) Metal clad building on brick plinth, with metal windows and metal pitched roof; 4) Brick building with parapet to flat roof. Garage door to side & metal windows. Monopitch metal roof to brick single storey extension at rear.	Brick walls with pitched, tiled roof. Large, single glazed metal windows in partially bricked up openings. Single storey, brick extension adjacent with pitched tiled roof, timber windows & brick chimney.	Brick walls with pitched, tiled roof & timber windows.	Brick & metal clad walls with metal roof & metal windows. Large brick entrance porch with ramps and flat metal roof.

Building/Setting Features & Characteristics of Note			2 storey workshop noteworthy		
Potential Uses	Currently in use	Workshop / offices	Currently in use	Currently in use	
Status/Condition	3 fair	3 fair	3 fair	2 good	3 fair

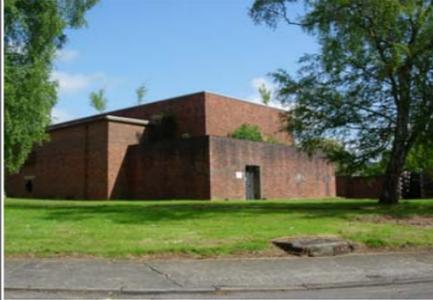
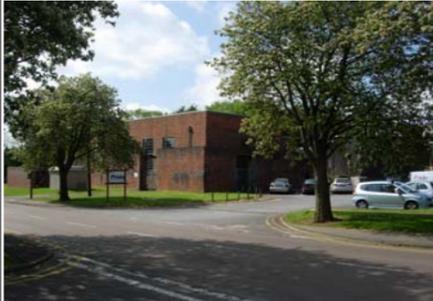
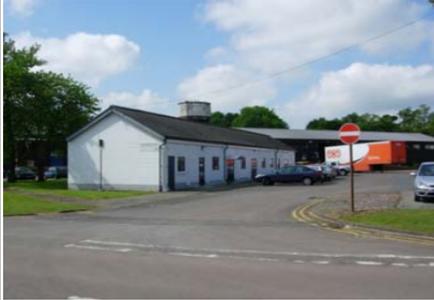
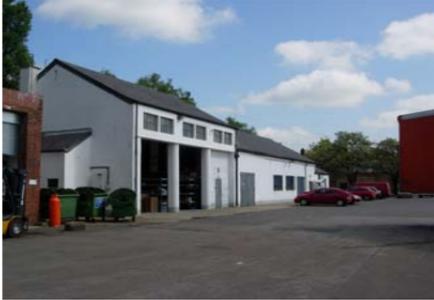
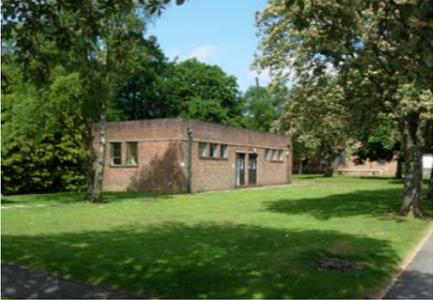
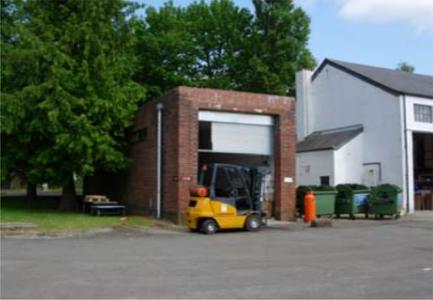
Building No.	114	115	117	118	119
Current Use	Generator	Workshop/office - 'Integration Technology'	Store - 'Integration Technology'	Office - 'Integration Technology'	Garage and store - 'Integration Technology'
Date of Construction (NB: info from asset register)	1940	1939	1939	1935	1939
Floor Area/Volume m²/m³ (NB: info from asset register)	302	221	384	132	86
Number of Floors	1 double height	1	1 high storey, 1 double height	1	1.5 storey height
Building Height (Eaves, Ridge) m, estimated	5	2.5, 4.5	3.5, 5.5; 4.5, 6.5	3.4	4.5
Construction/Structure	Brick walls with large windows on one side only. Flat roof. Surrounded by single storey height brick secondary wall.	Concrete & steel structure with brick & some timber infill - painted. Concrete end walls. Pitched, tiled roof with rotting timber fascia.	Concrete & steel structure with brick infill. Concrete end walls. Pitched, tiled roof.	Brick walls with parapet to flat roof. Mixture of newer UPVC double glazed and metal windows.	Brick walls with parapet to flat roof. Metal roller shutter garage door at front.

Building/Setting Features & Characteristics of Note		Recently renovated	Double height building has three large garage doors & clerestory windows.	Windows at high level, interior in good condition.	Mezzanine level internally.
Potential Uses		Currently in use	Currently in use	Currently in use	Currently in use
Status/Condition	4 poor	3 fair	3 fair	3 fair	3 fair

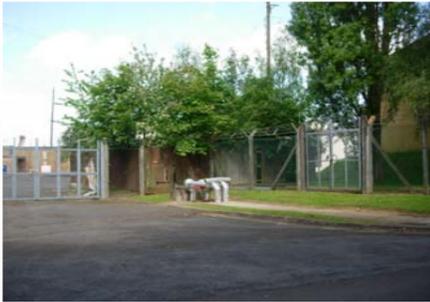
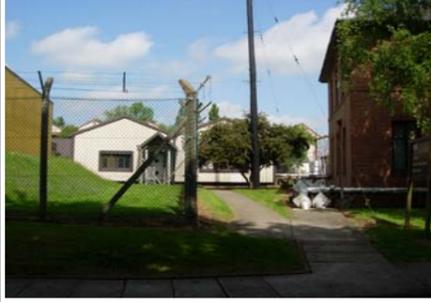
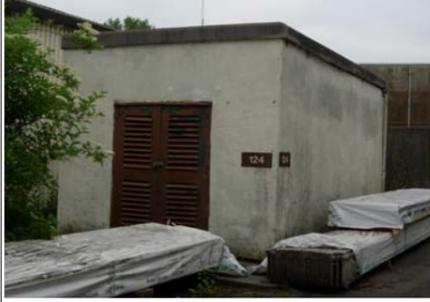
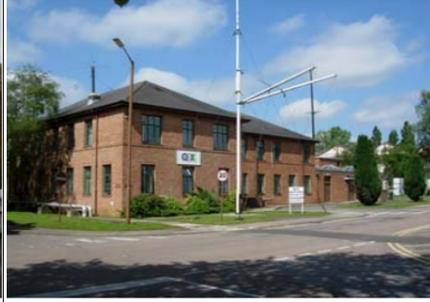
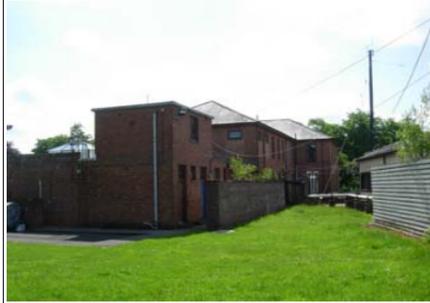
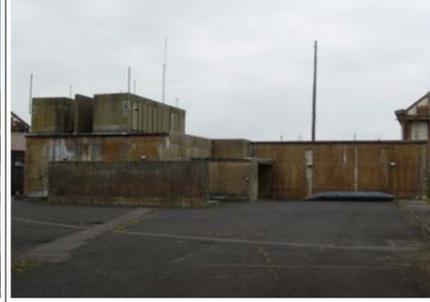
Building No.	121	123	124	125	126
Current Use	Water tank	Disused office	Disused store	Office - QEK	Disused - command point
Date of Construction (NB: info from asset register)	1952	1953	1940	1926	
Floor Area/Volume m ² /m ³ (NB: info from asset register)		1847	25	845	
Number of Floors		1	1	1 & 2	1 & 2 equivalent
Building Height (Eaves, Ridge) m, estimated	1.8	2.5, 3.5	3	5, 7	4.5
Construction/Structure	1.8m high timber fence panel enclosure supported on concrete posts. Barbed wire on top.	Metal clad walls & metal pitched roof. Double glazed metal windows.	Brick plinth, rendered walls with flat roof. Metal louvred doors at front.	Brown/red brindled brick walls with pitched, tiled hipped roof to main 2 storey building. Some flat roofed single and double height extensions. Metal double glazed leaded windows.	Concrete walls with flat roof. Secondary wall 2m high.
Building/Setting Features & Characteristics of Note		Interior reasonable.			No windows

Potential Uses				Currently in use	
Status/Condition	3 fair	3 fair	3 fair	3 fair	3 fair

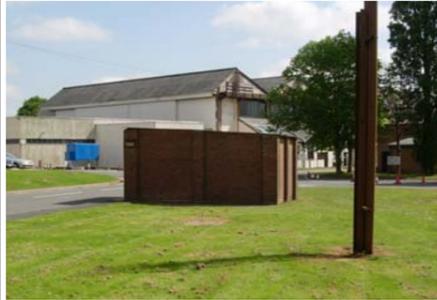
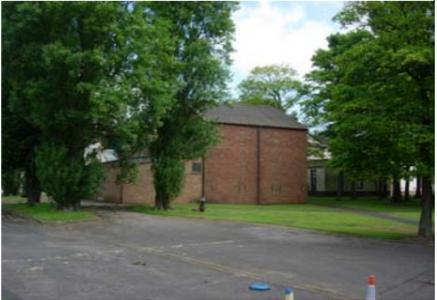
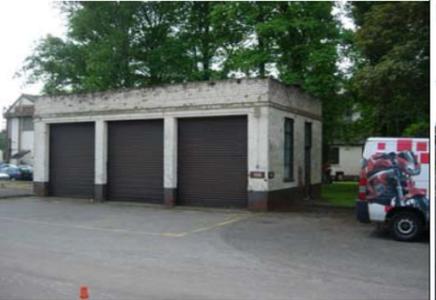
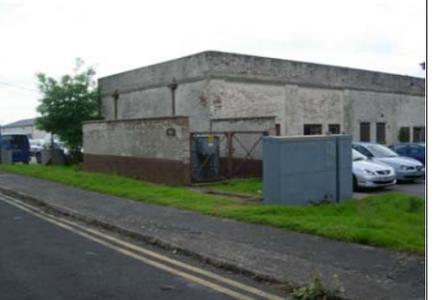
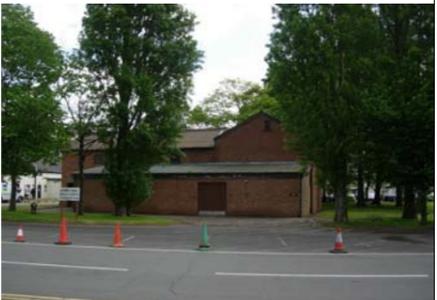
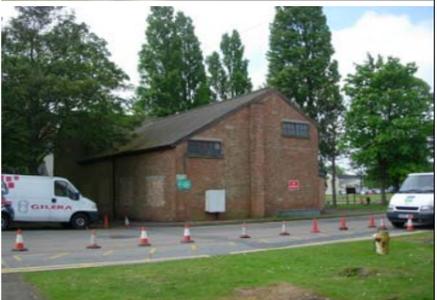
Building No.	151	156	157	158	170
Current Use	Disused - store/workshops	Disused - store	Community - scouts	Store - 'Events management'	Electric sub-station
Date of Construction (NB: info from asset register)	1950	1935	1935	1935	1940
Floor Area/Volume m ² /m ³ (NB: info from asset register)	3927	21	239	53	
Number of Floors	1 triple height	1	1 & 2	1	1
Building Height (Eaves, Ridge) m, estimated	8, 10	1.7, 1.9	2.1 & 4, 6	4	2.1
Construction/Structure	Steel frame, concrete infill. Asbestos multi-pitched roof with corrugated plastic clerestory. Various lean-tos and adjacent brick plant buildings.	Brick walls with external piers & shallow monopitch metal roof.	Brick walls with pitched, metal roof. High level windows in parts of the 2 storey building some of which have been bricked up. No windows in single storey, metal roofed lean-to.	Painted brick walls with parapet to flatroof. Tall metal windows, 3 roller shutter large metal garage doors at front.	Painted brick walls with metal gate at entry.

Building/Setting Features & Characteristics of Note		No windows			
Potential Uses	Stores / workshops				
Status/Condition	3 fair	3 fair	3 fair	3 fair	3 fair
