APPENDIX B

Formation Level Validation Photo Record

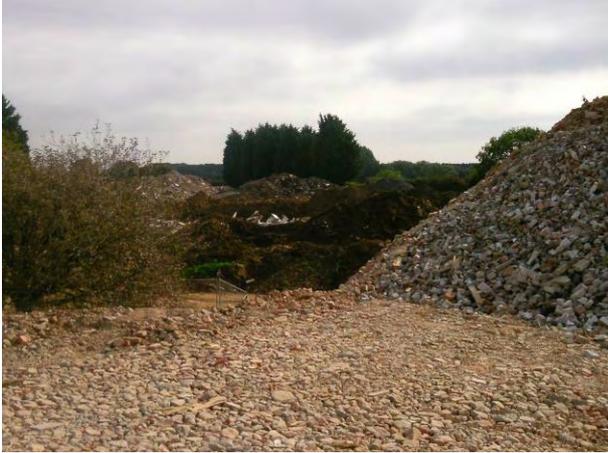
25.

10.09.14 Eastern view along the south of the site, stockpile storage area

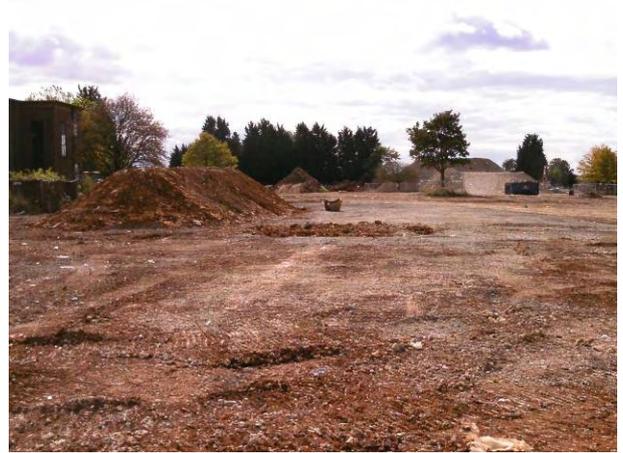
26.

24.09.14 View to the south of the site, Agg-SW visible in the background

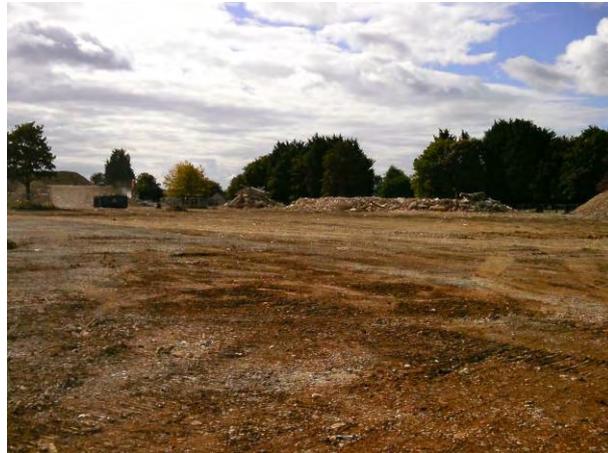
27.

24.09.14 Removal of hard-standing exposed natural soils across the south-west of the site

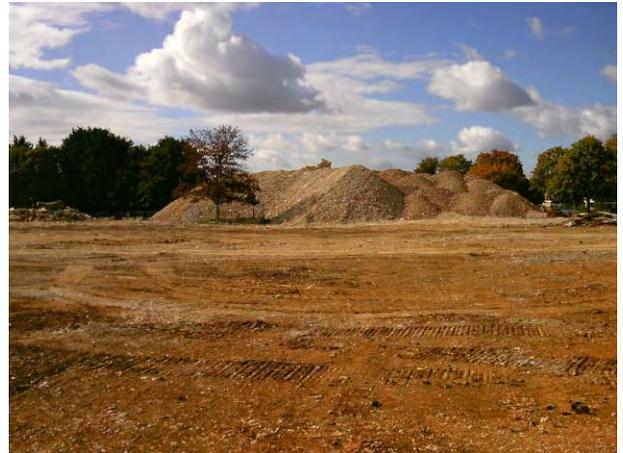
28.

24.09.14 Aggregate stockpile Agg-W located along the western boundary

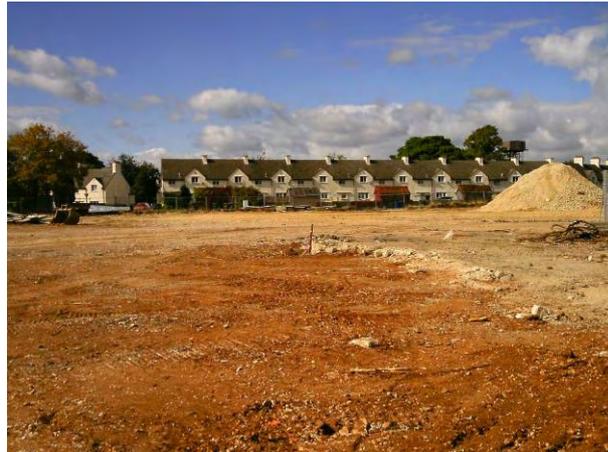
29.

24.09.14 Remediation earthworks completed in the north-west corner

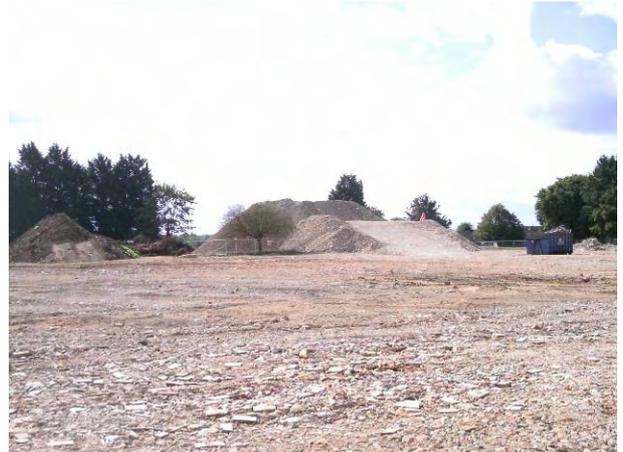
30.

24.09.14 Aggregate stockpile Agg-SW

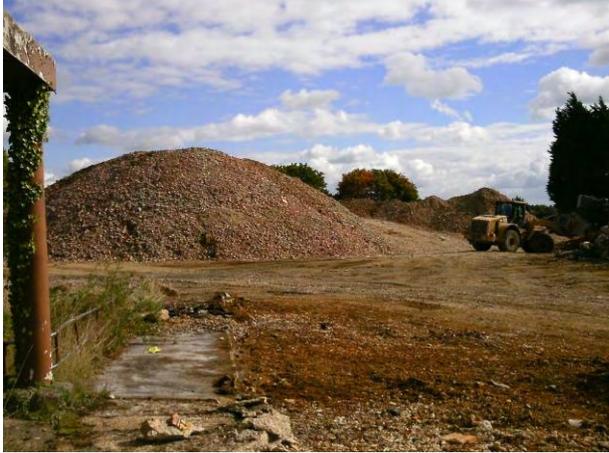
31.

24.09.14 Aggregate stockpile Agg-SE

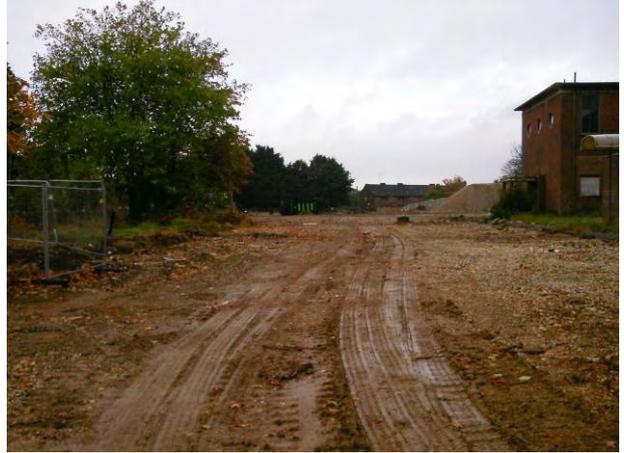
32.

07.10.14 Western view across the southern face of retained building 488

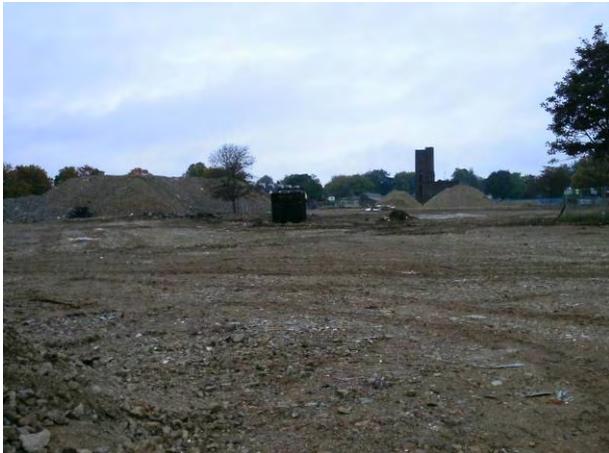
33.

07.10.14 Northern view along the western side of the site, exposed natural strata following hard-standing strip

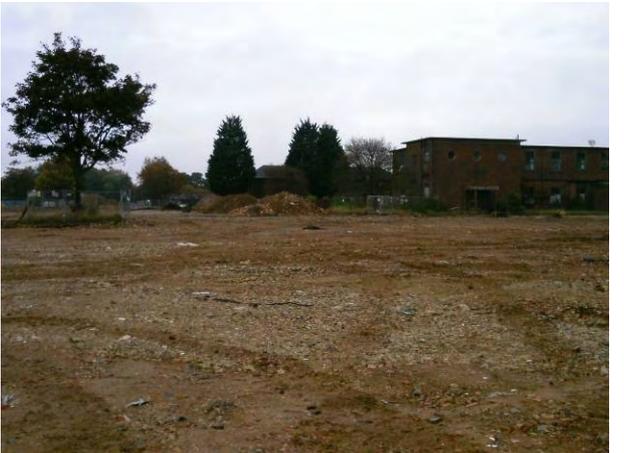
34.

07.10.14 Temporary stockpiles of hydrocarbon waste generated from UST remediation temporarily stockpile (background)

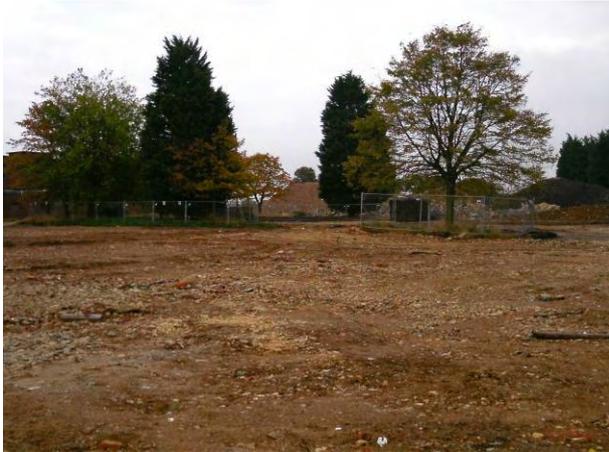
35.

07.10.14 Protected trees in the south of the site

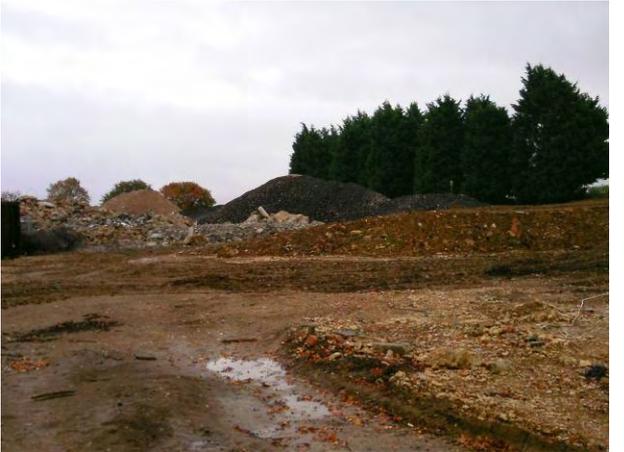
36.

07.10.14 Stockpile storage area in the south with tarmac, subsoil and concrete awaiting processing

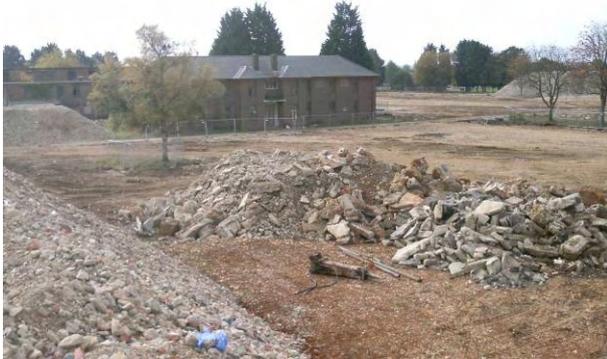
37.

22.10.14 – View of the centre of the site with building 465 visible in the background (to be retained)

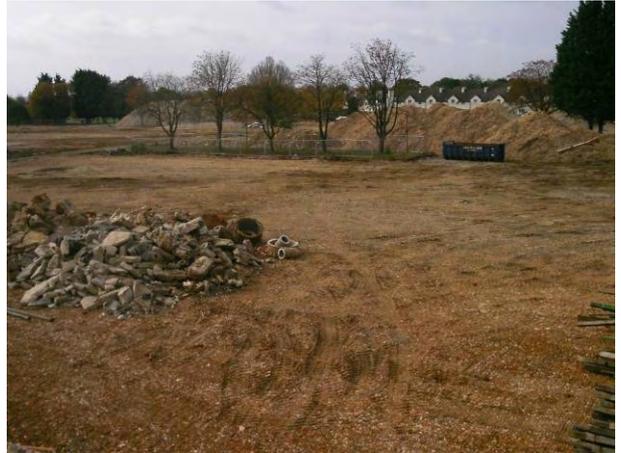
38.

22.10.14 – Central view of the site, natural soils exposed following strip of hard-standing

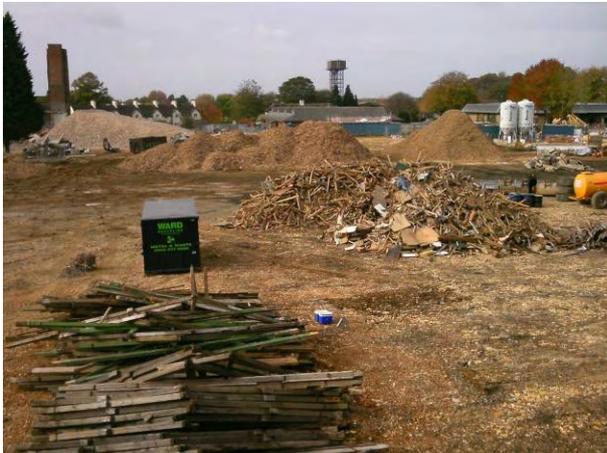
39.

22.10.14 – Waste processing area in the north of the site, waste awaiting off-site disposal/recycling

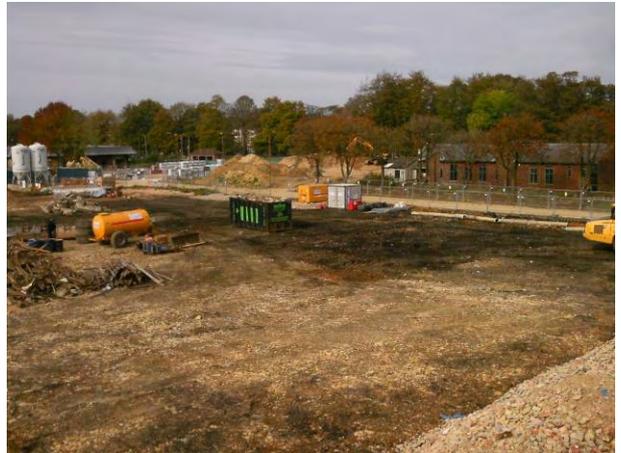
40.

22.10.14 - Waste processing area in the north of the site, waste awaiting off-site disposal/recycling

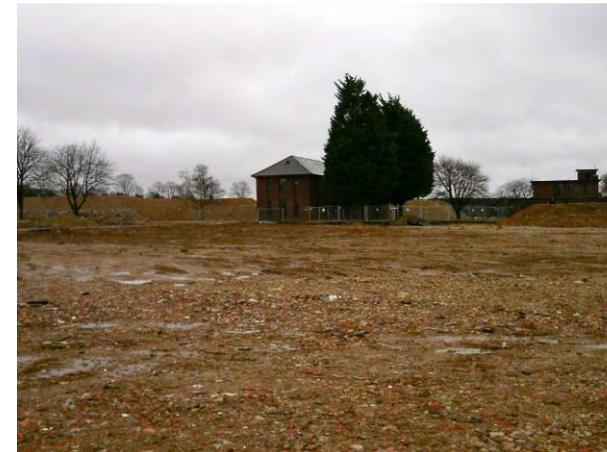
41.

12.01.15 – Eastern view to the centre of the site, building 465 which is to be retained is visible in the background

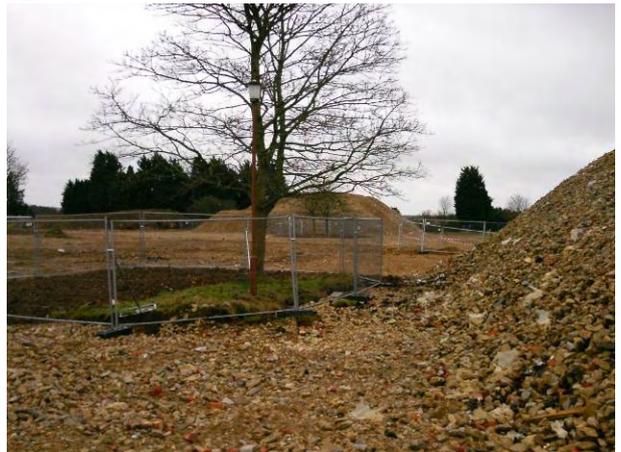
42.

12.01.15 - Southern view from the centre of the site, stockpile Agg-SW visible in background

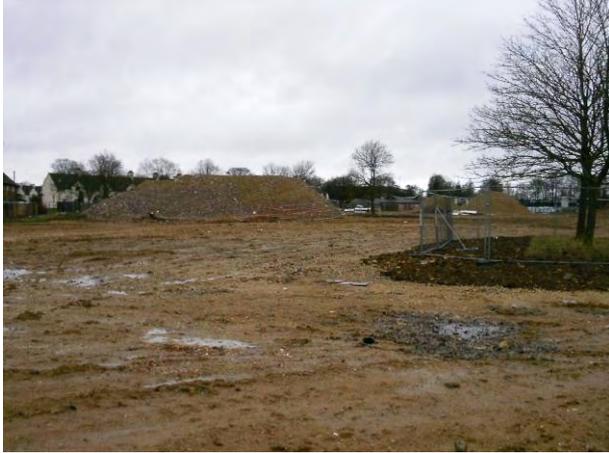
43.

12.01.15 – Western view across the site following completion of earthworks, stockpile Agg-W visible in the background

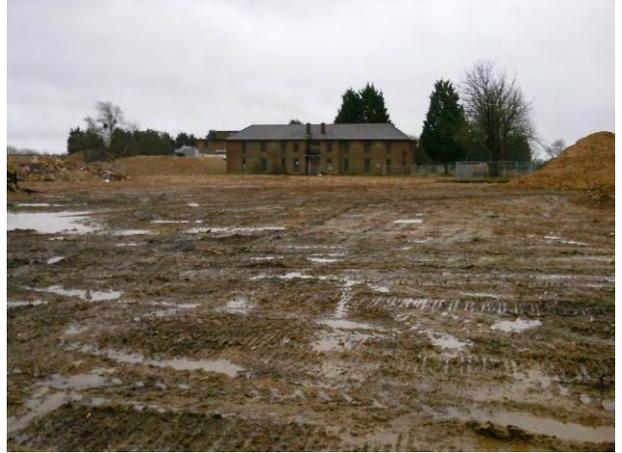
44.

12.01.15 – Southern view down the centre of the site, northern face of building 465 visible.

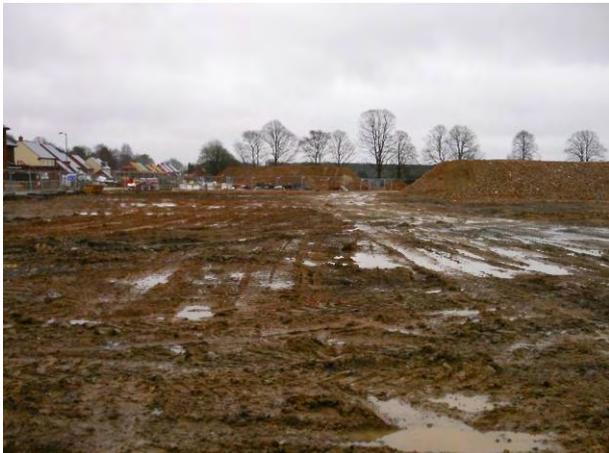
45.

12.01.15 – Eastern view across the north of the site following completion of earthworks, D1B:Area 1 visible in the background

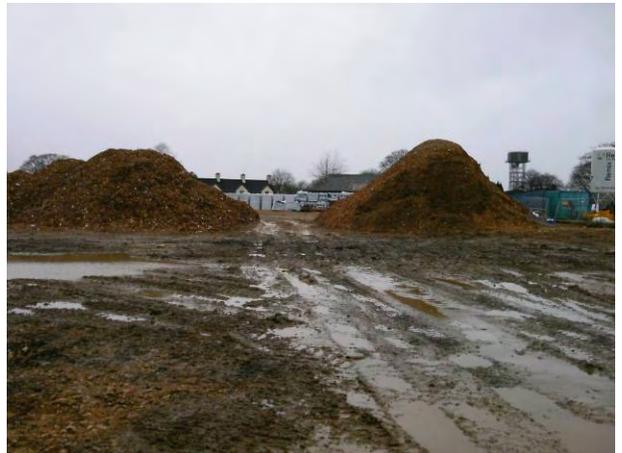
46.

12.01.15 – Temporary stockpile of waste wood which has undergone processing (chipping) awaiting removal off-site

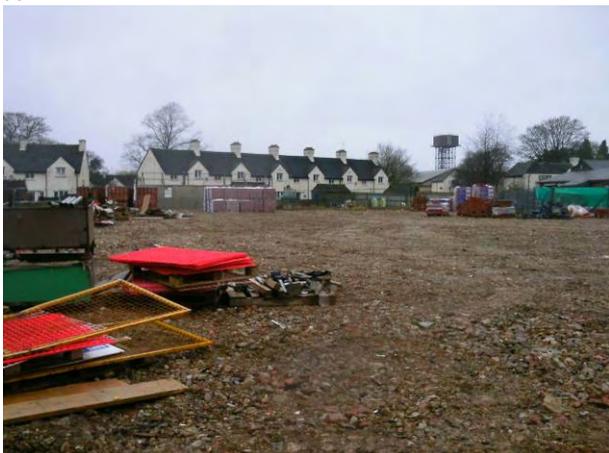
47.

12.01.15 – North-west corner of the site being utilised as a brick store following completion of earthworks

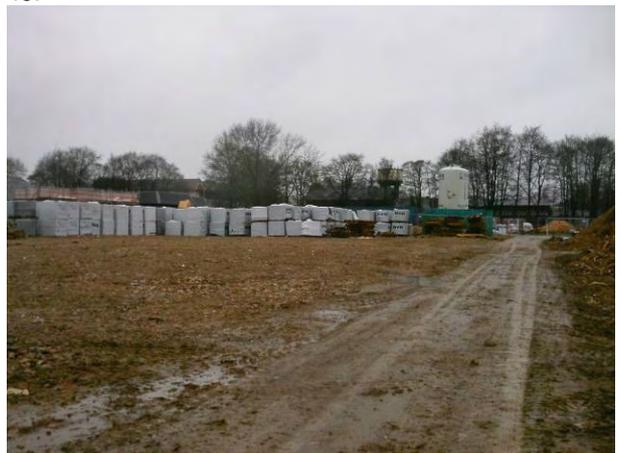
48.

12.01.15 - North-west corner of the site being utilised as a brick store following completion of earthworks. Retained road which not remediated.
