Additional Sites at Sites D&E, DSDC Bicester

Land Quality Assessment

Phase One: Desk Study
DE Project No.: 13014

Final LQA Report

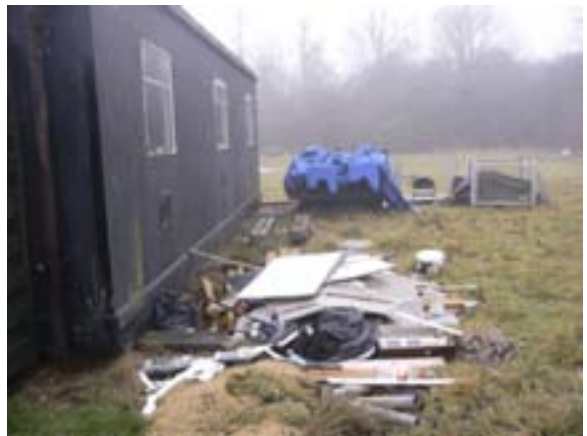
There is evidence of ad-hoc waste disposal at the rear of the changing rooms on the sports field in the southern part of Area 1, which appear to consist of building materials including plasterboard, timber and paint containers (see Plate 4 in Annex A). Scrap timber, barbed wire and apparently empty small calibre ammunition containers were noted at the rear of a container on the car park in the north of Area 1 (see Plate 8 in Annex A). Scrap metal and vehicle wheels were also noted in woodland directly to the south of the roadway loop in Area 1.

**Plate 4: Sports Changing Rooms and
Decorating Waste**

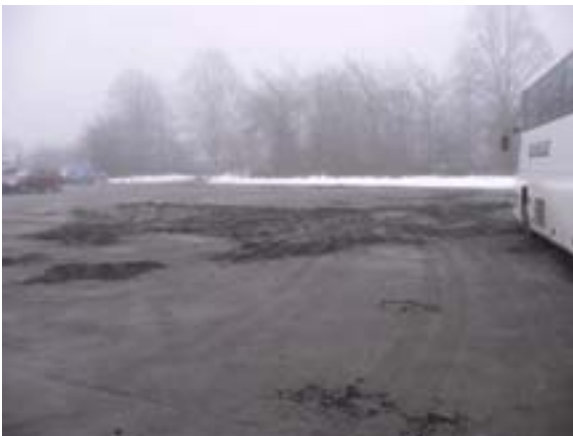
Plate 9: Broken Ground in Car Park

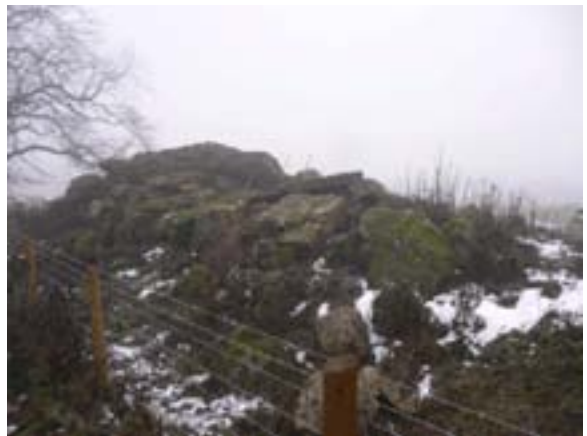
Plate 10: Building Rubble

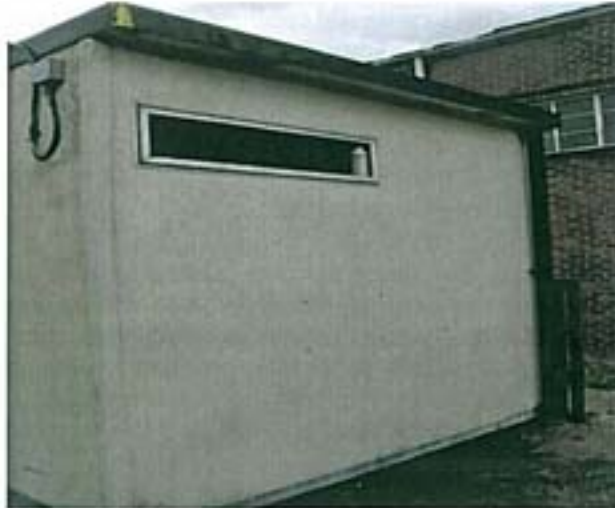
Photo 1 – External EX01 Main, Sample 1; Textured coating to external walls – No asbestos detected.
