Future Defence Storage and Redistribution Programme,
Redevelopment of MOD Bicester
Graven Hill: Land Quality Assessments
- Phase 1 and Phase 2

Site D and Site E, DSDC Bicester

Land Quality Assessment

Phase One: Desk Study
DE Project No.: 13104

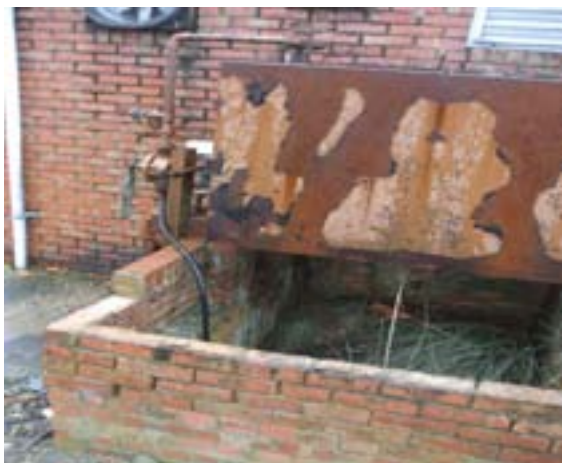
Plate 1: Above Ground Fuel Tank at Building E3

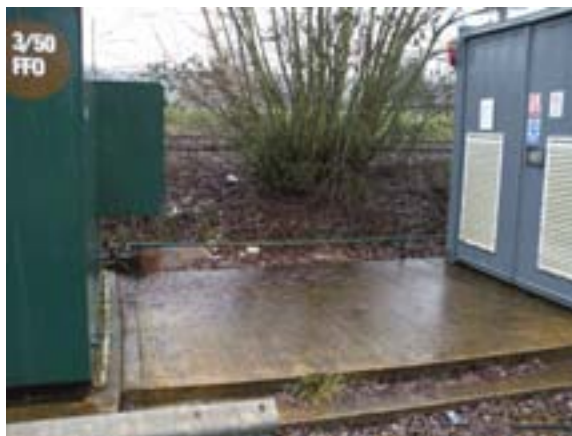
Plate 2: Modern Above Ground Fuel Tank and Containerised Boilers - Typical Arrangement

In addition, DE&S recommend that pipes running between the recent oil storage tanks and containerised boiler plants should be provided with some form of containment bunding to ensure compliance with the Control of Pollution (Oil Storage) (England) Regulations 2001.

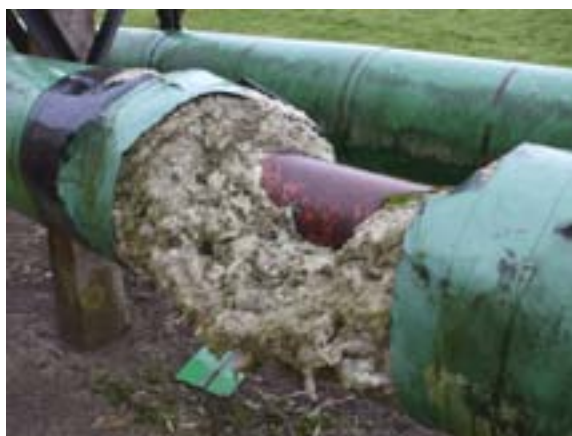
Plate 4: Exposed Cladding of Site-Wide Steam Pipes

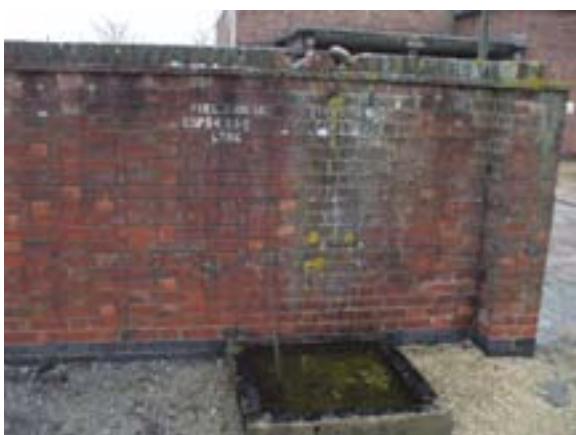
Plate 5: Building E20 Suspected Fuel Tank Filling Point

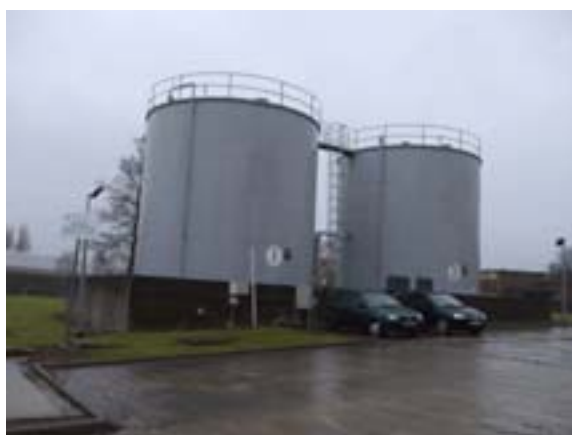
Plate 6: Large Above Ground Fuel Tanks Adjacent to E14 Former Boiler House

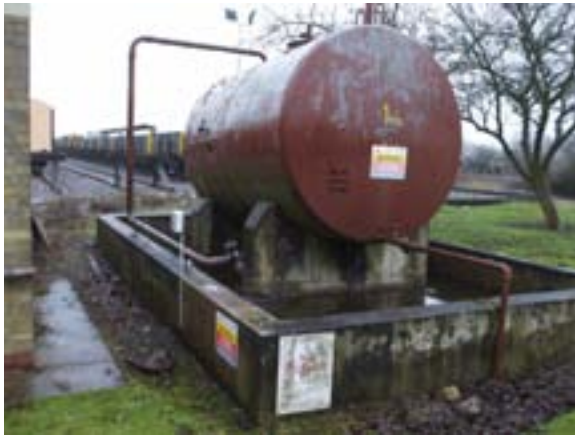
Plate 7: Loco Shed Above Ground Fuel Tank

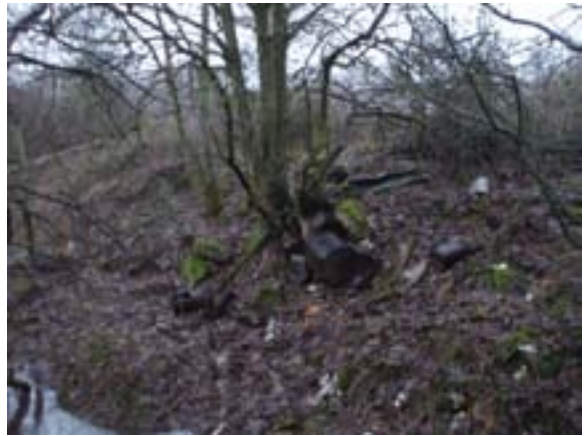
To the north-west of E15 is a heavily vegetated and wooded area with very uneven ground in places (see Annex A Plate 8). This area is understood to be a former tipping area, with evidence of broken concrete, leaf litter, wooden sleepers, plastics, steel pipes and rails, empty steel oil

Plate 8: E15 Tip

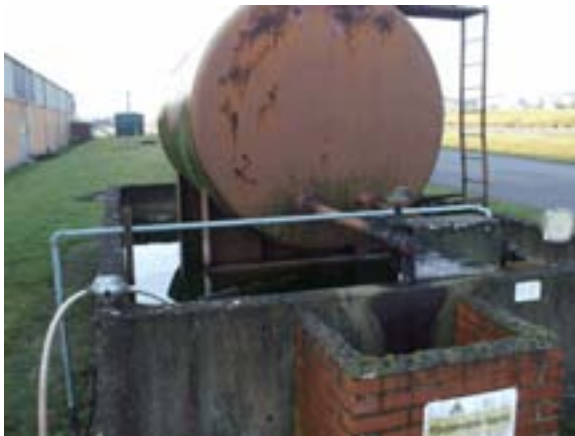
Plate 9: Building D2 Above Ground Fuel Tank

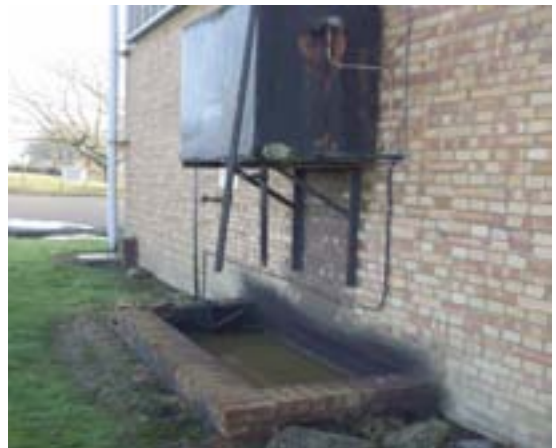
Plate 10: Stained Bunding on Wall Mounted Fuel Tank at Building D2
