Site Address: Heyford Park Upper Heyford	Rev: B
--	-----------

Title: As-Built Fuel Distribution Pipeline & Tanks

Client: Upper Heyford LP

Dwg: 2862_17	Contract: 1246 DOR	Scale: 1:4000
--------------	--------------------	---------------

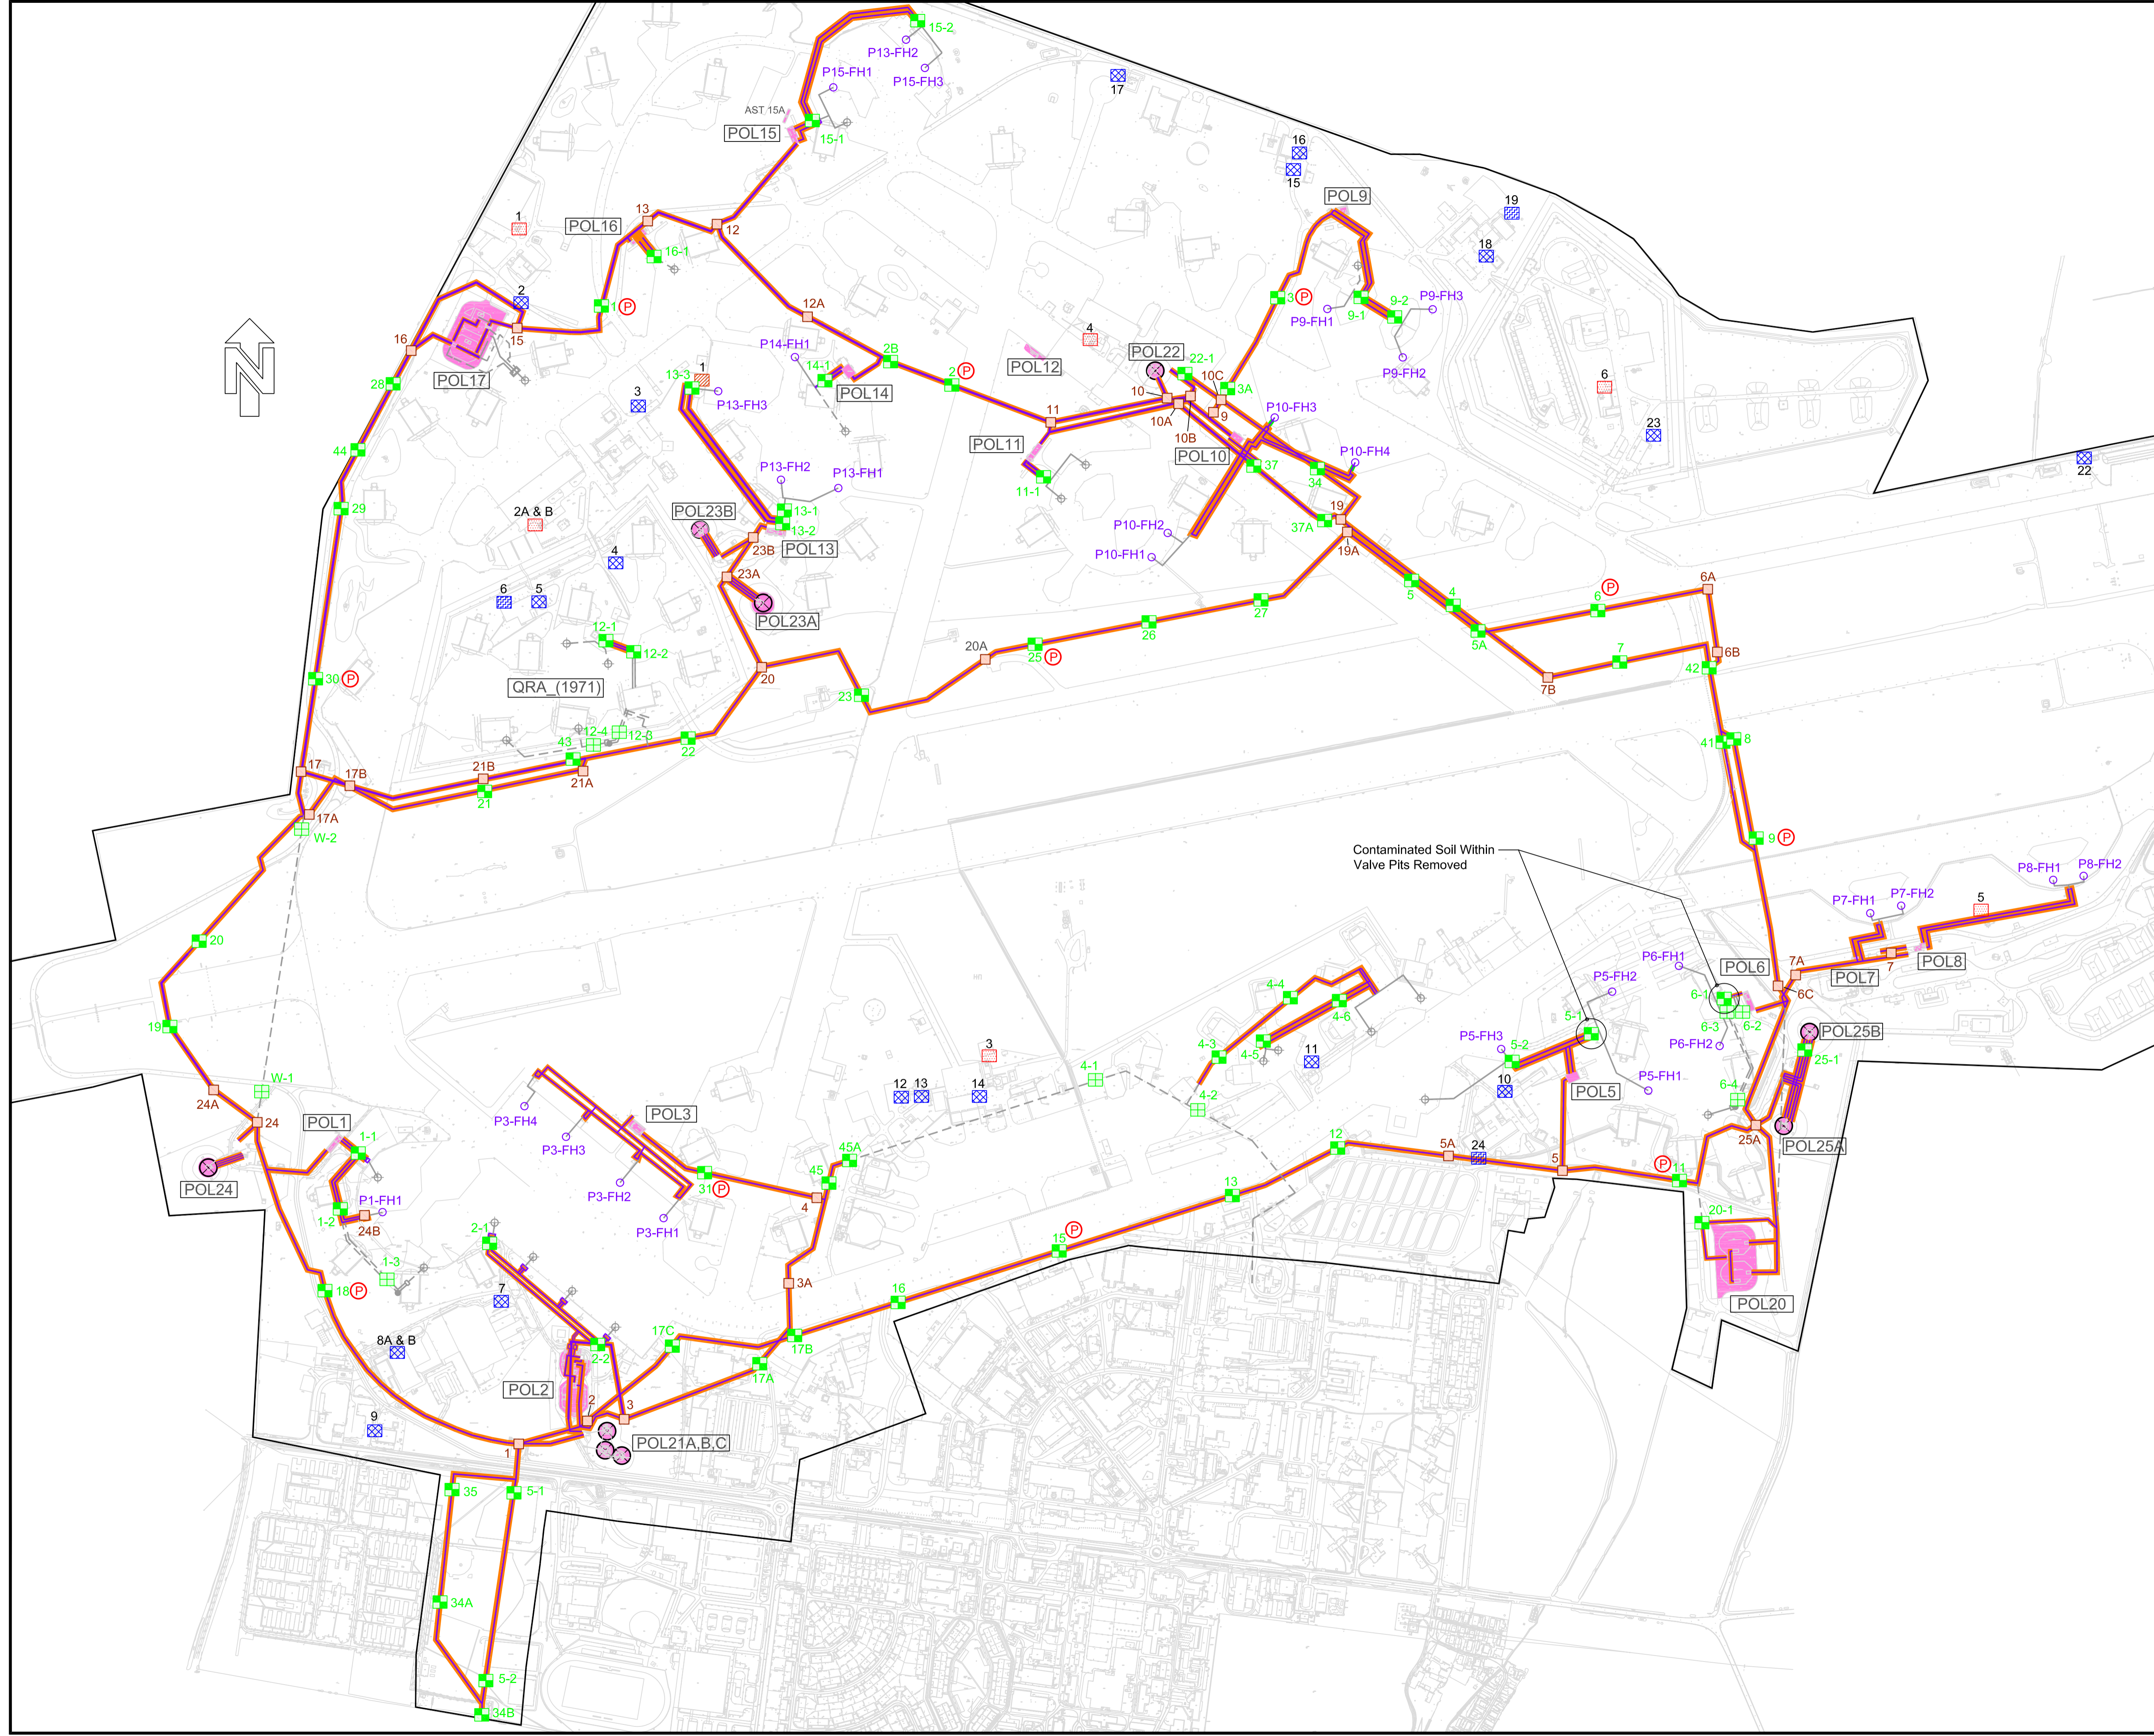
Contaminated Soil Within
Valve Pits Removed
