# Bicester Heritage

Report to highlight suitability of retaining  
specific trees around buildings undergoing  
further development.

**9/1/2016**

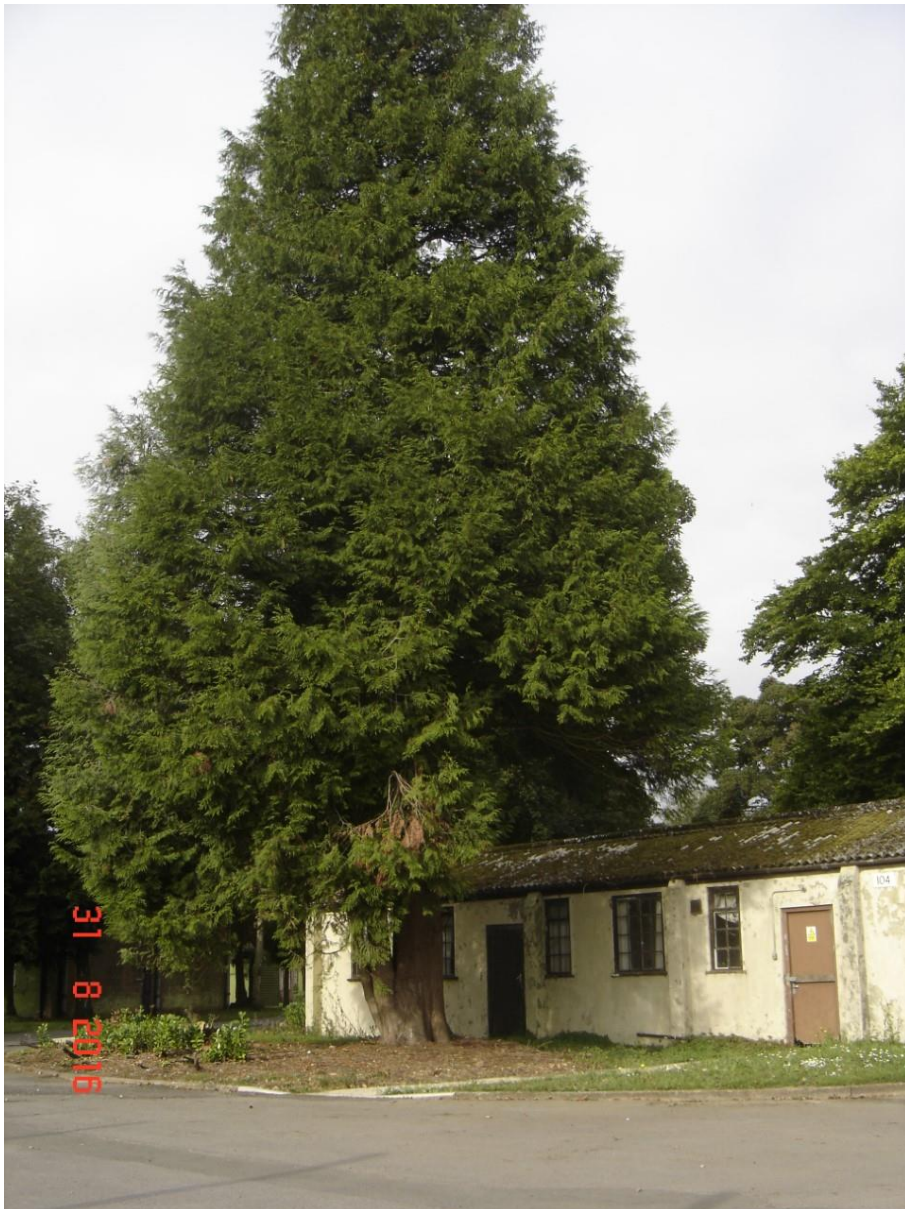
Fig. 1

3.1 – Tree 1227 is a mature *Thuja occidentalis* in good condition and is situated approximately 2 metres from the front elevation of Structure 104. (See Fig. 1)

4.7 – In the case of trees 1227, 1466 and 1211, it is in my opinion, not viable to incorporate any of the above mentioned protection systems quite simply because the trees are so close to

4.3 - Tree 1227 should be removed with the remaining stump ground out to below ground level.

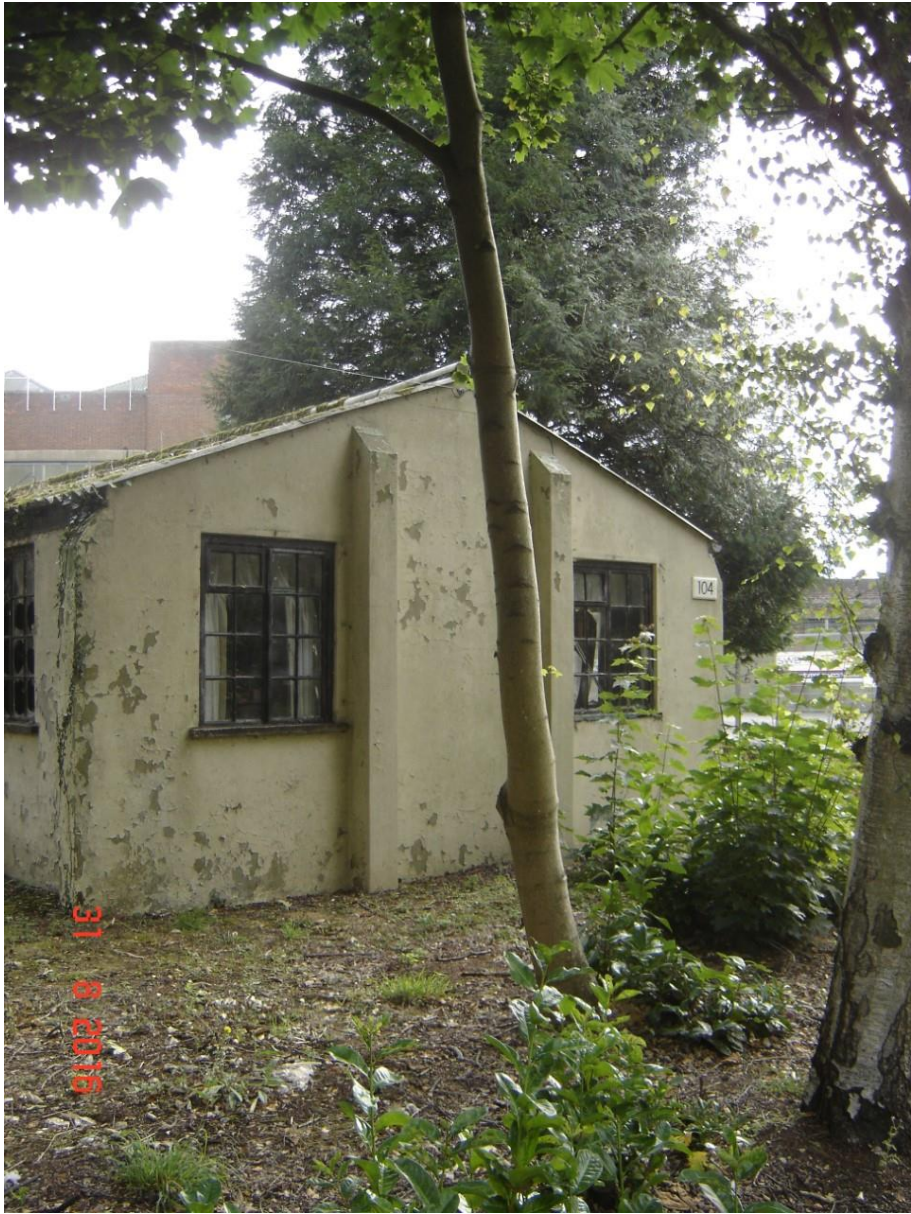
Fig. 2

3.2 – Tree 1225 is a semi-mature *Acer platanoides* in good condition but of poor form, and is situated approximately 2.5 metres from the left hand elevation of Structure 104. (See Fig. 2) It grows between a mature *Betula pendula* and *Acer psuedoplatanus*.

4.8 – Tree 1225 is unsuitable in its location. It will always be suppressed by the two trees either side of it.

4.2 – Tree 1225 should be removed with the remaining stump ground out to below ground level.

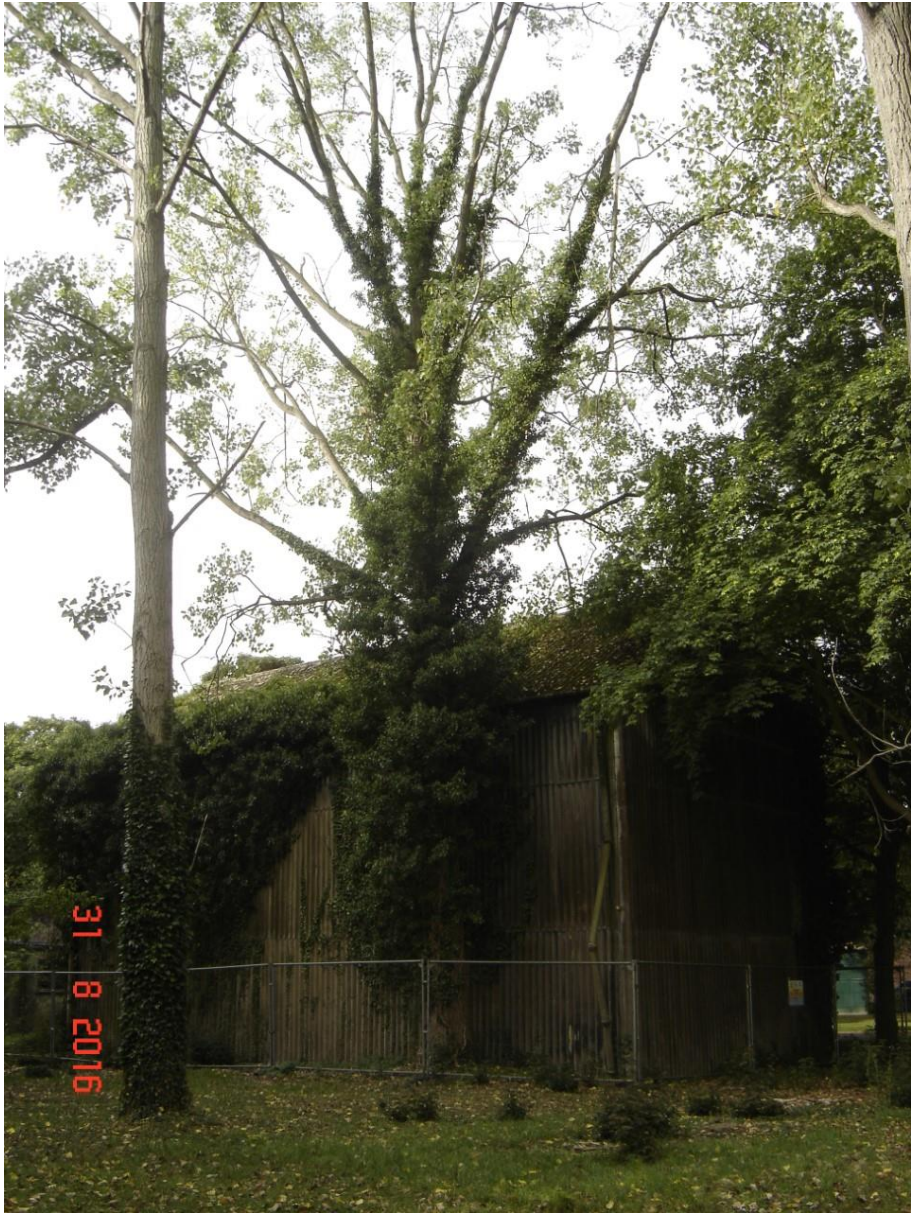
Fig. 3

3.3 – Tree 1466 is a mature *Populus x canadensis* in relatively good condition, with some major dead wood present, and is situated approximately 25 centimetres from the rear elevation of Structure 101. (See Fig. 3) Due to the extremely close proximity of this tree to the building, (See Fig. 4) the roots – via direct damage – have caused significant cracks to the concrete floor internally.

4.4 - Tree 1466 should be removed with the remaining stump ground out to below ground level.

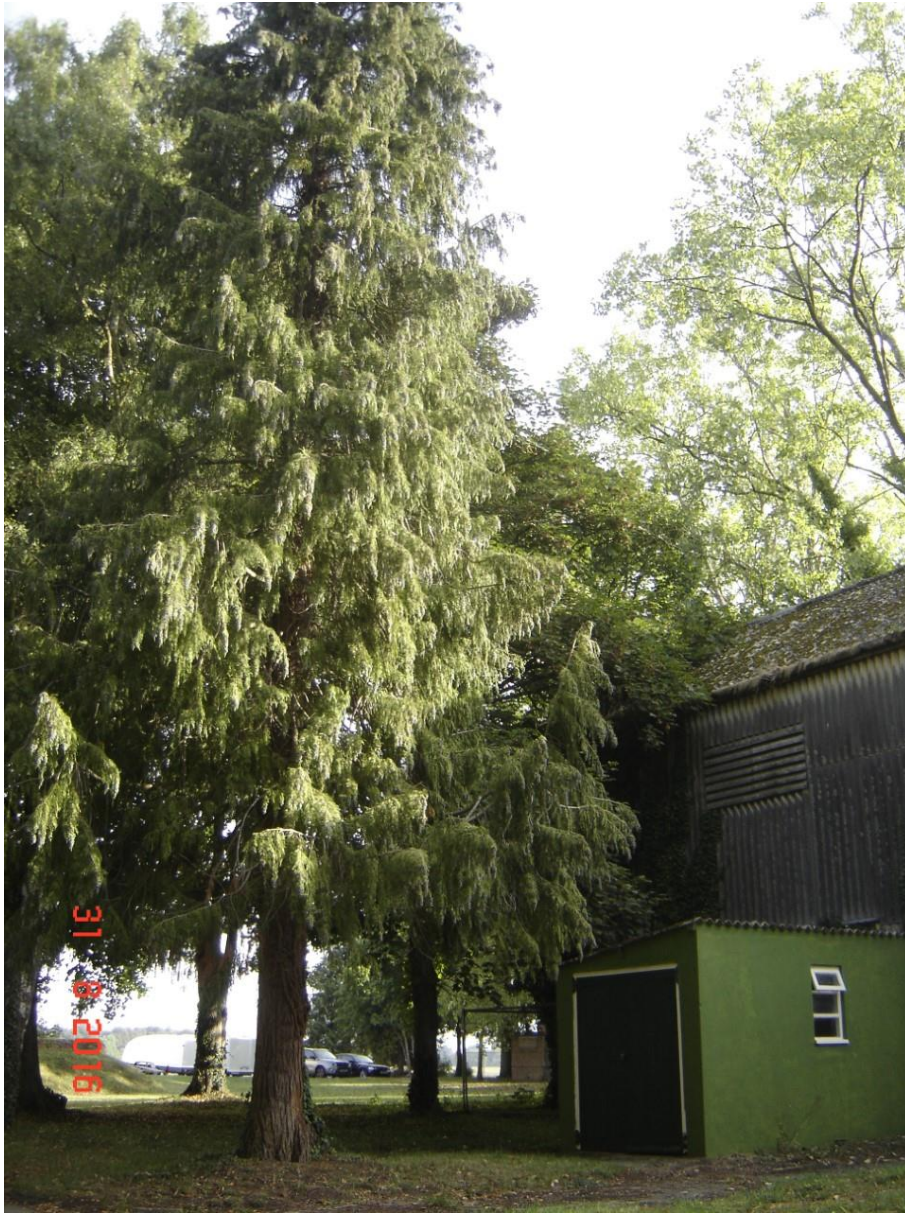
Fig. 5

3.4 – Tree 1211 is a mature *Chamaecyparis lawsoniana* in good condition and is situated approximately 2.5 metres from the front porch entrance of Structure 101. (See Fig. 5)

4.1 – Tree 1211 should be removed with the remaining stump ground out to below ground level.
