Iain Soden Heritage Services Ltd

A Heritage Asset Survey of former farm buildings at Crockwell Farm, Great Bourton, Oxfordshire

May 2016

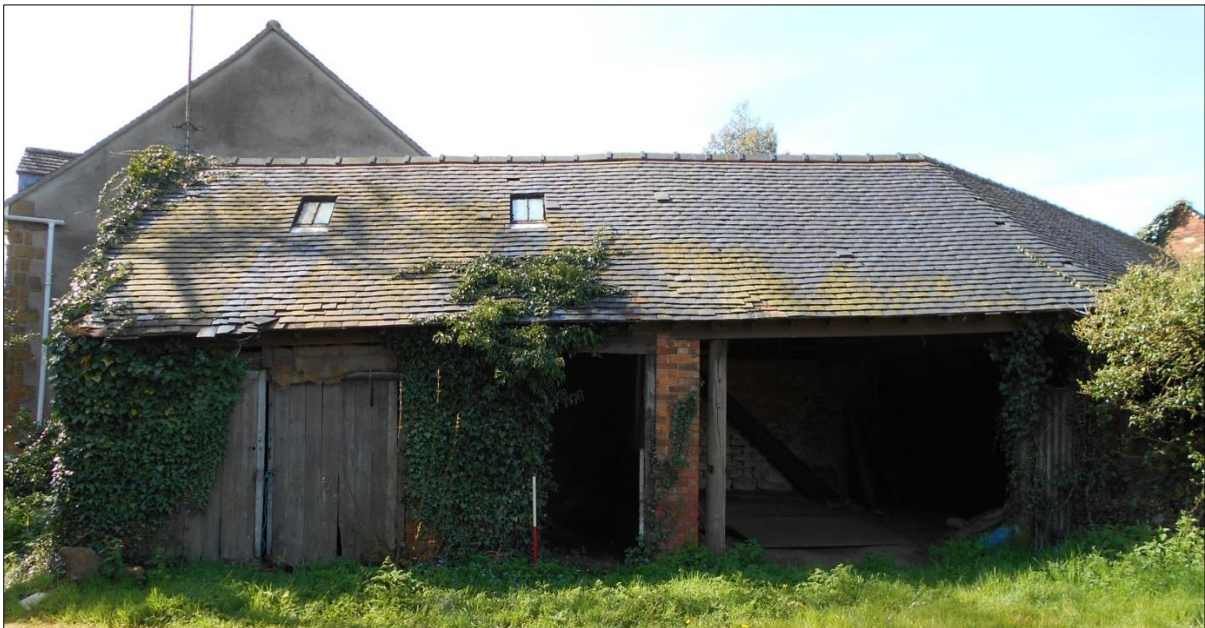
An open-fronted cart shed of three bays. It is constructed of ironstone rear, gable and dividing wall. The front edge of each north-facing wall is finished off in smooth-faced bull-nosed red brick of early 20th-century type. The floors are of brick or concrete. The roof is of machine-sawn pine and late 19th-century or early 20th-century assembly, and has a modern covering in blue engineering tiles stamped 'FINWOOD', with occasional modern skylights. Scars of a manger and hay-rack indicate that it enjoyed a previous use as an animal shelter.

Fig 3: Buildings 1 (left) and 2 (angled to right); scale 1m

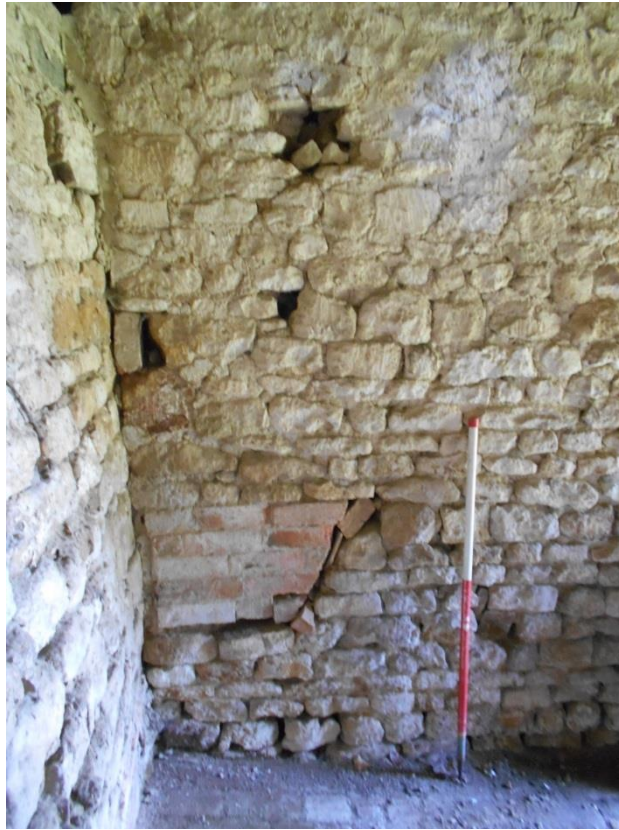
Fig 4: Scars of former manger and hay rack in Building 1 dividing wall; scale 1m

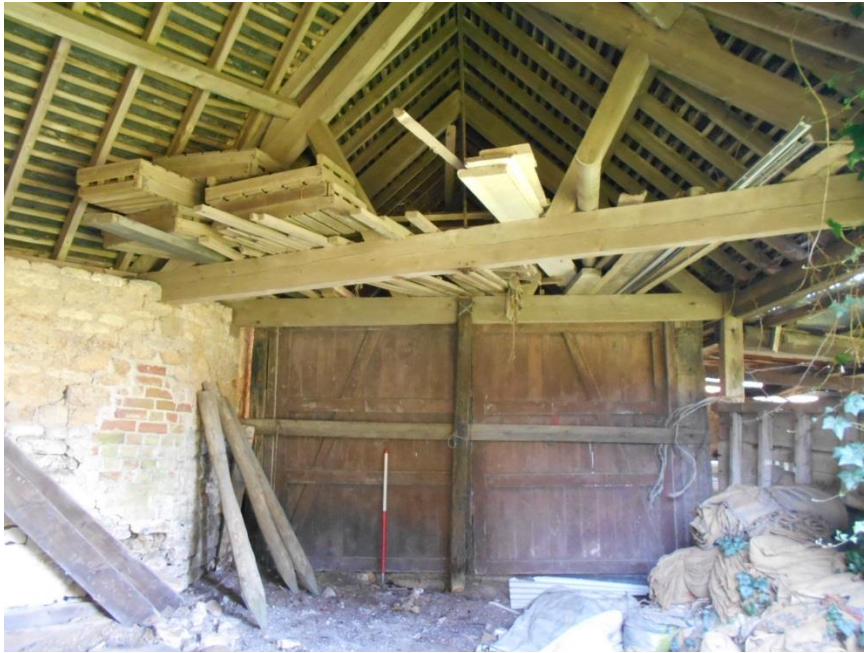
This is a building continuation north-west from Building 1 and is part of the same structure. However it appears never to have been used for anything but livestock, undivided for cart/vehicle storage, unlike Building 1. Original front wall-plate supported on oak uprights on chamfered sandstone/ironstone plinth-blocks to hinder rot.

Fig 5: Building 2 interior, looking west at the roof angle; scale 1m

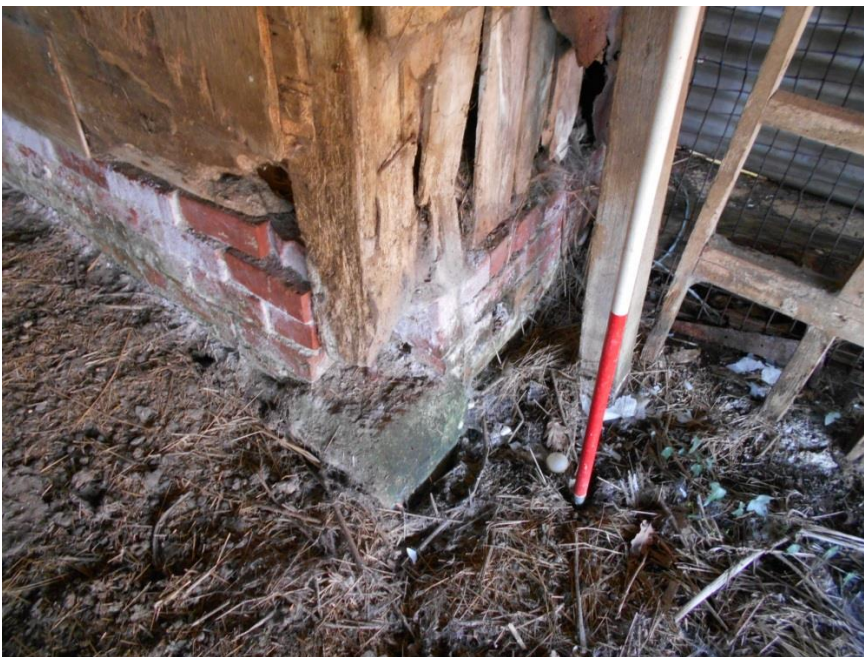
Fig 6: Original front chamfered plinth block on which rested the former open front of Building 2;
scale 1m

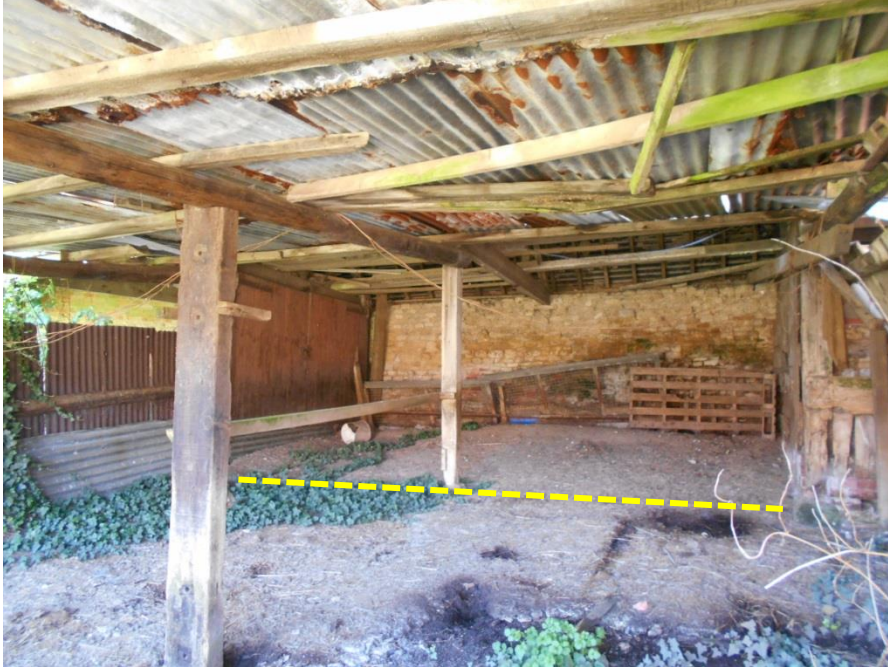
A ramshackle out-shut formed entirely of re-used railway sleepers, telegraph poles and miscellaneous timbers around original front and wall-plate of Building 2. Covering is a mixture of corrugated iron sheet, Trafford tile sheet and similar re-used sheeting. Sides are equally haphazard.

Fig 7: Building 3 interior, looking south into Building 2 (old open front is dashed)

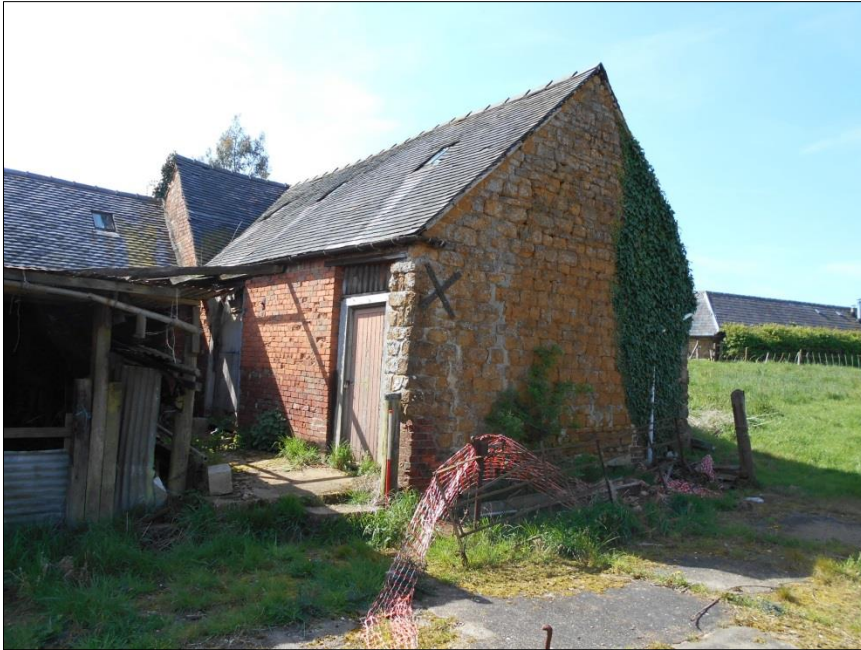
Formerly an open-fronted shed with rear and gable ends of Hornton ironstone ashlar, similar to the 17th-century farmhouse. One gable widened and heightened during its life. The east-facing front was filled-in with brick and the interior provided with pig-pens. A date scrawled into the wet concrete floor indicates this was in 1962. The roof is of machine-sawn pine in common with Buildings 1-2. The same blue engineering tiles cover it.

Fig 8: Building 4, looking south-west; scale 1m

Building 4 is constructed of Hornton (ironstone) ashlar, and for this reason may, at its core, be of a similar date to the Listed farmhouse. It is the only older farmyard building to have any historic merit, although its original use is now lost, having been converted to pig-pens in 1962.

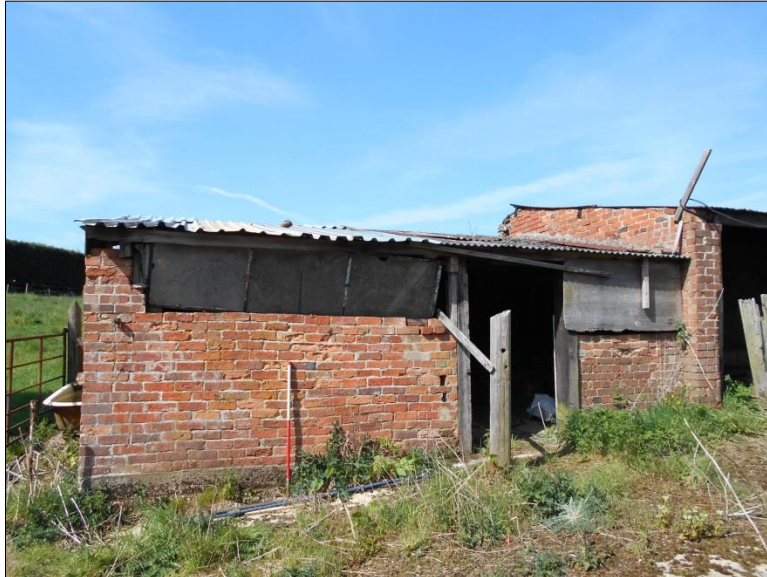
The southern half may have originally comprised simply a portion of a western perimeter wall to the farmyard, lined to the north half, but against which a building was constructed in two phases: firstly a narrow lean-to in ironstone, then an out-shut in brick, which by this time mirrored the plan of the northern half, doubling its area.

All of the timber work throughout this building was configured using re-used railway sleepers and corrugated tin sheeting of various shapes and sizes.

Fig 10: The southern half of Building 5, looking west; scale 1m; the footpath can be seen on top of the rise at far left

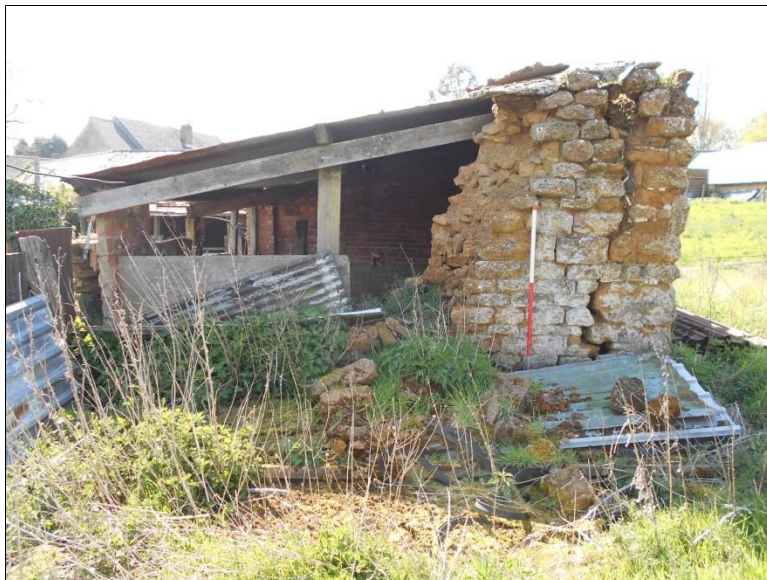
The northern half seems to have been a building of ironstone coursed rubble, clay-bonded. The north gable has collapsed and the rear wall has had to be strengthened with the addition of a red bull-nosed brick buttress.

Fig 11: The northern half of Building 5, looking south, collapsed gable; scale 1m

Buildings 6 and 11 are in ruins. Both date from before 1882 when they appear on the First edition Ordnance Survey map. Building 5 is approaching ruin.

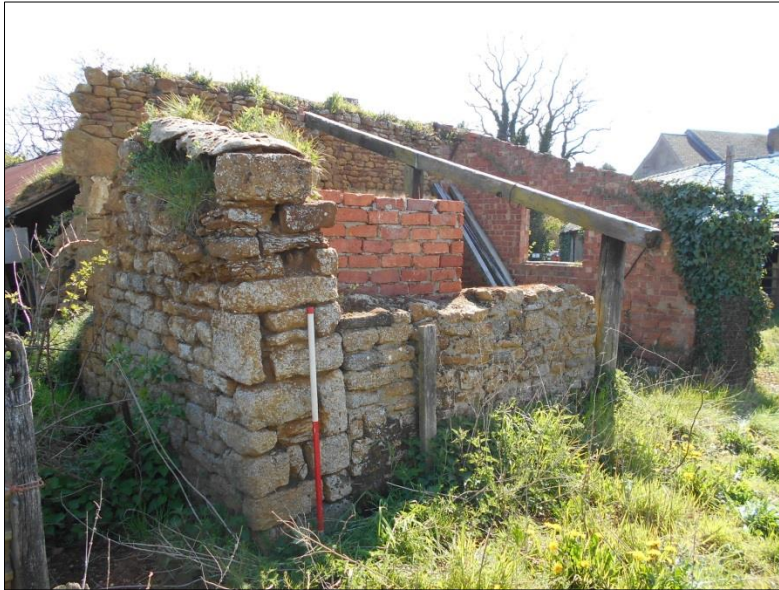
This structure is a roofless ruin, once of coursed ironstone rubble, but its southern gable has been lost, replaced in stretcher-bond brick in a mixture of Victorian or Edwardian brick (the lower half), and Fletton bricks of 1930s-80s (the upper half). It formerly had a single-fall roof, of which only the profile of the gables and a single principal rafter survive. It was formerly open-fronted on the west, but this front face was subsequently (partly) filled in with ironstone and brick. The floor was of brick.

Fig 12: The ruinous Building 6, looking south-east. Sheep-dip out of view at bottom left; scale 1m

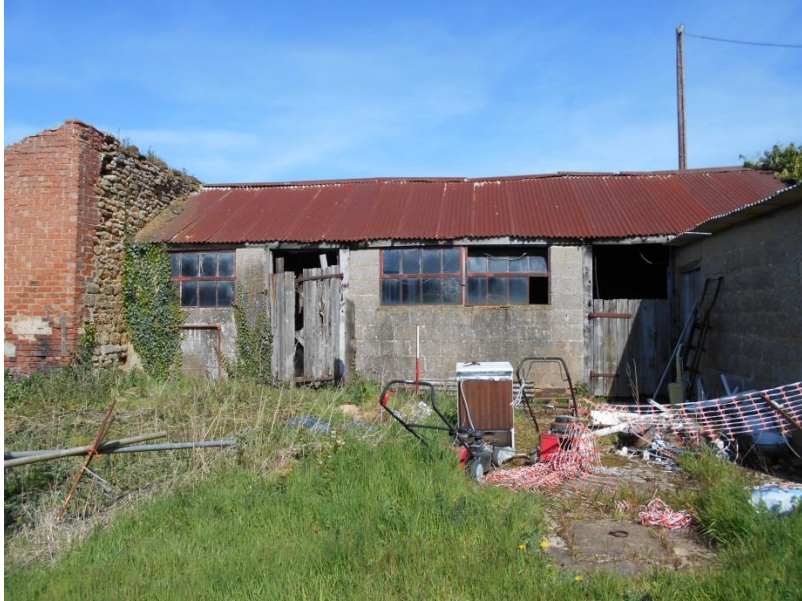
This building is of modern blockwork under a corrugated tin roof. Its west end is built off the east wall of the now ruinous Building 6. It has metal-framed windows and a concrete floor supports metal pig or calf-pens with a proprietary electric Alfa-Laval liquid feed system. Each pen contains a trough and the floor drains into a concrete drain. The back of the shed includes a narrow feeding passage divided off from the pens. The building is first encountered on the OS map of 1974, so is probably of late 1960s or early 1970s construction.

Fig 13: Building 7 of the 1970s, looking north; scale 1m. To the left is the ruinous Building 6 and to the right Building 8.

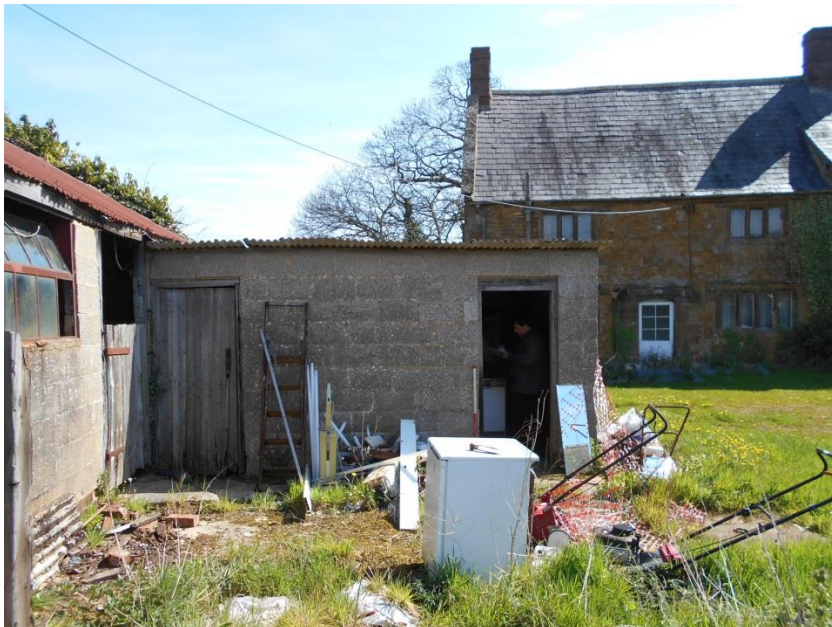
This building is a small structure containing two small rooms. One room contains the small generator and pump system for the liquid feed system in Building 7, to which it adjoins at the eastern end of its south wall. The building is of blockwork under a corrugated tin roof. It has a concrete floor. The building is first encountered on the 1:2500 OS map of 1974, so is probably of late 1960s or early 1970s construction.

Fig 14: Building 8, looking east, the farmhouse beyond; to the left is Building 7

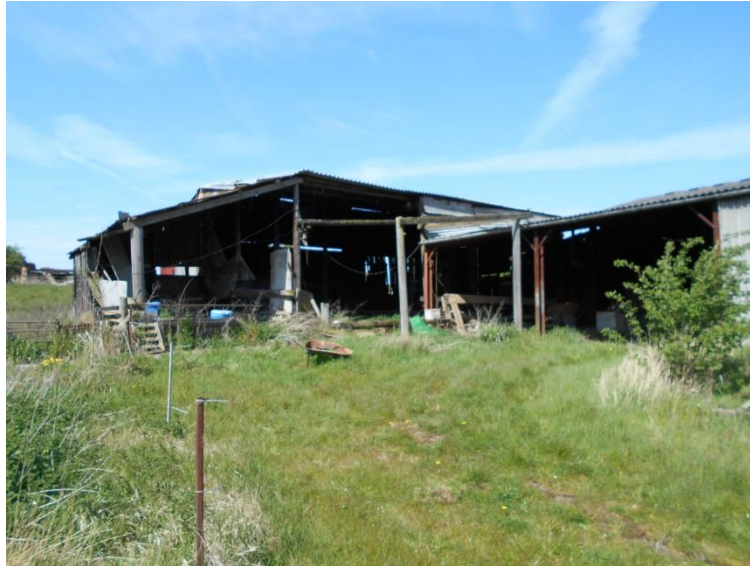
This building is a modern steel-framed agricultural shed with numerous haphazard elements of adaptation and conversion. It was formerly multi-purpose and is now derelict. It has an earth floor. It adjoins Building 10. It was not present on the 1:2500 1974 OS map, so derives from after that date.

Fig 15: Building 9 looking west, Building 10 to right. At far left in the distance is the ruin Building 11.

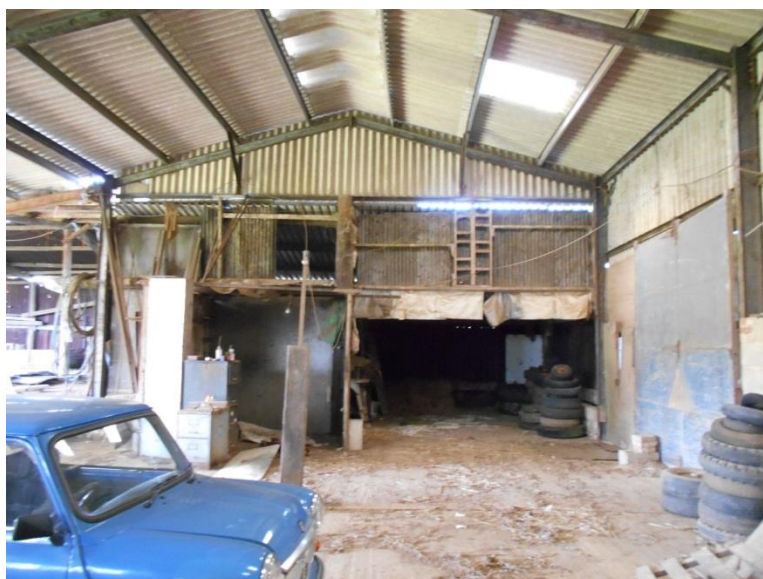
This building, like Building 9, is a modern steel-framed agricultural shed with a variety of similarly-constructed out-shuts to north and south. It has a concrete floor at its core, although its out-shuts have earth floors, and is currently used for miscellaneous storage, including redundant towed sheep-feeders. It was not present on the 1:2500 1974 OS map, so derives from after that date.

Fig 16: The interior of Building 10, a post-1974 steel-frame shed, looking west; Building 9 to left rear

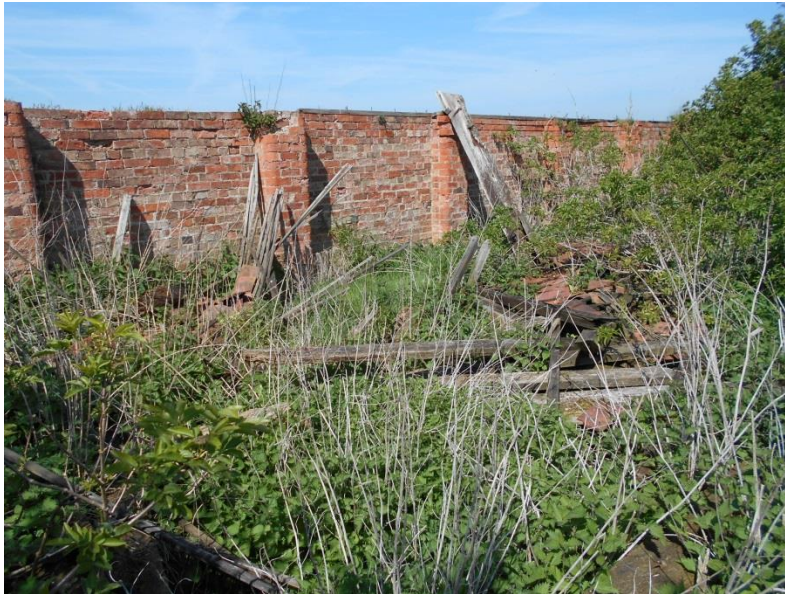
Is a former open-fronted animal shelter in brick, which is entirely ruined. The red clay tiled roof has collapsed in on top of the overgrown interior. It was present on the 1882 OS map, so may be considered mid-late Victorian. Extensive use of bull-nosed bricks indicates it is unlikely to pre-date c1850. It lies a full 30m west of Building 5 and the current proposed development area (beyond the scope of Fig 2), but has been noted as it was once the furthest-flung member of the overall farm buildings ensemble.

Fig 17: The ruined Building 11, its roof collapsed in
