Gladman Developments Ltd

**Land to the West of White Post Road, Banbury**

**Arboricultural Assessment**

July 2015

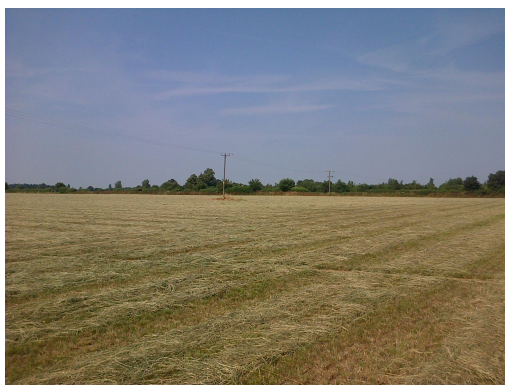
**Photograph 1: A view of typical tree cover around the boundaries of the arable fields**

- 3.4 The majority of the tree stock surveyed was situated within the hedgerows that surrounded the field parcels. From an arboricultural perspective the trees were insignificant due to their young and semi-mature proportions. T3 was a mature English holly *Ilex aquifolium* that was situated within H7 hedgerow between one of the arable fields and the amenity grassland. The tree was in a good overall condition with a dense canopy (typical for the species type), that was tidy in appearance with no major defects. The tree was considered as having a moderate arboricultural value and was regarded as retention category B.

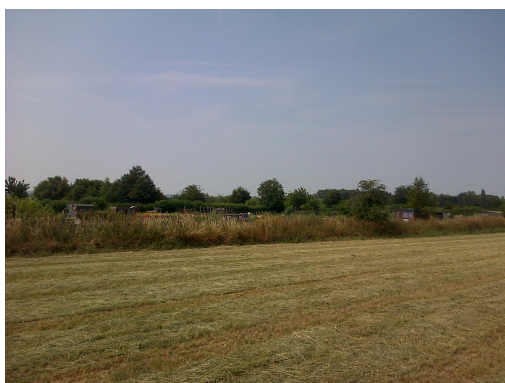
**Photograph 2: Trees associated with the edge of the allotment**

- 3.5 There were several trees bordering the allotment area that were young to semi-mature and of a mixture of different species; (refer to Appendix A Tree Schedule). They were sparsely distributed and of small dimensions hence were therefore considered to have only a low arboricultural value.

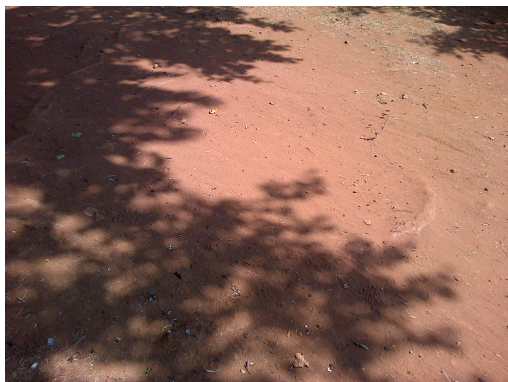
**Photograph 3: Exposed and damaged roots**

- 3.8 All of the trees within the field parcel had suffered from soil poaching with some specimens having some exposed and damage roots resulting from vehicular access to the field. From visual observations those trees that had suffered most were TG17 that comprised of two common lime, T14 copper beech, T15 common beech, and T16 common lime, which were all close to the access gate into the amenity grassland. Direct damage to some of the rooting area was evident although limited to the surfacing material however the damage had only exposed a relatively small proportion of the total root plate and as the trees appeared to be generally in a fair or good overall condition they seemed not to have been adversely affected by damaged parts. It should however be taken into account over the long-term that if the continual use of vehicles accessing the field is to occur it is more likely to cause decline to the trees overall health, as the soil in the rooting area housing the roots will become permanently compacted, and this is likely to reduce the availability of nutrients and water vital to long term good health and survival.

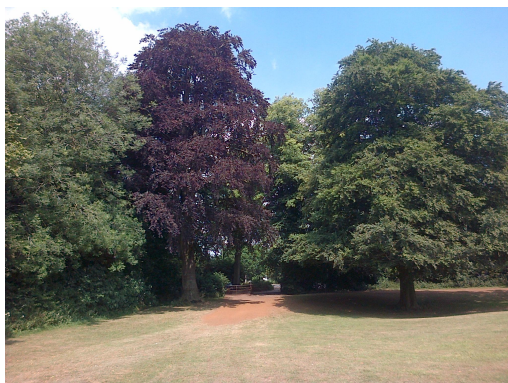
**Photograph 4: Beech trees situated within amenity grassland**

- 3.11 Located within the field parcel were T14 copper beech and T15 common beech that individually and collectively added high aesthetic value to the locality, and were regarded therefore as retention category A accordingly. As mentioned in paragraph 3.9 both trees had also suffered from soil poaching and exposure to some of the roots caused by vehicles using the gated access point. Both trees contained both minor and major deadwood. T15 contained major deadwood within the lower half of the crown with some dead branches up to 5m long. Stubs were present on both trees from past pruning operations. The overall ground clearance of T15's canopy was 3m.

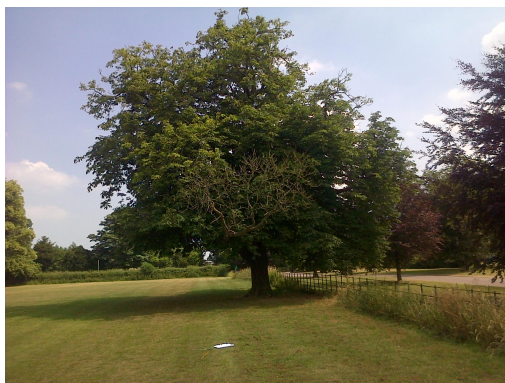
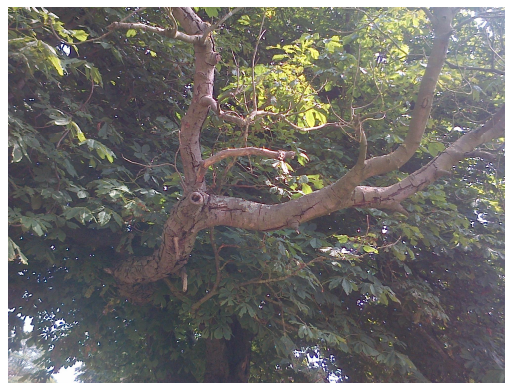
- T8 showed a degree of recovery from infection by Bleeding Canker identified in the previous survey. However, due to the progressive nature of this condition the specimen, if retained should be monitored for further changes in its condition on a regular basis and appropriate action for rectification of any deterioration in its condition applied accordingly.

**Photograph 5: T8 horse chestnut with dieback    Photograph 6: 7m long dead branch on T8**

- 3.13 T8 was an over-mature horse chestnut *Aesculus hippocastanum* that was previously in visibly poor physiological condition exhibiting major dieback throughout the canopy. Major deadwood was visible and included a 7m long branch in the western side of the crown. Exposed wounds and bark necrosis was also visible and particularly prevalent on the lowest 2m of the stem. A 5m vertical large split to a primary limb was also visible that formed a potential “hazard beam”, the nature of which would have a higher likelihood of branch failure. Soil poaching had also occurred near the roots of the tree close to the stem that had resulted in minor root exposure. Visible during the observation of T8 were a number of black spots present on some of the dead branches. This is a potential indicator of Bleeding Canker of Horse Chestnut *Pseudomonas syringae* pv. *Aesculi*, a pathogen which can lead to the eventual demise of the condition of the tree and ultimately death. T8 had a low canopy in places with just 1 - 2m ground clearance.

- 4.12 Only one tree would need to be removed. T8 was an over-mature horse chestnut, which is afforded statutory protection through a Tree Preservation Order however, the tree was assessed as being in a slightly poorer physiological condition than normal for what would be expected for a tree of such an age. There was major deadwood present within the canopy and indications of infection from the disease; Bleeding Canker of Horse Chestnut, a disease that has the potential to eventually cause the death of a tree in most cases where it occurs. Despite it's category B grade in its current condition the tree was considered as offering a lower overall arboricultural value due to the current compromised structural health and more importantly for having a much reduced life expectancy due to the presence and nature of the disease affecting it.

- 4.14 The suggested approach, involving the removal of T8 in order to achieve this should not raise objection on arboricultural grounds especially considering the trees limited future prospects and that it can be replaced close by within the open space provision being proposed.

- 4.15 If approval is given to the development and T8 is removed to facilitate the consented layout, the status of the Tree Preservation Order would be overridden but, the manner of its replacement would need to be agreed with the LPA.
