Report on the Condition of

**CHANCEL COTTAGE
FIR LANE
STEEPLE ASTON**

On behalf of Justin Granger

ORIGINAL ISSUE DATE:
November 2013

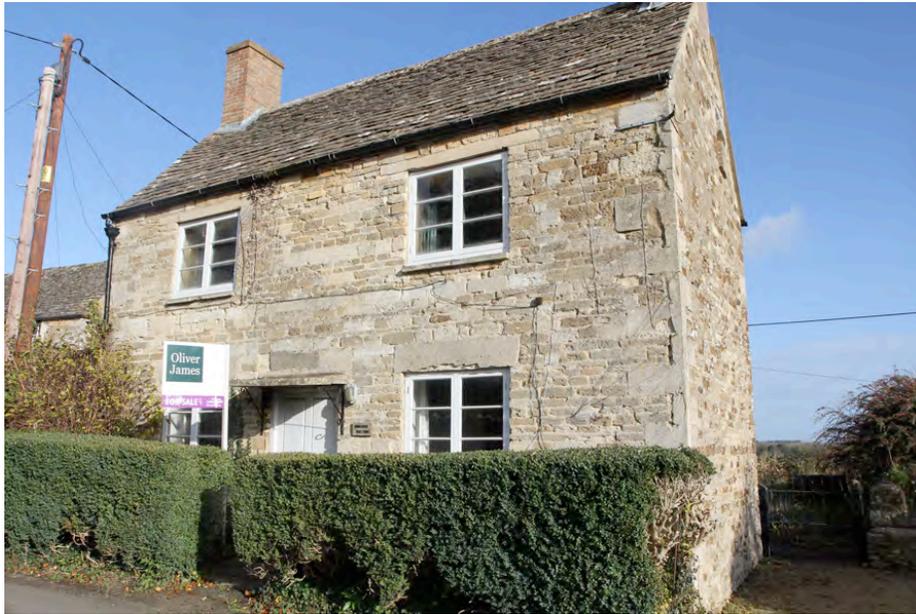
7.1 West Elevation

The wall is coursed limestone with ashlar dressing, which is affected by ivy and vegetation growing at low level to either side of the doorway, the general clearing out of this is required. This is clearly not assisting with the damp internally. There are open joints generally to the wall, particularly beneath the windows and between the windows. Local overhaul of the stonework and repointing is required to an area of approximately 30 sq. metres. To the ground floor there are two 2-light windows, which have been replaced which are in fair condition but will require redecoration. Both have stone lintols which have been rendered, the render is breaking off to the window to the south and replacement will be required. The general making good is required around the lintol and to the lintol to the window to the north. It may be possible to reinstate the stone lintols but investigation to the removal of the render is required.

To the centre of the elevation is the 4-panelled doorway, which is in reasonable condition but will require redecoration. There is some rot occurring to the lower rail to the door and to the weatherboard. Over the door there is a stone slab, which forms the porch supported off two cast iron brackets, which is in fair condition. The lintol over the door is again rendered and scribed which has been inserted over a stone lintol. General making good to this is required.

The first floor has two 2-light windows, which have been replaced and are in reasonable condition. Both have concrete cills, which have been lined with lead and rendered, the render is breaking off to the window to the north and general repair is required, as it is to the pointing beneath this. The lintol to both are stone which are in reasonable condition. There are open joints beneath the eaves, which require repointing. As noted internally there has been some outward movement to roof, which has caused the eaves

The quoin stones on the south side are affected by some movement to the outer face of the wall to the east gable. Repointing is generally required in conjunction with repairs to the gable.

To the north of the wall is a plastic gutter on a timber fascia which discharges into a cast iron downpipe with hoppers. The gutter requires general cleaning out. The downpipes themselves are in fair condition but again the cleaning out and redecoration is required.

The roof is formed in stone slates in diminishing courses. The roof has been relaid. There is some slippage to the slates beneath the ridge and around the chimneys. The recovering will be required. The stone ridge is in fair condition. Both end stacks are in brick with a lead lining. There are open joints around the lining from the west slope to the chimney to the east, clearly repairs are required. There are several missing small bricks to this chimney and slates missing under the flashing. Overhaul and repointing is required to the stack. The stack to the north is in brick, which appears to be generally sound.

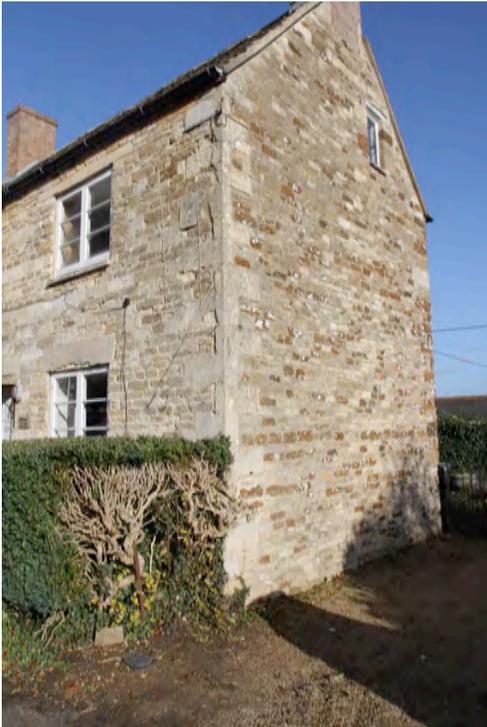
7.2 SOUTH GABLE

The south gable to the main range is in limestone rubble and ironstone, there are open joints to the corner to the west and at ground level, which require urgent repointing. The wall itself has been pointed in a hard cement mortar and some decay, consideration should be made to the replacing of this.

At high level there is the single light window with timber lintol and stone cill. The window is metal, general overhaul of this is required together with re-puttying. The lintol appears to be in reasonable condition. The cement dubbing has broken away allowing the mortar to ingress behind the flashing which is causing the damp internally. The verges are formed with a tiled overhang and pointing which are in reasonable condition.

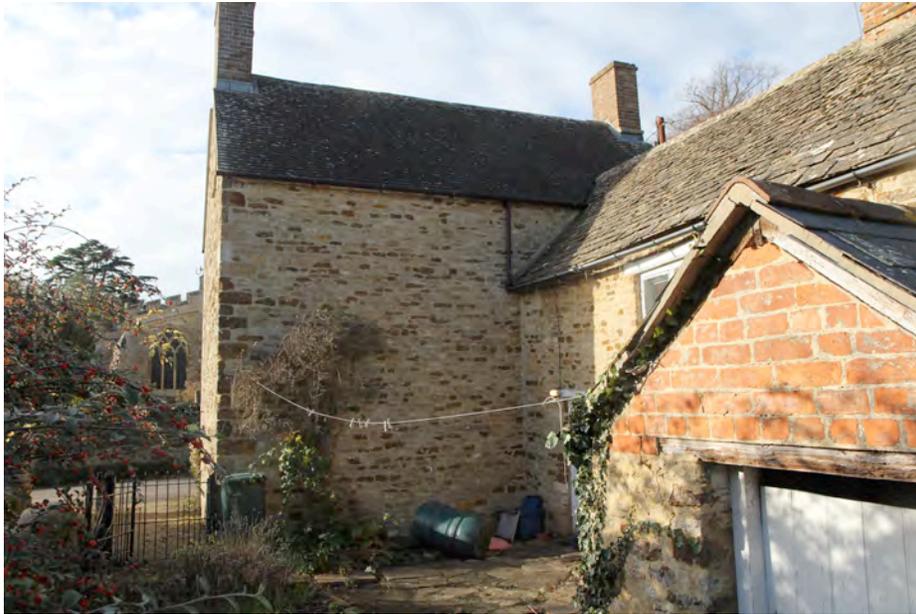
7.3 EAST ELEVATION TO THE FRONT SECTION

At ground level void there is the lightwell to the window to the basement, which requires general clearing out and repointing together with the ground floor replacement of the window. As noted internally there should be some arrangement for ventilation made.

There is a blocked window with a timber lintol and cill remaining.

The roof is formed with a fascia and plastic gutter and downpipe, which discharges into the gutter extending along the outbuilding. As noted previously there is brickwork cracking to the chimney to the south and general repair is required together with replacement of the flashing. Attention is required to the flashing to the chimney to the west where the chimney itself is in reasonable condition.

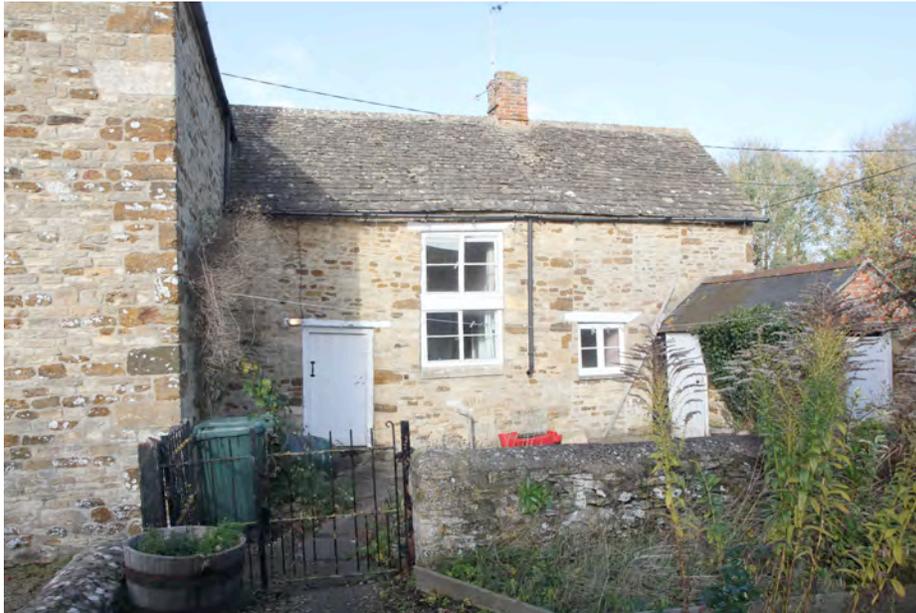
7.4 SOUTH ELEVATION TO REAR WING

The elevation is a mixture of limestone and ironstone, which has been flush, pointed. The stonework generally requires overhaul and repointing. There is a movement crack to the main building, which has been repointed in a hard cement mortar, which is coming away, and further movement cracks beneath the eaves. The movement has occurred to the centre of the wall where the central window has distorted. There is damage to the stonework to the junction with the gable wall to the bathroom section. Clearly there has been outward pressure from the roof. The general tying in and repointing is required. There is a substantial bow to the wall. Investigation should be made into the ground conditions in this area.

Returning to the stonework, there are open joints and movement beneath the window to the kitchen. The stonework to the section appears to be in reasonable condition although repointing is required. To the west of the wall is the boarded entrance door, which is decoratively in poor condition. There has been some rot to the lower members of the frame, which has been replaced in the past. Overhaul, repair and redecoration is required.

The kitchen window had repairs in the past, which had been pieced into the cill, this is decaying. The metal replacement opening light appears to be in reasonable condition. Over this is a timber lintol to which there is settlement to the lintol. The general overhaul and repair is required. There is a plastic gutter on rise and fall brackets which has discharged into a rainwater pipe, which is now removed. Improvement of the drainage system here is urgently required.

The roof is formed in stone slates in diminishing courses, which is in poor condition, and recovering is required. To the ridge there is a brick chimney to which the brickwork is

spalling and the pointing is poor. The general overhaul of this is required in conjunction to any new roofing scheme.

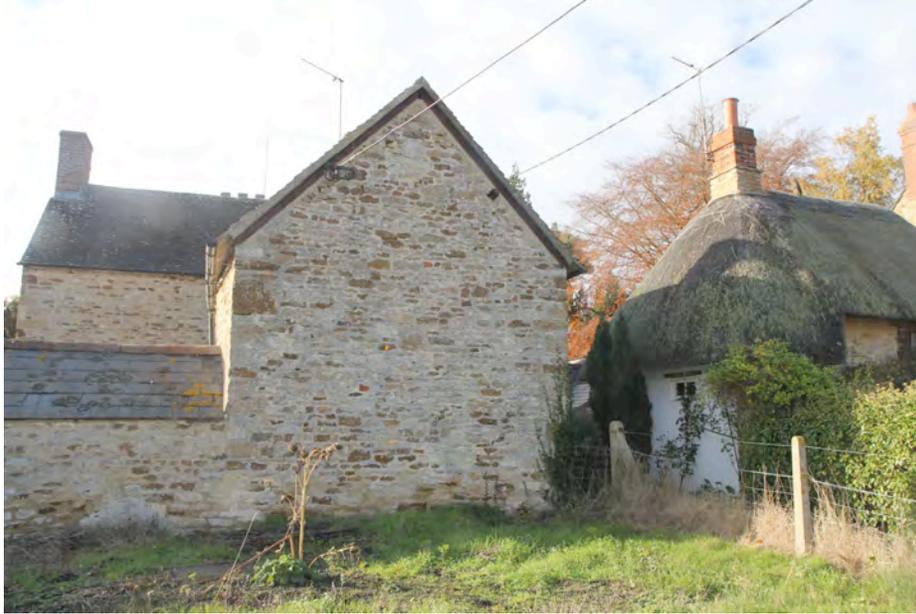
7.5 EAST GABLE

The stone gable has considerable opening joints and movement cracks which extend down the centre of the wall to both corners. General repointing is required and overhaul to the gable complete and local replacement of stonework. The verge is formed with timber boarding with overhanging slates, which are in fair condition. The incoming electrical mains is fixed to the purlin end which is clearly not helping the condition of the movement of the gable and the replacement of this by an underground supply is strongly recommended. The installation of a land drain at the base of this wall should also be considered.

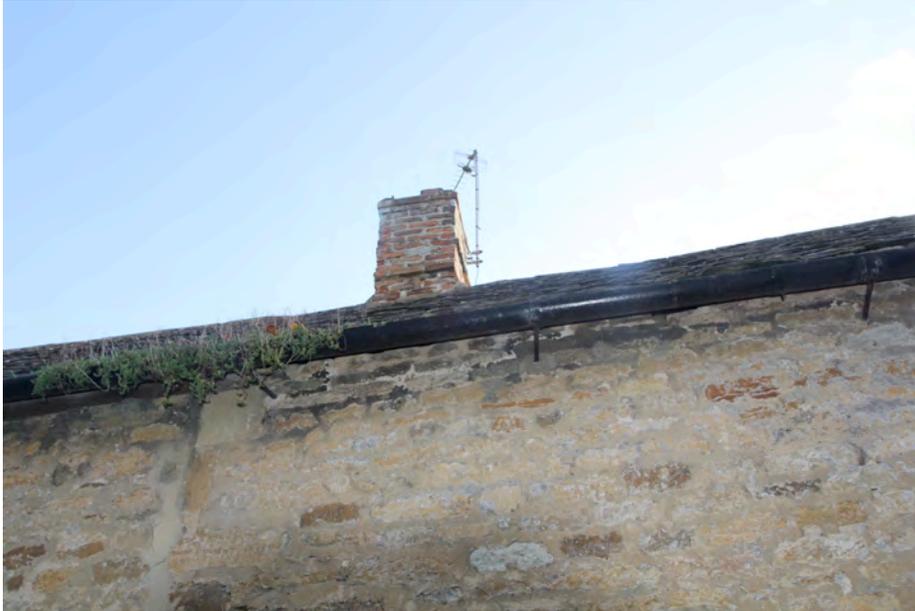
7.5 NORTH ELEVATION TO THE REAR WING

There are movement cracks evident to the bathroom, the general making good and repointing is required. The window, which is a timber 2-light casement window, is in fair condition, although the overhaul and redecoration is required. There is a timber lintol, which is affected by furniture beetle, and a tiled cill.

To the kitchen section again general repointing is required. There is an open joint, which has been pointed in a hard cement mortar between the extension and the main gable, this should be repointed and monitored for continuing movement.

The roof eaves is formed with overhanging tiles. There is an aluminium gutter on rise and fall brackets, which is blocked, the general cleaning out of this is urgently required. The roof is in stone slates, which are in poor condition, and the general recovering is required. As noted previously, the chimney sack is in poor condition and the overhaul and replacement of brickwork generally is required.

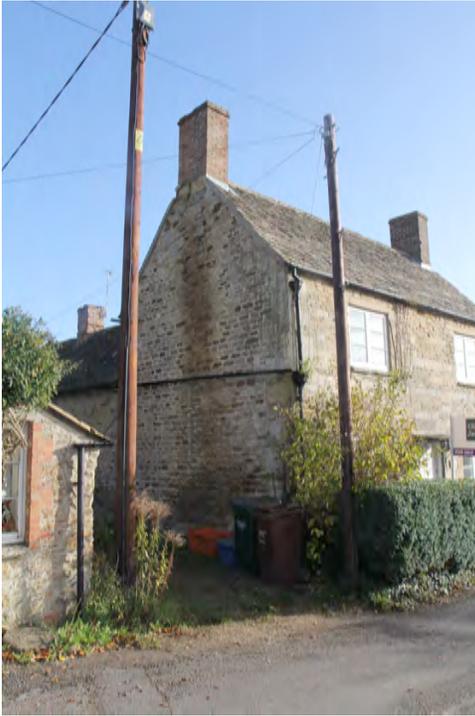
7.7 NORTH GABLE FRONT SECTION

The main house gable is stone. There has been some movement to this, particularly to the corner to the west. The general repointing here is required together with the removal of vegetation. The chimney stack has decayed stonework beneath the brick chimney stack, replacement of this and general repointing is required to an area of approximately 30 sq metres. Extending across the elevation is the aluminium gutter which discharges into the copper grating to the front elevation. The replacement of this is required in conjunction with improvement of the system.

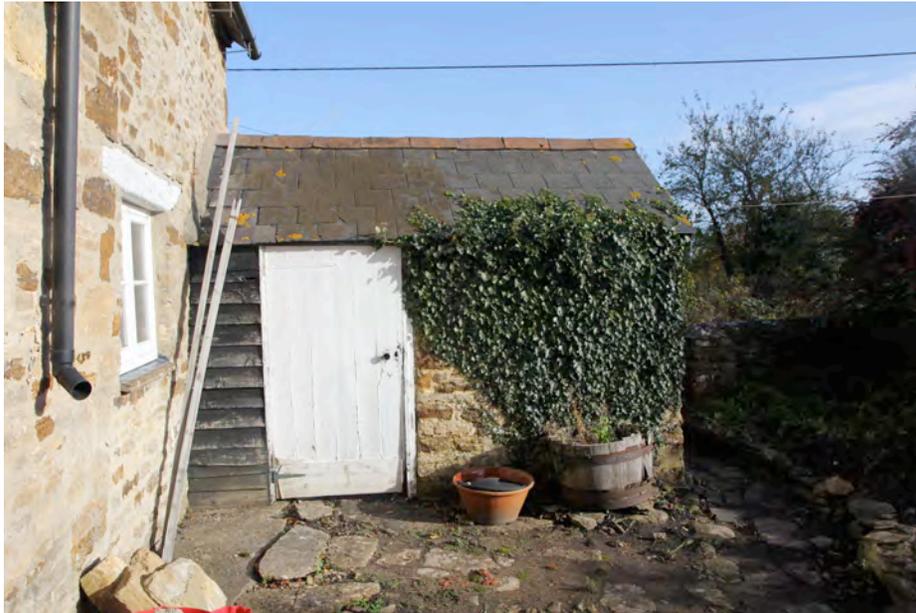
7.7.1 WEST ELEVATION

The elevation is boarded as it adjoins the main building and stonework to the south of the doorway. The general repointing and removal of ivy is required to the outbuilding. The door is boarded which is generally in poor condition and repair is required. The stone gable requires repointing. There is the boarded door with timber lintol, the timber lintol is affected severely by furniture beetle and treatment is required. The door itself is of poor quality and rotting at the base, replacement is required.

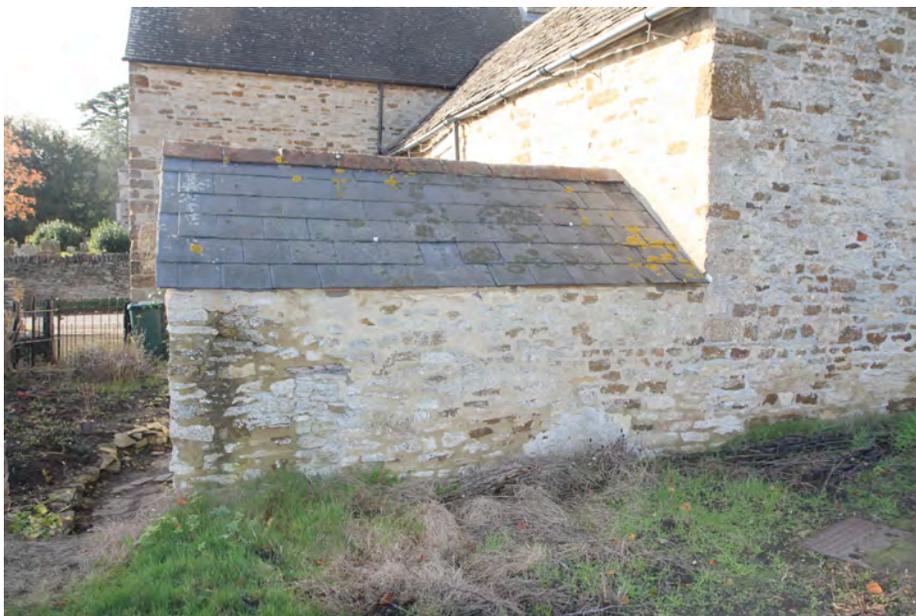
7.7.2 EAST ELEVATION

The east wall above ground acts as a retaining wall. There are slight movement joints to this to the corner to the south, general repointing is required. There is no gutter fitted to this outbuilding and this is recommended. The roof is slate with clay bonnet tiles, which is in fair condition.

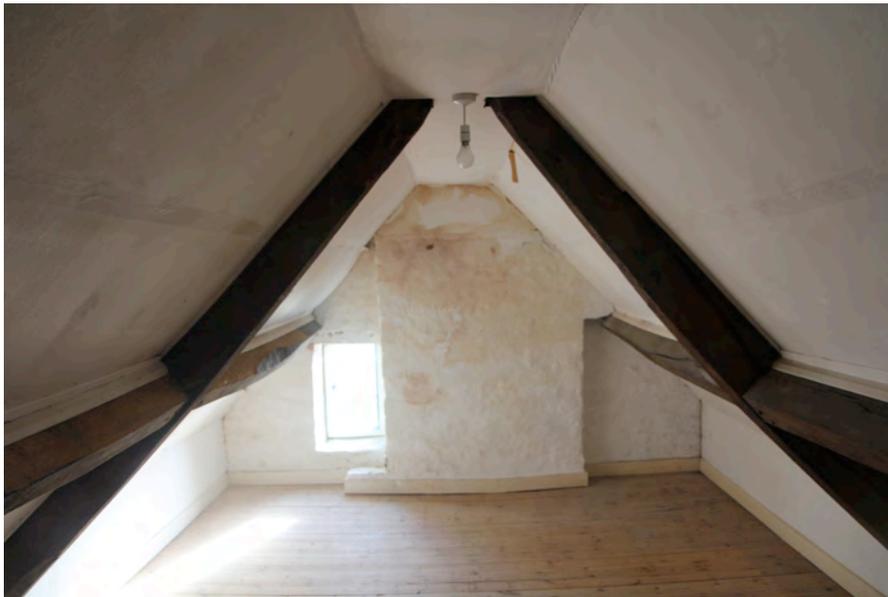
8.1.1 BEDROOM 4

The Bedroom is formed into the roof space, which includes two trusses, with a central purlin to each slope. To the gable to the south there is a small single light window. The roof is formed into the roof space, which is lined with insulation board, this is taped to the joints and peeling and generally sagging, the upgrading of this is necessary. There is a small section of flat ceiling to the ridge. Water is ingressing to the centre of the roof.

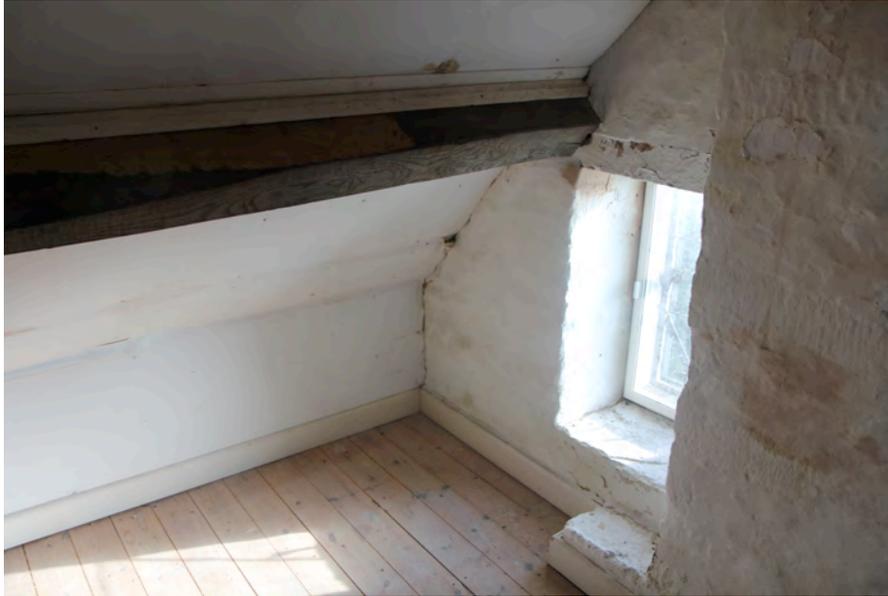
Photo showing the damp ingress to the south gable

The south gable contains the chimney breast to which there is staining to the plaster, repairs are necessary externally. There has been slight movement of the gable moving outwards due to lack of restraint from the roof beams. The provision of such restraint is required to both purlins.

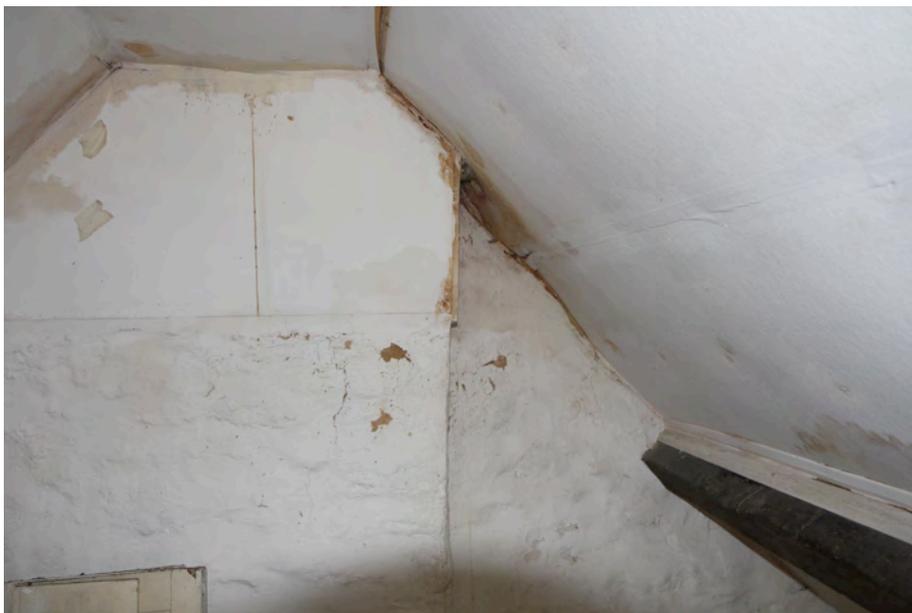
Photo showing the damage ingress to the north gable

The gable to the north is plastered to just below the ceiling where insulation board has been fitted, again damp is ingressing at high levels around the chimney breast. There is slight movement of the gable where it has moved outward due to lack of restraint.

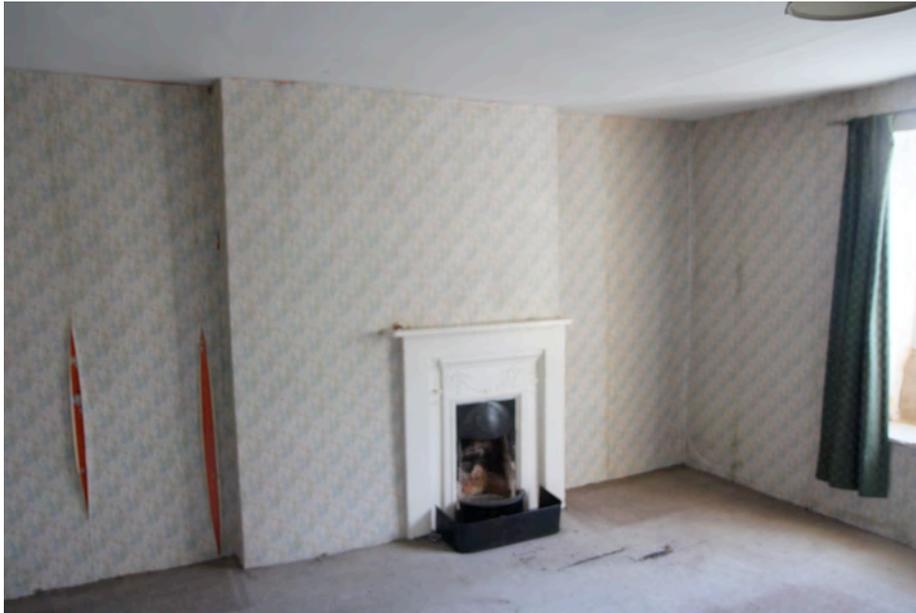
8.2.1 BEDROOM I

The floor is boarded with a fitted carpet, which is in poor condition. The floor boarding has been lined with hardboard, generally this appears to be in fair structural condition, but affected by condensation.

The walls are plastered and papered and the decorations are in poor condition. To the west elevation there is a 2-light window in fair condition, but water is ingressing and to the lintol of the window, which is affecting the wall, plaster which has become de-bonded, particularly around the north side of the window.

The north wall is papered, on lathe and plaster, this is generally sound. There has been some slight movement to the wall to the west end where there is an open joint between the wall and the west wall, this has been made good but cracked again. To the wall there is an original 4-panelled door, which is in fair condition. There is a rim lock fitted to this. The door is warped slightly.

The east wall is plain plastered, which is decoratively in poor condition.

The south wall is affected by damp to either side of the fireplace. Due to poor pointing externally. This is particularly severe to the corner to the west. The wallpaper is generally peeling. There is a chimney breast with timber surround and a metal fireplace with fire bricks, which is in sound condition, although decoratively poor.

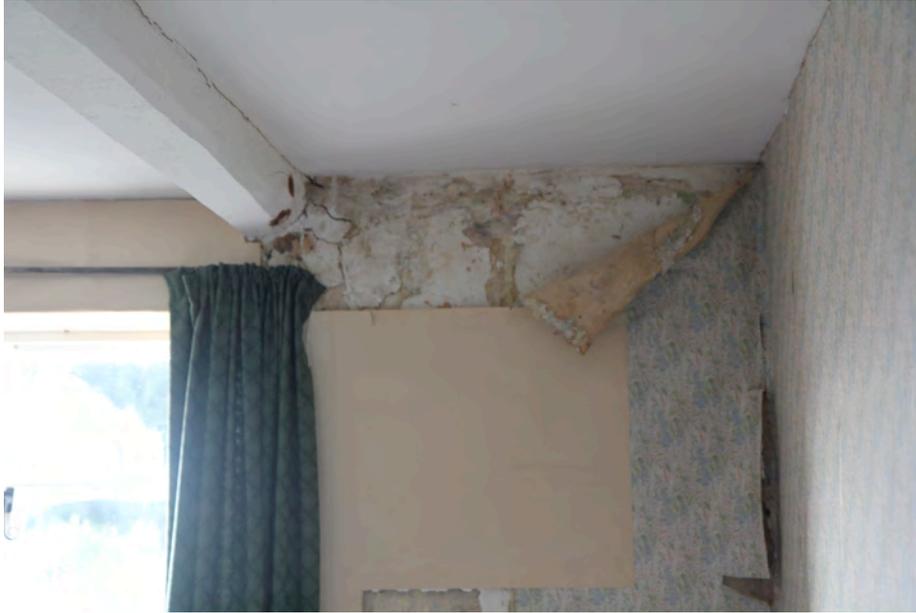
There is a cross beam spanning from east to west, which is in fair condition, the ceiling in lath, and plaster that has been lined with plasterboard and skimmed. It is unclear as to the condition of the lathe and plaster beneath this. There is some movement to the west wall where there is cracking to the plaster over the window, due to the wall moving outwards caused by the outward thrust of tying in of this is required.

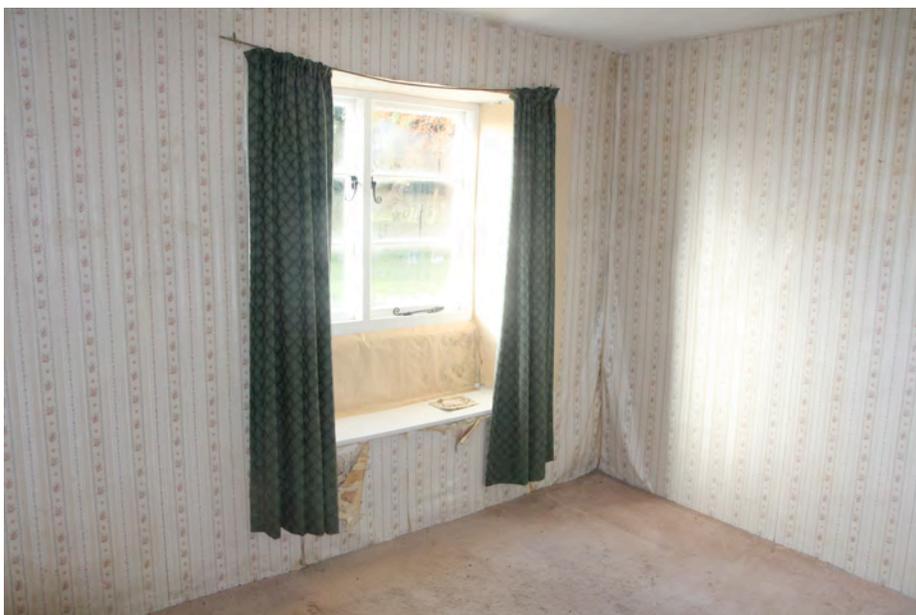
8.2.2 BEDROOM 3

Bedroom 3 is in similar condition to Bedroom 1. The floor is carpeted which is laid on an underlay. The floor is boarding which appears to be in fair condition. There is a cupboard to the corner to the north west, which is in reasonable condition. The walls are plastered and paper but generally the paper is peeling from the walls.

To the west wall there is a 2-light window, which has been renewed. There is damp ingressing beneath this to the window seat and to the window reveals due to the external pointing. There is damage to the plaster at skirting level.

The ceiling is lathe and plastered with a single cross beam, which is chamfered. Generally this is in fair condition, there has been outward movement of the west wall which has affected the beam, tying is required. The ceiling has been lined with paper, which is peeling, particularly to the junctions to the west wall and to the corner to the north west.

As noted in the comments on Bedroom 1 and Bedroom 4, there is no restraint to the roof in the form of collars to the second floor. There has clearly been some outward thrust of the wall over the years which has caused both the east and west wall to move outwards. This has damaged the plaster to the ceiling. In any refurbishment the addition of some form of restraint to the roof to arrest this movement, is necessary.

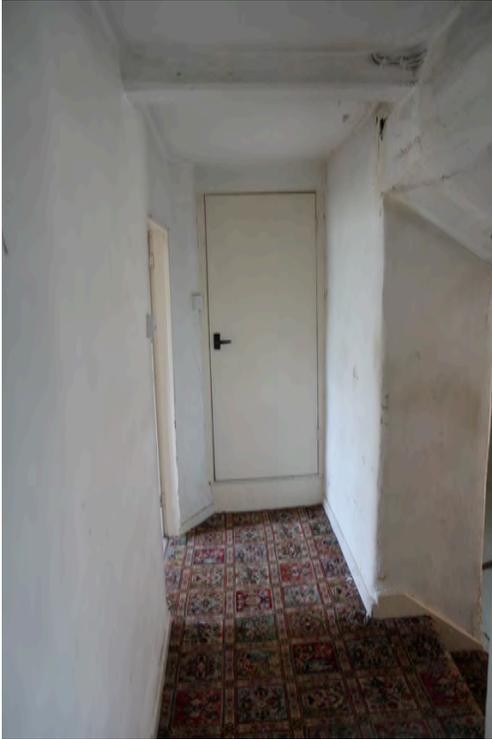
8.2.3 CORRIDOR OUTSIDE BEDROOMS 2 AND 3

The floor is boarded with a fitted carpet, which is sound structurally. The walls are plastered.

The west wall is in fair condition but decoratively poor. To the north of the wall there is a 4-panelled door which leads to Bedroom 3 which, as noted previously, is in fair condition, but general adjustment and overhaul is required. There is a slight crack where the stud partition has sunk slightly over the doorway. The north wall has the flush door, which leads to the staircase to the second floor Bedroom. This is of poor quality and as noted before contains no fire separation.

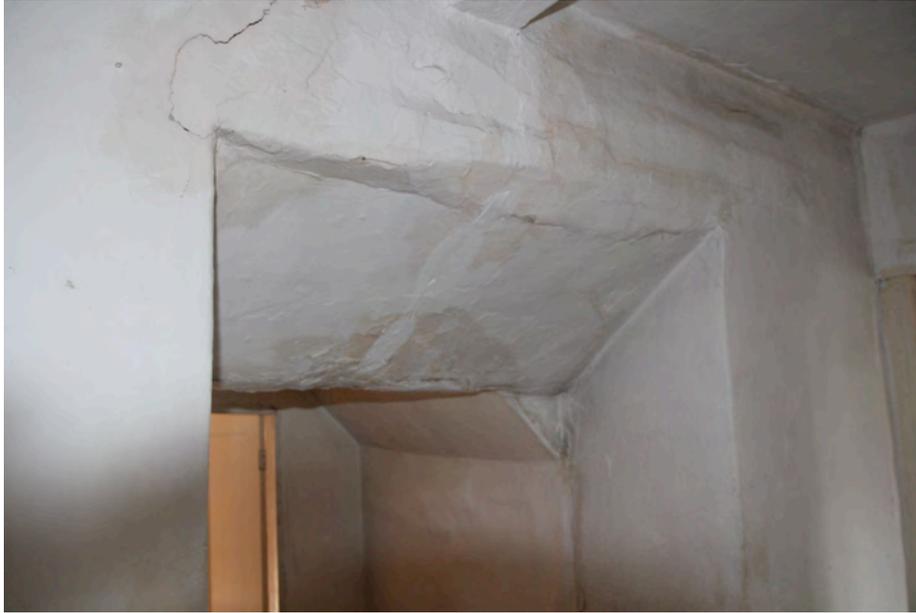
Photo showing the lintol and the opening to the staircase

The east wall at the opening leading to the staircase. There is some damage to the plaster to the lower side of the chamfered opening and to the north of the beam. The removal of the plaster to identify the cause for this is necessary.

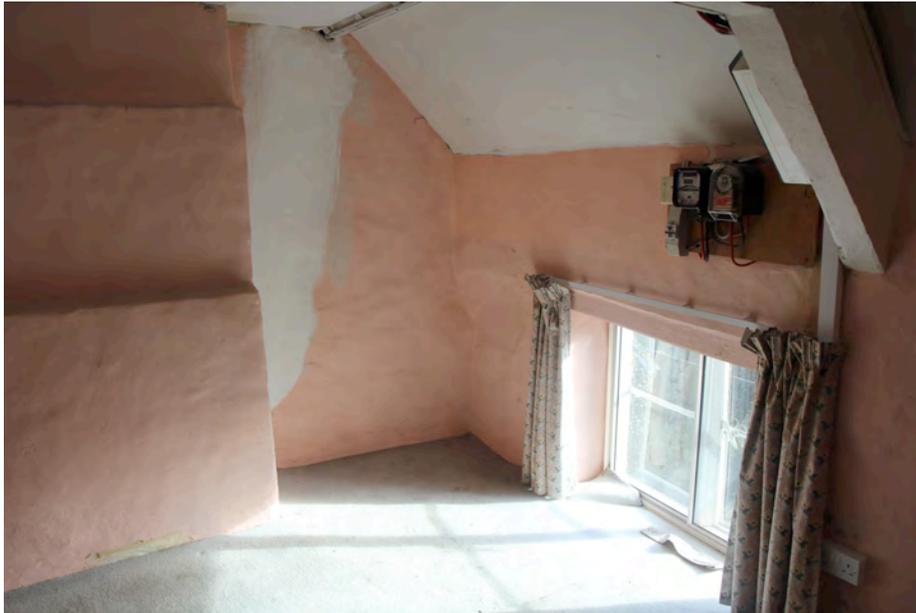
8.2.4 BEDROOM 2

The floor is boarded with a fitted carpet. The floor has been lined with hardboard. There is considerable sag to the floor where settlement has occurred to the corner to the south east. The settlement to the extension is evident where the door has deflected and a make-up piece added.

The movement is thought to relate to settlement caused by the ground water conditions being affected by the faulty rainwater disposal system.

There are cracks to the corner to the south of the door head.

The north wall is plain plastered. There are movement cracks extending down the corner to both corners and the plaster is debonding around the central feet of the truss. The settlement is more evident to the corner to the east. The east wall again has movement cracks and there is a movement crack extending down the corner to the south, which has been made good, this appears to be stable. There is further evidence of making good of plaster to the corner itself. To the centre of the wall there is a stepped chimney breast, which is plastered and appears to be in reasonable condition. The plaster is cracked to the corner to the east and there are horizontal cracks to the section of the wall to the west.

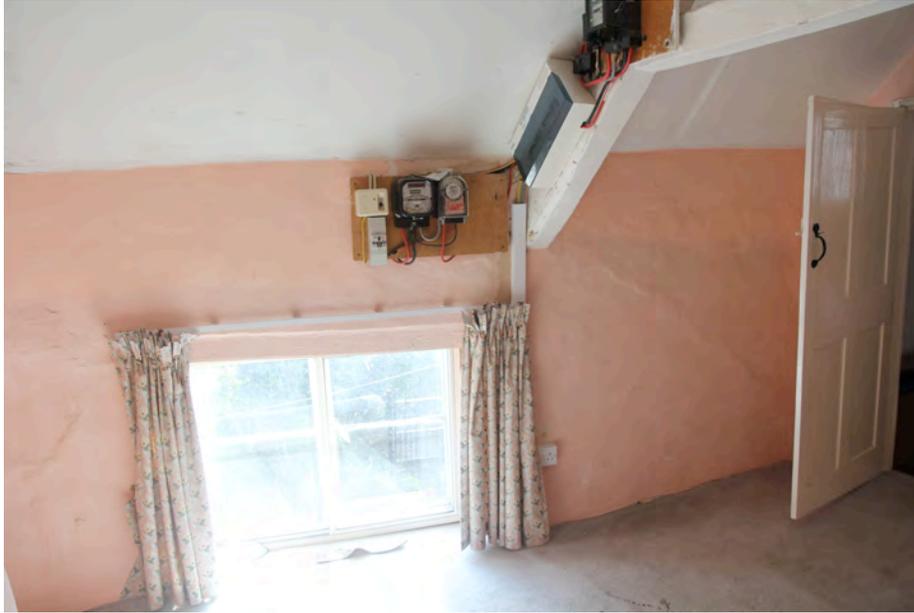
Photo showing the electrical incoming mains and distribution boards

To the area is the incoming electrical main, which is fixed to the roof purlin and truss. To the south wall are the electrical meters, which include the provision for night storage heating. There is an RCD distribution board fitted to the base of the truss. This was installed in 1962 and last inspected in December 2007. The electrical system is mainly exposed surface fitted wiring. The distribution board was installed in 2002. The decorations to the area are poor.

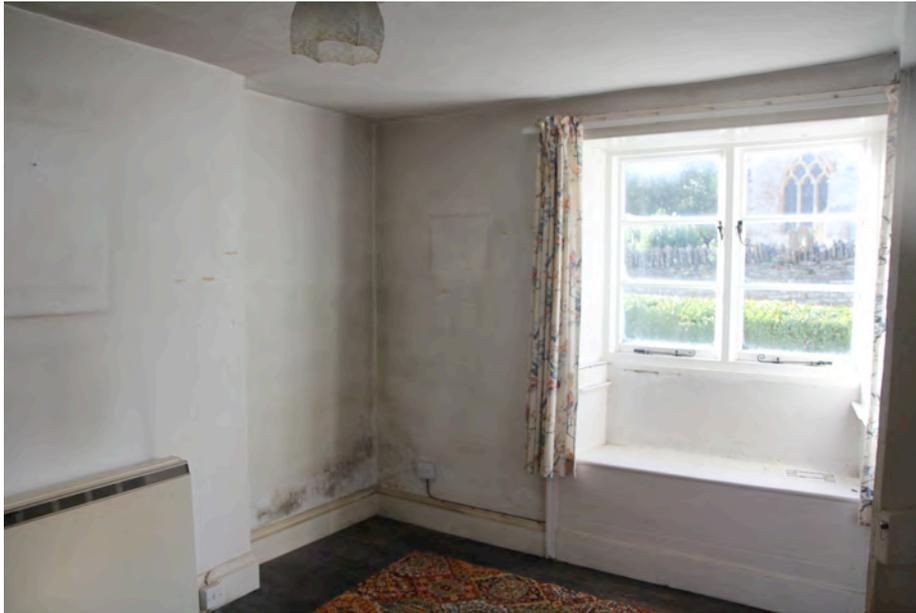
8.3.1 DINING ROOM

The floor is boarded which has been stained around the perimeter. The boarding generally is in fair condition. There are slight undulations to this. The walls have a moulded timber skirting fitted.

To the west wall there is a 2-light window, which has been replaced. A window seat has been formed beneath this. The window itself is in fair condition, but there is a high level of damp to the reveals. There is further damp ingress at low level to the corner to the south, which extends fully up the wall.

The door to the north is the original 4-panelled door with 'L' hinges, which is in fair condition. There is slight splitting to the panels. The door has sunk, adjustment is required. The door is of historic interest. The east wall is plain plastered, and again damp is ingressing from low level to the corner to the south. There is a shelf unit fitted at low level.

The south wall has damp, as noted, to both corners at low level. To the east is a wide cupboard with single panelled door with 'L' hinges. The redecoration of this is required. The knob is missing to the lock to the cupboard. Internally the cupboard has three shelves fitted. The plaster is generally in place but decorations are poor. To the centre

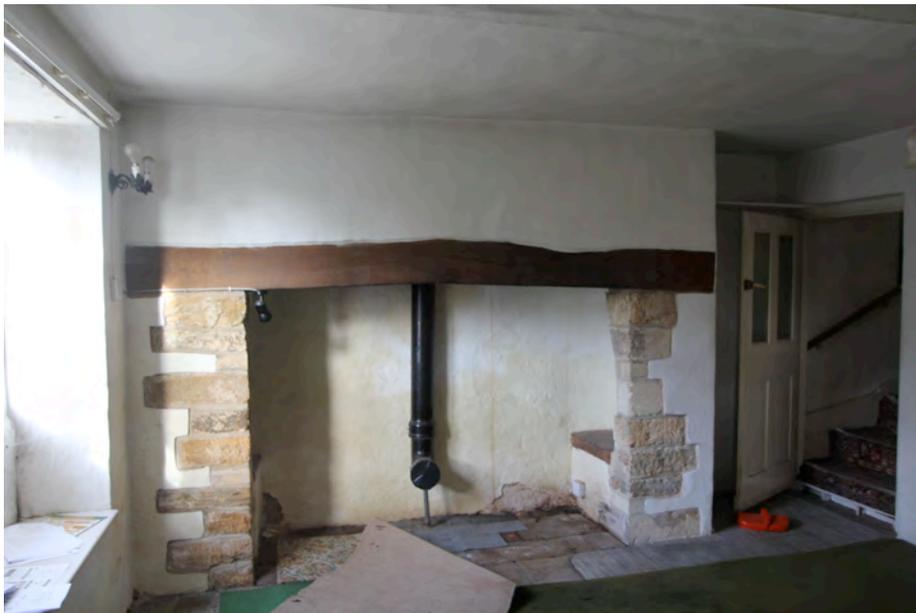
8.3.1 SITTING ROOM

The floor is stone flagged which has been overlaid with hardboard and carpet, the stone flagging appears to be generally in reasonable condition except where it extends into the fireplace now removed was fitted. Here the floor is affected by damp to the centre of the area where there was a wood burning stove. The floor and the fireplace which has been reformed but replacement of the brickwork to the fireplace is recommended together with repointing.

To the east to the doorway, which leads to the kitchen, this is heavily worn. The walls are plastered without a skirting and there is damp ingress to the corners particularly, and to the wall to the north to the inglenook fireplace.

The north wall has the inglenook fireplace, which has two stone reveals, which have been repointed in a hard cement mortar and a timber bressumer beam. There are two timber seats within the inglenook. Generally the inglenook opening is in reasonable condition but the wall inside the inglenook is affected by damp, which is causing damage to the plaster itself. There is a flue central to this, which related to a stove now removed.

The east wall has, to the north, the 4-panelled half glazed door which leads to the staircase which is in serviceable condition but of a poor quality. There is a 4-panelled door, which leads to the kitchen, which is of similar construction. As noted previously there are high levels of damp rising into the wall to the corner to the south east. The wall to the south is a stud partition with lathe and plaster, which appears to be in reasonable condition. There is an opening blocked to the corner to the east of the wall. To the west of the wall there is the 4-panelled door leading to the Dining Room, which is in fair condition. There is a slight movement crack to the head of the doorway, which has caused damage to the plaster. General making good of this is required.

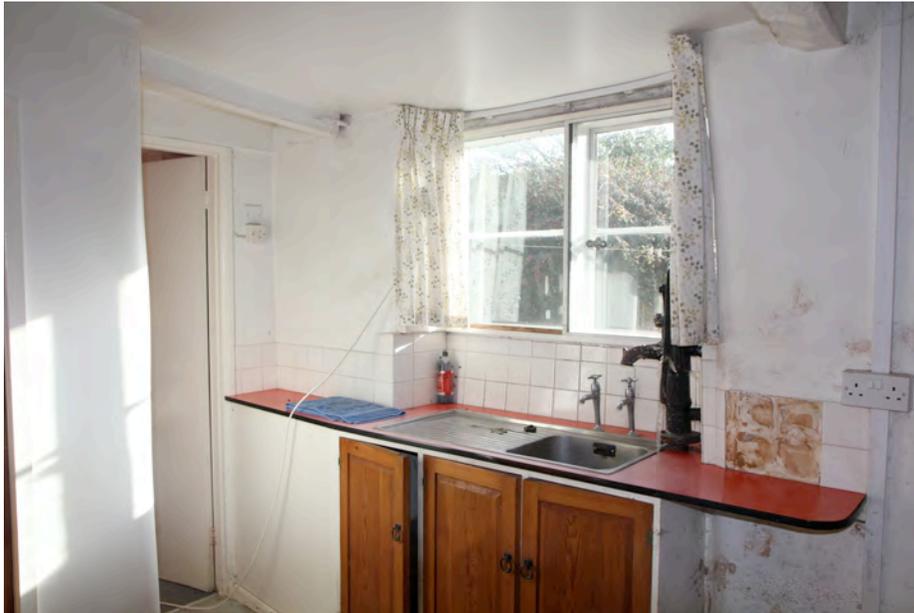
8.3.3 KITCHEN

The floor is concrete to which thermoplastic tiles and then a thermoplastic sheet have been added, the condition to this cannot be ascertained but clearly there is damp ingress affecting the wall and floor around the perimeter, particularly to the north and south walls. In any refurbishment the investigation and improvement of this will be required. The walls are plastered and part-tiled. To the west of the wall there is the 4-panelled door leading to the Sitting Room, which is in reasonable condition. The general overhaul and redecoration is required. As noted, the threshold requires general improvement. Over the door there is a timber lintol, which appears to be in reasonable condition. To the north of the staircase there is an enclosure to the staircase leading to the basement. This has a set of double boarded doors, which are in fair condition. To the north is a brick wall, which is part lime, washed and part white tiles, this appears to be sound but the tiling is of poor quality.

The north wall is plastered. To the centre of the wall there is a blocked window opening, which has damp evident around the reveals. The plaster has been damaged by the removal fittings, but is generally sound.

The east wall has to the north a fitted cupboard with two modern 2-panelled doors. The cupboard is formed within the original fireplace, which presumably contained a range. There is a bread oven within the cupboard to the north, which is formed with brick walls, and a brick arched lintol, which is in reasonable condition. The walls within the cupboard are plastered and generally affected by damp and mildew. To the south of the wall is a flush door, which leads to the bathroom. There has been historic movement related to the walls, which is evident in the room above.

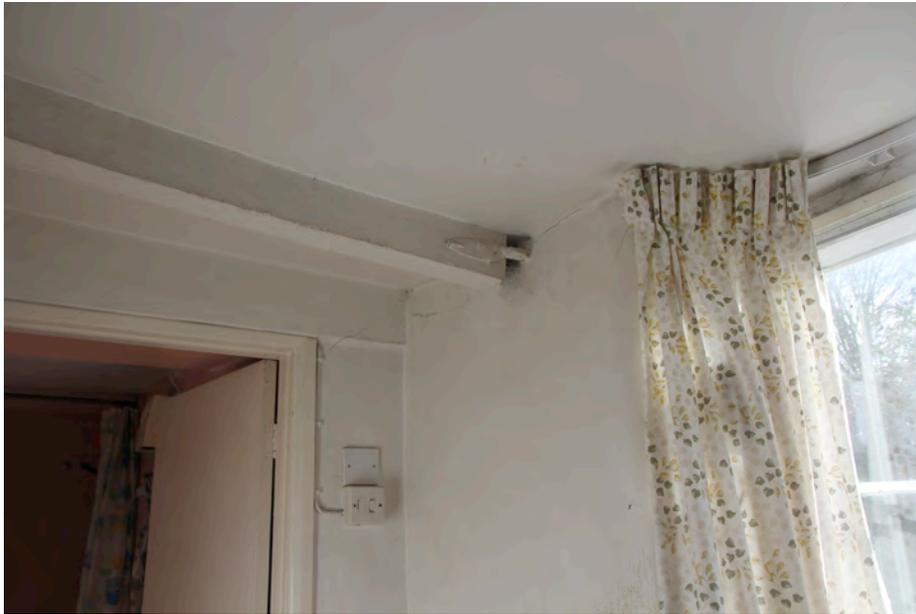
Photo showing the beam to the kitchen ceiling affected by the wall leaning outward

The ceiling, which is supported off a central beam and in reasonable condition. To the west of the wall the ceiling is formed with the soffit of the landing to the staircase. This has suffered some slight settlement and sagging and there is some cracking to the plaster, generally making good and strengthening is required. To the east of the room there has been substantial settlement to the ceiling and there is a beam, which expands across the opening the function of which is unclear. This no longer adjoins the wall, a metal strap has been added. Clearly in any refurbishment the improvement of the detail this area is required.

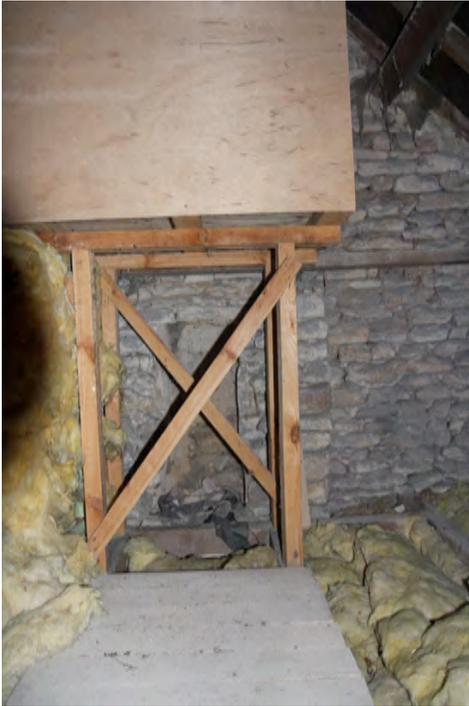
8.3.7 ROOF SPACE OVER THE BATHROOM

The ceiling joists to bathroom to WC have been replaced beneath the original timber beams, which span east to west, with a glass fibre quilt, which is disturbed and requires replacement. The walls are stone. To the west wall there is the gable wall, which contains the chimney breast. There is damp ingress from around the chimney. There are further movement cracks beneath the purlin. The water ingressing at the ridge has affected the end rafter to the roof where the ridge has rotted away.

The west wall is stone approximately a metre high. There is movement to the corner, but generally sound, repointing is required.

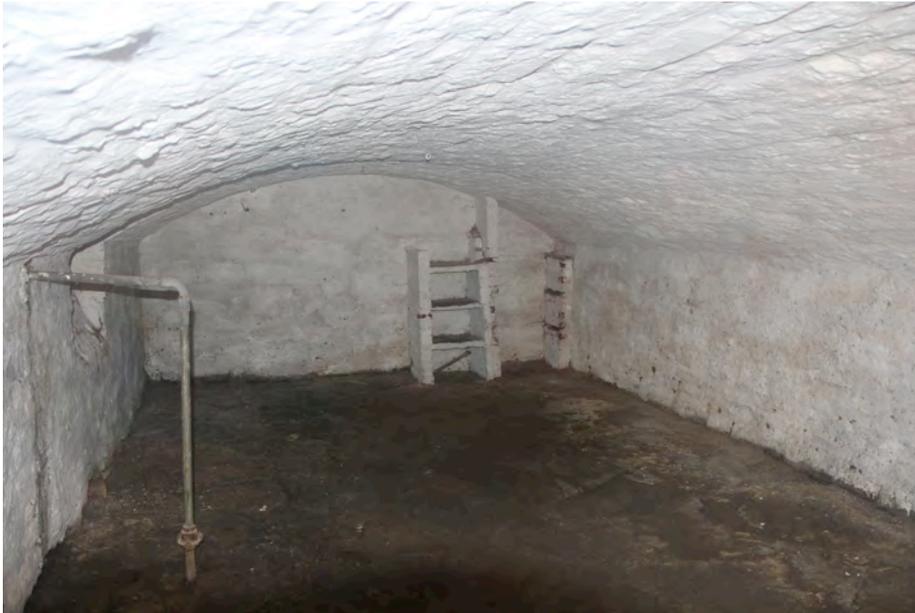
8.4 BASEMENT

The basement is approached by a stone staircase, which is formed of winders to the centre section. This is in reasonable condition. The walls are part painted stone and part plastered to the staircase itself and in reasonable condition. The ceiling to the staircase is formed by the winders to the main staircase, which is limewashed and is in reasonable condition.

The cellar itself is formed with a stone flagged floor, which is in reasonable condition, although damp. The walls are limewashed stone. To the west the wall is affected generally by damp at low level, but generally sound.
