**CONTAMINATION HOTSPOT
REMOVAL VERIFICATION REPORT
FOR
CAULCOTT PARK,
LOWER HEYFORD ROAD,
CAULCOTT,
BICESTER
OXFORDSHIRE
FOR
DAVID SMITH**

**REPORT NO. SE1311C
JUNE 2016**

**CONTAMINATION HOTSPOT REMOVAL VERIFICATION REPORT FOR
CAULCOTT PARK, LOWER HEYFORD ROAD, CAULCOTT, BICESTER,
OXFORDSHIRE**

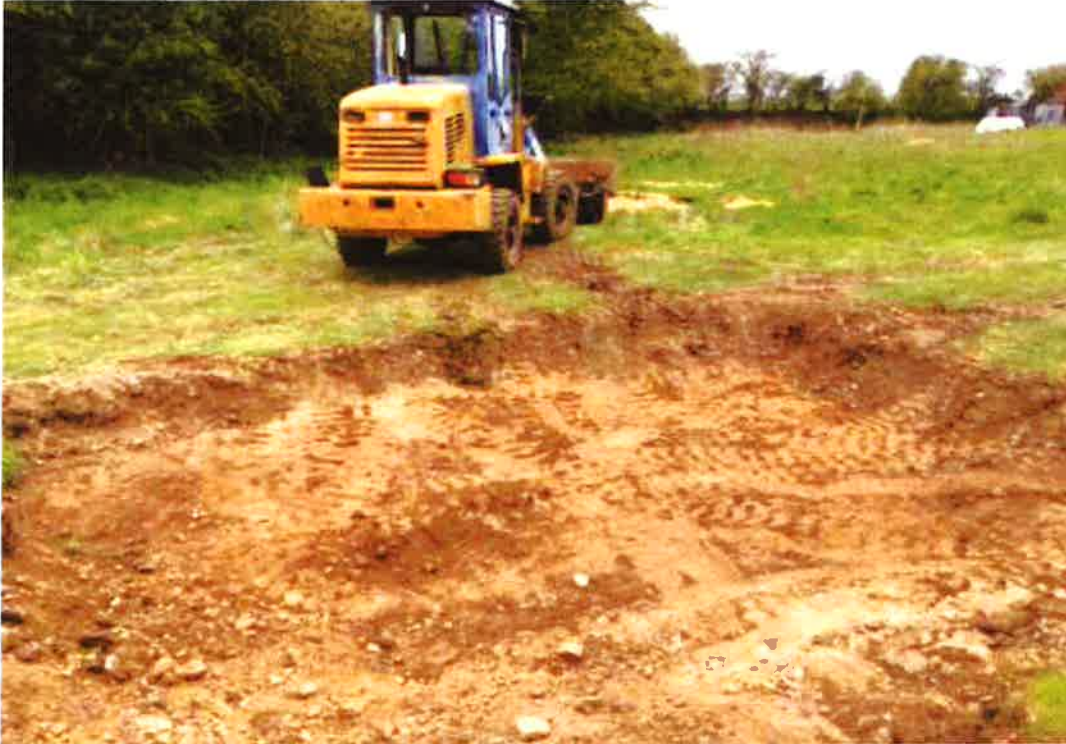
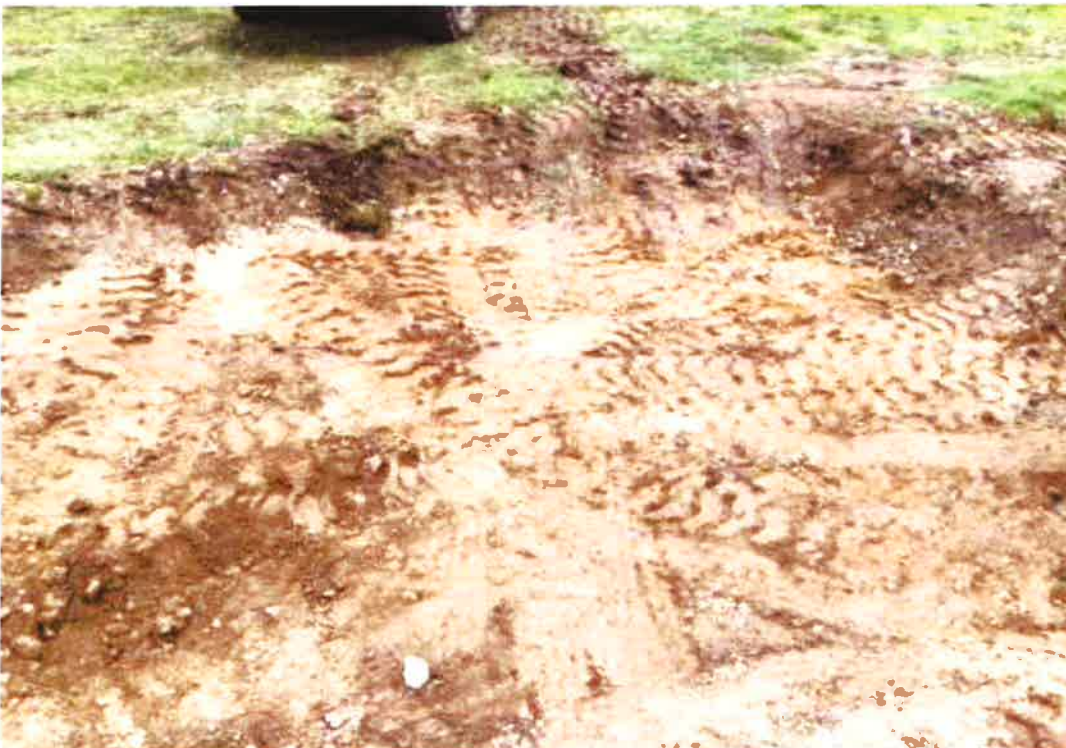
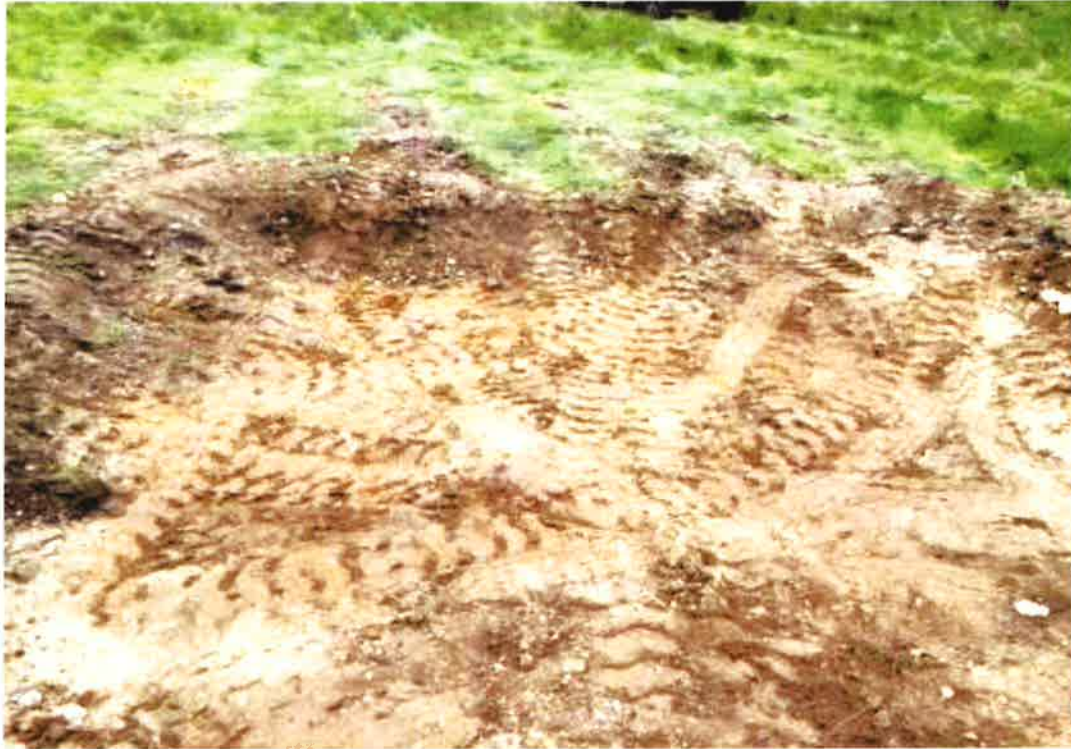
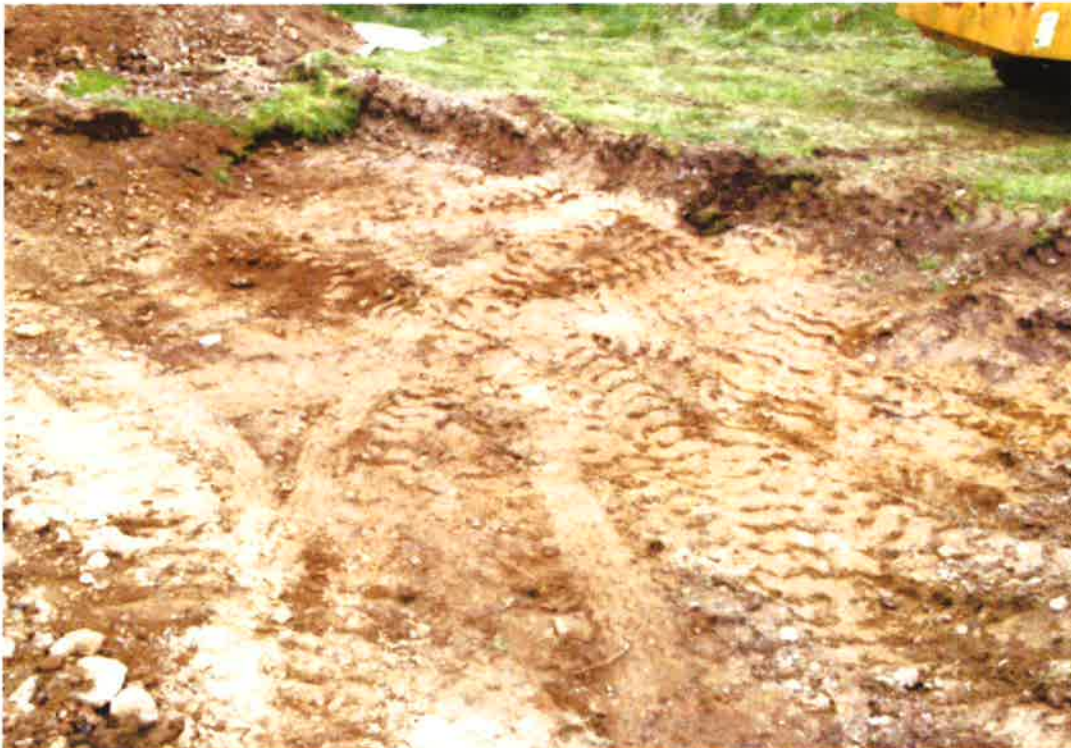
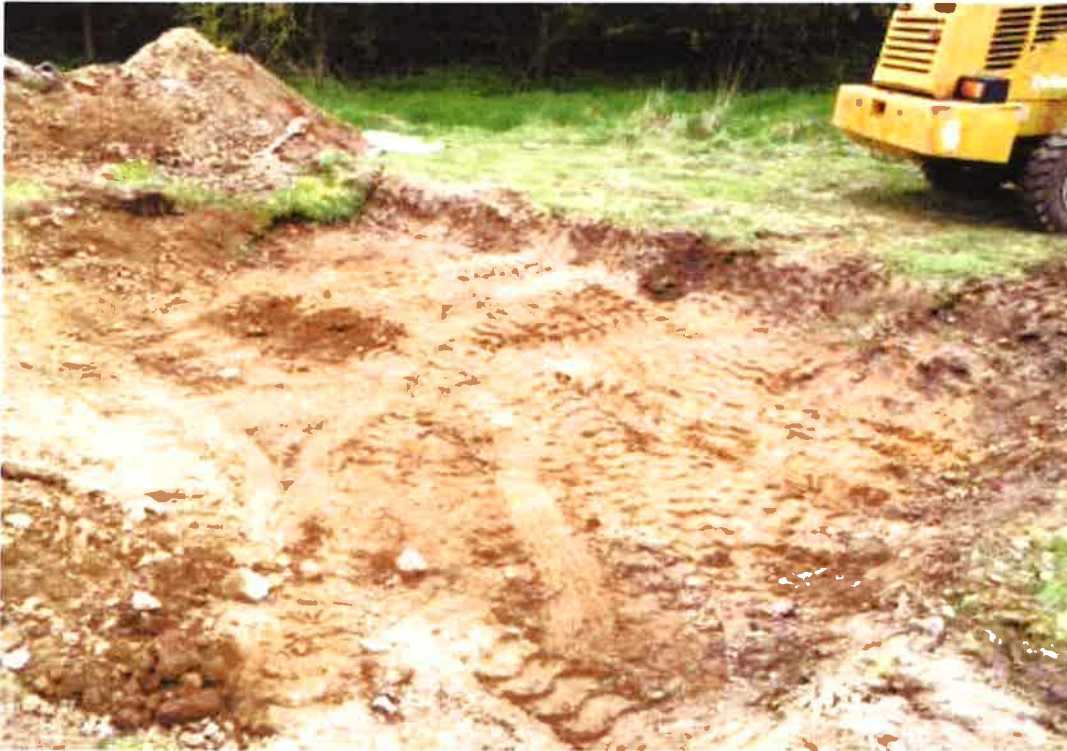
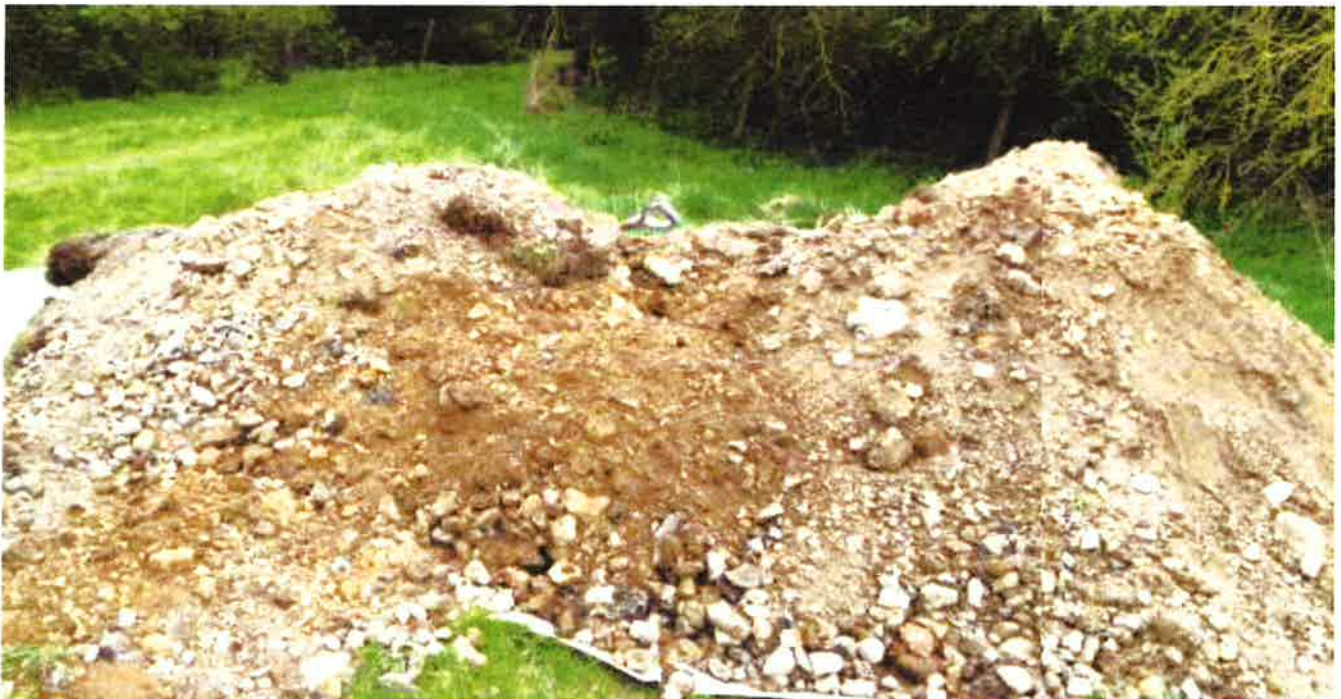
PHOTOGRAPHS - EXCAVATION WORKS

Work was undertaken on 22nd April 2016. A 5m square excavation was removed to a depth of 0.30m from the area surrounding M5. Samples were taken from the base and sides, as shown in Figure 4, and sent for PAH chemical contamination analysis. Excavation record sheets detailing the strata found at sampling locations are appended.

The results of the analyses indicated that no significantly elevated levels of PAHs were present in the base and sides of the excavation demonstrating that the potentially contaminated material has been removed.

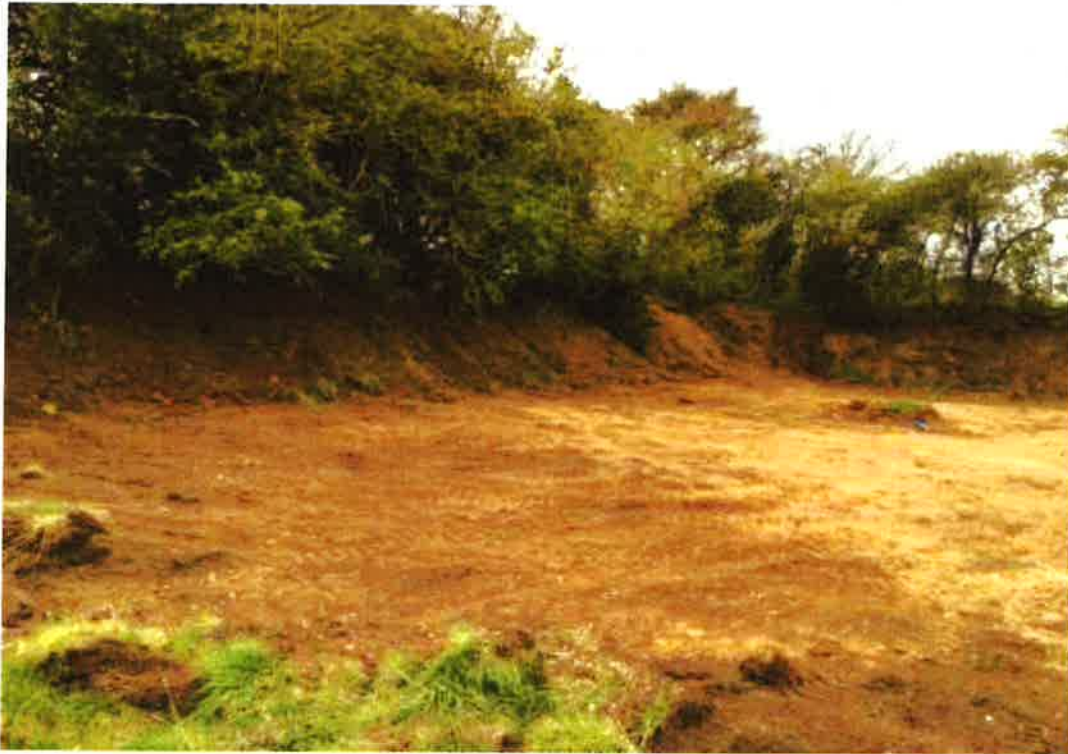
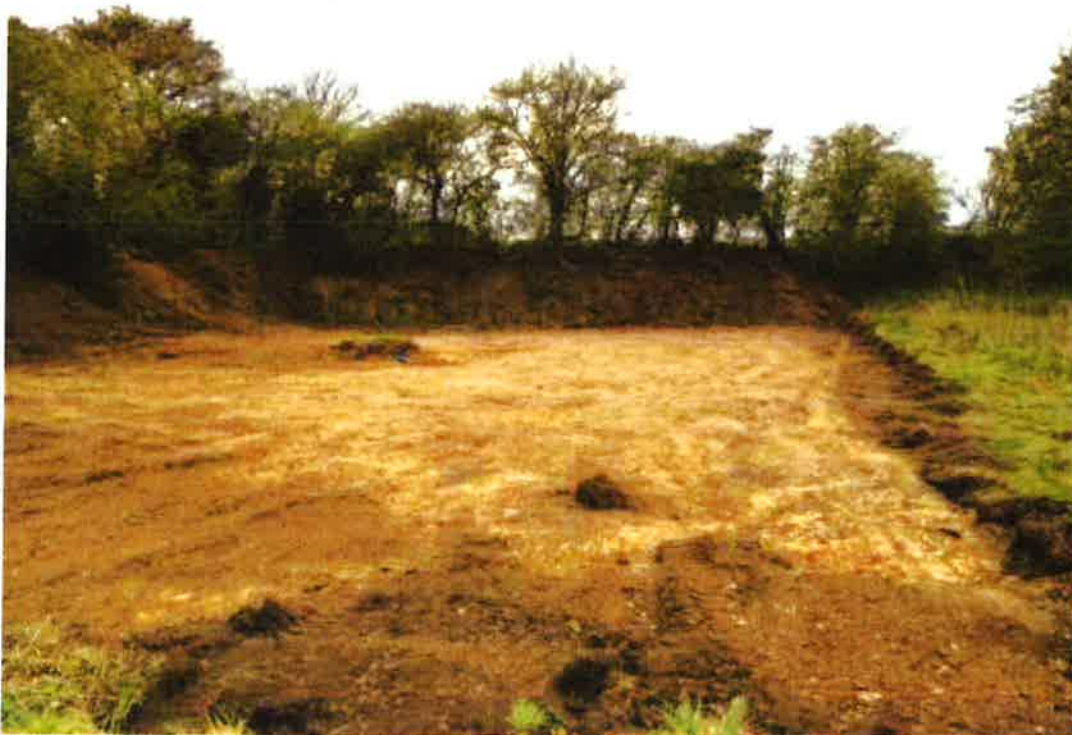
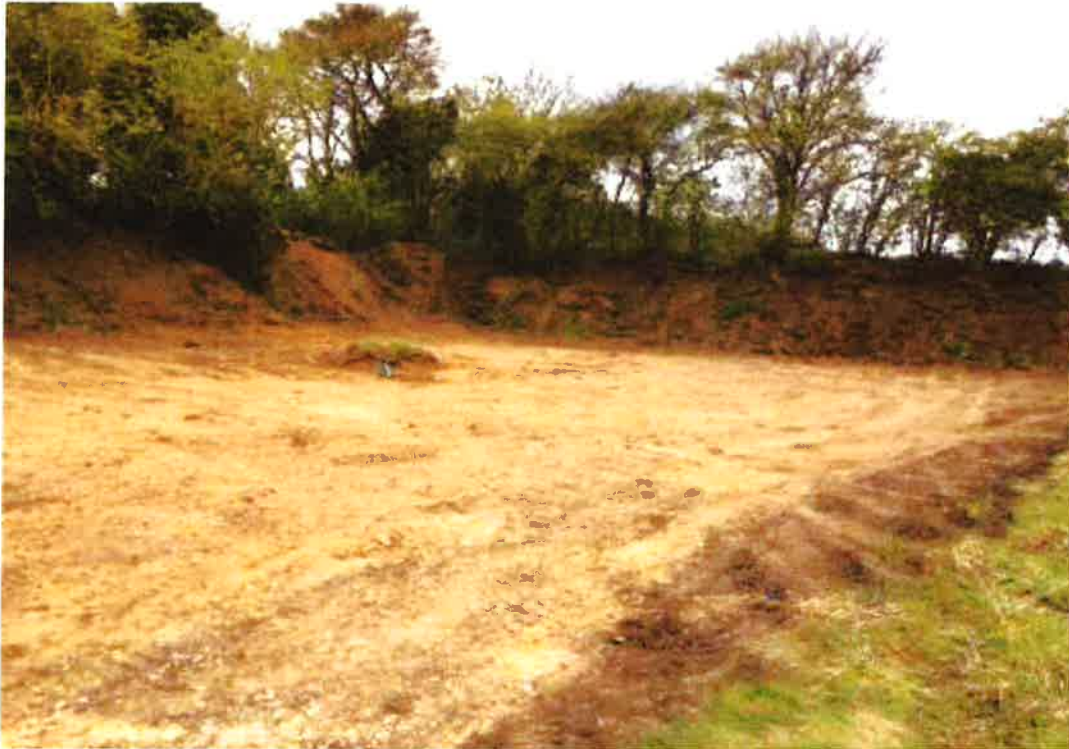
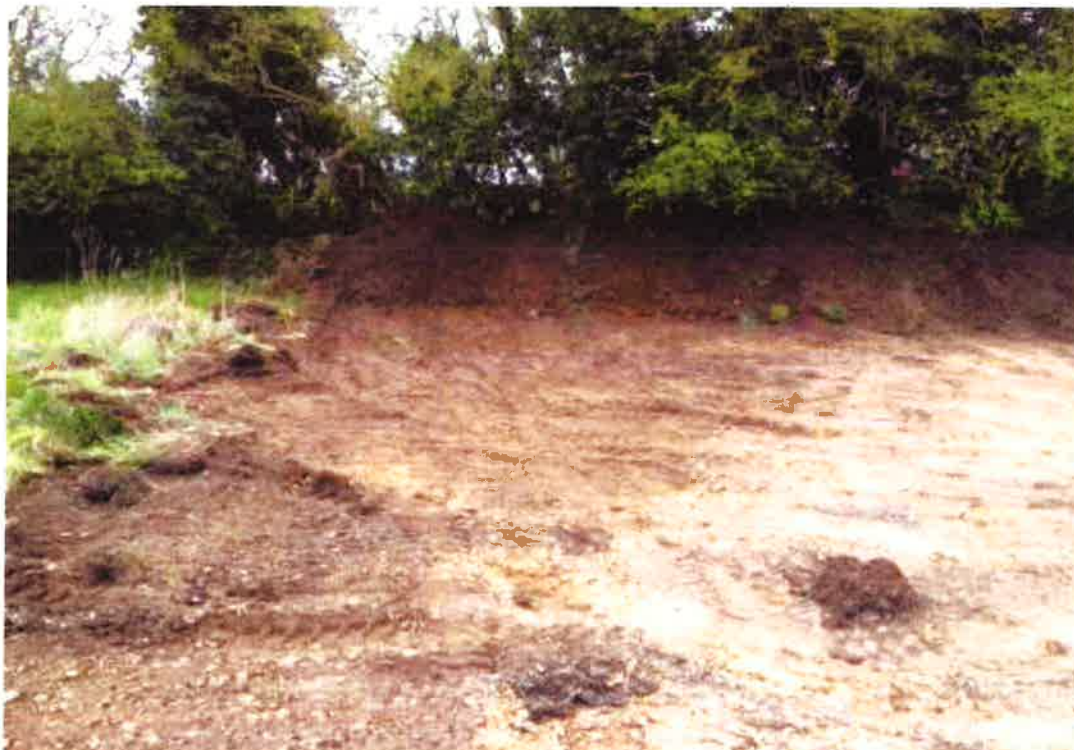
PHOTOGRAPHS - SITE STRIP AREA IN SW

A visual inspection was also undertaken in an area in the south west of the site, as indicated in Figure 3, where topsoil had been recently removed. There was no visual or olfactory evidence found of any contamination or potentially contaminative made ground being present.

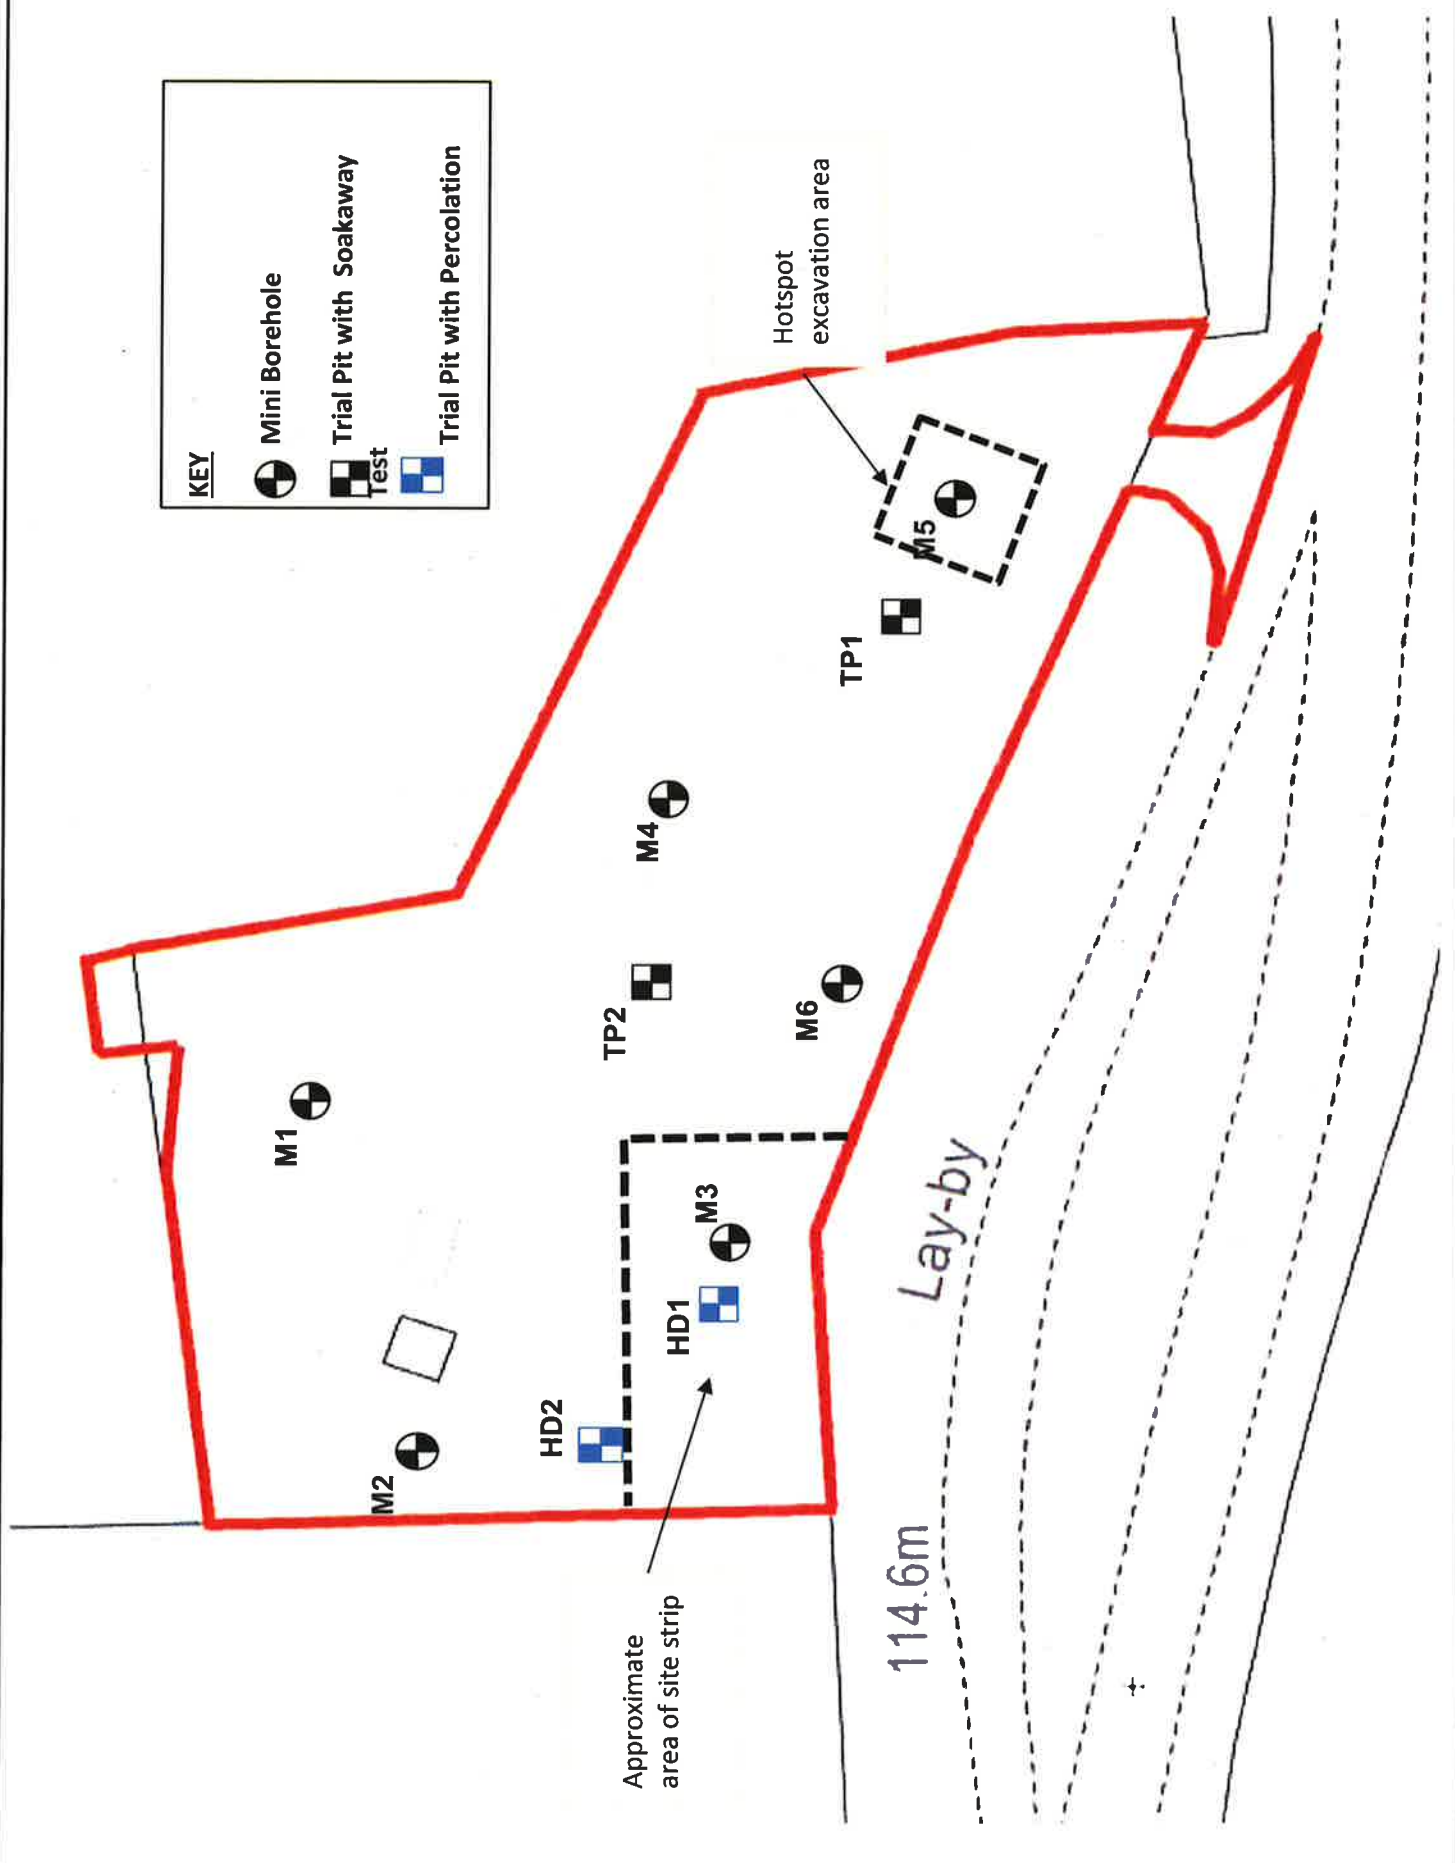
The purpose of the Verification Report is to document the removal of a contamination hotspot identified within the made ground during the Phase II ground investigation, as indicated on Figure 3.
