**The Old Malthouse  
St. John's Road  
Banbury  
Oxfordshire  
NGR: SP 454 400**

**A  
Heritage Impact Assessment  
of  
Proposed Development**

April 2018  
**Mercian Heritage Series No.1227**

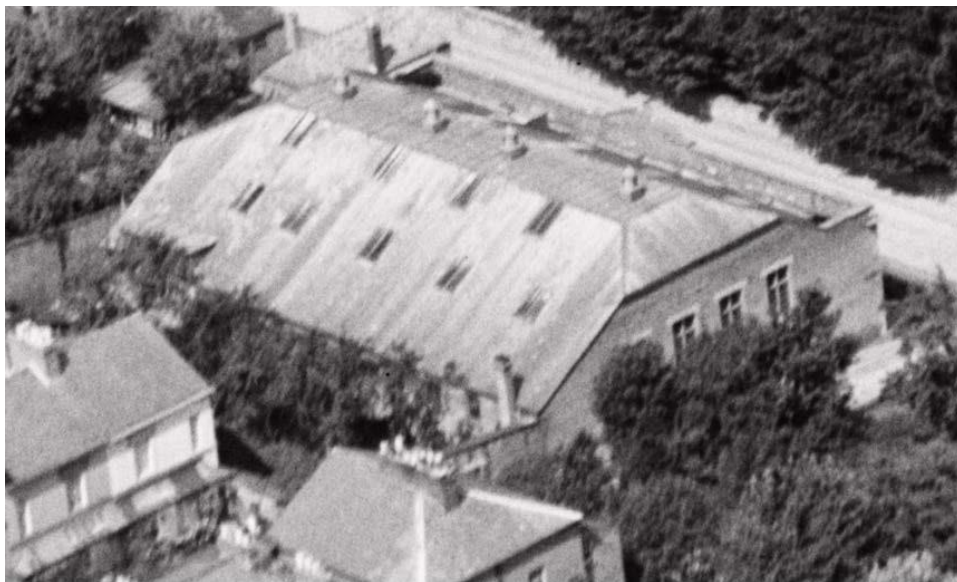
Pl.1: Extract from a 1929 aerial photograph of the works from the south-east.

Above the central bay is a rather limp triangular pediment which presumably has lost its original coping; the 1929 aerial photograph suggests that it was topped by a finial (*see Pl.1*).

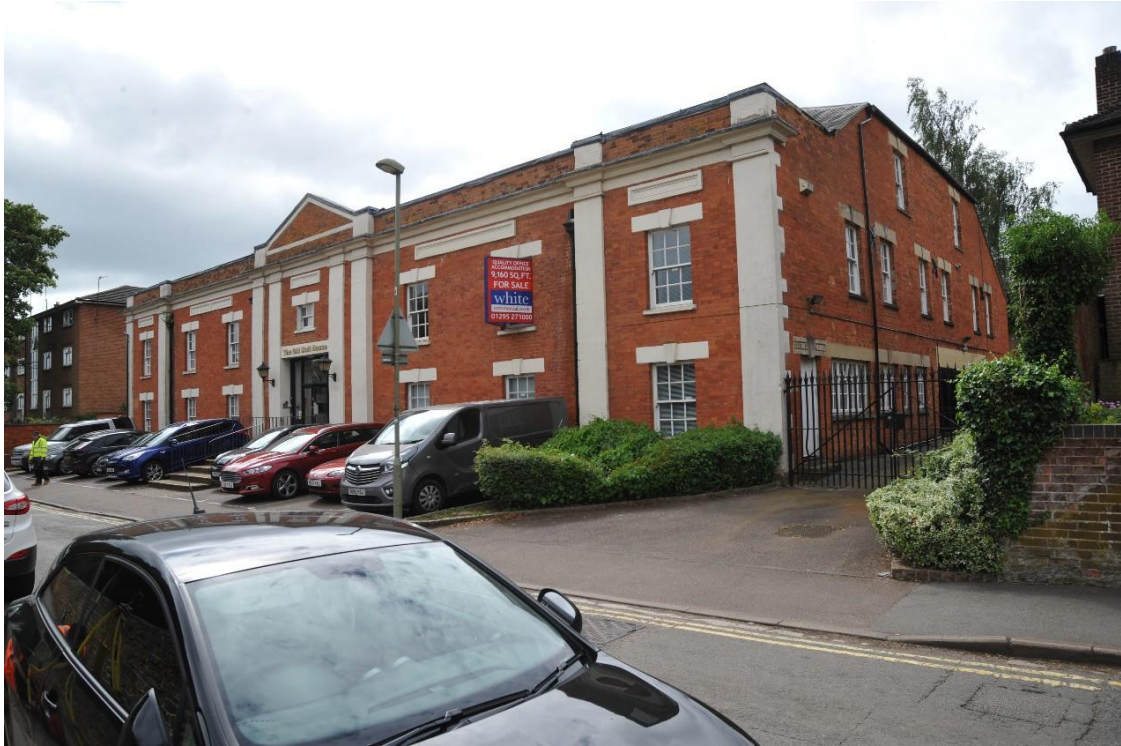
At the wall head is a simple painted stone entablature and above that, a solid brick parapet. This is, oddly, made of cruder bricks than the rest of the wall beneath. It was capped by a painted stone coping – as shown on the older aerial photographs – but it is unclear how much of that survives beneath the modern lean or zinc overhang that now tops the parapet.

Pl.2: The front, or north, elevation from the north-west.

No major changes are proposed for the front elevation other than remodeling the modern central doors and, more importantly, rebuilding the presently degraded parapet and central pediment. This will be a significant enhancement of the listed building.

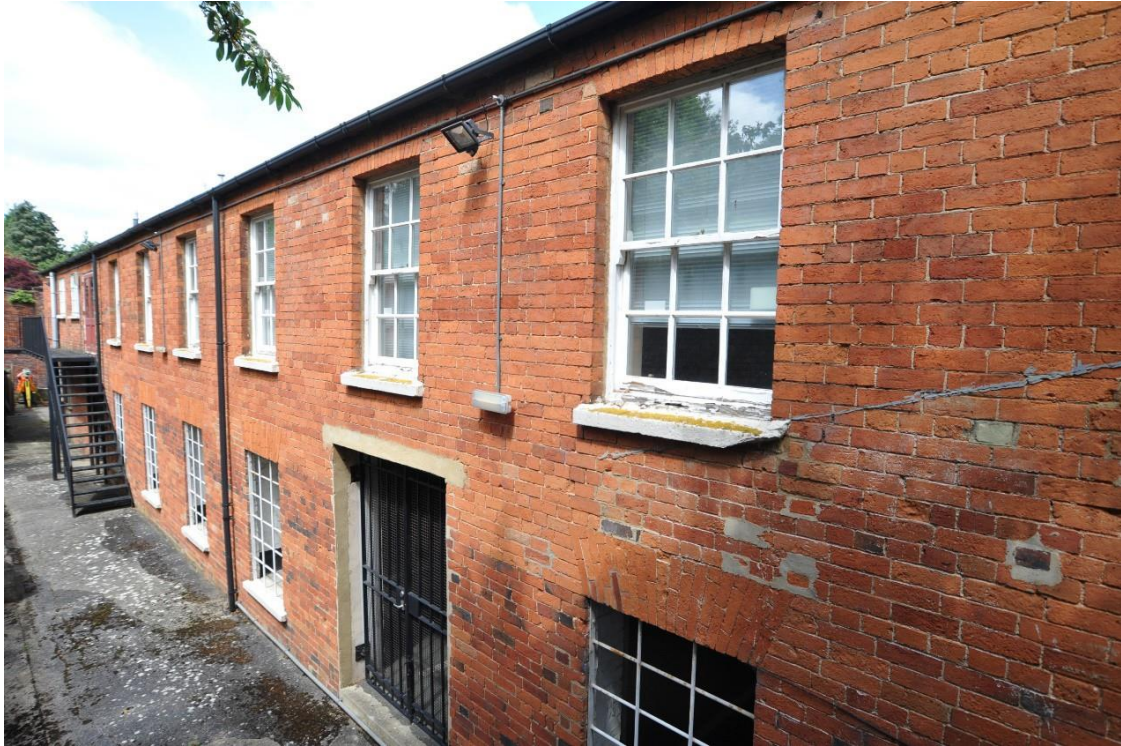
The two left-hand windows at ground-floor level have higher sills than the others; the one at the very left-hand end could be a primary opening of this shape and size. The one next to it has been altered; the present window does not quite fit beneath an original flat-arched brick head. It appears that an original window was replaced by a doorway – and then that was blocked and replaced by the present window.

The window pattern on the first floor is more regular; the two left-hand windows have been reduced in size by the raising of their sills and what was presumably another window just east of them has been removed and replaced by a double fire escape doorway under a soldier course of brick. At the extreme right-hand end of the elevation a window has been replaced by another, single, fire door – though the original flat arch head has survived.

The glazing of all the windows has been replaced. There are modern horned sashes in most of the first-floor windows and some of the ground-floor ones have iron barred openings to match.

Pl.4: The rear elevation from the south-east.

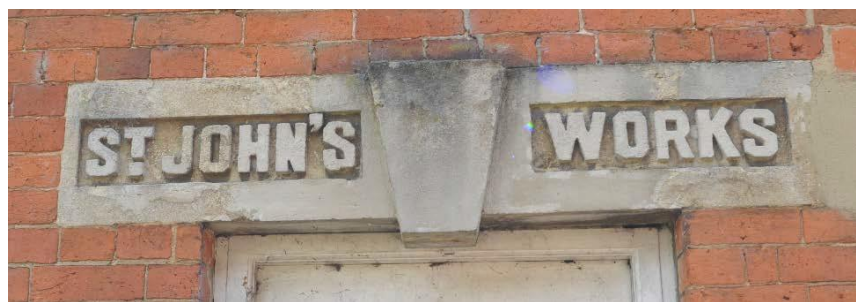
In the left-hand section of the elevation at this level is a sequence of much altered openings. At the extreme left-hand end is a doorway beneath a stone key-stoned lintel inscribed with the name 'St. John's Works'; this could be original, but the term 'works' seems more in keeping with a manufactory and the lettering could have been added when it became a hosiery works.

Pl.6: Lintel of the left-hand doorway of the west gable.

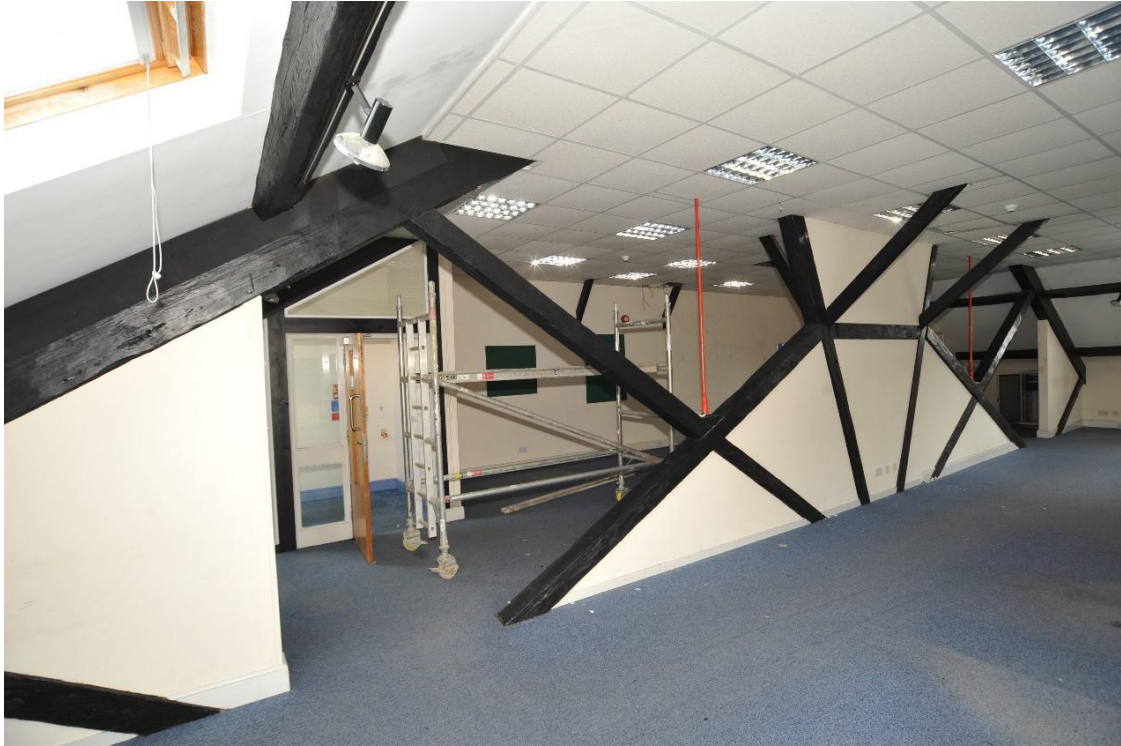
The jointing of the roof timbers seems to be of simple shouldered mortice and tenons with no indication of pegging. The joints are, however, mostly hidden by modern steel reinforcing plates presumably added in the recent past.

Pl.9: The exposed section of the westernmost truss, viewed from the second floor.

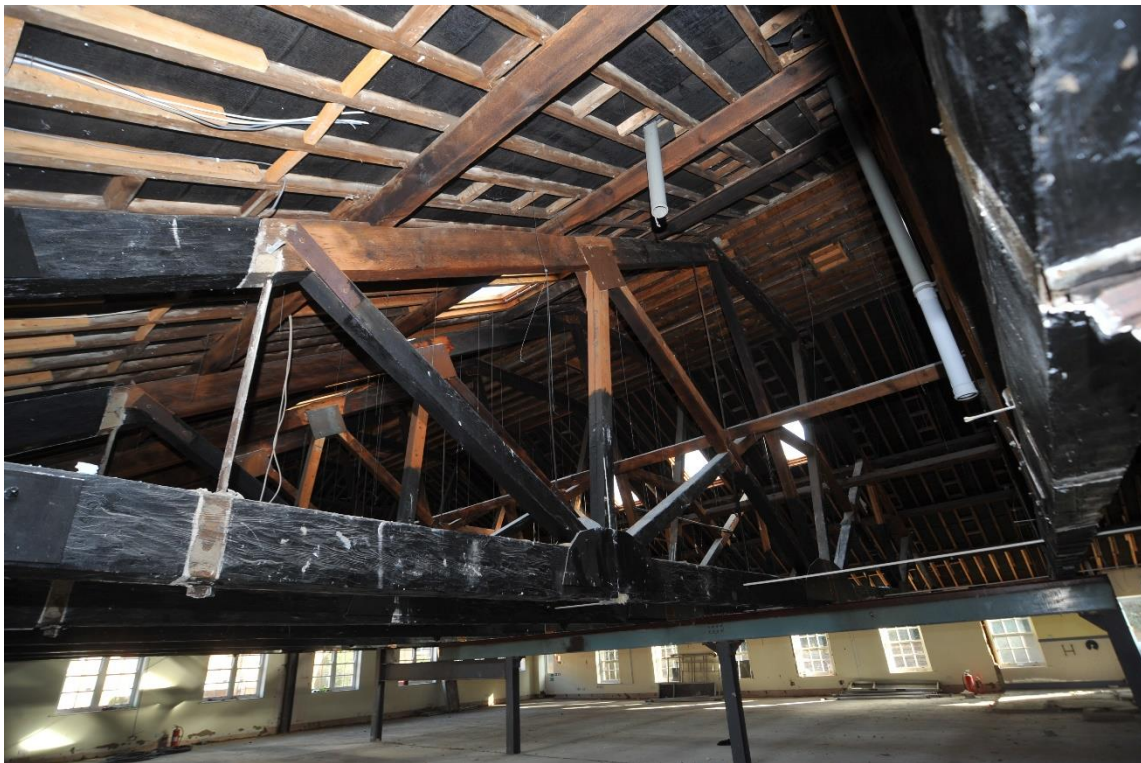
The investigations also demonstrated the unsympathetic nature of the insertion of these new partitions and ceilings – specifically the way in which an axial partition beneath a series of RSJs had been inserted into the building; the way the new ceilings took little care in respecting the roof structure – and hid the trusses from view; the addition of additional timbers in the trusses which confused their interpretation; and the wholesale addition of cut steel fish-plates at the main jointing in the trusses.

Pl.10: Some of the trusses exposed recently; the tie-beams are in two sections and the vertical studs are recent additions.

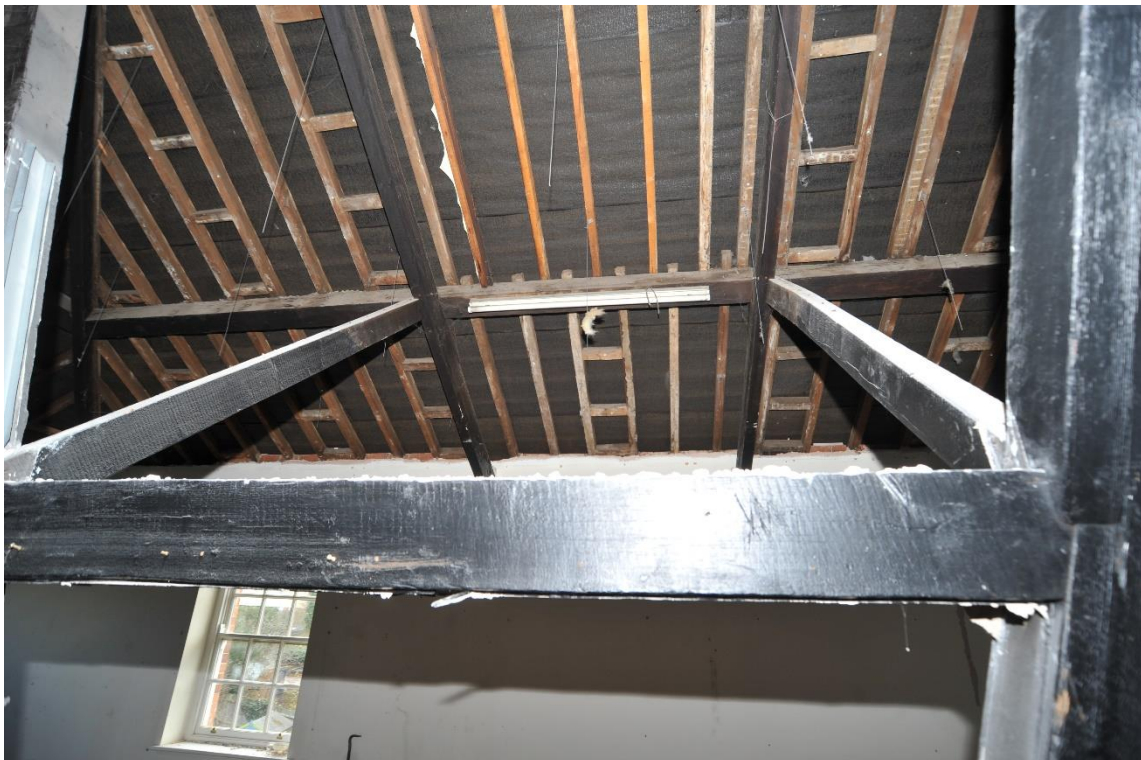
The complexity of the changes in the roof-lights is reflected in the complexity of the existing common rafters and trimmers. Some sections have 'ladder' cross-pieces, some have single trimmers and other rafters have been completely replaced.

There is evidence in some original rafters to show that they were once covered by lath-and-plaster; this, coupled with the existence of the roof lights, clearly indicates that the first floor was either open to the roof or, more likely, that there was a loft throughout the building.

Pl.12: Evidence of lath-and-plaster in the roof space as well as trimmers between rafters indicating an original rooflight position and recently inserted rafters.

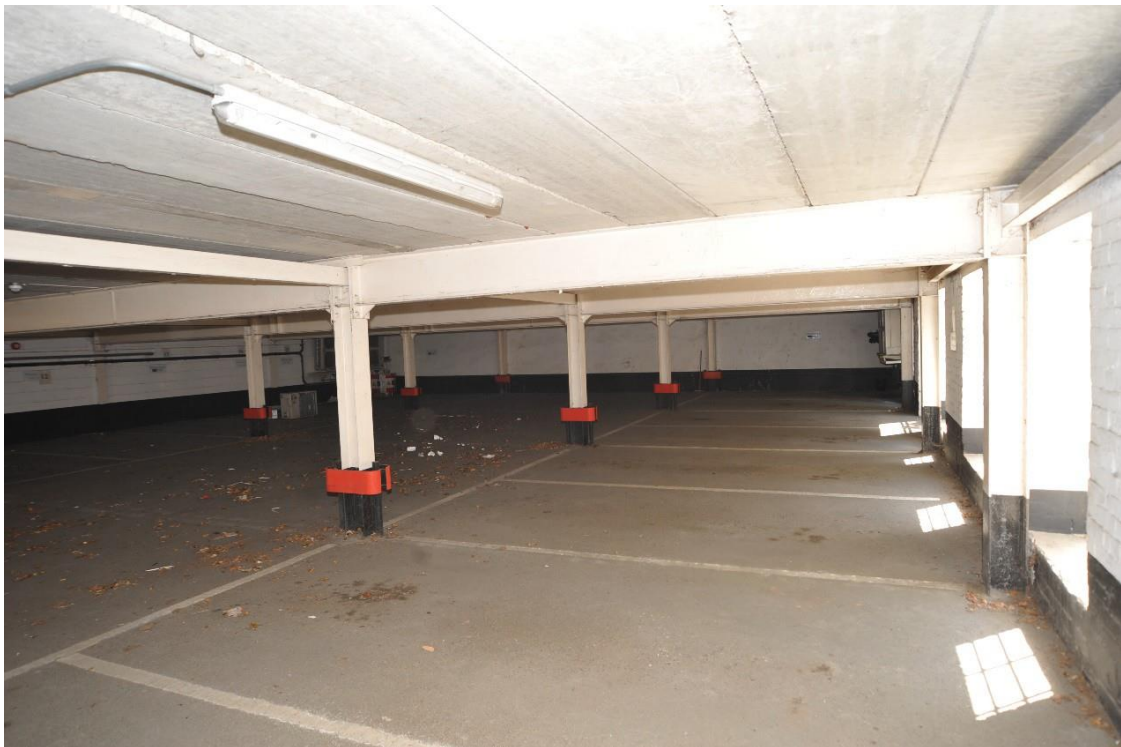
Pl.14: The bulk of the ground floor of the building is a covered car park; note the RSJ stanchions and concrete first floor, presumably dating to the engineering works phase.

The replacement of an original internal first floor and its replacement with a concrete floor on RSJ stanchion and girder support probably occurred in the mid-20<sup>th</sup> century when the building was converted into an engineering works.

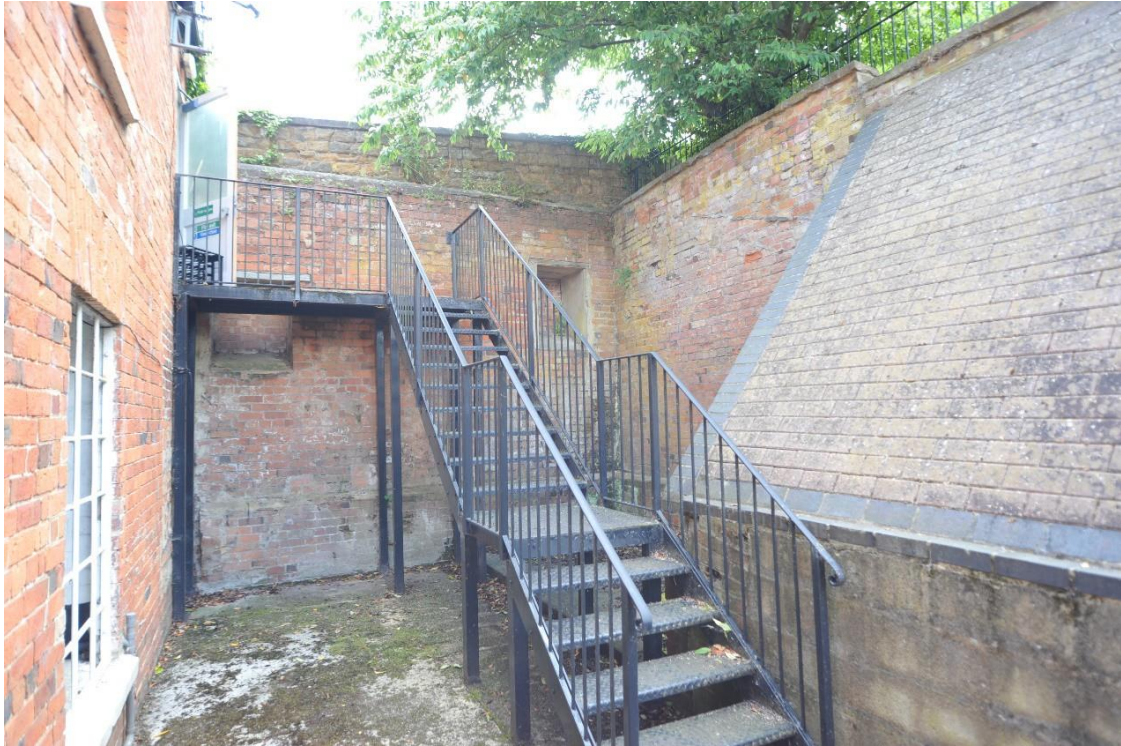
Pl.18: The eastern end of the rear yard with the brick wall and revetment of the terrace to the right. The area beyond the sloping section was once infilled with a building.

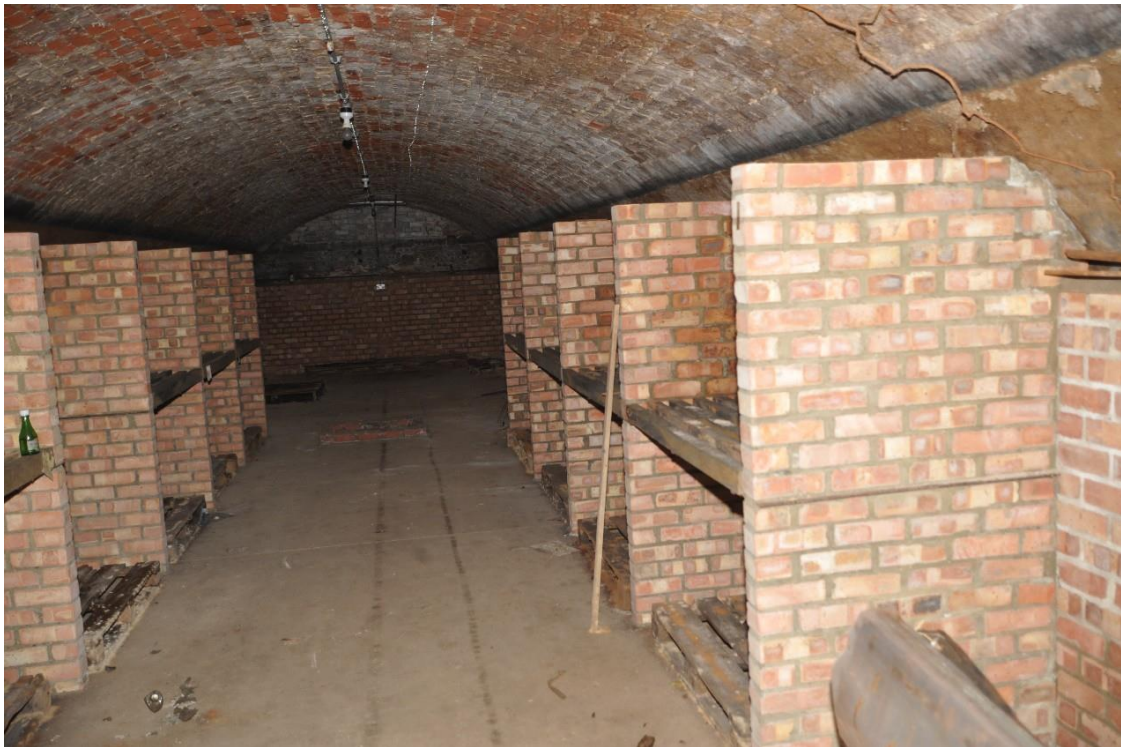
Pl.19: Below the terrace; the brick walls of the shelving is quite modern.

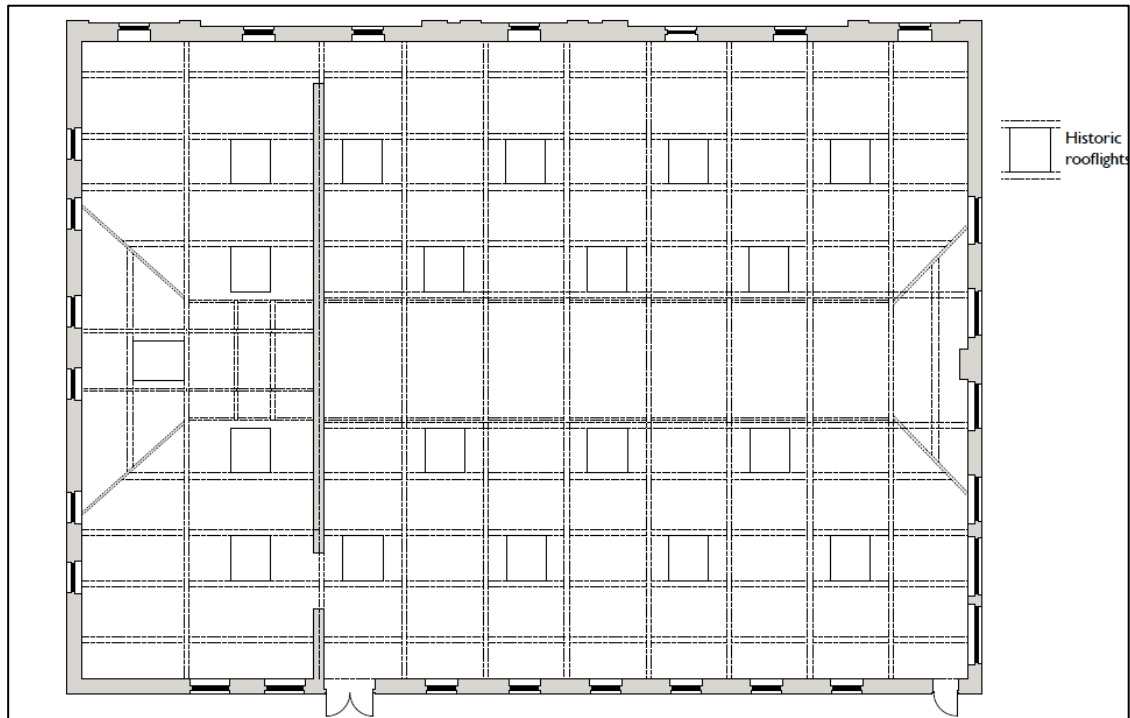
Fig.18: Reflective ceiling plan showing the positions of original rooflights.  
(Acanthus Clews).

It is, however, possible to identify the precise positions of the most of the former rooflights in the fabric, several trimmings retaining a grey paint colour (*see* Fig.18). The situation is further complicated by the evidence of the early-20<sup>th</sup> century aerial photographs which shows a row of cowled vents rising from the flat section of the roof top.

The slight changes to the roof include the re-introduction of a sequence of larger roof lights of a type known to have existed in the past; not only do these restore an element of the design, but they are also difficult to see from street level and the public domain.
