Structural Report

Former Pig Barn

5 The Colony, Sibford Gower

Project No.....18/129

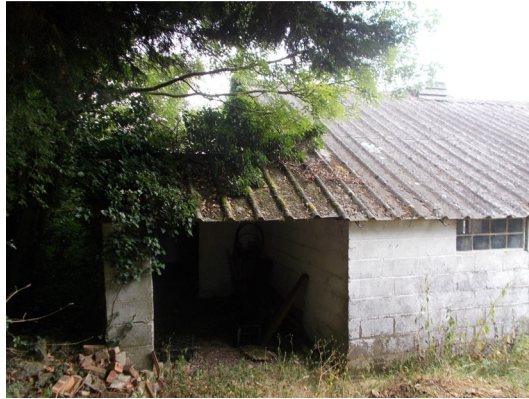
This structure is a former agricultural building. The main part is divided into pens with corridor routes providing access. It was clearly built for animal use. The size and arrangement of the runs suggest that it housed pigs. A lean-to section has been added at the east end. The initial phase of this lean-to (as noted on SK/01 of Appendix A) appears to be original from the initial construction but the open fronted section is likely to have been added later. This later section has the appearance of a domestic car part (see photographs below) but the original lean-to is likely to have been constructed to provide storage (including feed).

The building is accessed through a drive beside 5 The Colony which is a semi-detached domestic residence. The redundant farm building is now in the same ownership as the domestic property but this may not necessarily always have been the case as it is located approximately 28 metres away. This building is relatively close to the eastern boundary of the site. To the opposite of this boundary there is a modern domestic garage and the nearby property that it serves. To the south there are a number of externally accessed pig houses and their associated pens all of which appear to have been unused for some period. There are no other adjacent buildings but the trees on the boundary are very close as can be seen from the photograph.

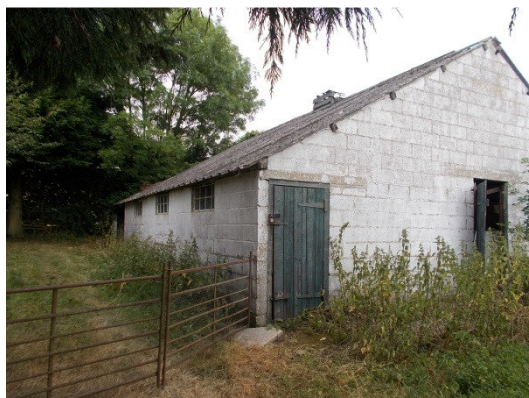
The Colony comprises a number of domestic properties lying to the south-western limit of Sibford Gower and accessed from it by Colony Road. The site is somewhat lower than the main part of Sibford Gower and Colony Road is on a significant downward slope. The land also slopes to the south from 5 The Colony so that this former pig building is below the road and the land continues to fall beyond the building to the south. It is, therefore, cut into the bank to a moderate degree, as shown below.

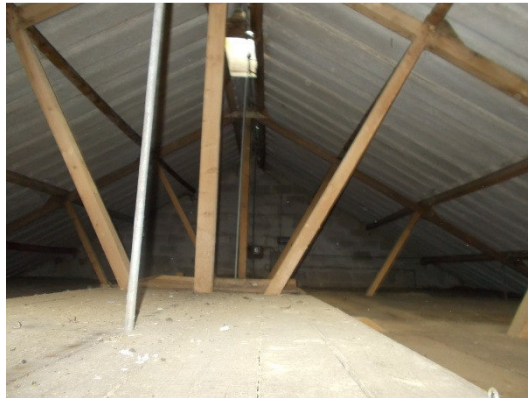
The building is constructed with concrete blockwork walls and a pitched corrugated fibre cement roof covering. The roof structure comprised timber purlins supported on what appears to be two timber trusses. Closer inspection shows the trusses are actually propped from internal piers. There is a very large roof space as shown below.

The area is boarded but there is no permanent access and it appears to have been used only for storage.

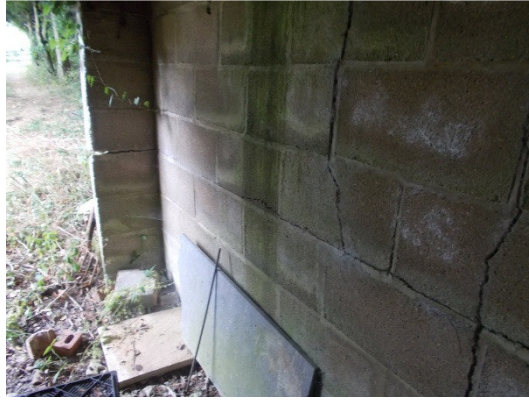
The external walls of the main building and the internal loadbearing walls have been constructed in 150mm block walls apart from the lean-to. Here the external walls are 200mm thick on the older section. This thicker wall has been adopted as the external ground level is raised compared with the internal floor level resulting in the wall needing to resist the lateral earth pressure. The newer open fronted section of the lean-to is constructed with 100mm blocks. This is not adequate for the ground pressure being exerted resulting in the wall being displaced laterally and cracking has resulted as shown below

The wall has been displaced inwards at the bottom but the top has been retained in position by the roof. A horizontal crack has therefore been caused due to the wall 'bellying' inward. The distortion has resulted in a lean of 1 in 80 as indicated on SK/03 in Appendix A. Remedial measures to both parts on the lean-to to address damp penetration in addition to the structural reinforcing required. This would require excavation for strengthening and tanking to the outside of the building. This would require considerable excavation within the root protection zone of the adjacent trees. Demolition of this section of the property and new construction at the opposite end of the building is the preferred solution.

As the lean-to element is proposed to be demolished it will not be necessary to address the structural issues causing it to crack

The existing building is in fair condition and is performing well except for lateral movement and associated cracking in the open fronted garage lean-to. Demolition of this section and an addition at the opposite end, away from the trees, is recommended.

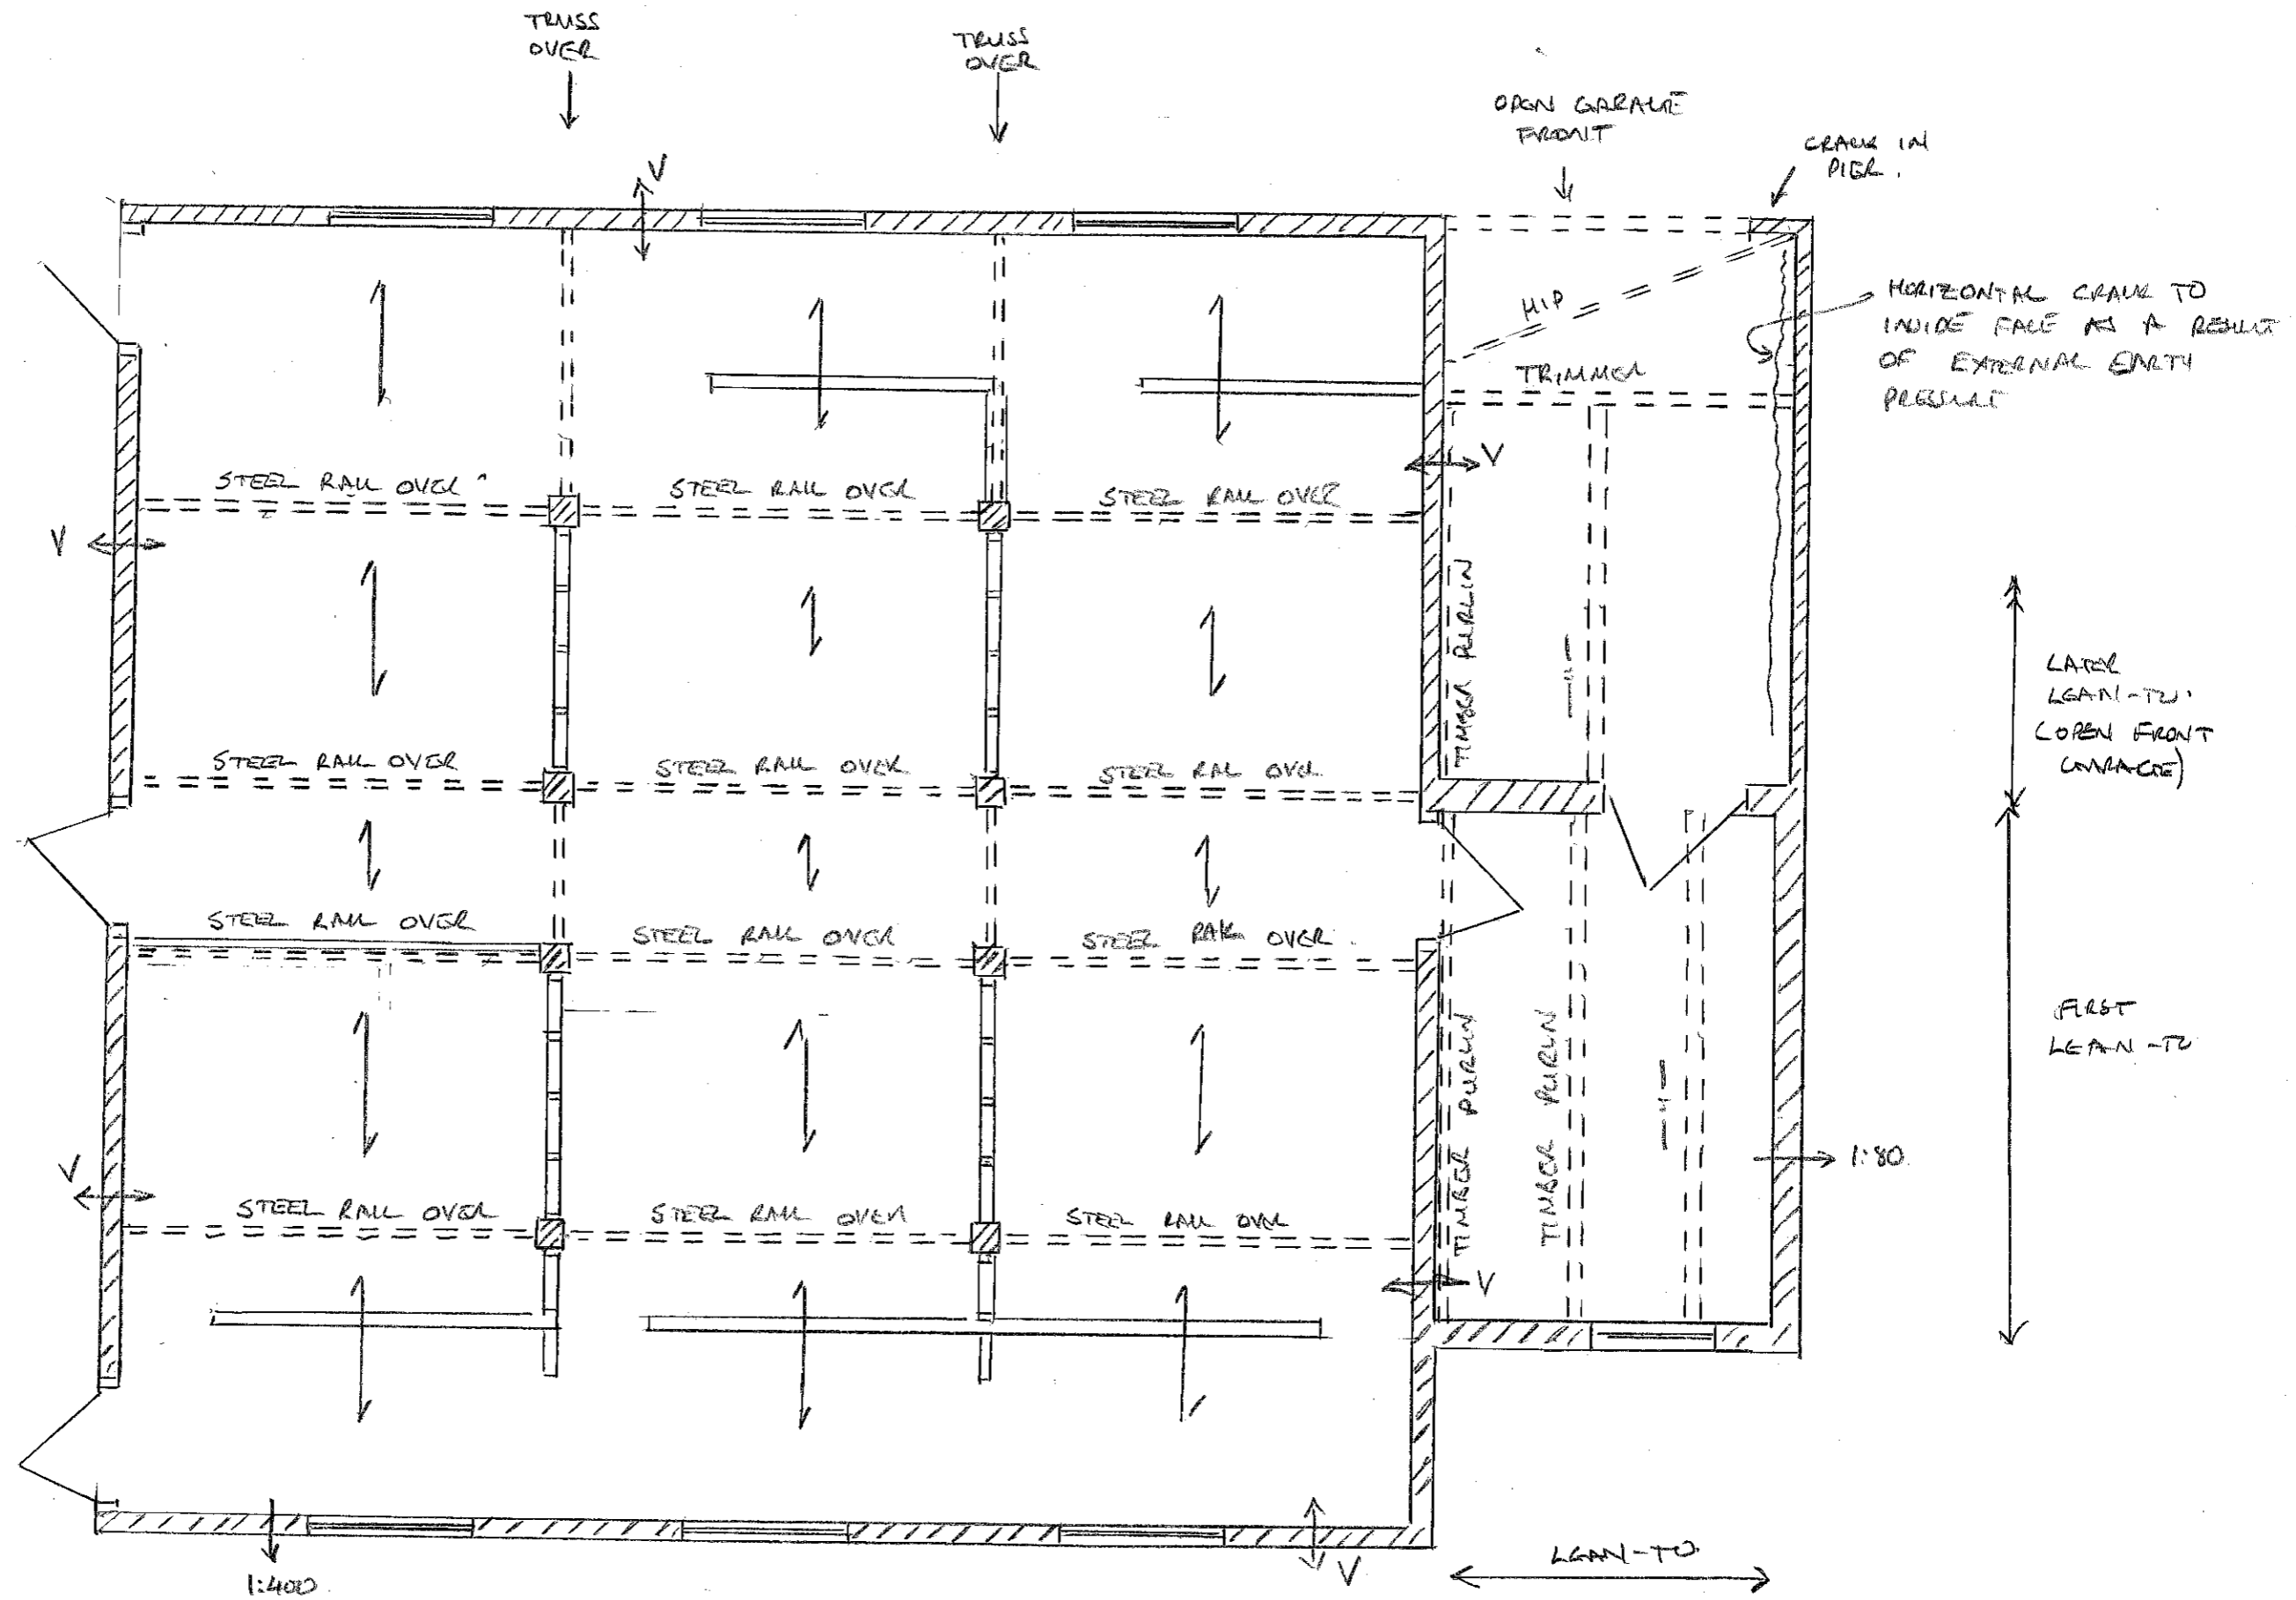
GROUND FLOOR PLAN SHOWING CONSTRUCTION OVER

Internal walls are generally not loadbearing but there are eight square masonry piers supporting the roof. These are identified on SK/01. They are more 225mm square and are more than adequate to support the applied load.

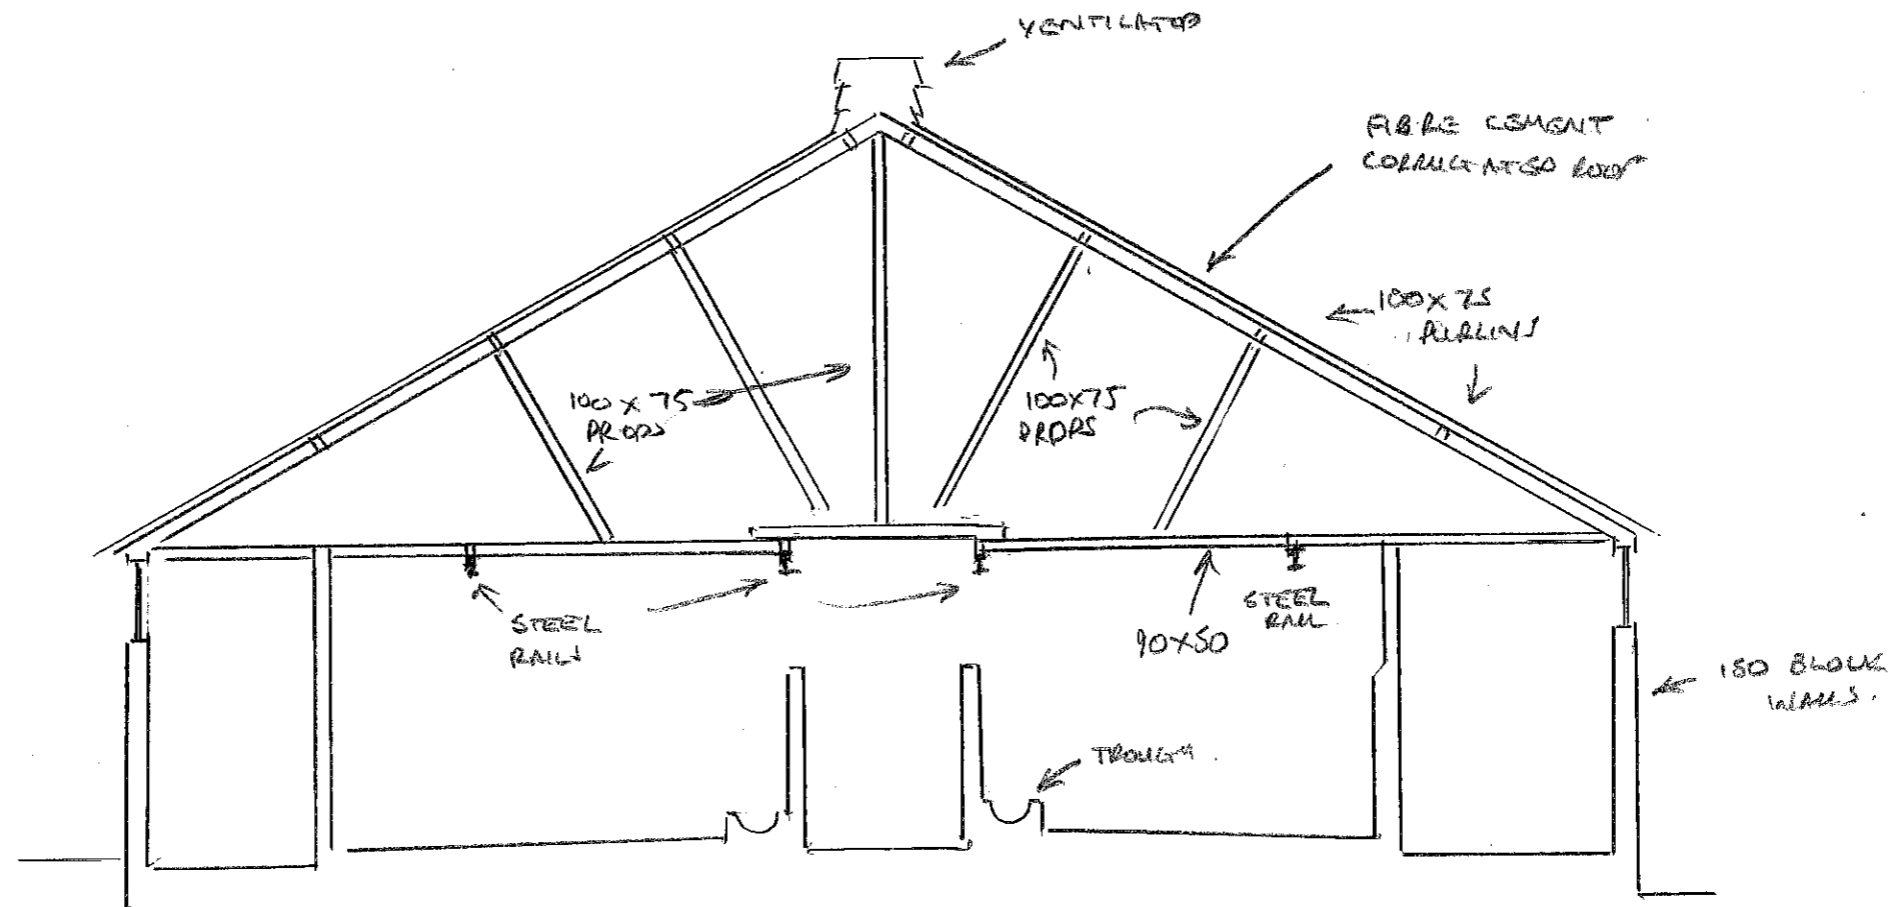
TYPICAL SECTION

The roof section is shown on SK/02. The corrugated roof sheeting spans between the timber purlins which are at approximately 1.4 metre centres which is comfortably within its span capacity. This sheeting is generally in good condition though there is evidence of a possible leak.

The purlins are 100x75mm softwood timber. They have performed satisfactorily with very little deflection evident and are in good condition. They are, however, relatively slim for their 3 metre span and will require replacement or reinforcing if an increase to the roof design loading is required. This can be easily undertaken by fixing a larger timber section alongside or, if the roof height is not to be raised then a steel angle reinforcement should be used.

The timber props are also 100x75mm are comfortably adequate for the present or future loading.

The loft space floor comprises 90mmx50mm joists spanning up to approximately 2 metres. They are near to the limit of their span based on domestic loading but are performing adequately with no evidence of overstressing or excessive deflection.

It is not known whether this sheeting contains asbestos fibre but it should be treated as an asbestos containing material (ACM) unless proved otherwise. It must be tested prior to any remedial work is carried out. If the sheeting is an ACM, as is likely to be the case, it is recommended that it is removed and replaced by a suitable material.

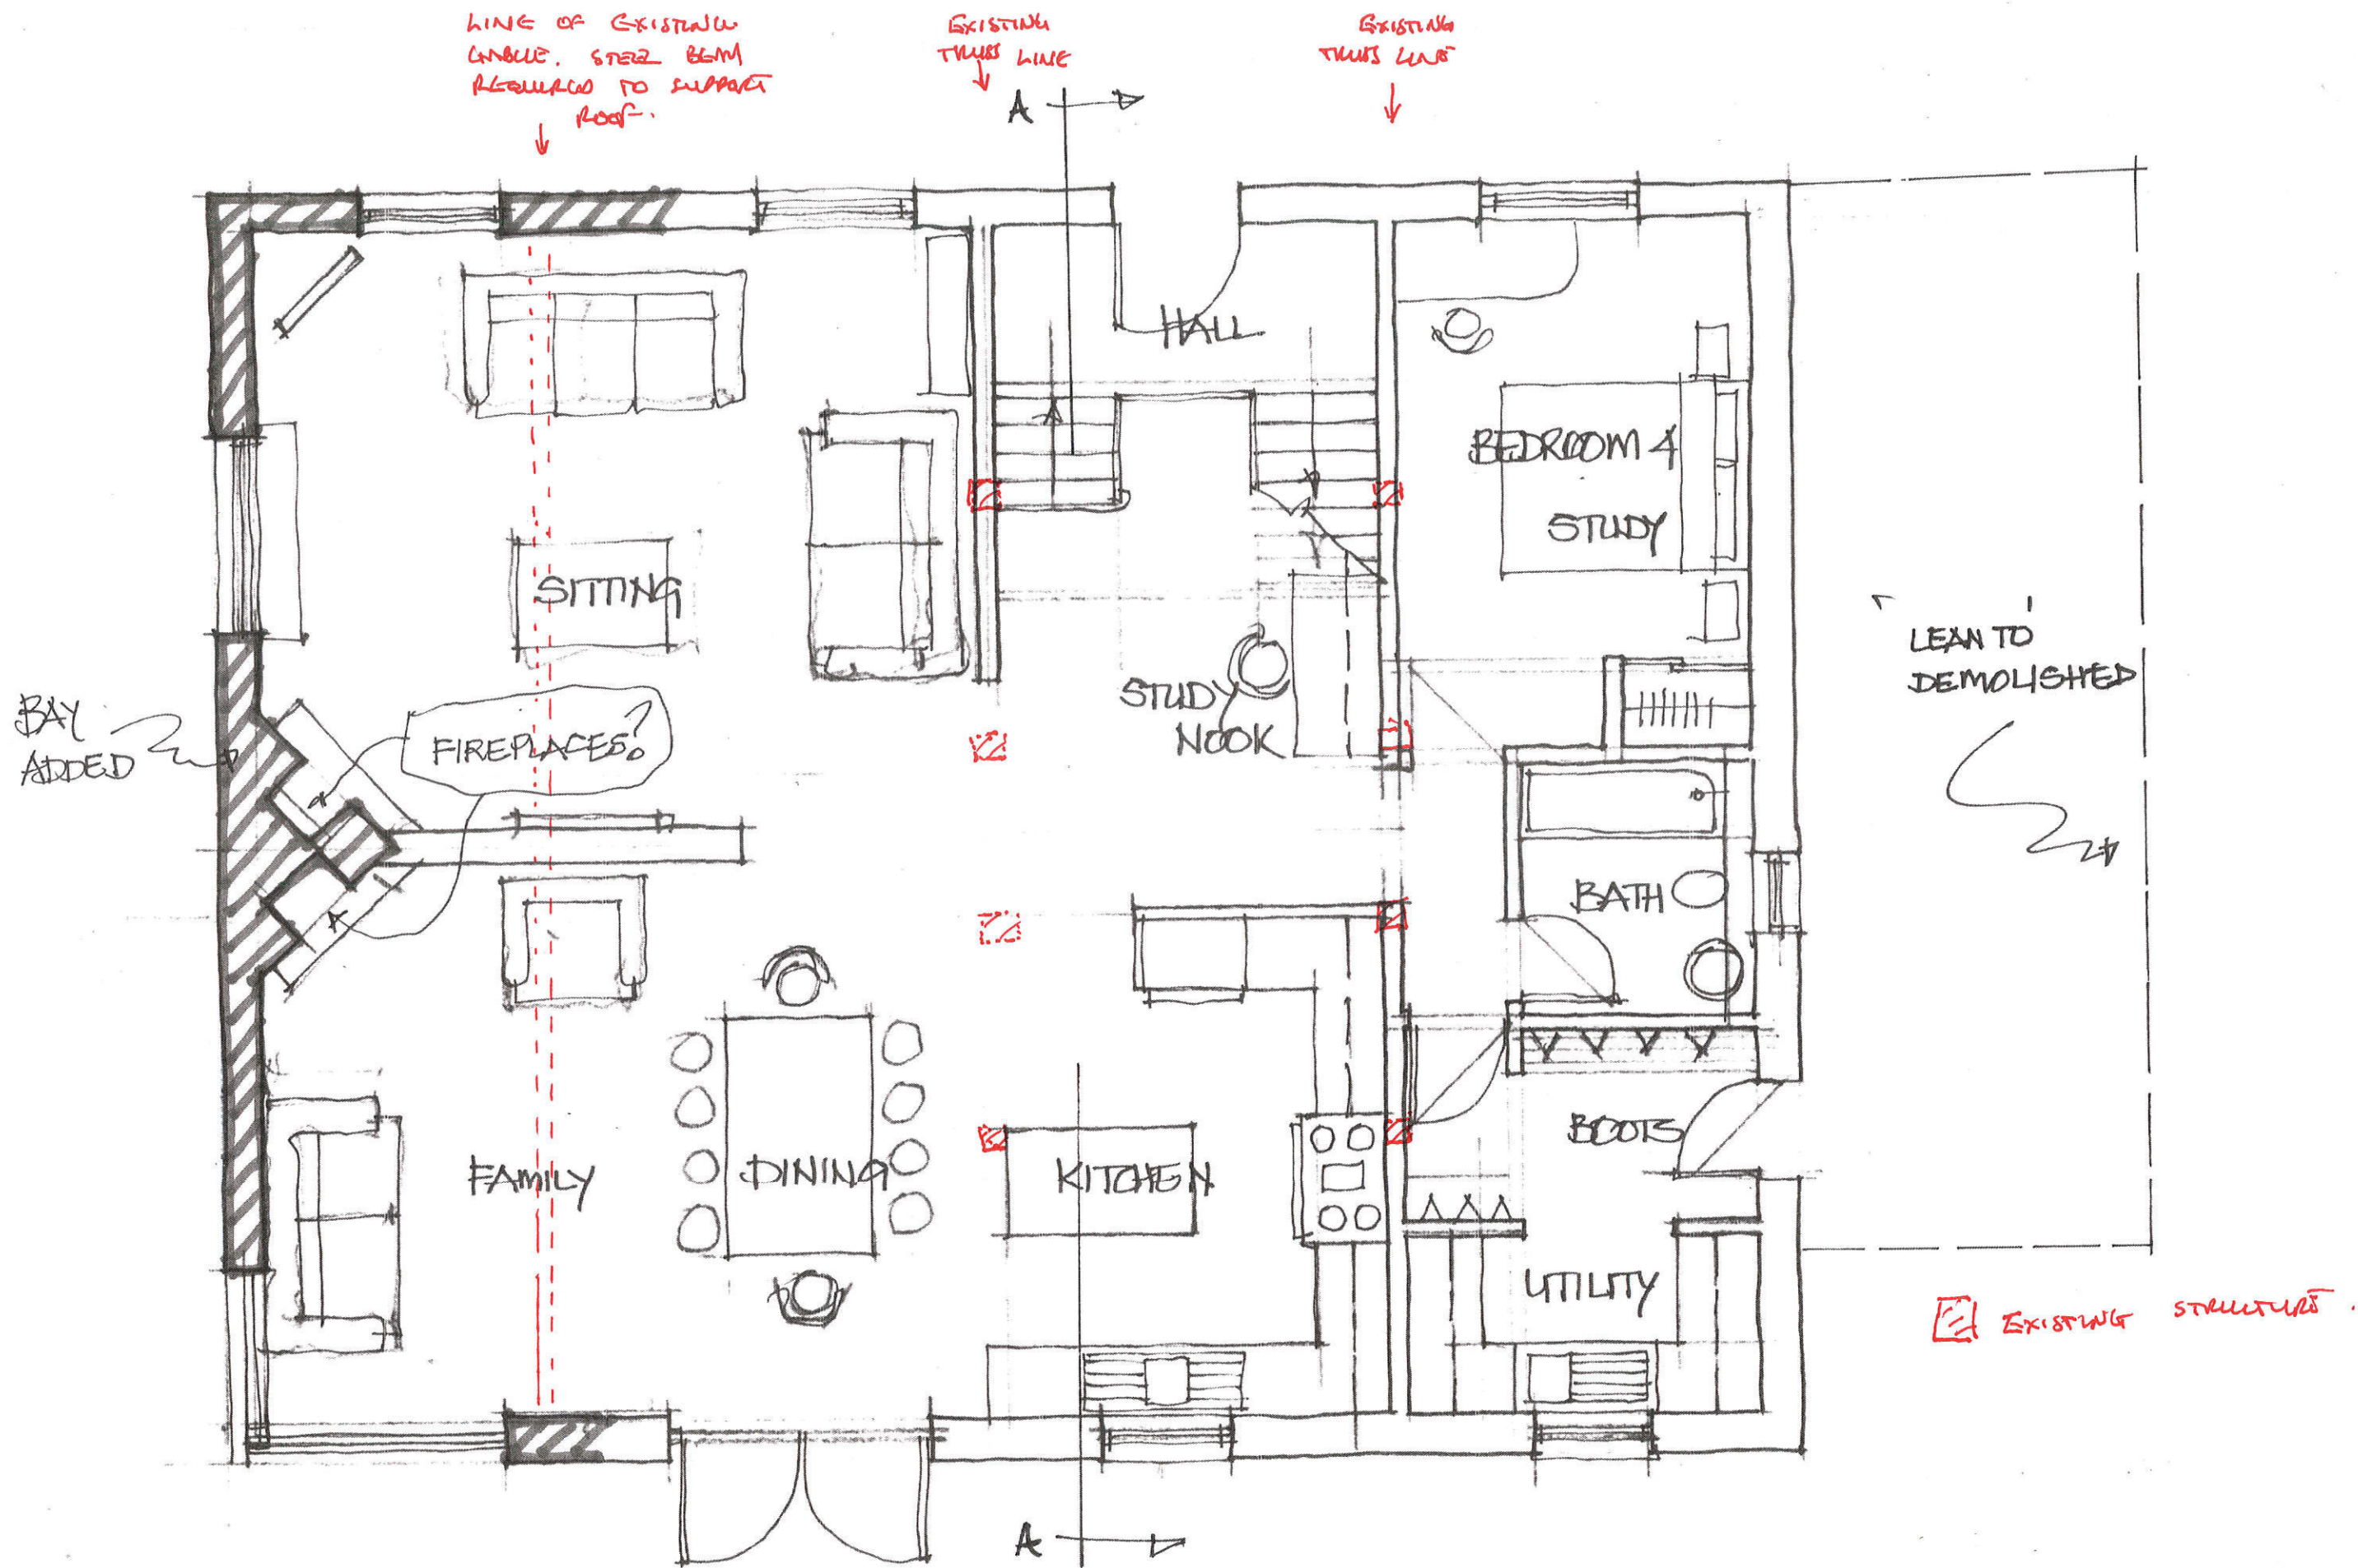
EXISTING STRUCTURE OVERLAID ON PROPOSED PLAN

The proposed architectural layouts is shown in Appendix A. This has been marked with the position of the existing structural elements which could easily be retained within the proposed layout.
