Phase 9, Heyford Park, Upper Heyford, Bicester

S.38 Works

Road Safety Audit Stage 1

TMS reference no: 14436

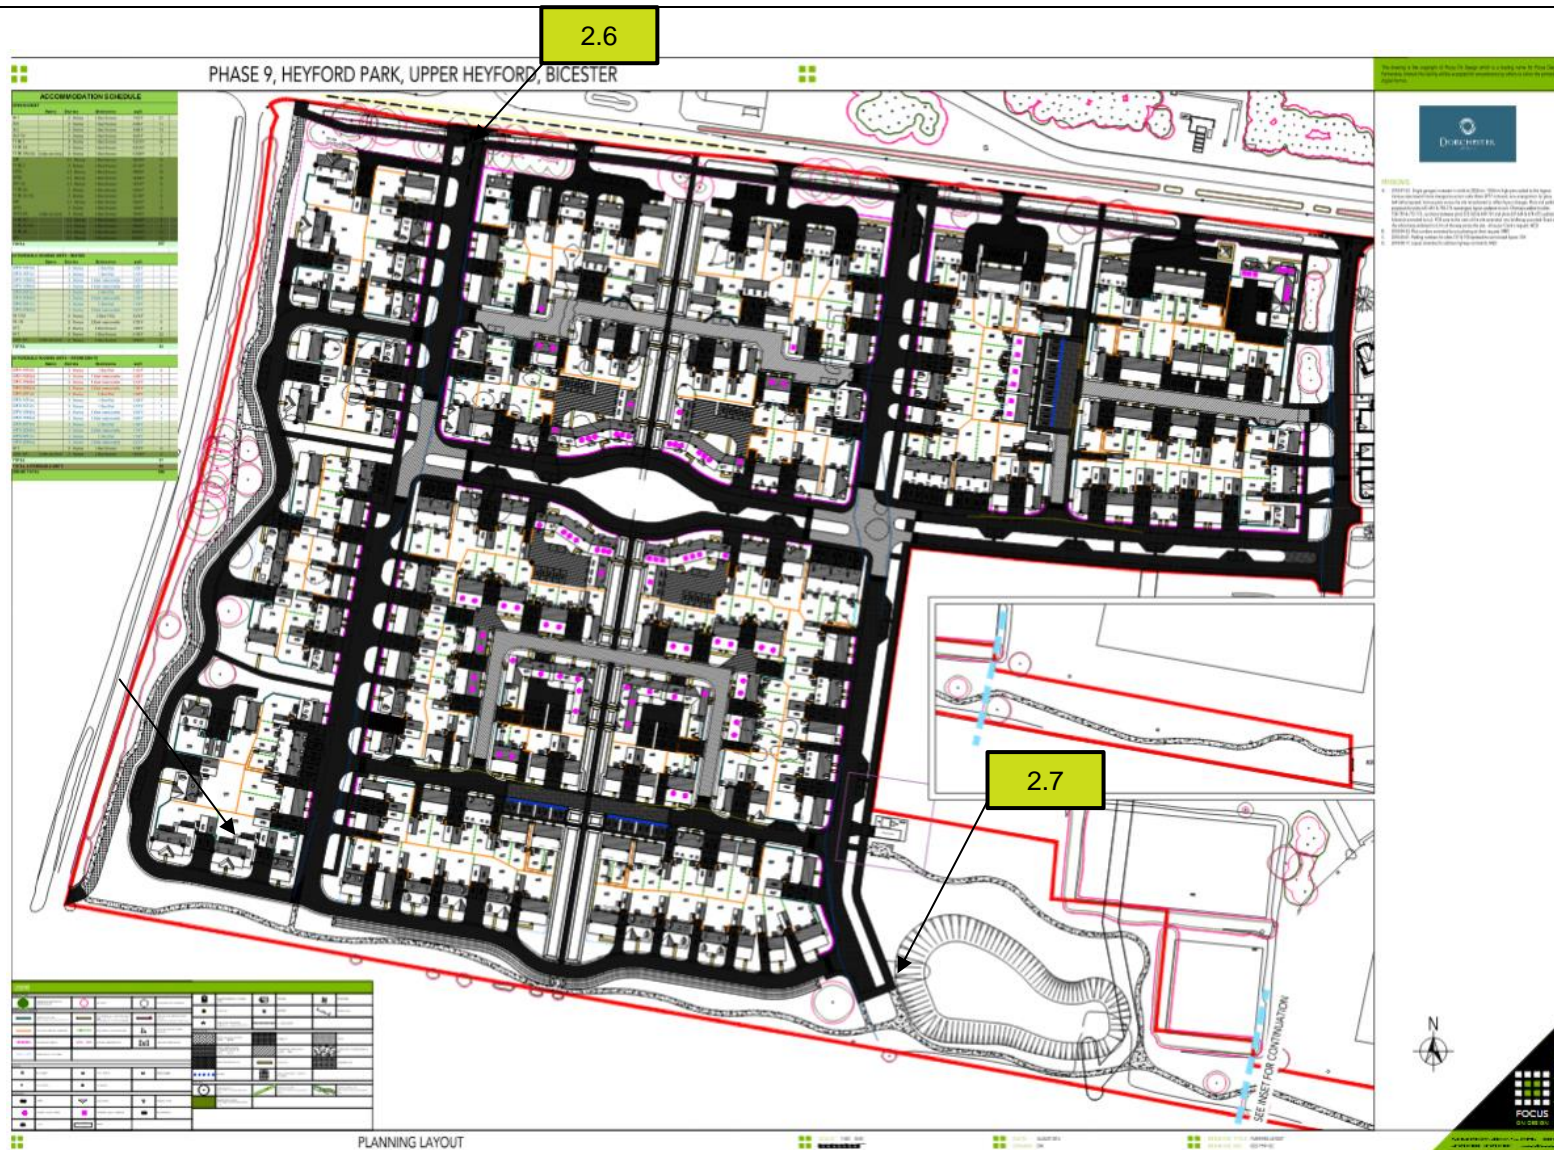
The western access junction is proposed directly opposite an existing priority junction. Right turning vehicles travelling along Camp Road to turn into the existing or proposed junction could conflict with one another resulting in head on or side swipe type collisions.

The embankment slope for the attenuation pond is shown to be at the rear edge of the adjacent footway. Pedestrians who inadvertently step off the back of the footway could trip and fall down the embankment slope. The attenuation pond is also located close to the edge of carriageway and could pose a hazard to the occupants of errant vehicles, especially if the road is extended as part of a future building phase.

The location of the western access junction should be adjusted to ensure that right turning traffic for the proposed or existing junction do not conflict with one another.

A level verge area should be provided between the rear of the footway and embankment slope for the attenuation pond. A risk assessment should also be carried out to consider the need to provide a suitable restraint system as part of the detailed design.
