# BICESTER GATEWAY HOTEL

Stage 1/2 Road Safety Audit

**PROJECT NO. 70033775**

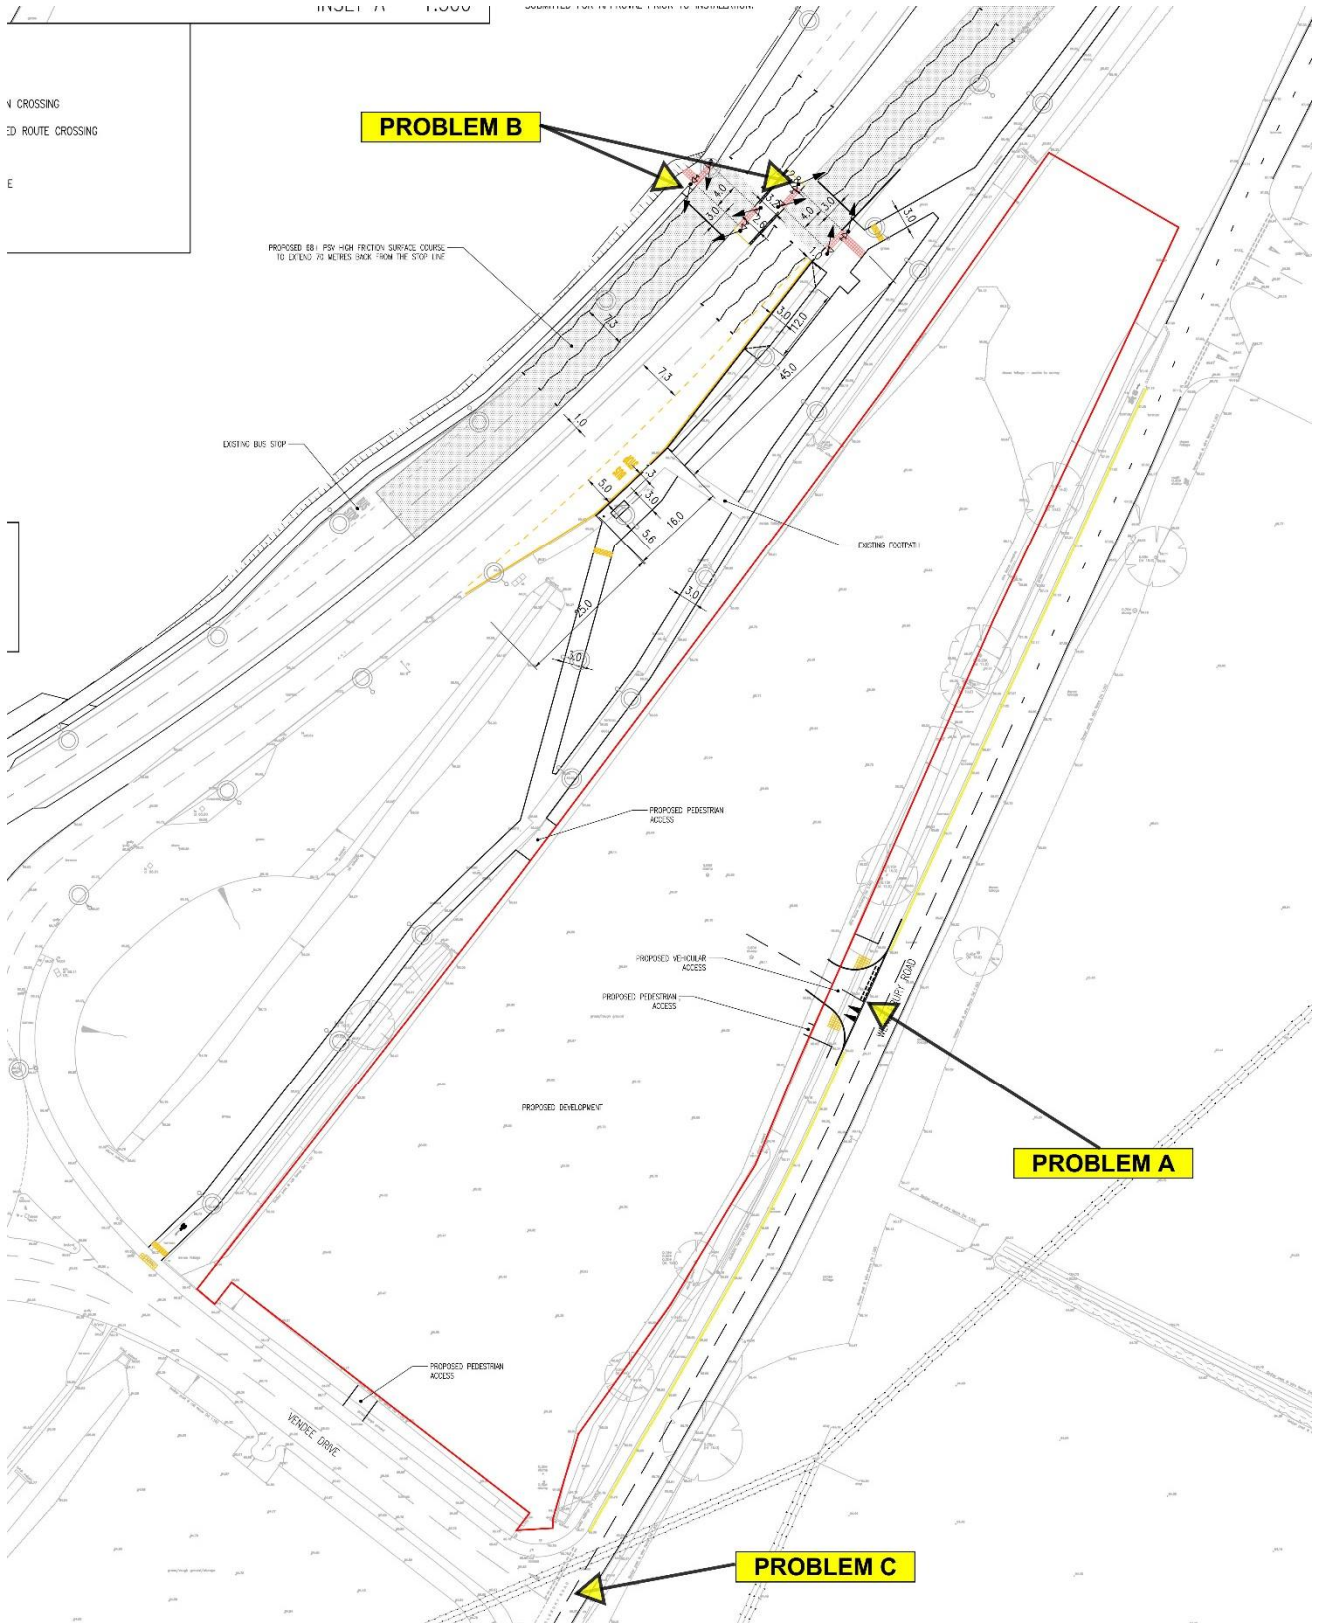
PROBLEM LOCATION PLAN

Summary: Vegetation may continue to obstruct visibility to the south for drivers turning out of access leading to shunts or T-bone collisions

Summary: Visibility to signal heads may not be adequate for the actual vehicle of speeds travelling along the A41 leading to rear shunts, pedestrian or cyclist collisions.

Summary: Narrow width of carriageway at junction could lead to collisions between northbound and right turning vehicles

It is recommended that where necessary vegetation is removed rather than just trimmed and hard landscaping is considered within the splays.

It is recommended that a speed assessment is undertaken to confirm 85<sup>th</sup> percentile speeds on the A41. If speeds are higher than the posted speed limit, speed management measures are recommended to ensure awareness of the upcoming Toucan crossing. Enhanced trimming of vegetation is recommended to ensure that sight lines are clear.

It is recommended that the carriageway of Wendlebury Road is widened at the junction so a northbound vehicle can safely pass a vehicle waiting to turn right.
