ARBORICULTURAL REPORT

to **BS5837:2012** at:

'Tapper's Farm'
Oxford Road,
Bodicote,
Banbury,
Oxfordshire
OX16 9HA

Reference: *AWA2120*

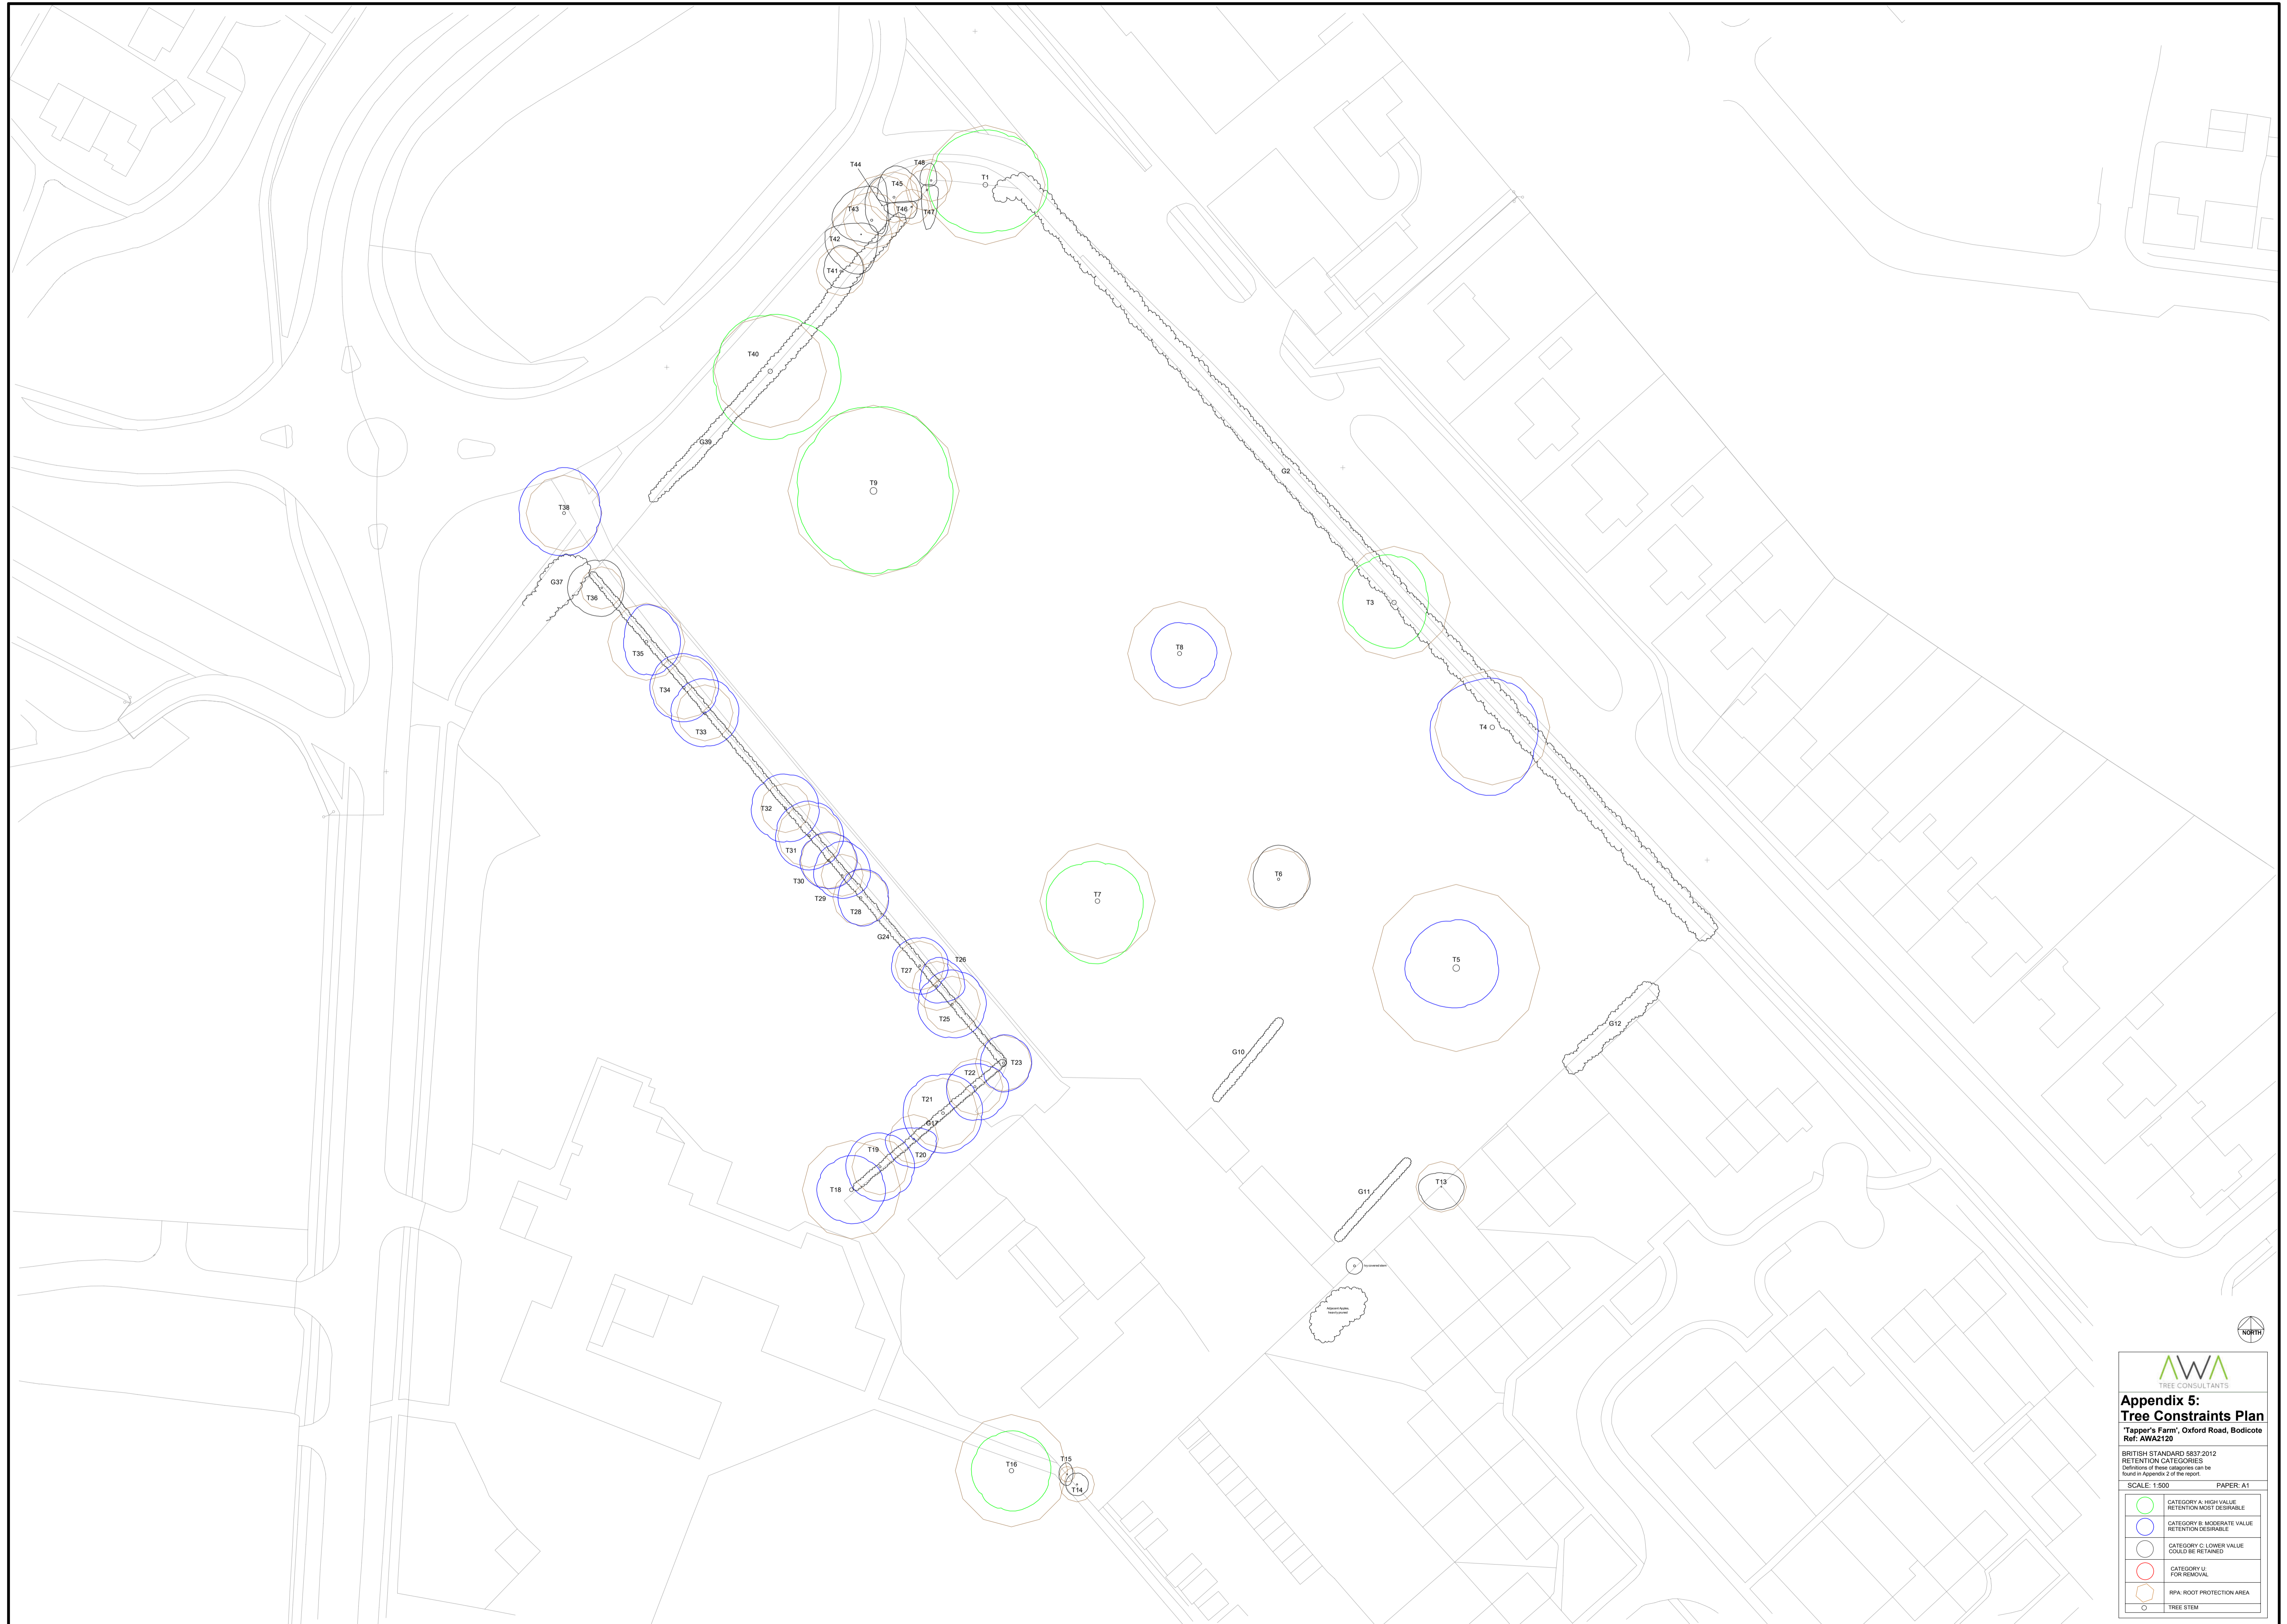
Appendix 5:
Tree Constraints Plan
 'Tapper's Farm', Oxford Road, Bodicote
 Ref: AWA2120

- 3.2.12 The tree Root Protection Area (RPA) detailed on the Tree Constraints Plan at Appendix 5, has been used as a layout design tool, to inform on the area around a tree where the protection of the roots and soil structure is treated as a priority.

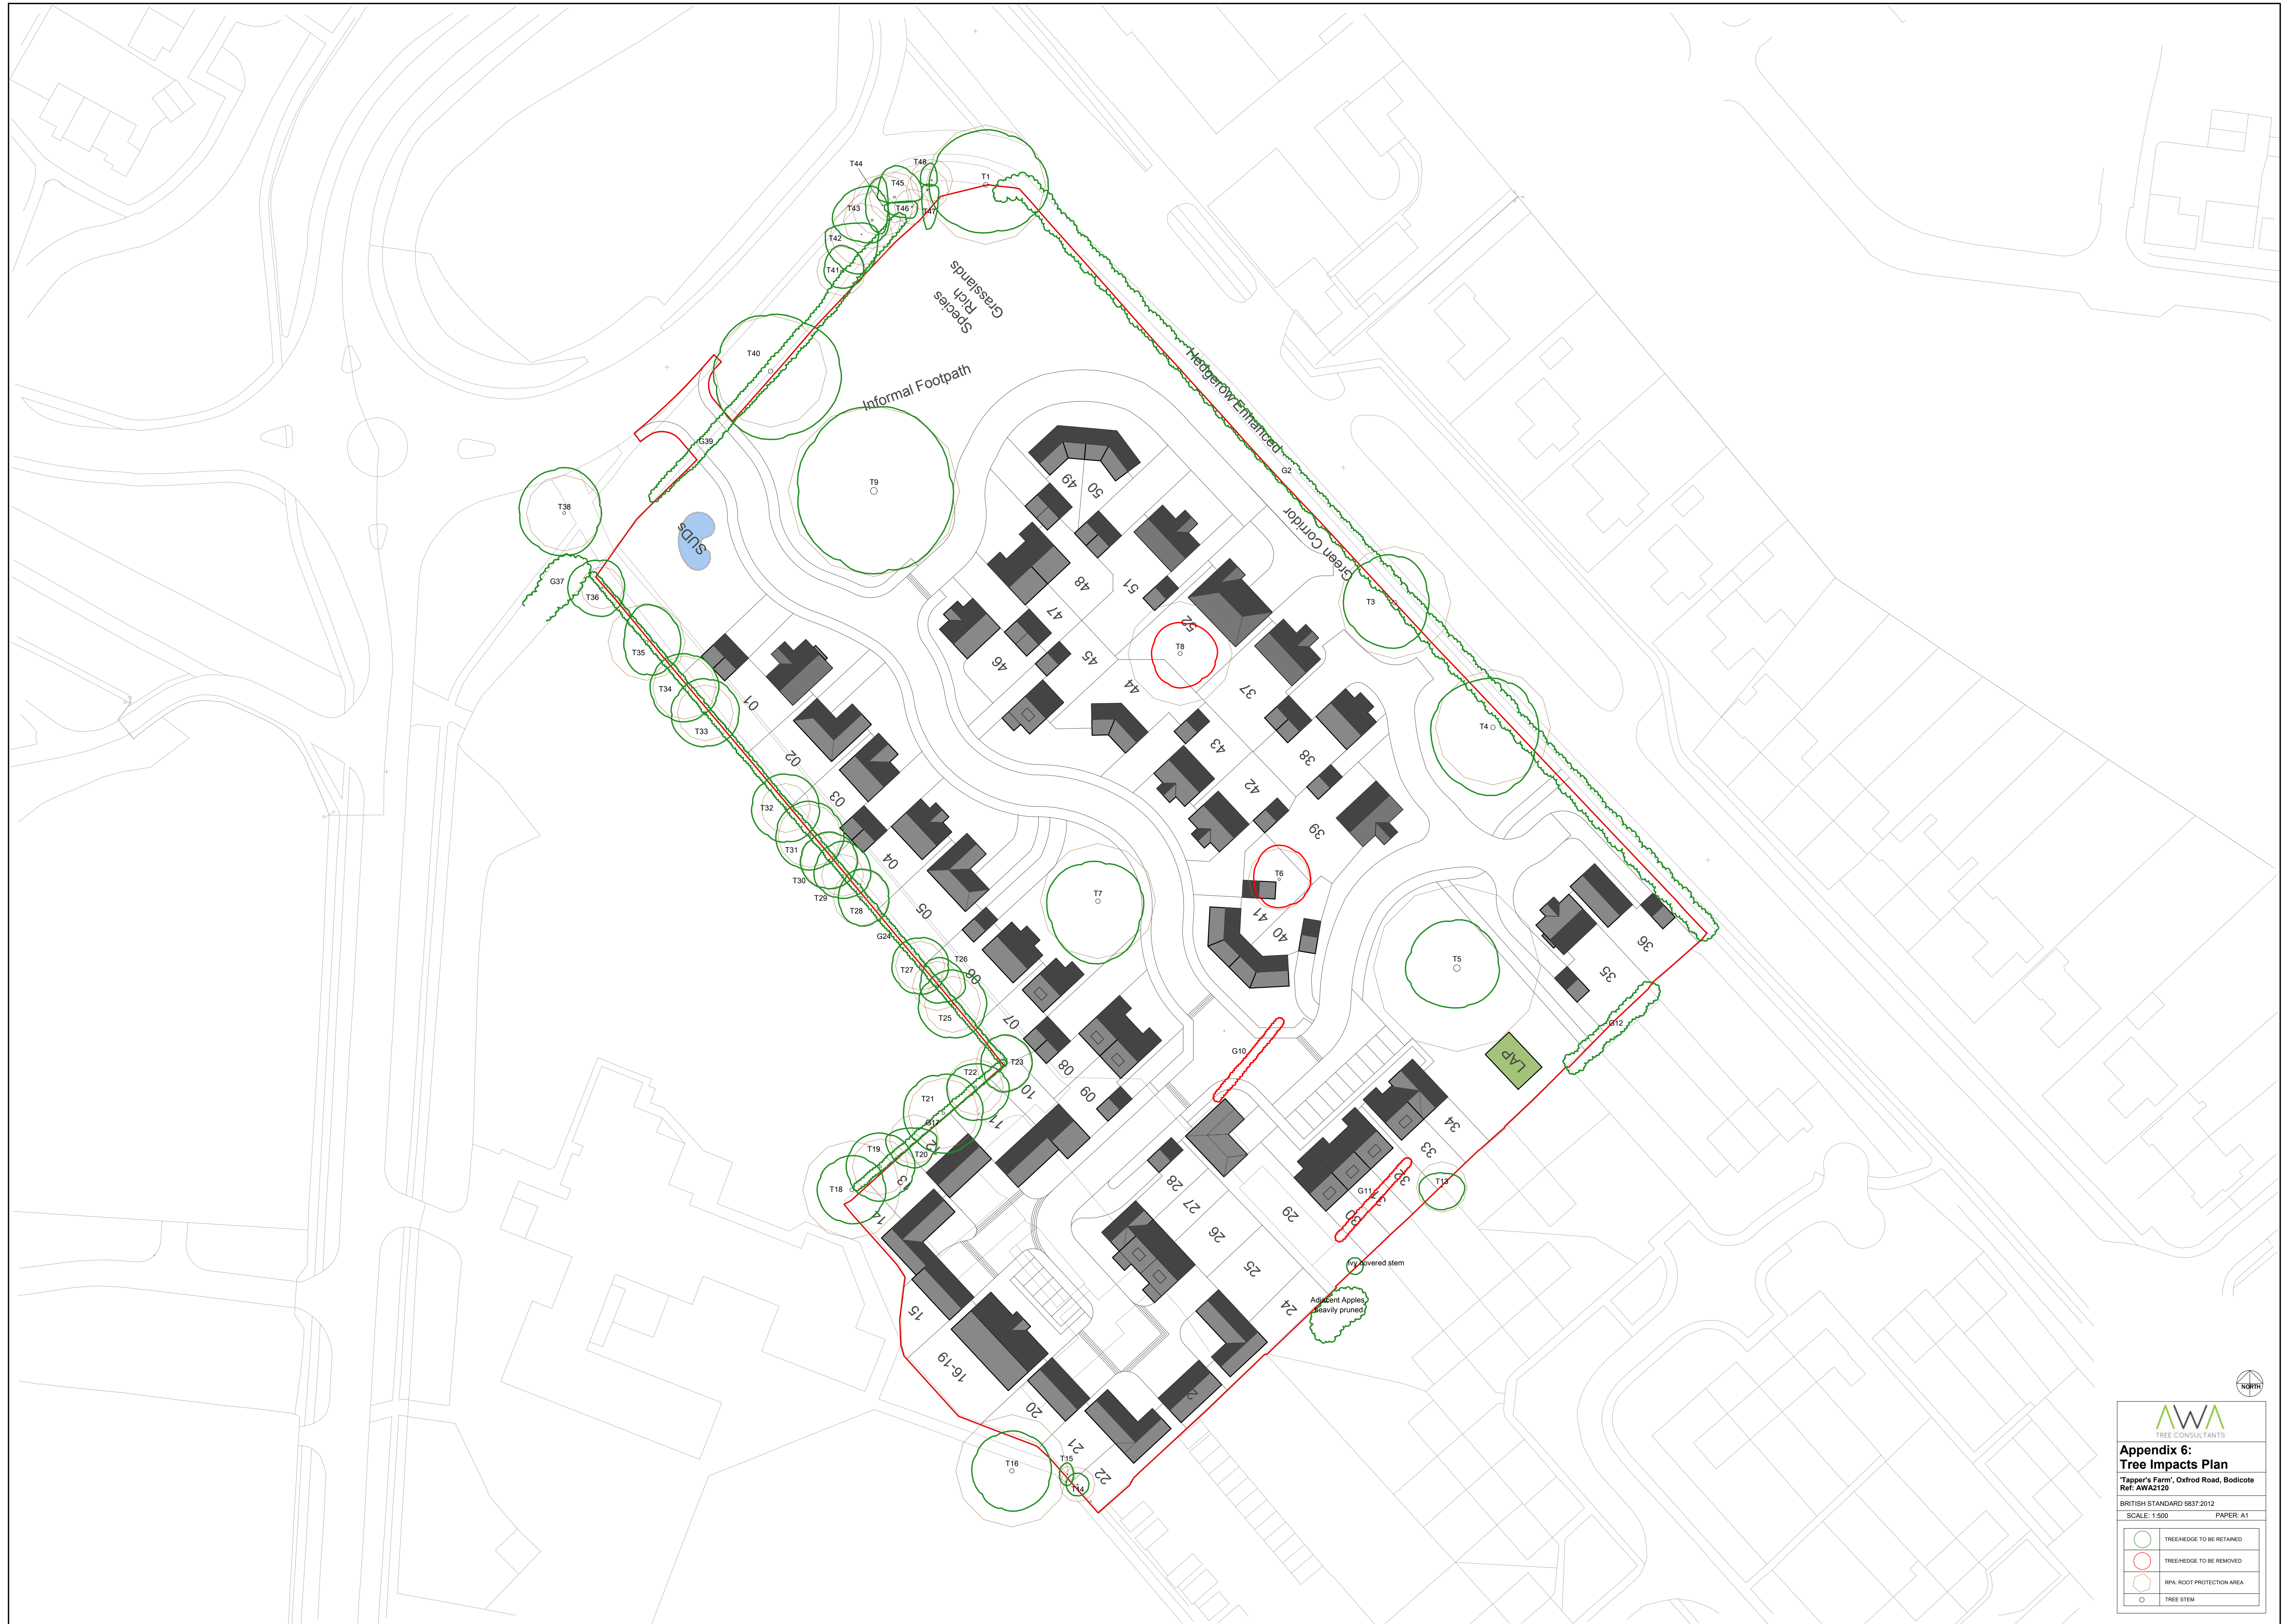
Appendix 6:
Tree Impacts Plan
 'Tapper's Farm', Oxford Road, Bodicote
 Ref: AWAZ120
BRITISH STANDARD 5837:2012
SCALE: 1:500 PAPER: A1

4.2.1 From assessing the indicative development proposals, the potential removal of 2 trees and 2 hedges may be required (T6, T8, G10 and G11).

4.2.2 The removal of the Hawthorn tree T6 and Hawthorn hedges G10 and G11 are of little consequence as they are of low value or have limited long term prospects regardless of potential development at the site.

4.2.3 The potential removal of the Horse Chestnut T8 would mean a moderate loss of visual amenity in the short term; however, the proposed landscape strategy associated with the potential development would more than mitigate for the tree's removal and would improve the site's overall tree cover in the longer term, resulting in a net green infrastructure gain.
