Arboricultural Method Statement - Addendum

NW Bicester Eco Town (Phase 2)

Planning Consent Ref: 10/01780/HYBRID

Date:
24th March 2015
Project Ref: 206

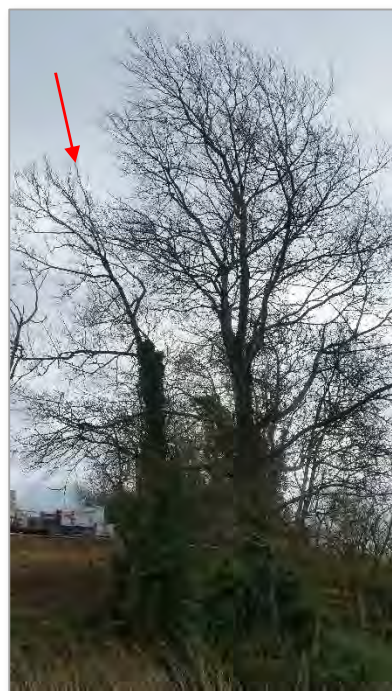
Figure 1 – Crack Willow T16 is arrowed red and is adjacent Aspen T17

T16	Crack Willow	390 x1	15	4	0	2	3	EM	F	P	4	Situated within G2. Single-stemmed. Large wound from branch failure at 3m, with extensive decay. At risk of imminent collapse.	Fell to ground level. (As recommended in Hyder AMS)	<10	U	4.7
T17	Aspen	500 x1	18	6	5	6	6	MA	G	G	3	Situated within G2. Single-stemmed. Ivy prevented detailed inspection.	Remove ivy and resurvey	40+	B2	6

- Crack Willow T32 has been removed;
 - Crack Willow T16 has been retained; and
 - Young broadleaf plantation G6 has been removed.
- 2.4 Crack Willow T16 was previously recommended for removal due to its condition. The re-inspection of the tree revealed significant structural weaknesses rendering the tree at risk of imminent collapse. See Figures 1 and 2 below. It is recommended that T16 is removed.

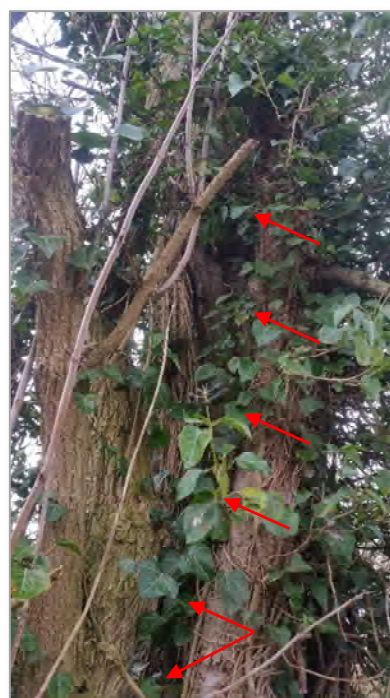
Figure 2 - Close up of stem of T16. The arrows indicate a large cavity partially hidden by ivy

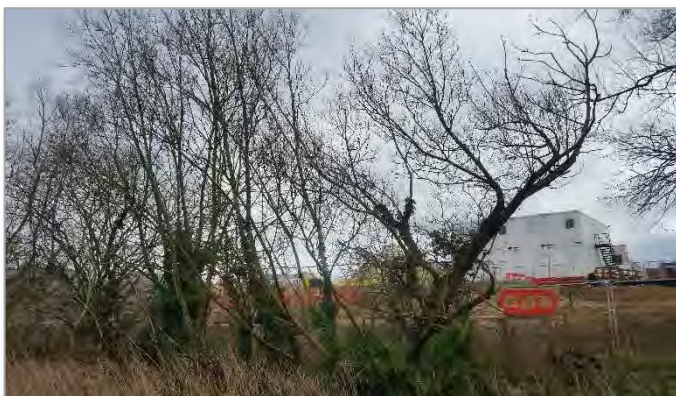
Figure 3 (below) – view of Willow at southern end of G2.

G2	English Elm, Hazel, Common Ash, Elder, Aspen, Common Horse Chestnut, Crack Willow, Field Maple, Dogwood	-	13	-	-	-	-	EM-OM	G-P	G-P	-	Mixed group adjacent to existing stream containing trees of varied species, age, size and condition. Willow at south of group is dying, with extensive dead wood and decay. At risk of collapse. Valuable habitat, but risk of tree and branch failure poses a risk in areas open to public access.	As part of River Corridor works (not Phase 2): Pollard Willow at south of group at 3m height. Walkover survey of areas to be open to public access to determine appropriate works to reduce risk of harm arising from tree failure.	20+	B3	-
G6	Hazel, Sessile Oak, Cherry		4									Felled prior to survey

- Young broadleaf plantation G6 has been removed;
 - A Crack Willow at the southern end of G2 requires pruning to make it safe;
 - Crack Willow T2 at the southern end of G1 requires pruning to make it safe;

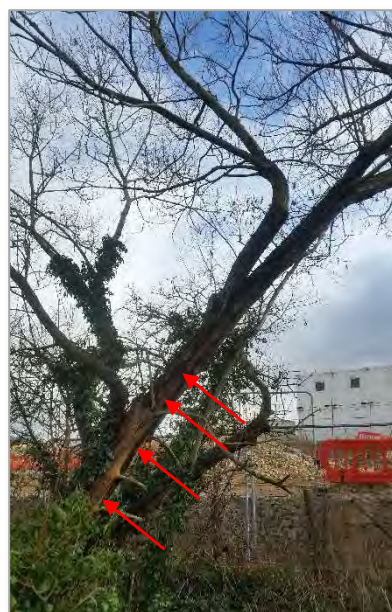
Figure 4 (right) – closer view of stem, area of exposed decayed wood indicated by arrows

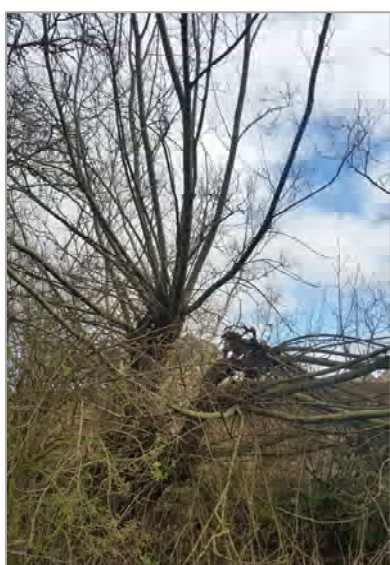
- 2.5 In respect of G6, the Hyder AMS states that G6 is to be removed (paragraph 3.1, page 4). However, in the Tree Data Schedule at Appendix 1 of the Hyder AMS, it states “No action required”. G6 is also shown to be retained on the Tree Protection Plan (Sheet 1 of 2) at Appendix 2 of the Hyder AMS. Given that the proposed development footprint extended over the location of G6, it seems evident that removal of G6 was always necessary for the implementation of the planning consent and that the contrary indications within the Tree Data Schedule and Tree Protection Plan were erroneous.
- 2.6 In addition, a Crack Willow at the southern end of G2 has significant decay and dead wood. It is recommended the tree is pollarded at 3m - see figures 3 and 4 below. Crack Willow T2 has recent failure of regrowth from old pollard points and should be re-pollarded – see figure 5 below.

Figure 5 (left) – shows Crack Willow T2 at southern end of G1. The tree has previously been pollarded and regrowth has recently failed.
