**STRUCTURAL FEASIBILITY REPORT**

**EXISTING BARNs**

**TOP BARN FARM  
SIBFORD GOWER**

**EXECUTORS OF THE LATE KEITH SABIN**

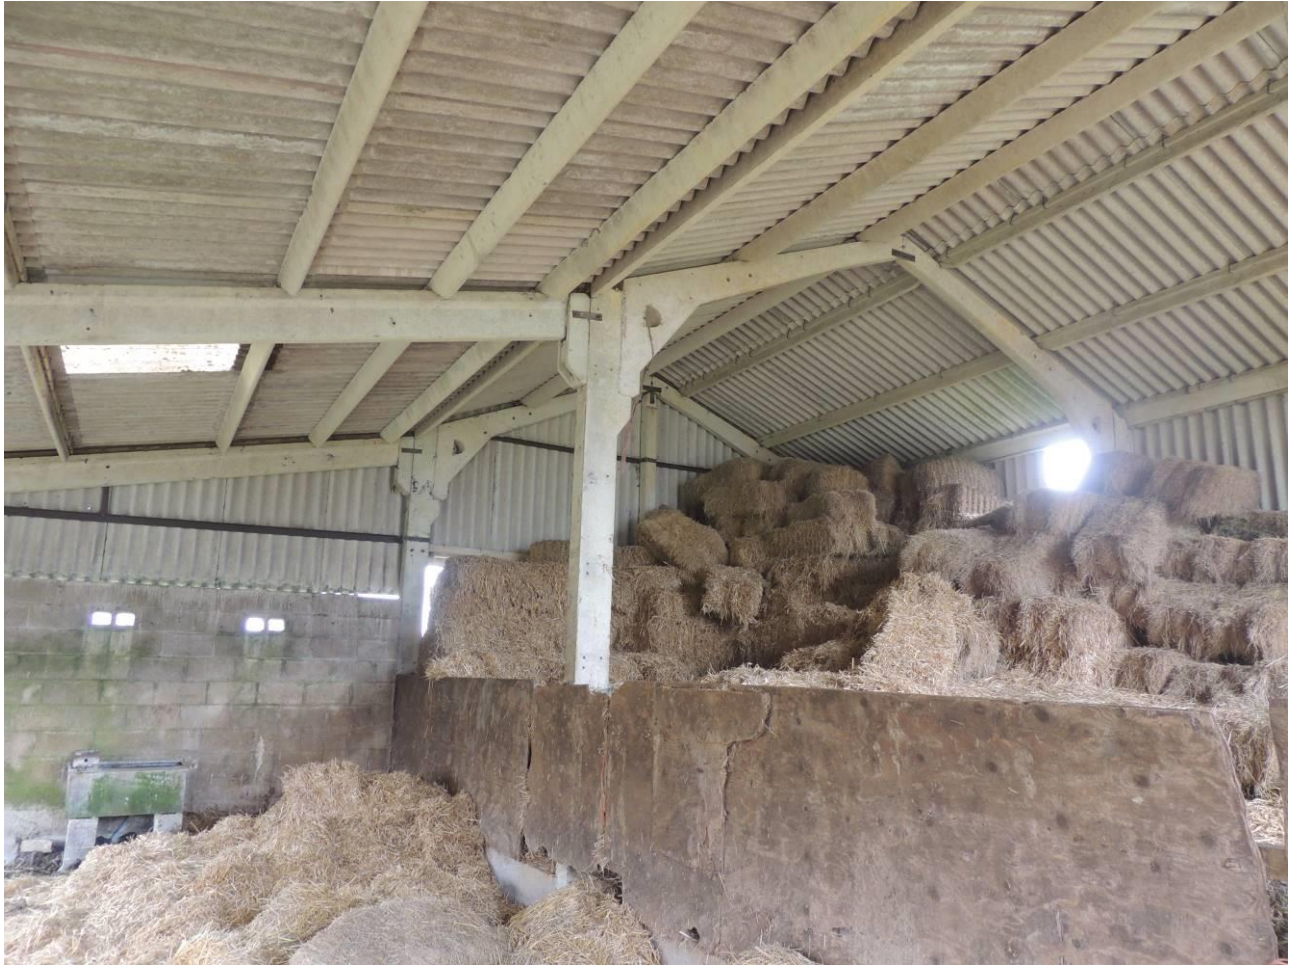
**Photograph No. One**

4.1.1.1 The barn is a portal concrete building with profiled cement fibre roofing sheeting supported on concrete portal frames. A lean-to structure is attached to one side.

4.1.2.1 The walls are also profile cement fibre cladding also supported on concrete sheeting rails.

4.1.3.1 The floor is agricultural concrete. A blockwork dwarf wall is located at the perimeter of the building.

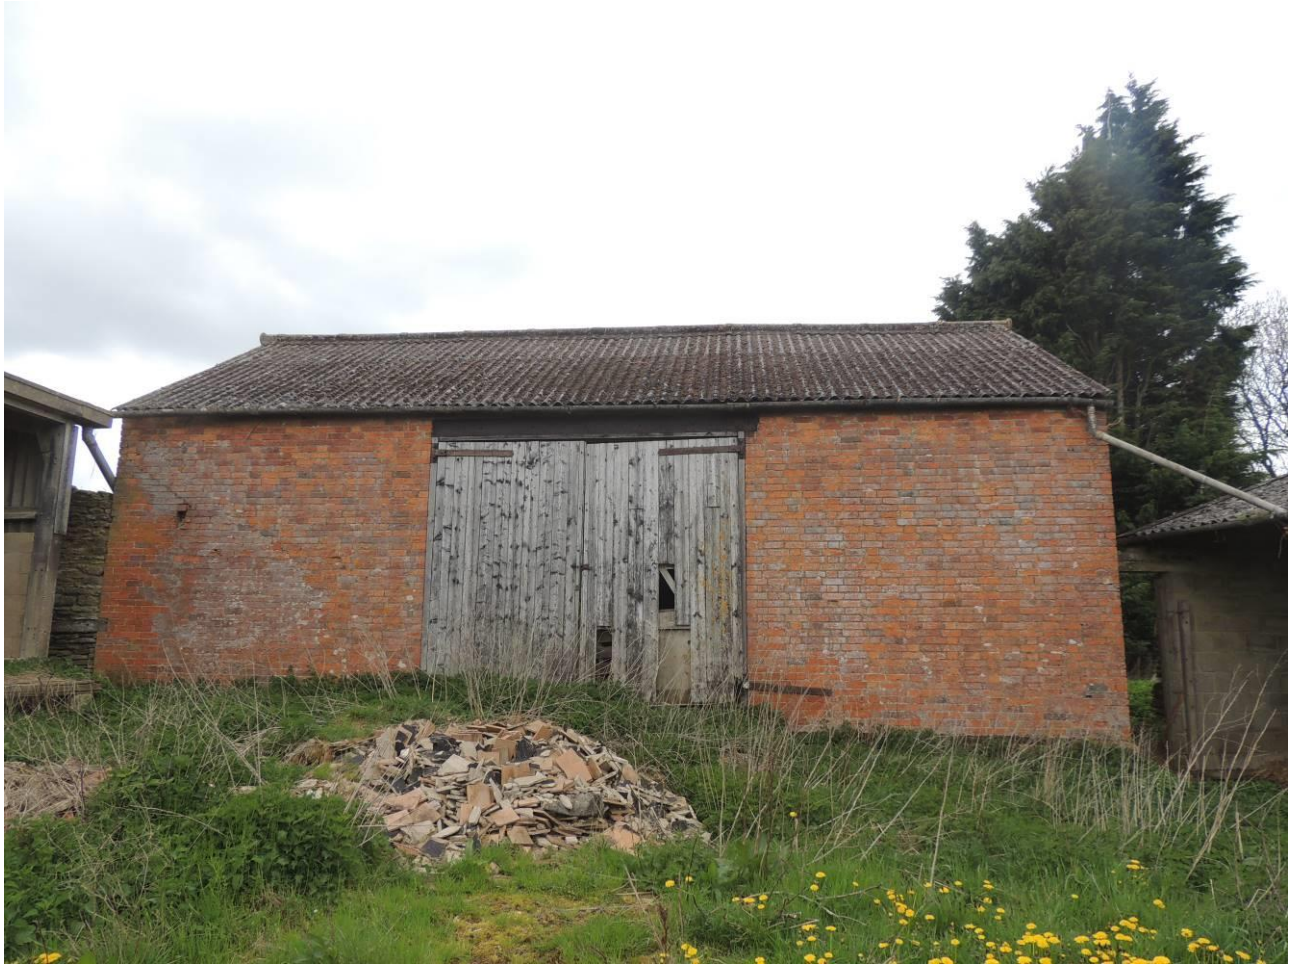
**Photograph No. Four**

4.2.1.1 The roof again comprises profiled cement fibre sheeting supported on steel angle purlins and steel trusses, supported on the brick walls.

4.2.2.1 The walls are of solid brick, with cart openings at mid point along each of the long elevations. There was no evidence of structural distress.

5.2.2.1 Existing brick walls are in sound condition with very minor evidence/slight movement to the LHS. New loadings will not vary from existing and no structural concern is raised.

6.2.1 Again, the conversion of the barn is entirely feasible without significant attention to the structure. Some tying of the cracked brickwork is recommended to re-establish in the wall. There is sufficient headroom with the beam to allow new floor to be formed without the need to undermine the existing foundations, so underpinning is not necessary.

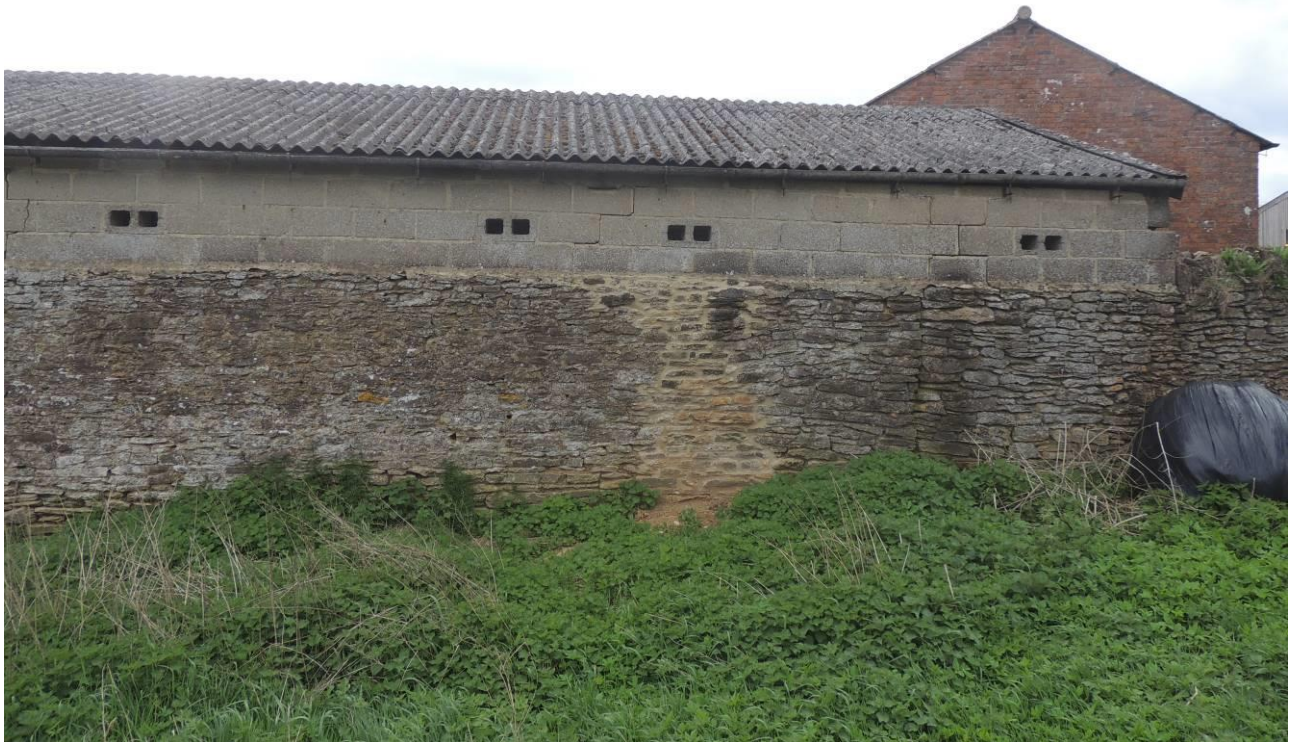
**Photograph No. Eight**

4.3.1.1 Again, profiled sheet forms the roof, supported on timber framed structure. There was no evidence of distress to the frame.

4.3.2.1 The walls are both stone and block. Cracking was noted to LHS gable (when viewed from the road).

5.3.2.1 Cracking is noted predominately to the LHS & RHS gable, with the movement indicative of downward movement of the front elevation which is built off an historic stone wall. Ground levels internally are also higher than will be required and therefore levels internally will need to be underpinned, but this will address the evidence of movement and ground level reduction requirements.

6.3.1 The conversion of the stone faced barn is entirely feasible. Some localised masonry repairs will be necessary and underpinning of the front wall will probably be required due to lower floor levels.
