Project name	Heyford Park - Proposed new primary school		
Design note title	Structural condition survey of existing hangers		
Document reference	04583-HYD-SCH-ZZ-RP-S-0001		
Author	R Bareham		
Revision	P01		
Date	22 September 2021	Approved	✓

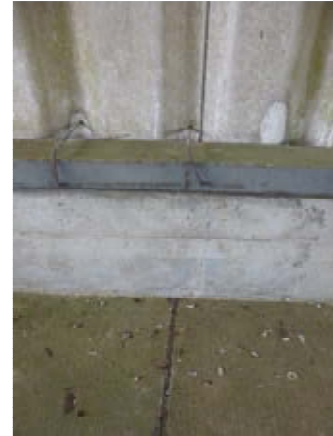
Hairline cracking to the concrete upstand at base of cladding. Happens regularly and seems to correlate with slab jointing.

Suspect the upstand is bridging the slab joints.

Not considered to be structurally significant in the context of proposed re-use as an external shelter. However, it will lead to on-going risk of water ingress and reinforcement corrosion. Concrete patch repairs may be recommended in places, but sometimes an elastomeric paint may be sufficient.

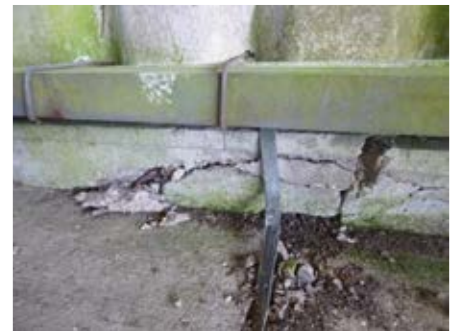
In a few areas the upstand cracking is much more significant and could be mechanical damage or a focus of cumulative movement.

Clearly concrete repairs will be required at areas such as this, with possibly new movement joints cut into the upstand to reflect the slab joints.

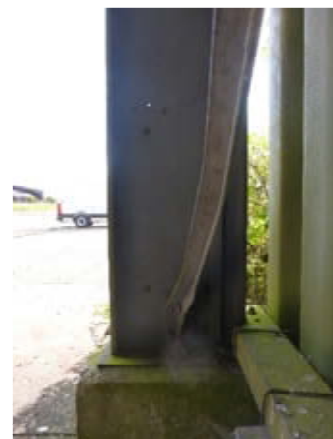
Bent brace. Note this only occurs in one location at south west corner of hanger 1.

Appears to be impact damage.

Brace to be replaced.

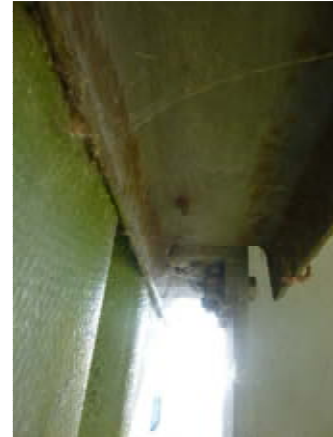
Light surface rust everywhere.

Original protection systems appear soundly specified; however, maintenance regime has probably been slack.

All steelwork will require cleaning and repainting.

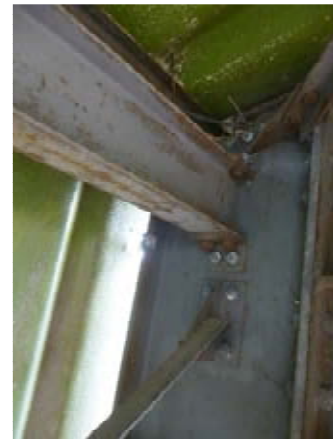
Bolts are generally in good condition, but some are showing excessive rust.

An allowance for replacing say 20% of bolts should be made.

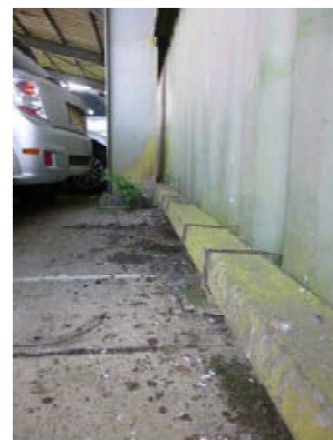
Occasionally the cladding rail channels are distorted torsionally. It is suspected that they may not be justifiable for spanning vertically supporting the weight of cladding.

It is suggested that any new cladding is designed to be supported vertically on the upstand, or cladding rails may need anti-sag measures (rods) to take out the vertical load.

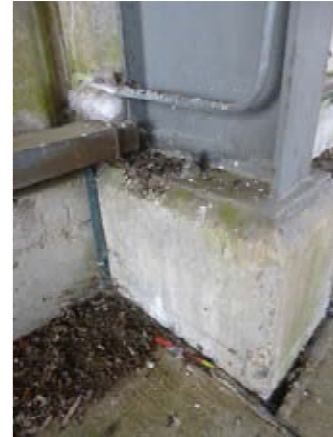
The portal frame bases could be described as being “frugally connected” with only 2No M20 HD bolts being cast into the RC plinth where we would expect minimum of 4. They do not seem to be exhibiting any adverse structural effects so no structural enhancement is considered necessary.

However, if there are to be any general structural upgrades to the hangers associated with the conversion (e.g. adding cladding which would increase wind forces and dead loads on the structure) then these connections may need more closely checking and may need to be upgraded.

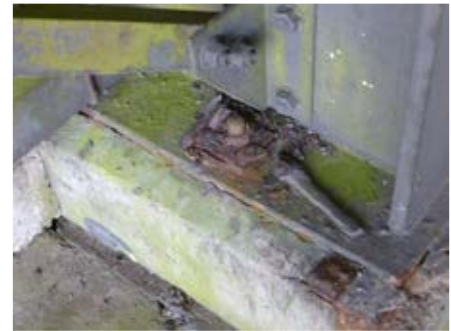
Holding down bolts appear generally in good condition as noted above. However, in hanger 4 they seem to be more badly corroded than the others.

They will need to be replaced with four new drilled expanding

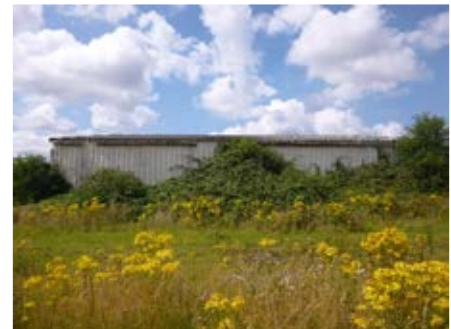
There is often much undergrowth growing around the outside of the building preventing close access.

This will require to be completely removed.

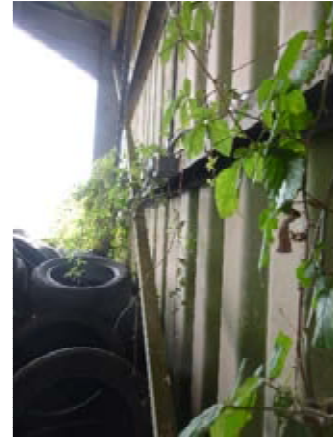
Sometimes the undergrowth outside the building is so rampant that it has ingressed through the cladding. This particular example occurs in hanger 3 but is not typical to all hangers.

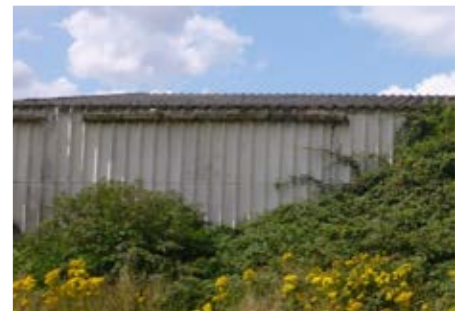
Guttering and down pipes are beyond the scope of this investigation but it is clear that they will need to be renewed along with packaging.

Advice of others to be sought.

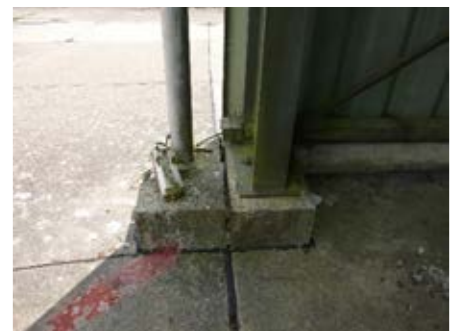
Slab joints appear to be function adequately. The mastic finish however is past its serviceable life.

Joints to be raked out and refilled as part of the works.

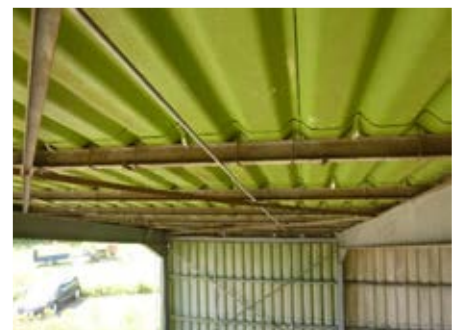
The cladding is assumed to contain asbestos so will present a H&S risk if disturbed.

If removal is required this should be by a licenced removal company and disposed of in line with regulations.

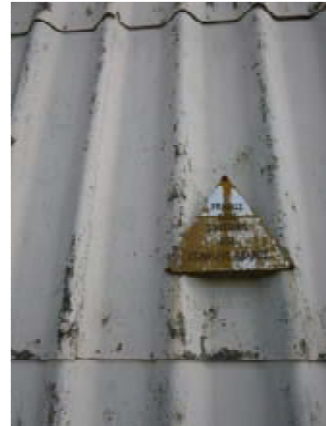
The cladding is fragile and should not be trafficked for fear of falling through.

All external works to be undertaken from cherry pickers.
