**New Settlement Area, Heyford Park,
Oxfordshire**

**Dorchester Phase 5,
Contamination Hotspot: Remediation Works
Verification Report**

July 2018

Report Ref: R1742-R16-v1

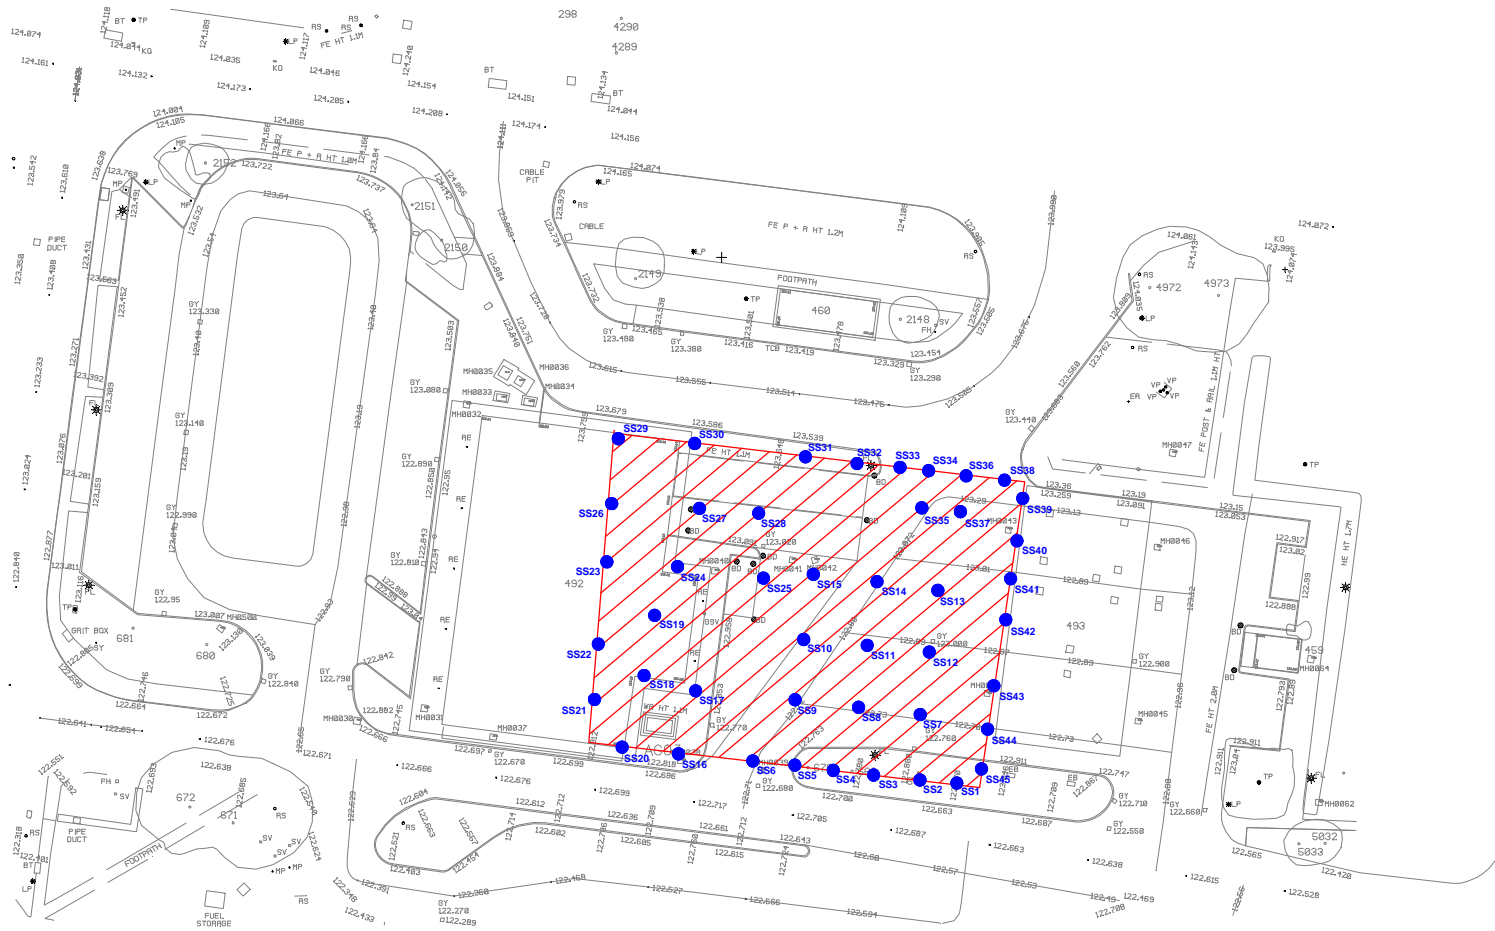
Project:	
Hayford Park, Upper Hayford	
Drawing:	
Dorchester Phase 5: Contamination Hotspot Excavation Extents and Sample Location Plan	
Drawn:	Checked:
SM	BJT
Date:	Scale:
18.07.18	1:750 @ A4
Job No:	Dwg No:
R1742b	R1742b-R16-D01

presence of roads and services and contamination indicators, as described earlier, were apparent on the eastern sides of these wall faces implying that impacted materials may extend beyond the treated area. The extents of the excavation (which had a total area of approximately 1,200m²) are shown on Drawing D01.

- 3.2.7 It was considered that the existing acceptability criteria for hydrocarbons set out in the approved Remediation Strategy remained applicable and that no significant modification to the Strategy was required. Subsequent to the removal of the grossly contaminated soils, SGP collected validation samples from the sidewalls and the base of the excavation to assess the potential for any residual hydrocarbon contamination that could present a risk to either current or future receptors. The locations from where validation samples were collected are indicated on Drawing D01.

4.4.2 SGP collected validation samples from the extents of the excavation sidewalls in order to confirm that residual contamination was not present at unacceptable concentrations. Samples were also collected from the base of the excavation from weathered bedrock in order to assess whether the bedrock had been significantly impacted by the observed hydrocarbon contamination. Samples were collected at an approximate frequency of 1 sample per 15m² of exposed sidewall in accordance with the strategy, with a reduced frequency of 1 sample per 67m² collected from the base of the excavation. Validation sample locations are indicated on Drawing D01.

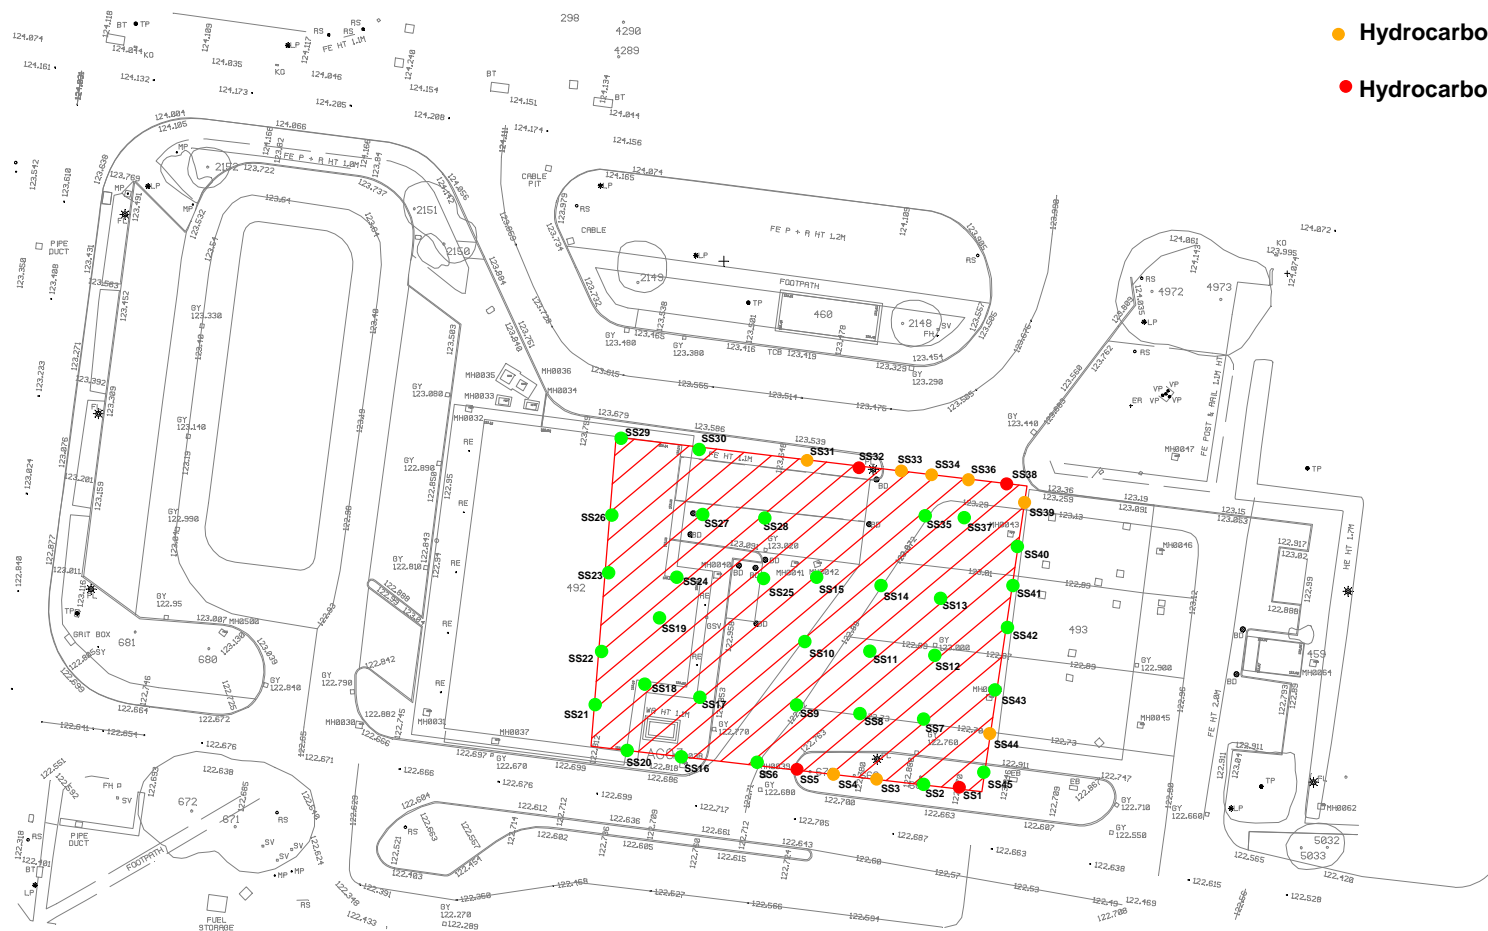
Project:	
Heyford Park, Upper Heyford	
Drawing:	
Dorchester Phase 5: Contamination Hotspot Hydrocarbon Concentrations of Samples Relative to RTVs	
Drawn:	Checked:
SM	BJT
Date:	Scale:
27.07.18	1:750 @ A4
Job No:	Dwg No:
R1742b	R1742b-R16-D02

- 4.4.4 Hydrocarbon concentrations were below the assessment criteria within the majority of the validation samples collected with the exceptions of samples SS1, SS3, SS4, SS5, SS6, SS31, SS32, SS34, SS35, SS36, SS38, SS39 and SS44 with respect to the Aliphatic hydrocarbon range C21-35 and/or the Aromatic hydrocarbon ranges C10-12 and C21-35. The majority of the exceedances were detected within samples collected from the eastern ends of the northern and southern sidewalls where contamination was observed but was unable to be excavated due to the presence of roads and services constraining the excavation. The only exceptions to this were relatively minor exceedances detected in samples SS39 and SS44 of the Aliphatic carbon range C21-35 at concentrations of 1,540mg/kg and 2,123mg/kg, respectively. These samples were collected from the eastern sidewall where residual contamination was observed on natural weathered bedrock; they are not, however, considered to be indicative of the presence of unacceptable levels of contamination and in any case, it is not a requirement of the strategy to remove impacted bedrock.

- 4.4.7 Drawing D02 indicates the locations of the samples with the concentrations of hydrocarbons relative to the RTVs.

- 5.1.2. Validation samples collected from the base and western sidewall of the excavation confirmed residual concentrations below the assessment criteria, whereas 2 samples collected from the eastern sidewall demonstrated minor exceedances; these are not, considered to be indicative of the presence of unacceptable levels of contamination requiring removal, however more significant exceedances in the eastern parts of the northern and southern extent of the remediation excavation contained moderate exceedances indicating the contaminated extends beyond the treated area at these locations.

- 5.2.2. It is therefore recommended that further risk assessment is completed through the installation of monitoring wells to determine the risk associated with residual vapours, or alternatively a precautionary approach should be adopted through the installation of a ventilated void within the floor construction and installation of a gas membrane specific for hydrocarbon resistance within all new buildings in the area; this corresponds to future plots 294-300 according to the development layout plan provided by Dorchester Homes (Ref: 0521-PH5-102). This precautionary measure is outside the scope of the approved Remediation Strategy and so will require approval from the EHO before implementation.

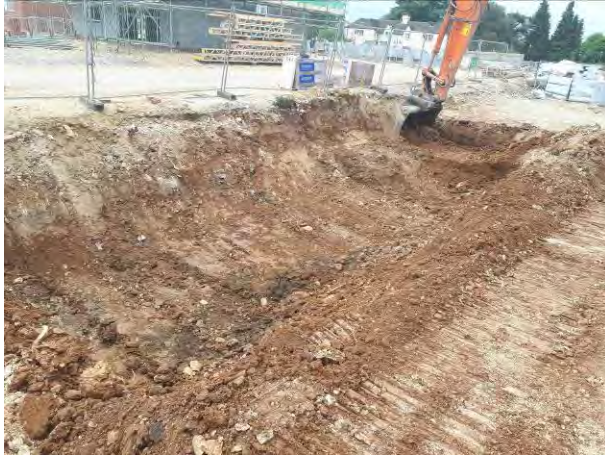
1.

12.06.18 – Initial strip of surface soils not demonstrating contamination indicators along southern extent of excavation.

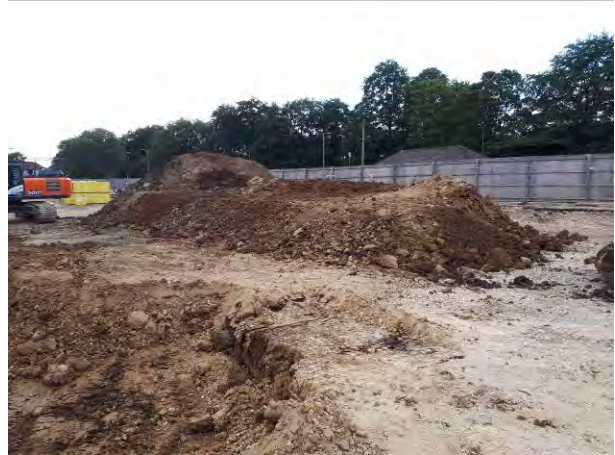
2.

12.06.18 – Stockpile of recovered soils retained for replacement after contamination removal.

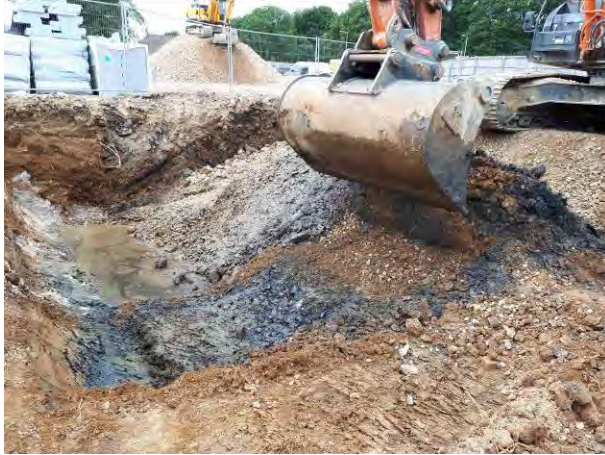
3.

12.06.18 – Excavation of hydrocarbon contaminated soils along southern extent down to weathered bedrock.

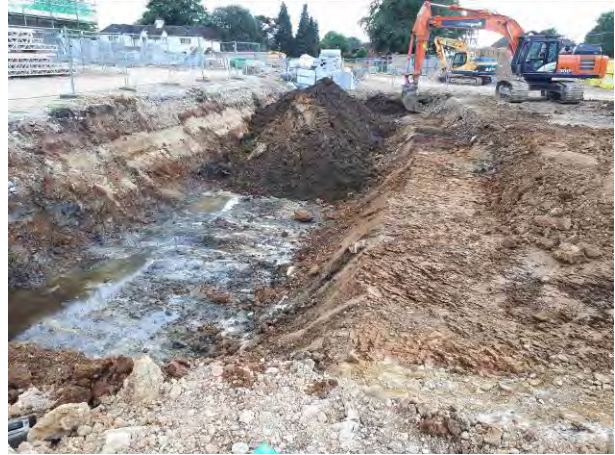
4.

12.06.18 – Hydrocarbon contaminated soils temporarily stockpiled within excavation pending removal offsite; residual staining present on lower reaches of southern sidewall.

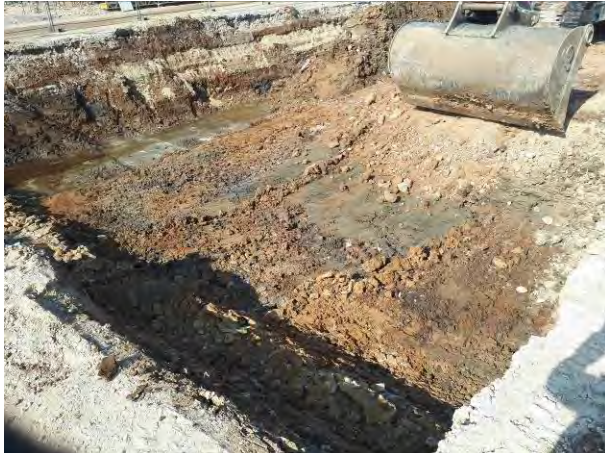
5.

13.06.18 – Continuation of soil strip of materials not demonstrating contamination indicators.

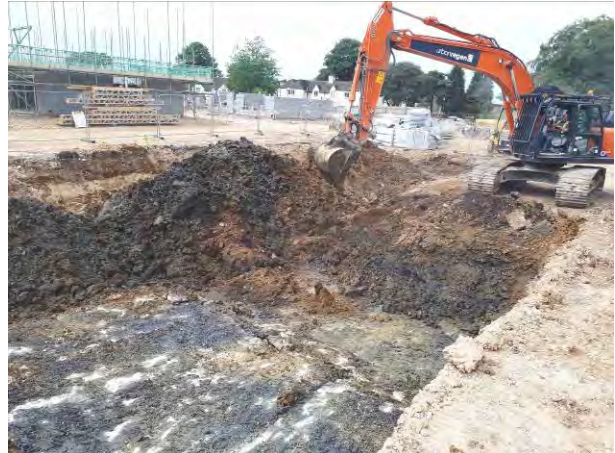
6.

13.06.18 – Continued excavation of hydrocarbon contaminated soils down to weathered bedrock.

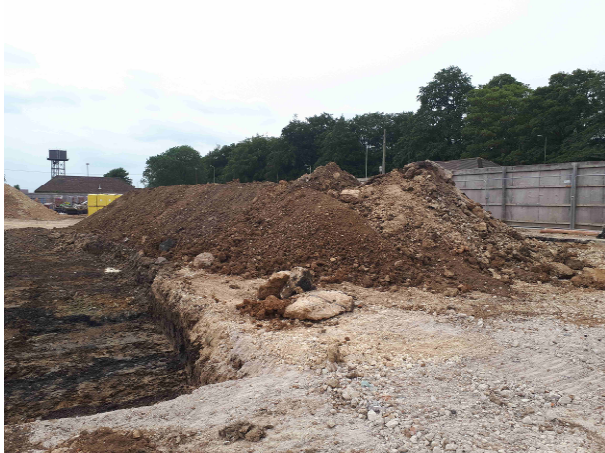
7.

13.06.18 – Material added to stockpile of soils retained for replacement.

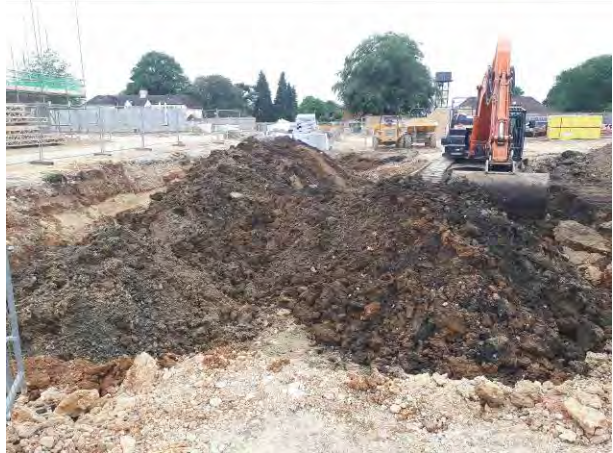
8.

13.06.18 – Temporary stockpiling of hydrocarbon impacted materials within excavation.

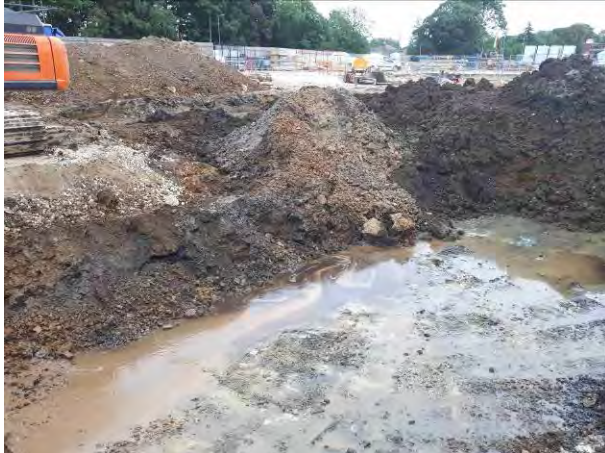
9.

- 3.2.6 During removal of the contaminated materials a significant inflow of water entered the excavation from the west. Black product and an iridescent sheen was observed on the pooled water, likely due to having flowed through hydrocarbon impacted soils. Following the excavation of all feasibly removable contaminated soils (i.e. not constrained by the presence of roads / services to the north and south), the water was pumped into the recently emptied USTs directly to the east of the hotspot.

14.06.18 – Inflow of water into excavation from western wall; black product observed floating on surface.

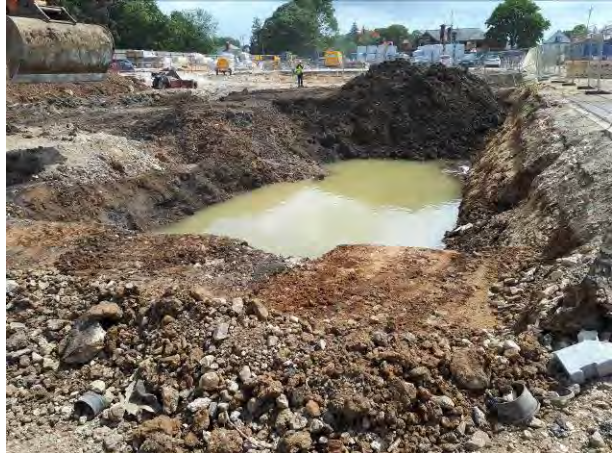
10.

14.06.18 – Pooled water within excavation following inflow from western wall.

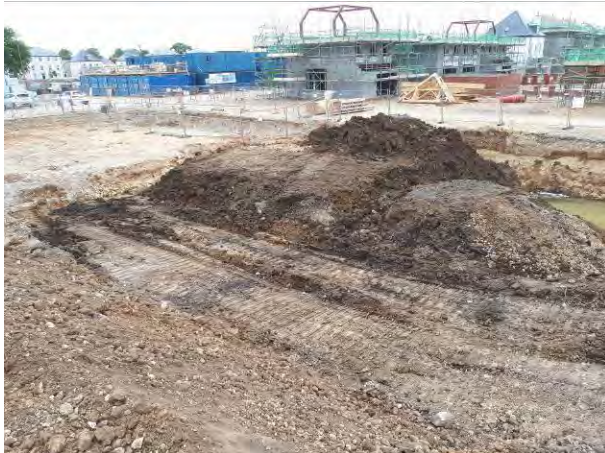
11.

14.06.18 – Temporary stockpiling of hydrocarbon impacted materials within excavation.

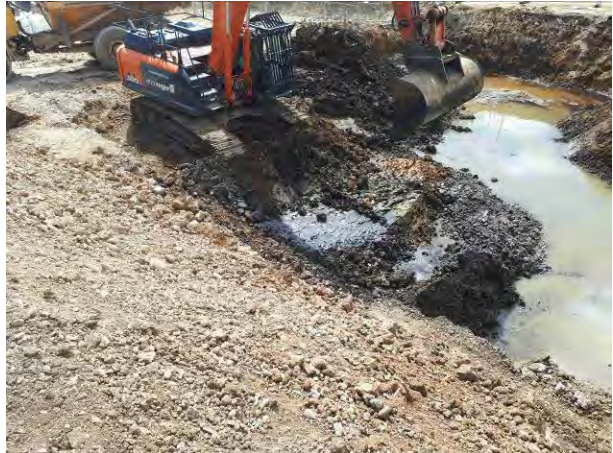
12.

20.06.18 - Continued excavation of hydrocarbon contaminated soils down to weathered bedrock.

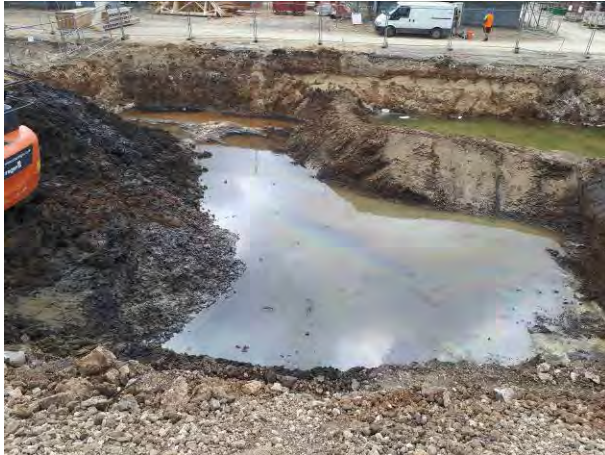
13.

20.06.18 – Iridescent sheen observed on pooled water within excavation.

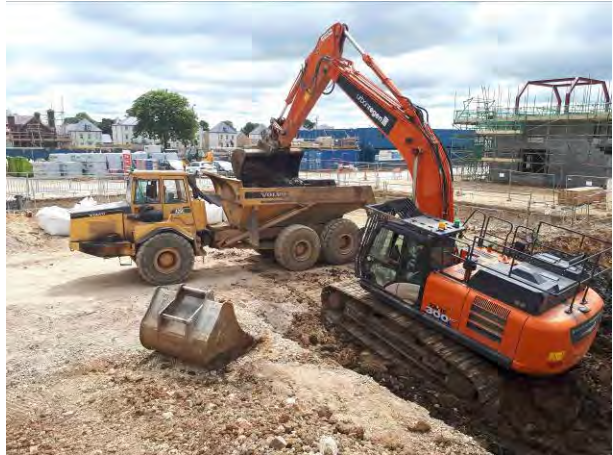
14.

20.06.18 – Removal of hydrocarbon impacted soils to quarantine area within wider NSA area.

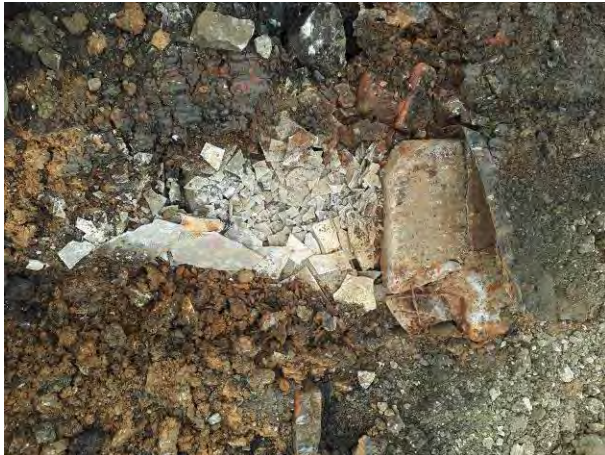
15.

- 3.2.4 Situated amongst the hydrocarbon impacted soils a number of small caches of broken asbestos cement sheeting was encountered temporarily causing the excavation to cease. The area was dampened down using water which had collected within the excavation and suitably qualified URL staff proceeded to handpick the visible asbestos containing materials (ACM) wearing protective masks and latex lined gloves. The ACM was double-bagged in appropriate bags which were then zip-tied. A total of five bags were filled with ACM which were removed from site for disposal. The excavation of hydrocarbon contaminated soils then re-commenced.

20.06.18 – Cache of broken fragments of ACM cement sheeting discovered within contamination hotspot.

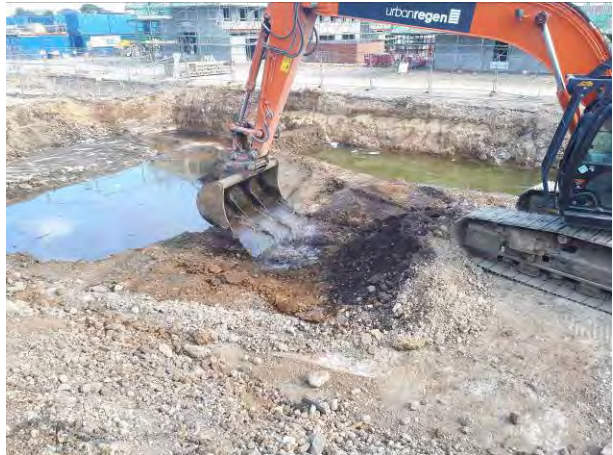
16.

20.06.18 – Pooled water used to dampen down discovered ACM cement sheeting to reduce potential for fibre dispersal.

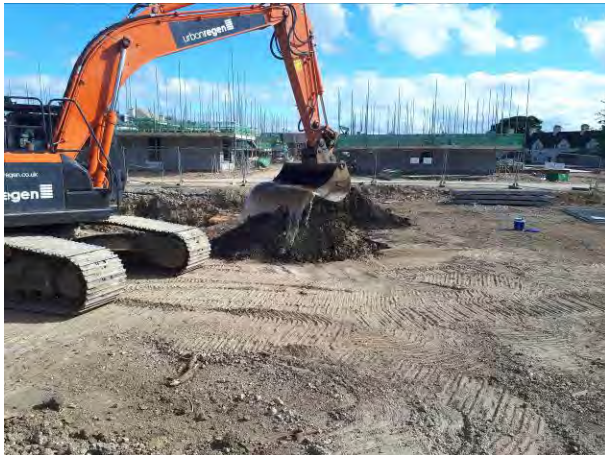
17.

20.06.18 – Soils excavated from area above ACM sheeting dampened down using pooled water.

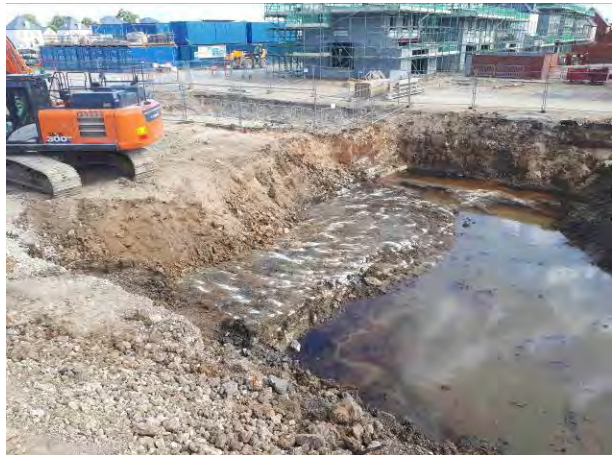
18.

- 3.2.3 The eastern extent of the excavation comprised natural weathered bedrock demonstrating some residual staining, for which there is no requirement for removal, and the excavation ceased on the western extent due to the consistent absence of any significant contamination indicators. The northern and southern extents of the excavation were constrained by the

20.06.18 – View of eastern extent of excavation following removal of hydrocarbon contaminated soils.
