Bicester Heritage Dilapidation survey 07.08.19

Buckingham Group
Authored by: A. Hurt

Bicester Heritage Dilapidation Survey

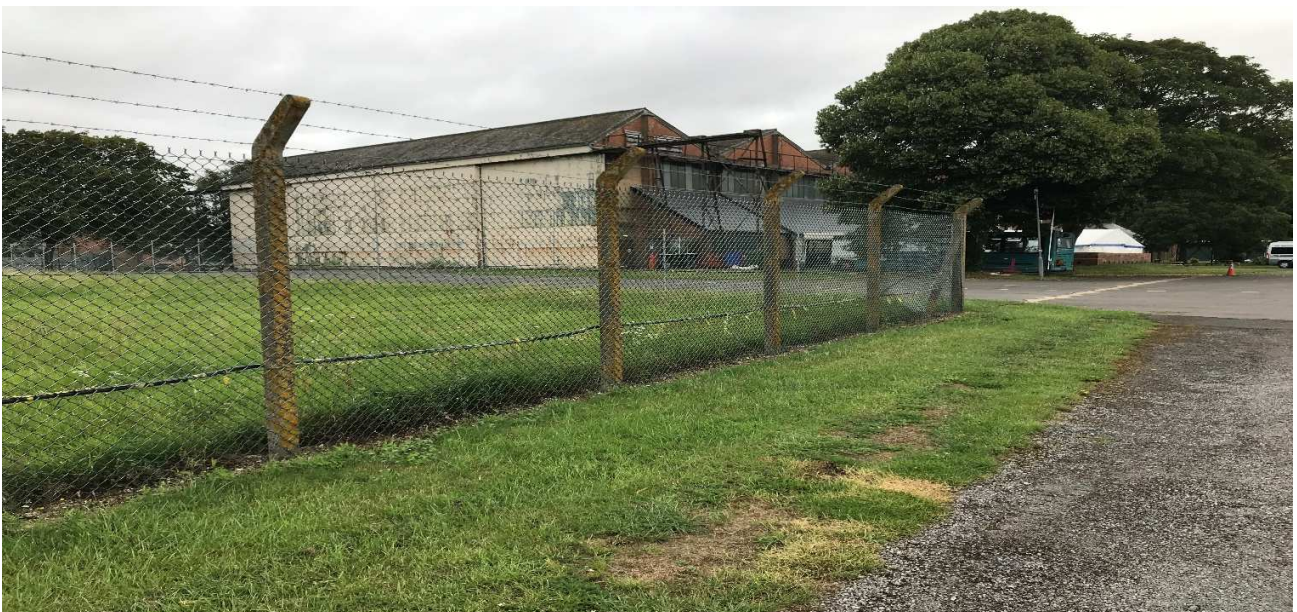
Photo 01

This photo was taken from the north east corner of the site. This is where we will be access site by removing the fencing and installing a temporary gate and turn style.

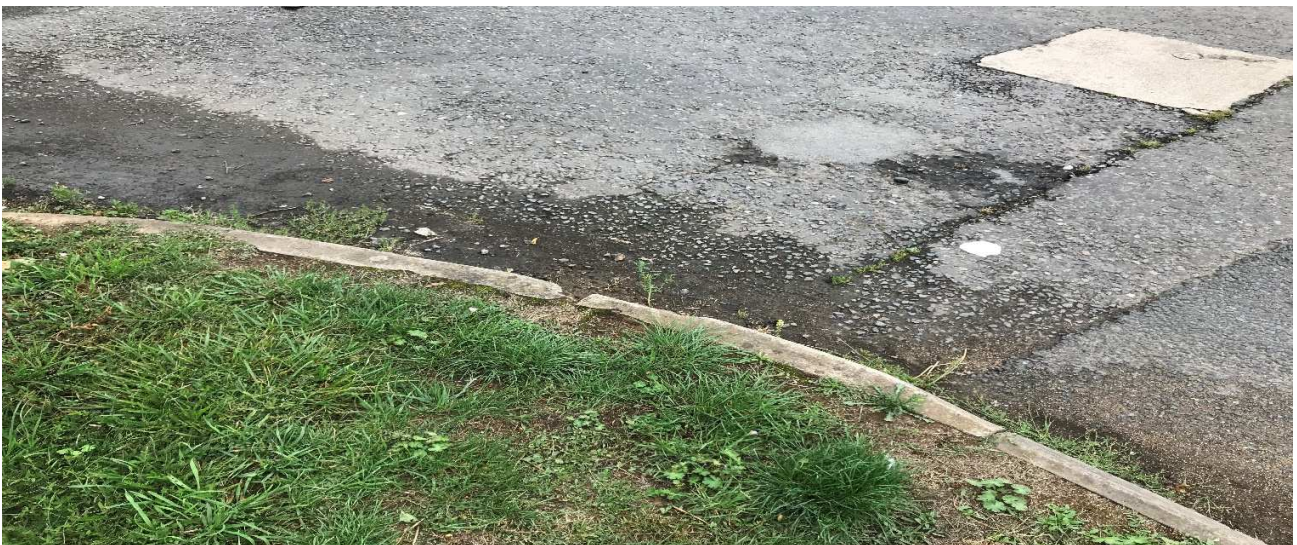
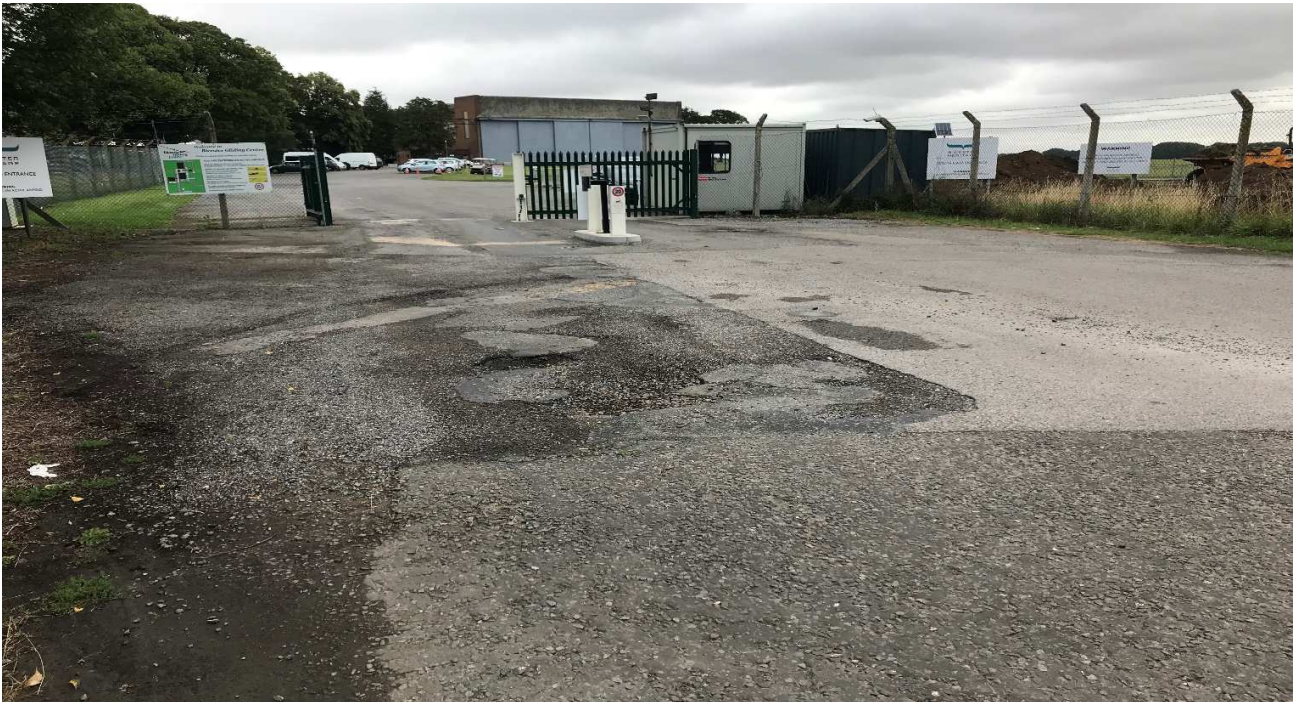
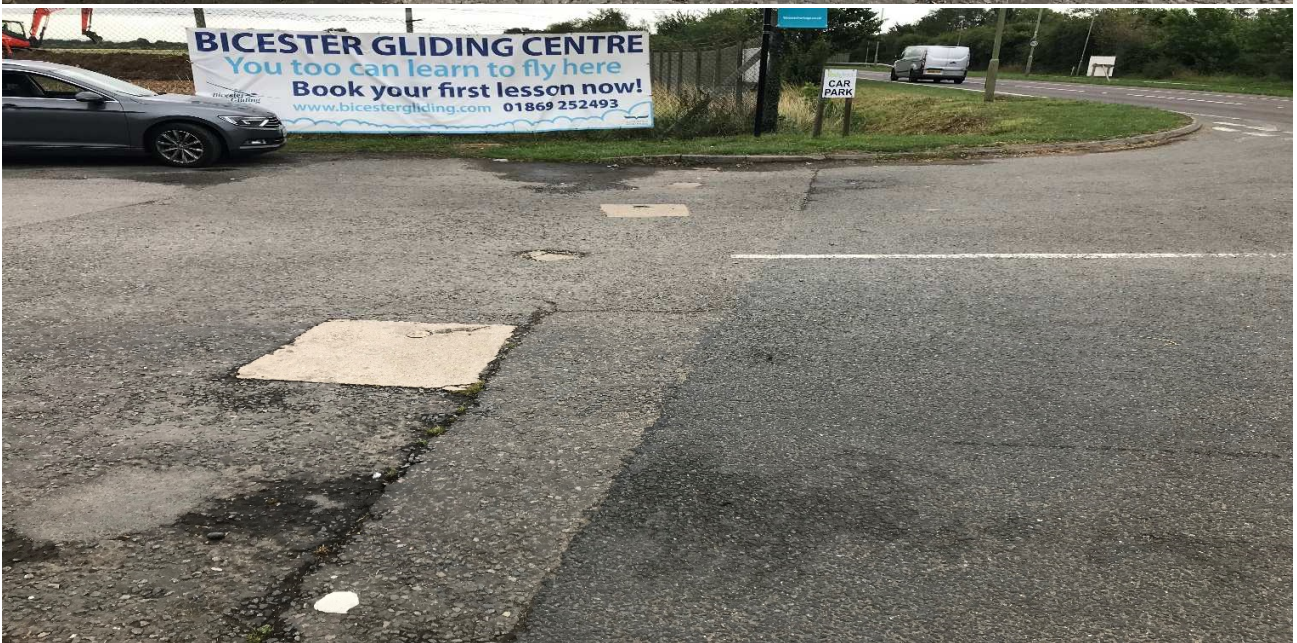
Video 02 – Photo 02, 03 & 05

This video shows the east elevation of the site and the entrance to the gliding club. This will also form BGCL site staff, contractor and visitor entrance. As you turn into the site off Skimmingdish Lane there are numerous potholes, low areas of tarmac and cracks. The tarmac on the road is also breaking up in places. The kerbs in some instances are also damaged.

This follows the same pattern around to our site compound entrance and further afield to where we are having to run the wagons to form the new bunds.

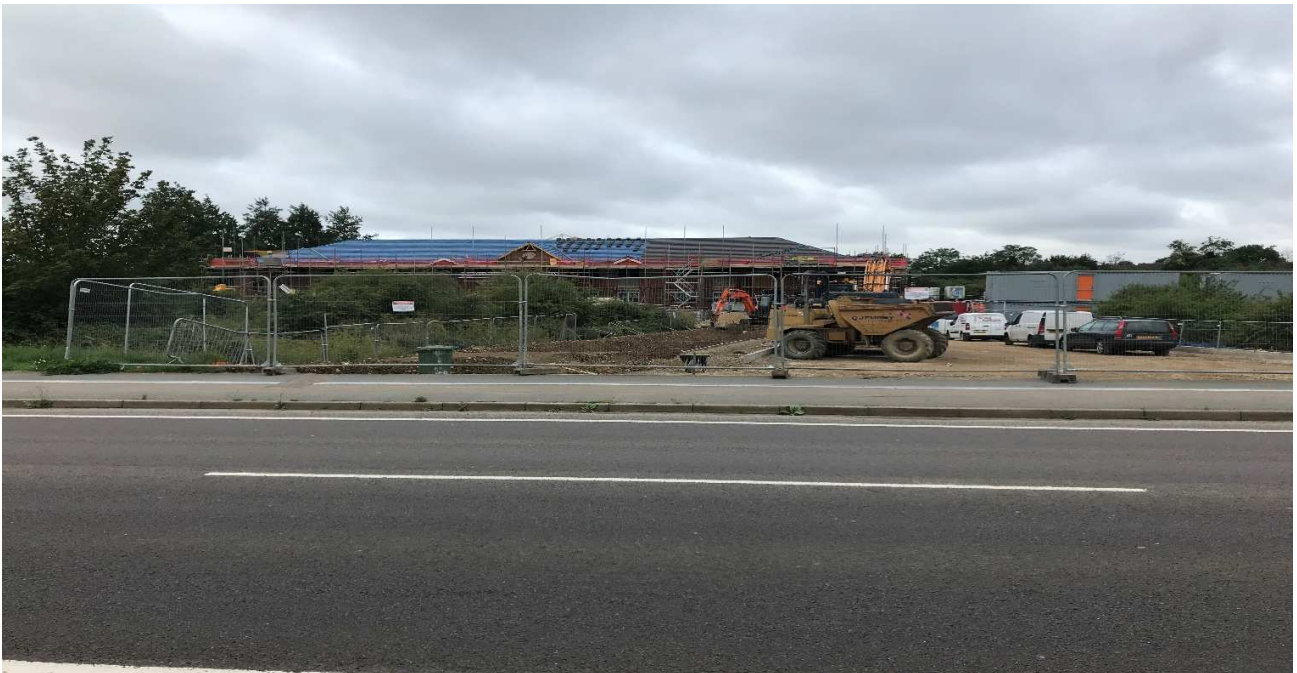
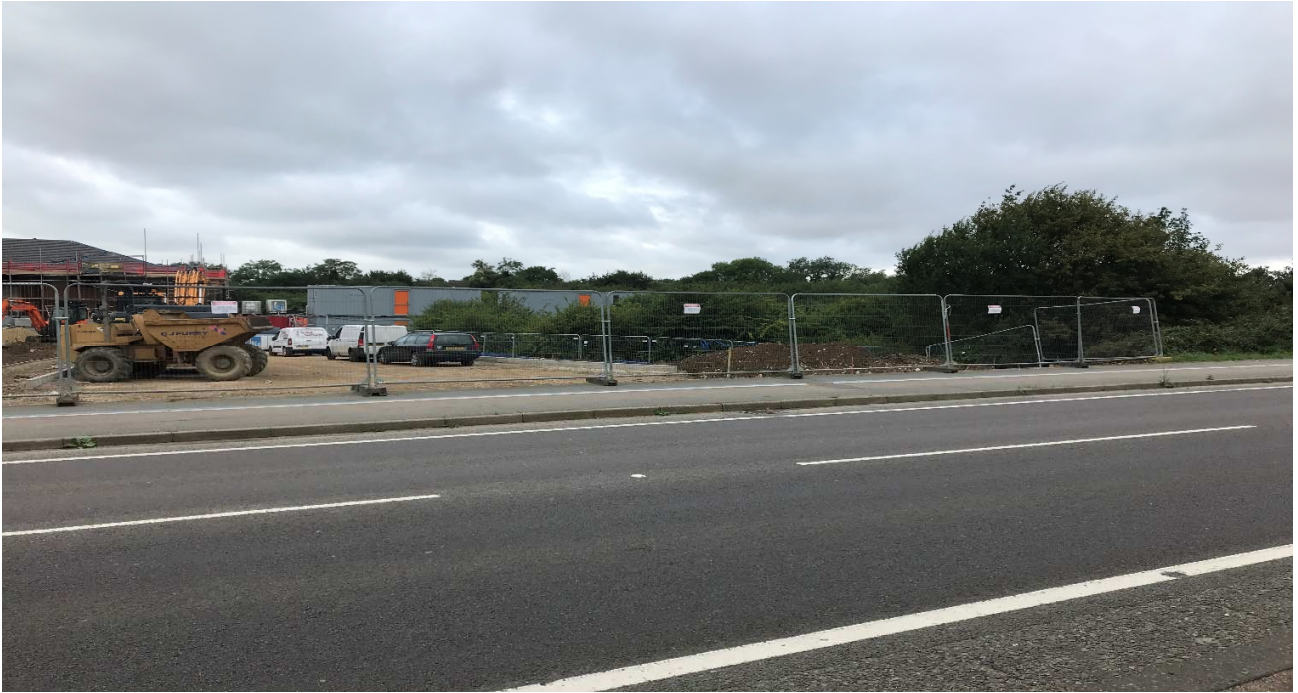
Photo 05 & 06

These photos show the construction works across the street and their readiness to construct a new bellmouth. The road and adjacent footpath are in reasonable condition at present.

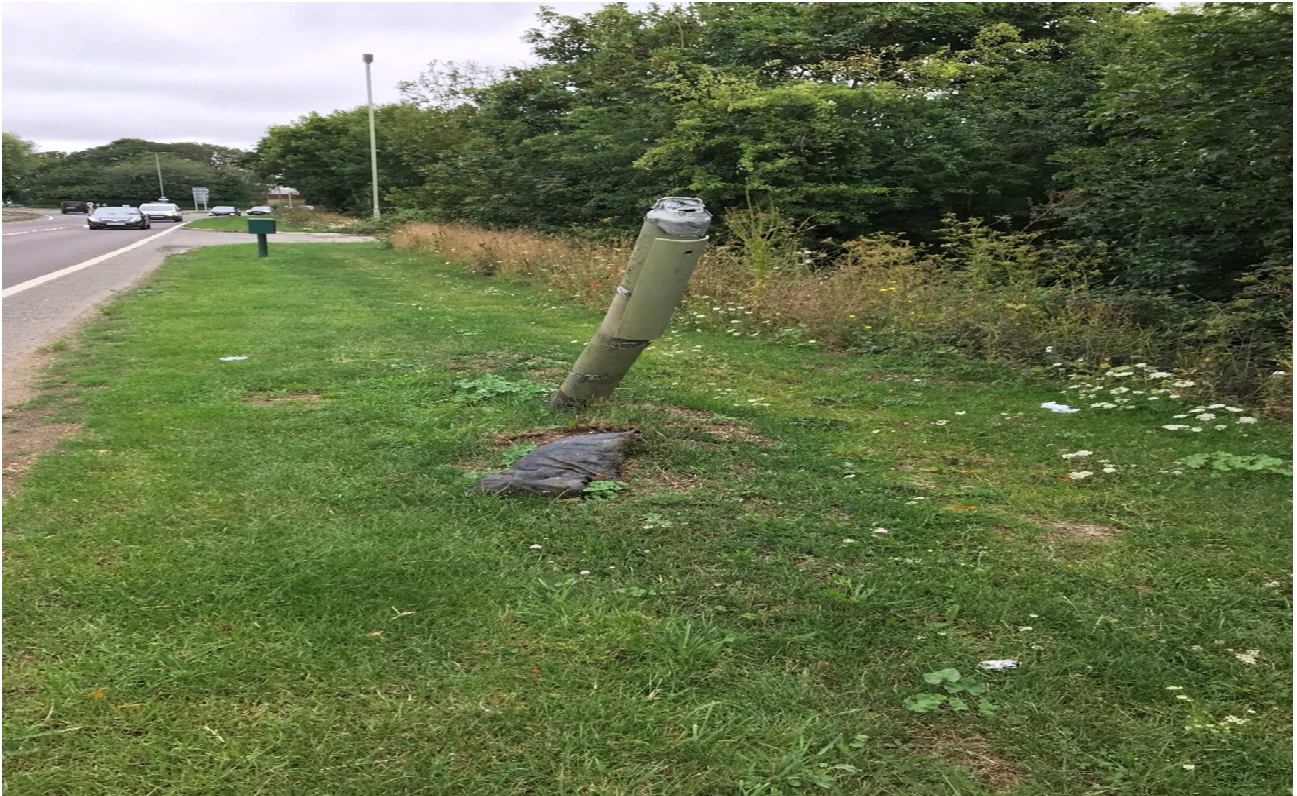
Photo 07

Video 05 is taken from the south elevation of the site and heading west to the existing bell mouth. It shows the existing verge and road. There is minor cracking to the tarmac road but generally it is in good condition. It also shows a lighting column that has been hit and the top two thirds removed.

This photo shows the damage to lighting column.

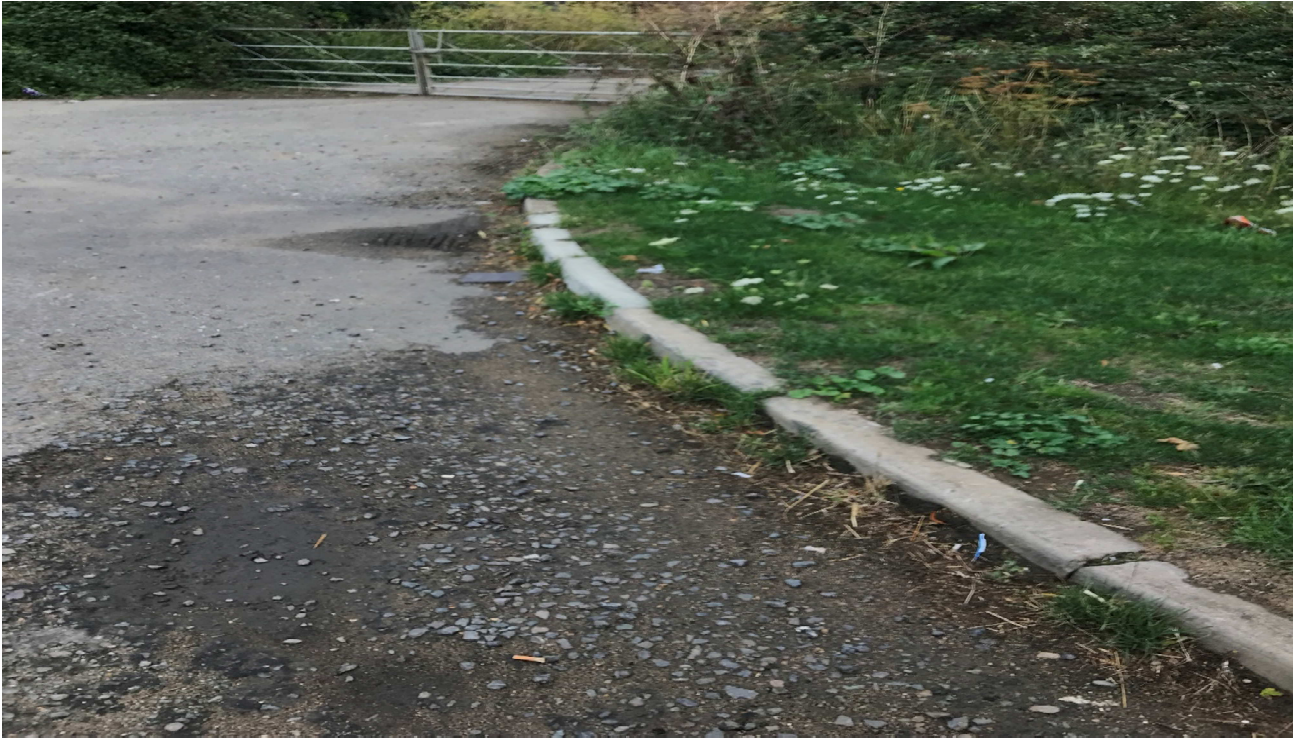
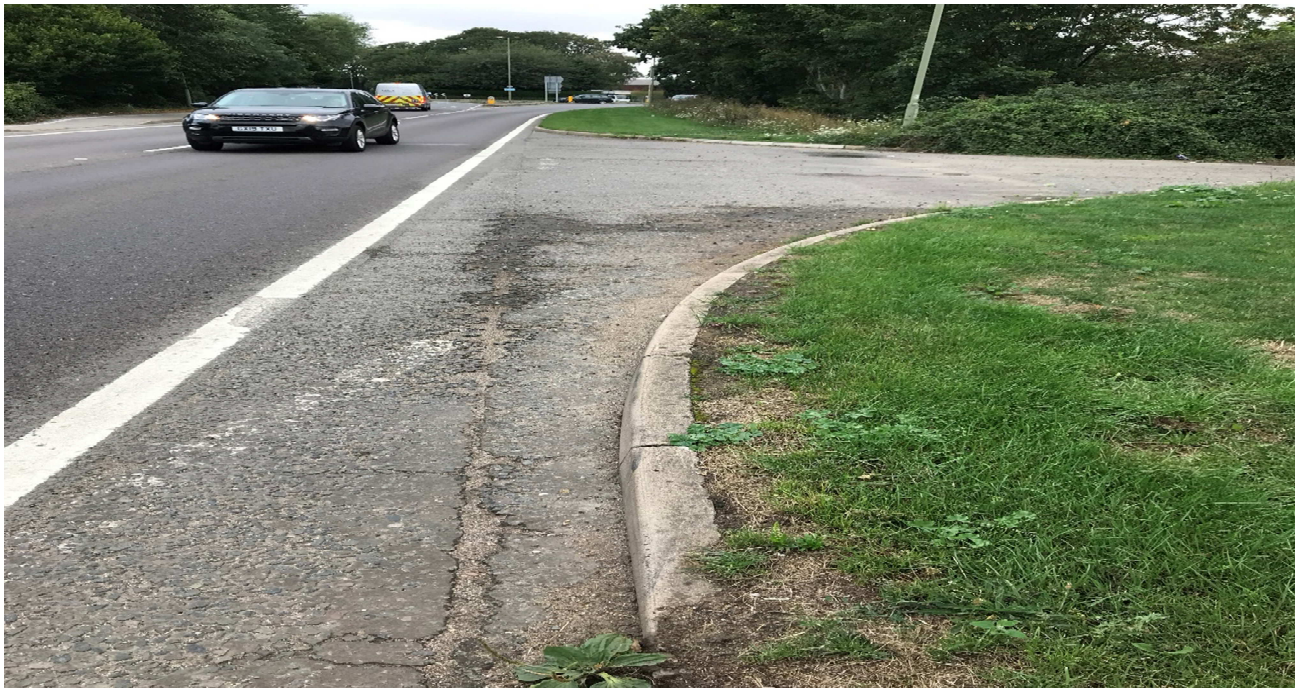
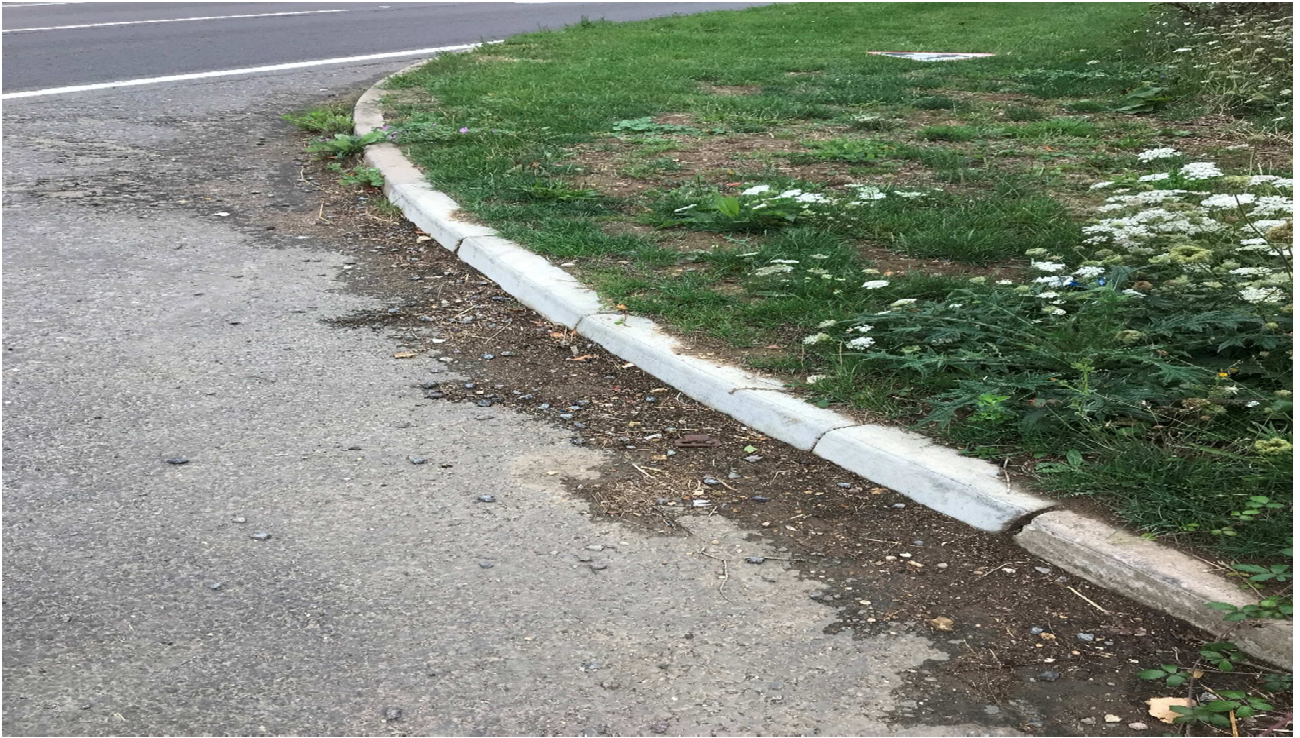
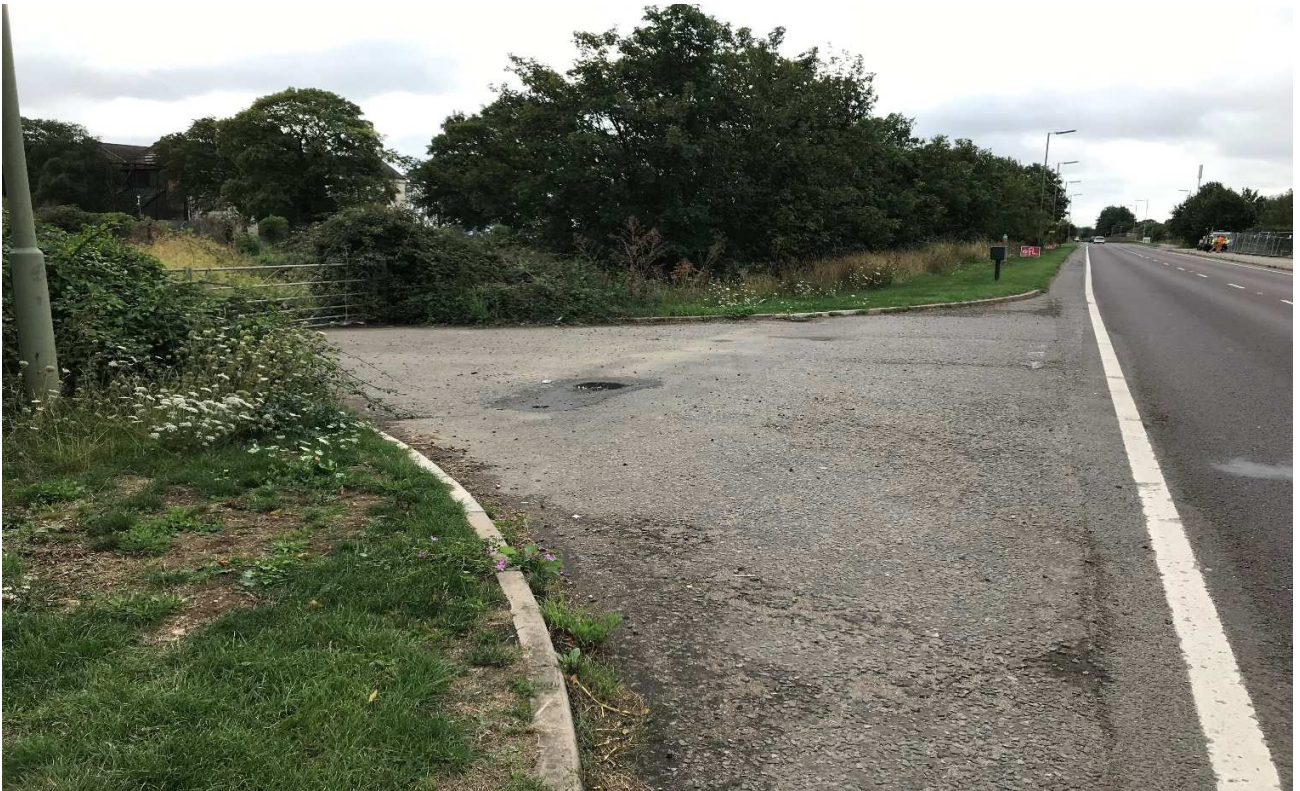
Photo 08,09,010 & 011

These collections of photos show the existing bell mouth on Skimmingdish Lane. The tarmac to the bellmouth is breaking up and cracking. Currently BGCL have made no allowance to repair this area. The kerbs to this area are also badly damaged in places and pot holes within the tarmac road have occurred. The vegetation into the site is also overgrown.

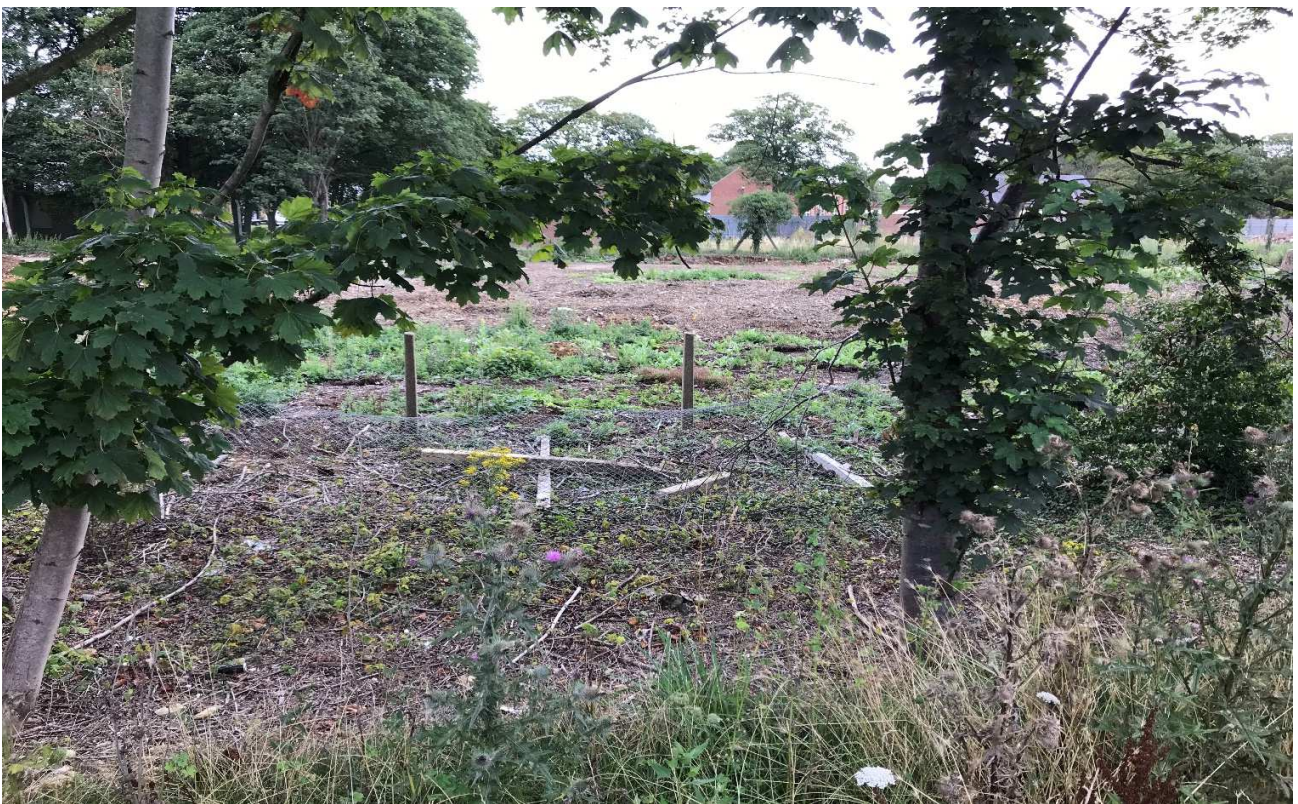
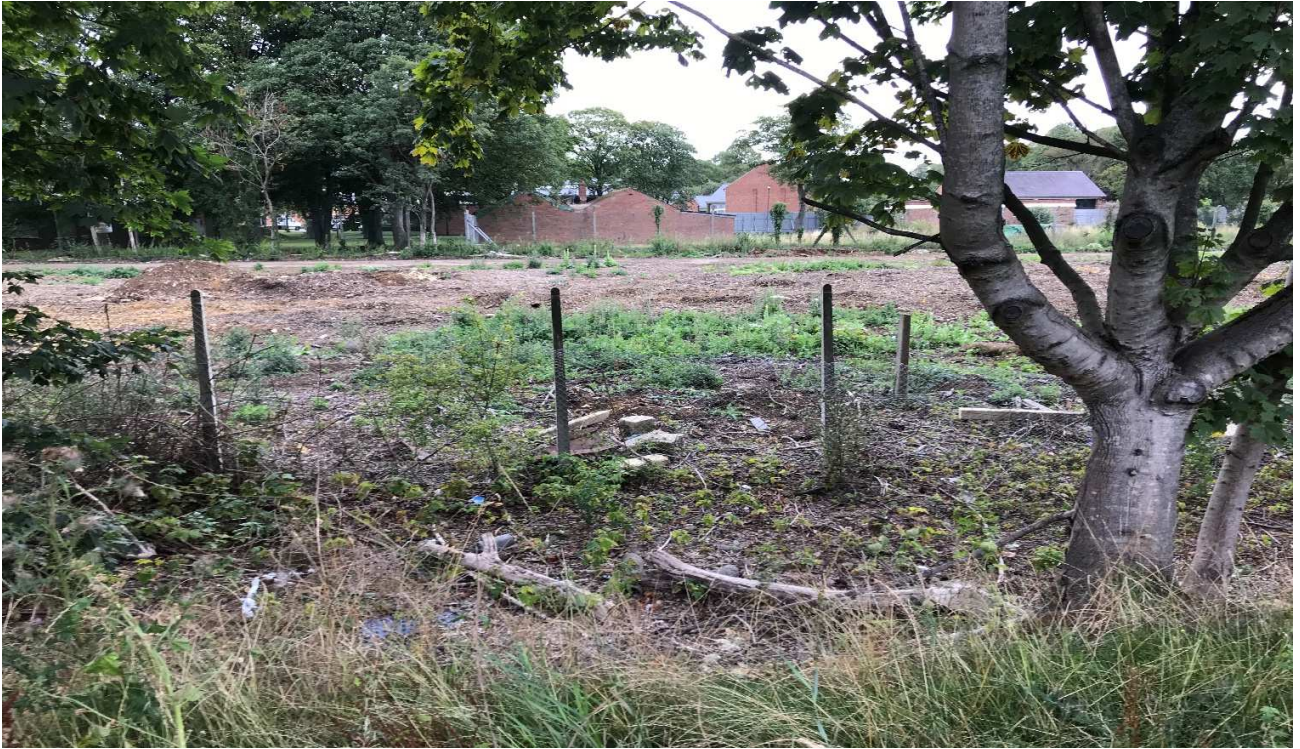
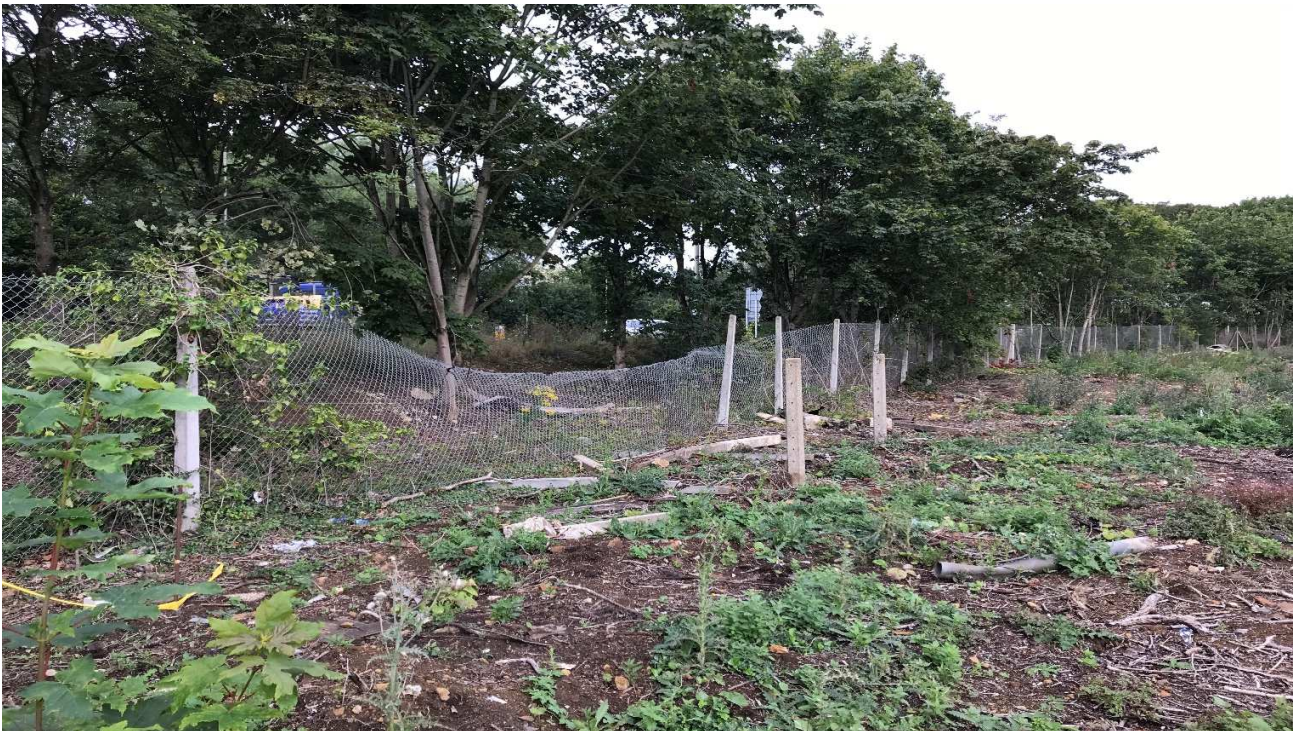
Photos 012, 013 & 014

These photos consist of the site fencing that is damaged and requires repairs. This is on the south elevation. The photos are from both the external and internal sides of the site.

Apart from the existing bellmouths of both the new site entrance and the entrance to the Gliding Club the general appearance of the road is ok. Highways England will need to confirm acceptance of the survey and report back any if their findings. The fencing will be repaired where applicable. Please advise if we are required to repair where appropriate.
