## **Graven Hill, Bicester**

### **Barrus Development D1 & D4 - Tree Survey Report, Arboricultural Impact Assessment & Method Statement**

February 2019

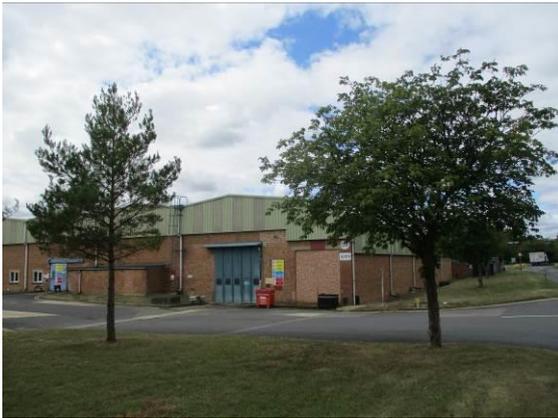
**Photograph 1:** The Site (looking south)

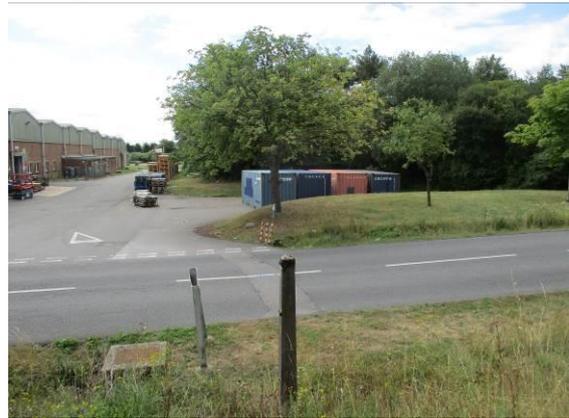
**Photograph 2:** Adjacent woodland

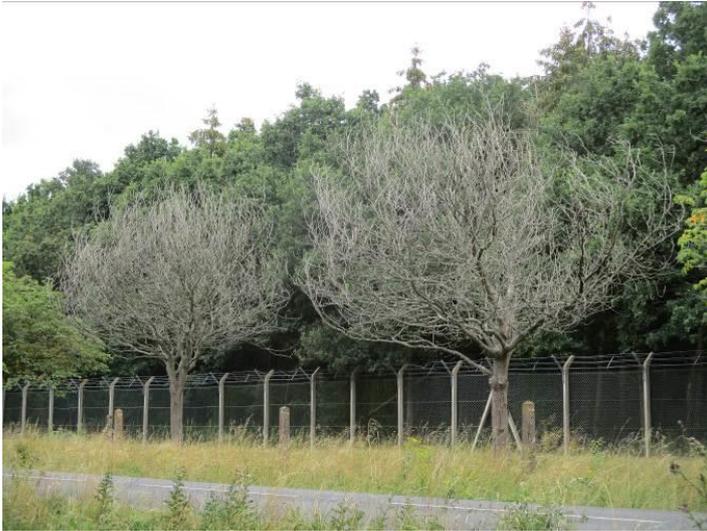
**Photograph 3:** Trees killed by Bleeding Canker of Horse Chestnut pathogen

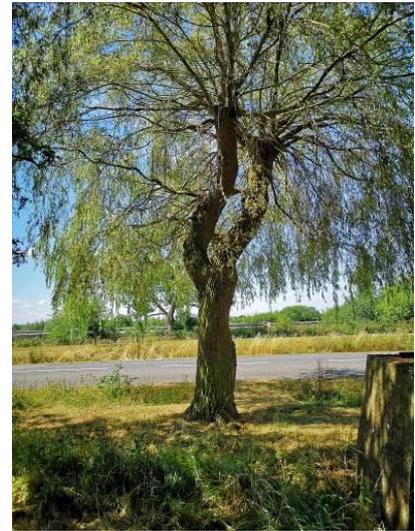
- 2.4. A large proportion of the trees recorded within the Site are native to the UK (although not necessarily indigenous to this location). Notable exceptions included the Red Horse Chestnut (*Aesculus x carnea*) avenue along Anniversary Avenue to the north of the Site. This tree species is progressively succumbing to Bleeding Canker of Horse Chestnut (BCHC) (*Pseudomonas syringae* pv *aesculi*) (**Photograph 3**) which has caused the decline and ultimate death of many trees. Several of such failed trees have been removed which has resulted in a locally gappy avenue. Distinctive Weeping Willow (*Salix x sepulcralis* 'Chrysocoma') was frequently recorded as individuals within areas of mown grass. Many trees had lost limbs and contained variable states decay, which is not uncommon for this fast-growing species (**Photograph 4**).

**Photograph 4:** Typical Weeping Willow

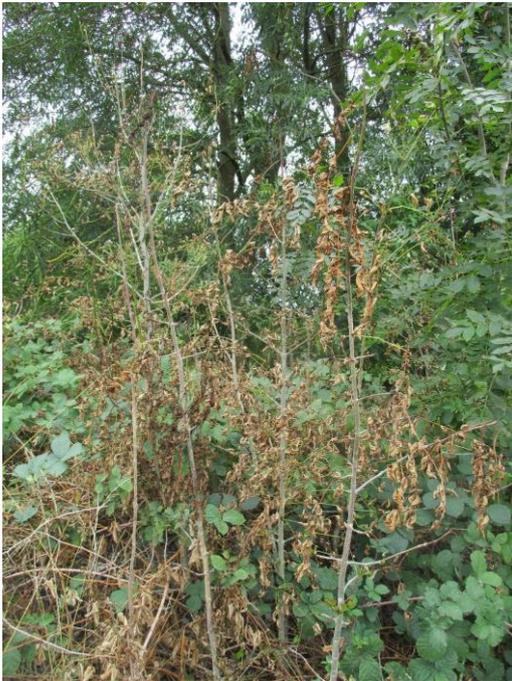
- 2.6. Several pest and pathogen species were recorded on Site. Symptoms consistent with Dutch Elm Disease (*Ophiostoma novo-ulmi*), spread by the Elm Bark Beetle (*Scolytus spp.*) are present within Elm (*Ulmus*) areas of natural regeneration and some hedgerows. Symptoms of bleeding Canker of Horse Chestnut were frequently recorded within Red Horse Chestnut trees, as noted above (**Photograph 3**). Chalara Dieback of Ash (*Hymenoscyphus fraxineus*) (also known as Ash Dieback Disease, ADD) has been recorded within the region and is progressively spreading through the UK. Some visible dieback of Ash (*Fraxinus excelsior*) foliage was recorded during the fieldwork (**Photograph 5 & 6**), however, this did not appear to be accompanied by the stem lesions that are characteristic symptoms of Chalara Dieback of Ash<sup>9</sup>. This disease is expected to impact the Ash trees within and immediately adjacent to the Site in the short to medium term with younger and weaker trees typically more susceptible.

**Photograph 5:** Possible Dieback of Ash    **Photograph 6:** Possible Dieback of Ash
