## A Heritage Asset Survey of former farm buildings at Crockwell Farm, Great Bourton, Oxfordshire

Iain Soden BA MCIfA

May 2016

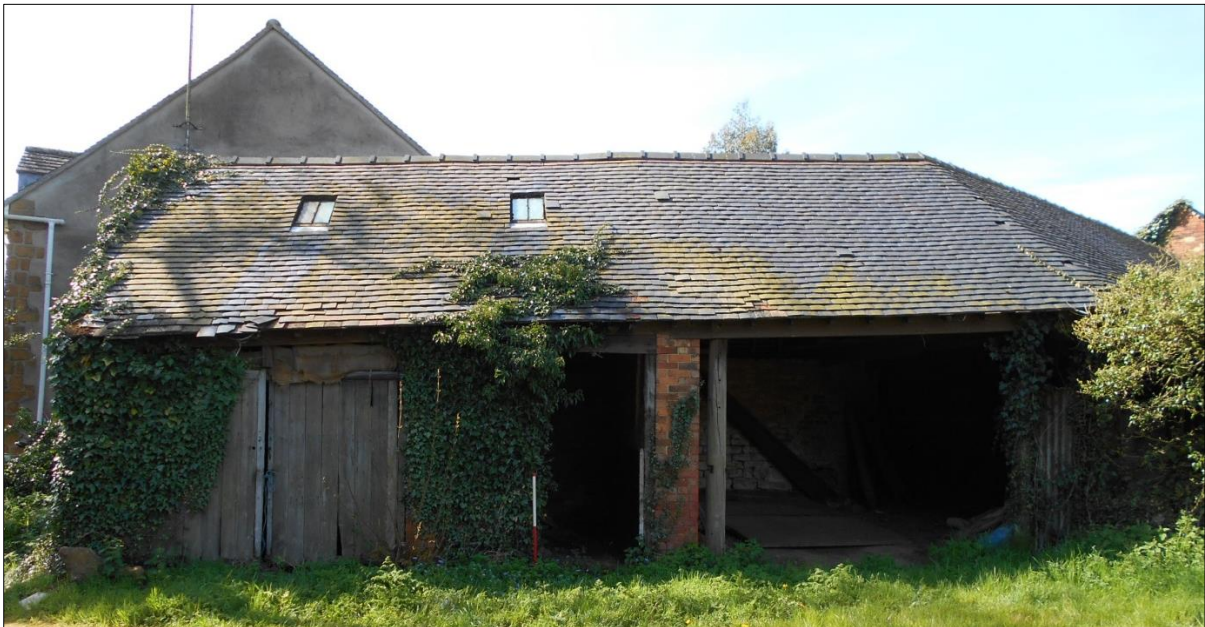
An open-fronted cart shed of three bays. It is constructed of ironstone rear, gable and dividing wall. The front edge of each north-facing wall is finished off in smooth-faced bull-nosed red brick of early 20<sup>th</sup>-century type. The floors are of brick or concrete. The roof is of machine-sawn pine and late 19<sup>th</sup>-century or early 20<sup>th</sup>-century assembly, and has a modern covering in blue engineering tiles stamped 'FINWOOD', with occasional modern skylights. Scars of a manger and hay-rack indicate that it enjoyed a previous use as an animal shelter.

Fig 3: Buildings 1 (left) and 2 (angled to right); scale 1m

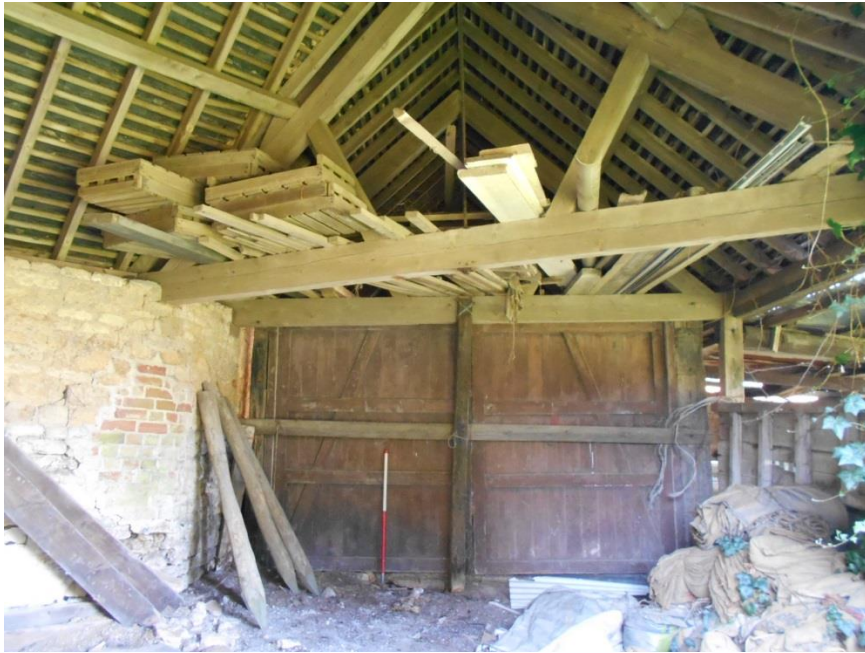
This is a building continuation north-west from Building 1 and is part of the same structure. However it appears never to have been used for anything but livestock, undivided for cart/vehicle storage, unlike Building 1. Original front wall-plate supported on oak uprights on chamfered sandstone/ironstone plinth-blocks to hinder rot.

Fig 5: Building 2 interior, looking west at the roof angle; scale 1m

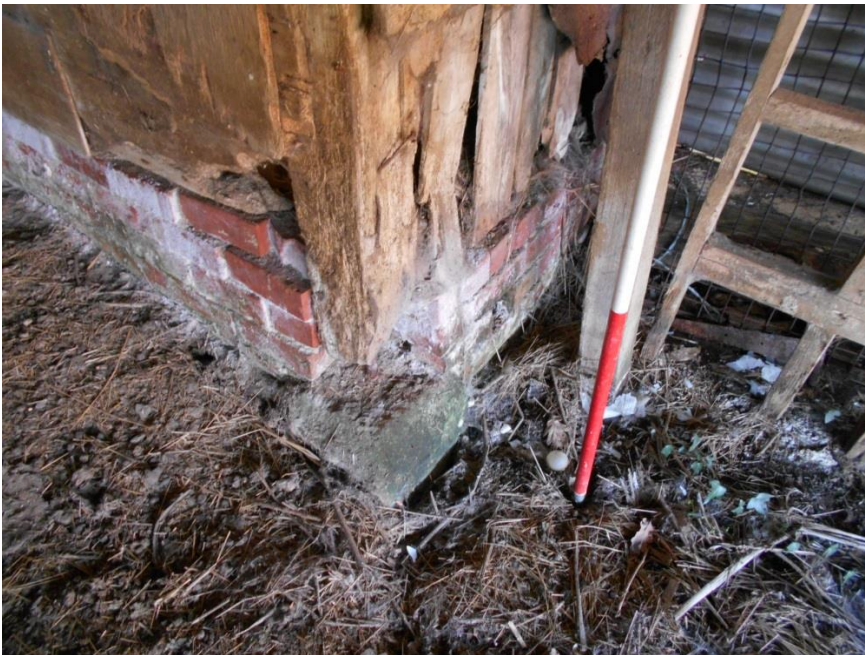
Fig 6: Original front chamfered plinth block on which rested the former open front of Building 2;  
scale 1m

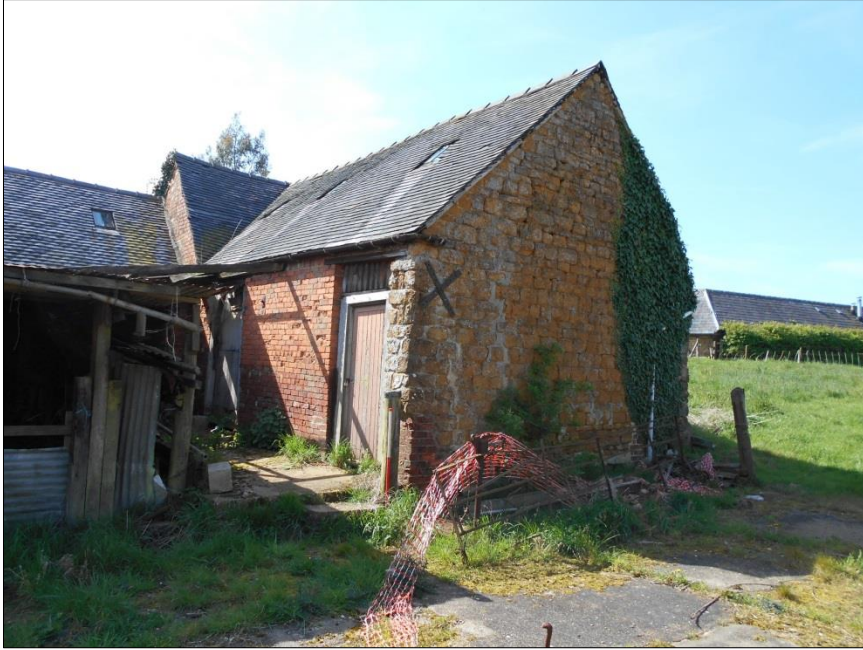
Formerly an open-fronted shed with rear and gable ends of Hornton ironstone ashlar, similar to the 17<sup>th</sup>-century farmhouse. One gable widened and heightened during its life. The east-facing front was filled-in with brick and the interior provided with pig-pens. A date scrawled into the wet concrete floor indicates this was in 1962. The roof is of machine-sawn pine in common with Buildings 1-2. The same blue engineering tiles cover it.

Fig 8: Building 4, looking south-west; scale 1m

Building 4 is constructed of Hornton (ironstone) ashlar, and for this reason may, at its core, be of a similar date to the Listed farmhouse. It is the only older farmyard building to have any historic merit, although its original use is now lost, having been converted to pig-pens in 1962.

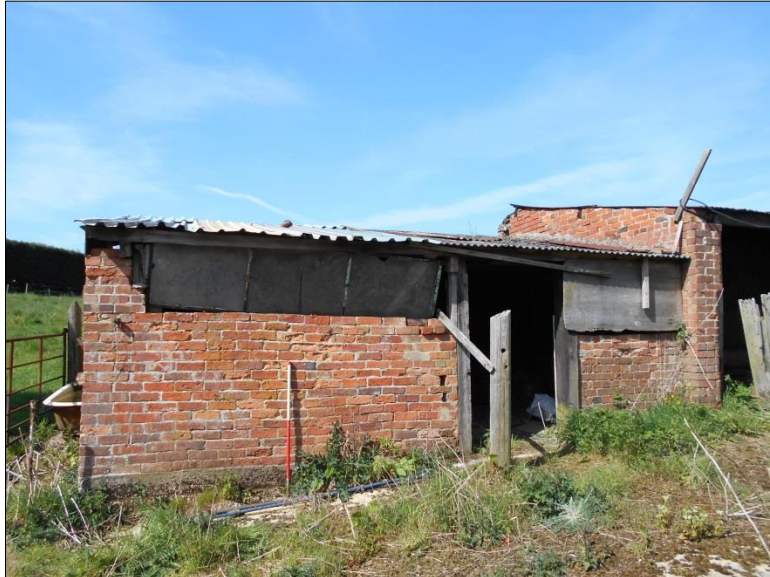
The southern half may have originally comprised simply a portion of a western perimeter wall to the farmyard, lined to the north half, but against which a building was constructed in two phases: firstly a narrow lean-to in ironstone, then an out-shut in brick, which by this time mirrored the plan of the northern half, doubling its area.

All of the timber work throughout this building was configured using re-used railway sleepers and corrugated tin sheeting of various shapes and sizes.

Fig 10: The southern half of Building 5, looking west; scale 1m; the footpath can be seen on top of the rise at far left

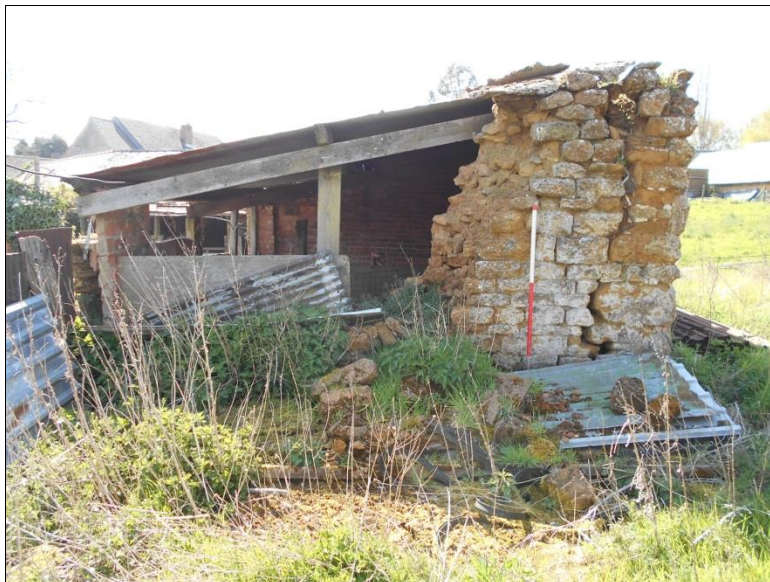
The northern half seems to have been a building of ironstone coursed rubble, clay-bonded. The north gable has collapsed and the rear wall has had to be strengthened with the addition of a red bull-nosed brick buttress.

Fig 11: The northern half of Building 5, looking south, collapsed gable; scale 1m

Buildings 6 and 11 are in ruins. Both date from before 1882 when they appear on the First edition Ordnance Survey map. Building 5 is approaching ruin.

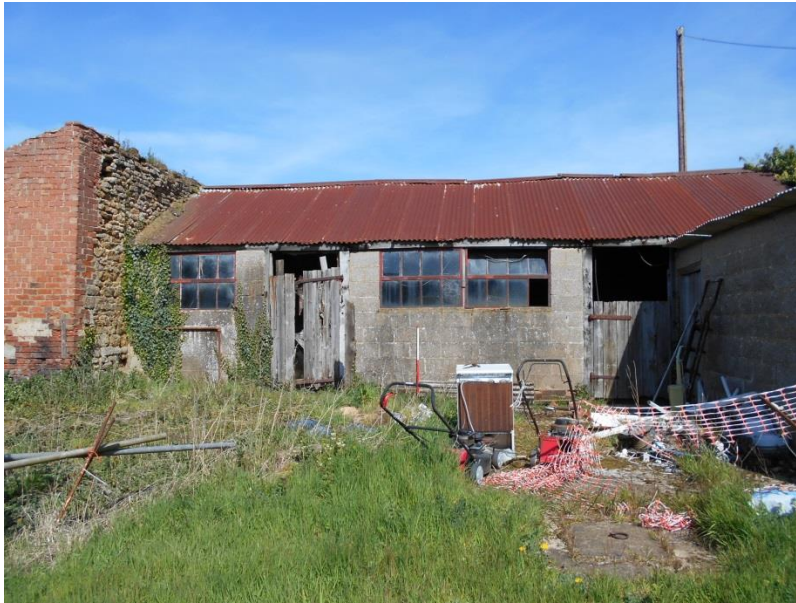
This building is of modern blockwork under a corrugated tin roof. Its west end is built off the east wall of the now ruinous Building 6. It has metal-framed windows and a concrete floor supports metal pig or calf-pens with a proprietary electric Alfa-Laval liquid feed system. Each pen contains a trough and the floor drains into a concrete drain. The back of the shed includes a narrow feeding passage divided off from the pens. The building is first encountered on the OS map of 1974, so is probably of late 1960s or early 1970s construction.

Fig 13: Building 7 of the 1970s, looking north; scale 1m. To the left is the ruinous Building 6 and to the right Building 8.

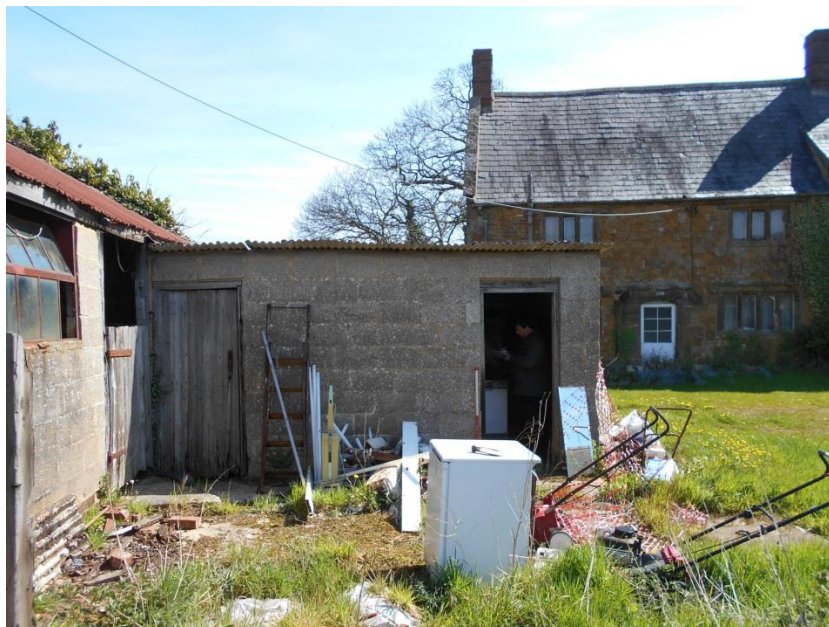
This building is a small structure containing two small rooms. One room contains the small generator and pump system for the liquid feed system in Building 7, to which it adjoins at the eastern end of its south wall. The building is of blockwork under a corrugated tin roof. It has a concrete floor. The building is first encountered on the 1:2500 OS map of 1974, so is probably of late 1960s or early 1970s construction.

Fig 14: Building 8, looking east, the farmhouse beyond; to the left is Building 7

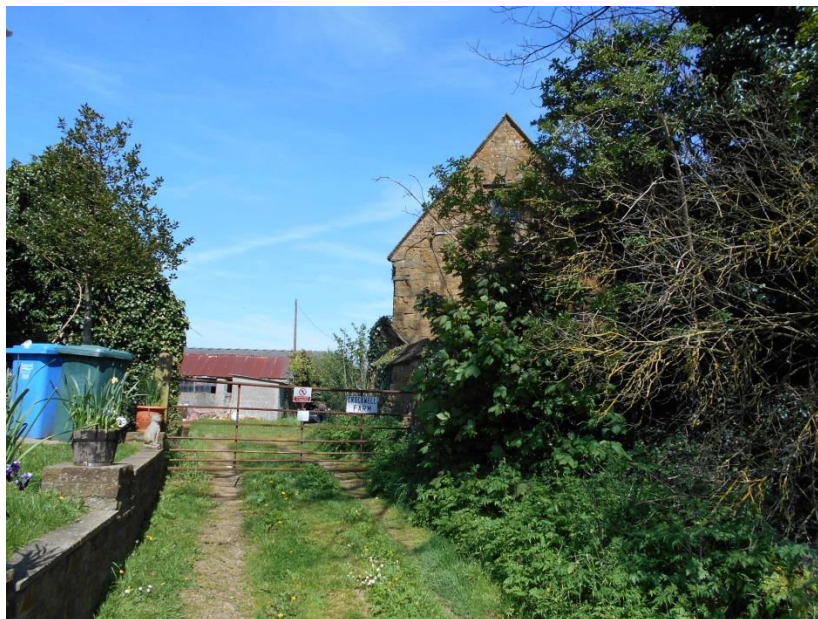
Fig 18: The public view of the listed farmhouse (right) and farmyard from Manor Road; a glimpse of Buildings 7 and 8 through the gate. The ivy-clad gable to the left is Building 1.

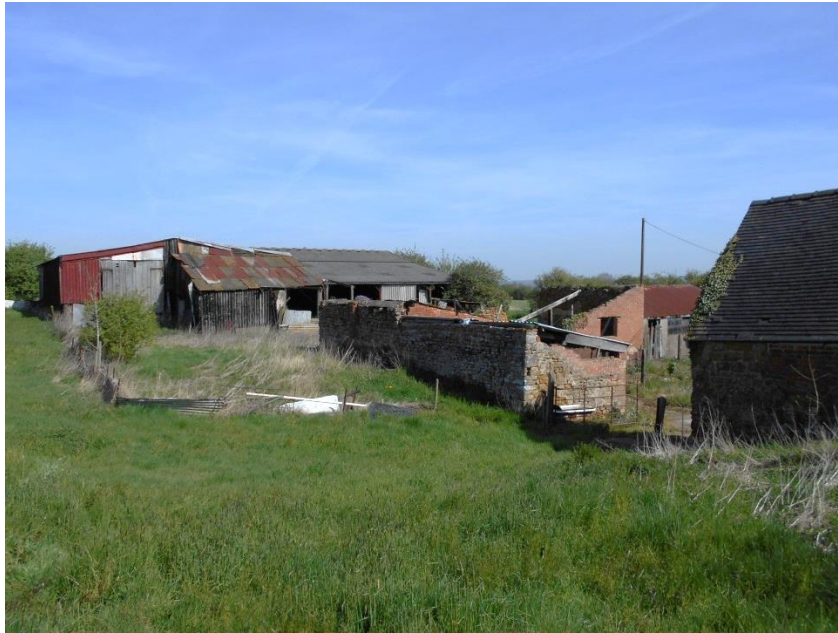
Fig 19: The public view of the farmyard from a footpath to the south-west; Building 5 is in the centre, Building 9 to the left; Building 4 to the right blocks views of the farmhouse.
