BS 5837:2012 Arboricultural Survey

Banbury 200, Southam Road, Banbury

Issued: January 2021

Delta-Simons Project No. 20-1787.01

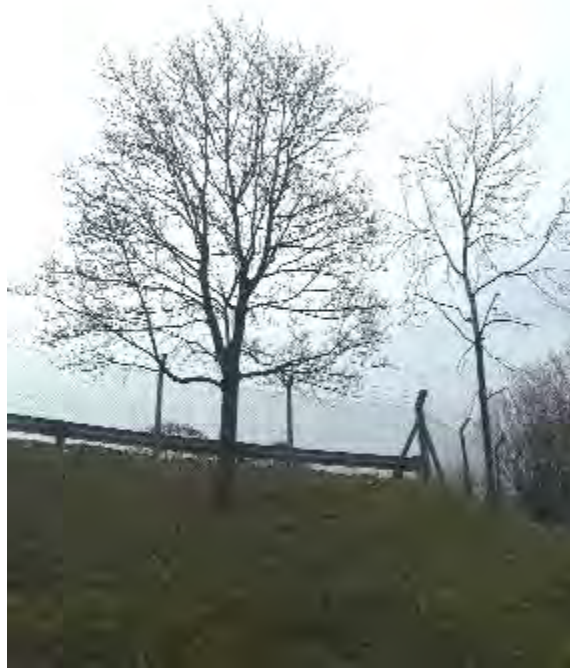
Photograph 5 – T5 (right) and T6 (left)

T5	Ash	<i>Fraxinus excelsior</i>	Y	8	S	150	4	3	2	1	2	No visual defects	Single stem, vertical	Sparse canopy	Tree tag 003296	P	20-40	C2	1.8	
T6	Norway maple	<i>Acer platanoides</i>	Y	8	S	275	3	4	4	4	4	Surface roots present on all aspects	Single stem, vertical	Rounded, balanced canopy	Tree tag 003297	F	20-40	B2	3.3	
T7	London plane	<i>Platanus x hispanica</i>	Y	8	M/S	175 x 2, 200, 250	3	5	5	5	5	Surface roots visible to north and east	Multi-stemmed at 1 m	Spreading canopy, balanced	Tree tag 003298	F	20-40	B2	4.8	
T8	Norway maple	<i>Acer platanoides</i>	Y	8	S	300	3	4	4	4	4	Surface roots present down the slope to north-east	Single stem, vertical	Rounded, balanced canopy	Tree tag 003299	F	20-40	B2	3.6	
T9	Norway maple	<i>Acer platanoides</i>	Y	8	S	350	2	4	4	4	4	Surface roots present to the east	Single stem, vertical	Rounded, balanced canopy	Tree tag 003300	F	20-40	B2	4.2	
T10	Ash	<i>Fraxinus excelsior</i>	Y	9	S	300	2	3	3	3	3	No visual defects	Single stem, vertical	Narrow canopy balanced	Tree tag 003301. Minor ivy cladding to stem base.	F	20-40	B2	3.6

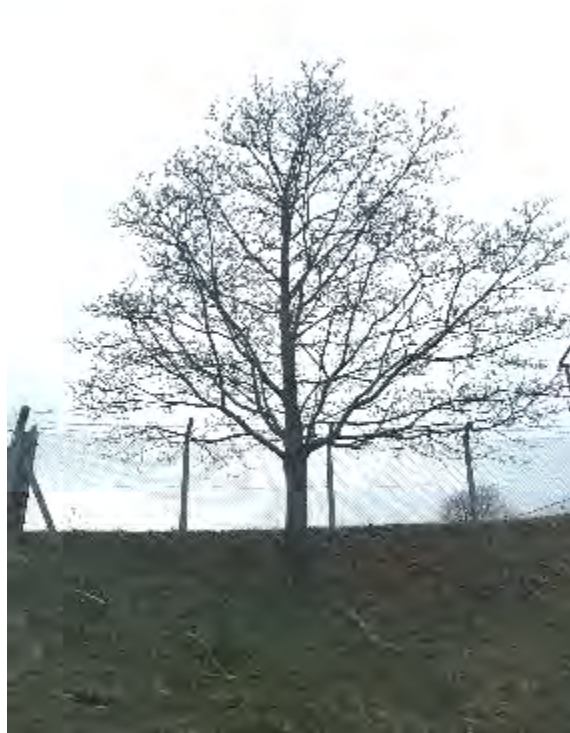
Photograph 10 – T11

T11	Norway maple	<i>Acer platanoides</i>	Y	10	S	325	2	4	4	4	4	Exposed surface roots down slope to north	Single stem, vertical	Rounded, balanced canopy	Tree tag 003302	F	20-40	B2	3.9	
TG12	Hawthorn Field maple	<i>Crataegus monogyna</i>	Y/SM	Av. 6	S /	Av. 250	1	2	2	2	2	No visual defects but in places ivy	Single and multi-stemmed specimens,	Canopy reads as one, heavy ivy cladding	Occasional larger specimens	F	20-40	B2	3.0	Sever and remove ivy

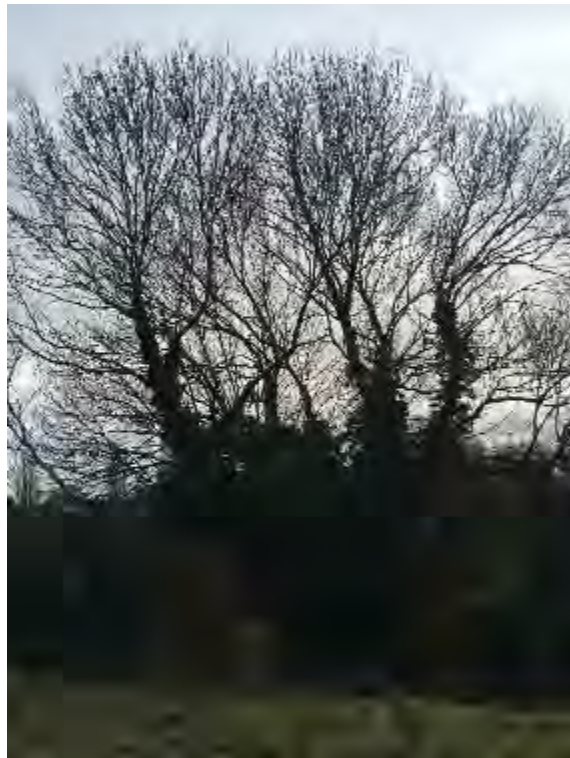
Photograph 12 – T13

Overhanging the southern boundary T13 and TG14 were assessed as offering low BRP due to the presence of ivy cladding which would offer limited roosting potential in itself but may be obscuring other damage that could provide potential. The damage on the stem of T15 also had created a cavity that despite its position within 1 m of ground level could also provide low BRP.

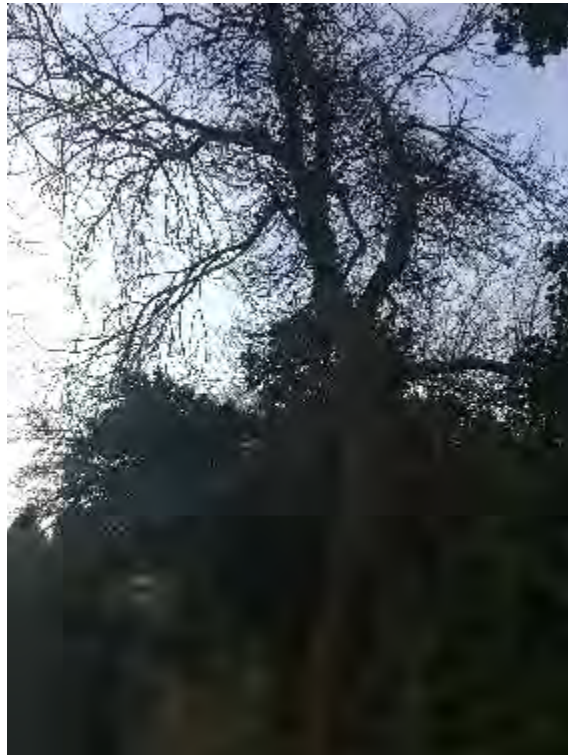
Photograph 14 – T15

T15	Ash	<i>Fraxinus excelsior</i>	SM	15	S	625	5	6	5	5	4		No visual defects	Single stem, vertical. Leans north- east.	Rounded, balanced canopy	Damage present on stem from ground to 1 m creating cavity and fungal growth present. Low BRP.	P	<20	C2	7.5
T16	Lombardy poplar	<i>Populus nigra 'Italica'</i>	M	25	S	1350	4	5	5	5	4		No visual defects, growing close to footpath to south and new gabion basket to north	Single stem, vertical	Compact, narrow canopy	Previously ivy clad but severed at 2 m	F	>40	B2	15.0
T17	Lombardy poplar	<i>Populus nigra 'Italica'</i>	M	25	S	1050	6	3	3	3	4		No visual defects, growing close to footpath to south and new gabion basket to north	Single stem, vertical	Compact, narrow canopy	Previously crown lifted to 6 m to south	F	>40	B2	12.6

Five trees were assessed as offering roosting potential, T13 and the three trees comprising TG14 were assessed as offering low BRP due to dense ivy cladding. Damage at the base of T15 was also assessed as offering low BRP due to the presence of a cavity.

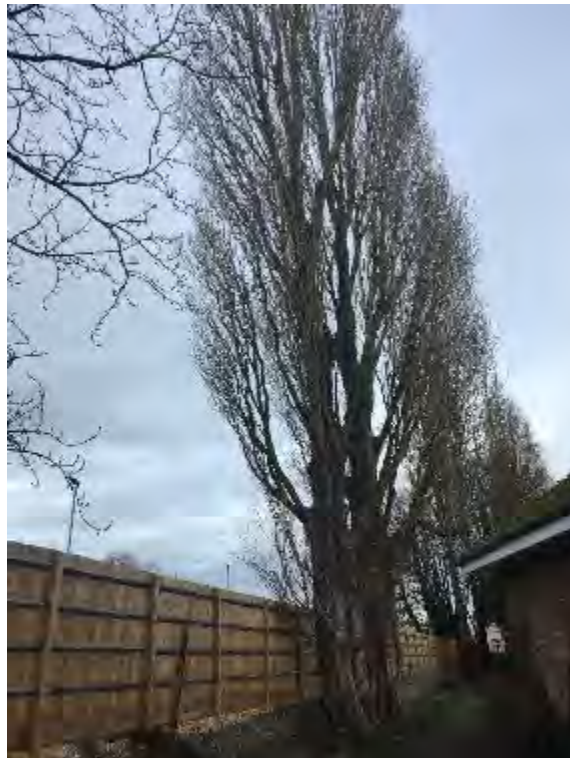
Photograph 16 – T17 and T18

T18	Lombardy poplar	<i>Populus nigra</i> 'Italica'	M	25	S	1300	6	3	3	3	4	No visual defects, growing close to footpath to south and new gabion basket to north	Single stem, vertical	Compact, narrow canopy	Ivy previously severed at 2 m	F	>40	B2	15.0	
T19	Lombardy poplar	<i>Populus nigra</i> 'Italica'	M	25	S	875	14	3	2	2	2	No visual defects but growing close to footpath and boundary fence	Single stem, vertical	Compact, narrow canopy	Close to boundary fence and borders footpath	F	>40	B2	10.5	
TG20	Sycamore Lime	<i>Acer pseudoplatanus</i> <i>Tilia</i> sp.	SM	Av. 15	S / M S	Av. 450	Av. 4	6	6	3	4	No visual defects	Single stems or multi-stemmed below 1 m, vertical	Canopy reads as one, limited to south due to off-Site trees	Sparse ivy cladding over stems, negligible BRP	F	20-40	B2	5.4	Sever ivy
T21	Sycamore	<i>Acer pseudoplatanus</i>	SM	14	S	325	8	3	3	3	3	No visual defects	Single stem, slight lean to north and bifurcates at 2 m	Canopy previously lifted to 8 m, sparse	Close to boundary fence and borders footpath	P	20-40	C2	3.9

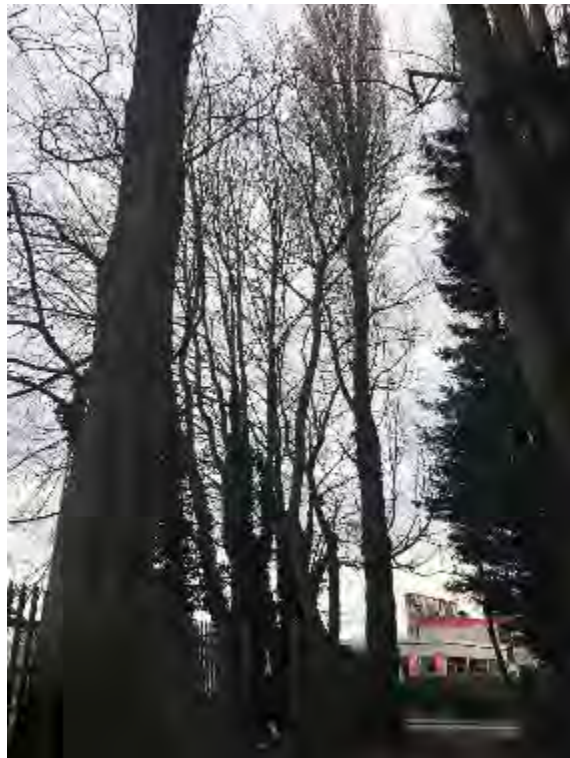
Photograph 20 – T22 (Centre)

T22	Lombardy poplar	<i>Populus nigra</i> 'Italica'	M	25	S	900	6	3	5	0	1	No visual defects	Single stem, vertical. Minor bark damage at base of stem to south	Compact, narrow canopy	Close to footpath and fence and borders footpath	F	>40	B2	10.8	
TG23	Lime	<i>Tilia</i> sp.	SM	Av. 12	S	Av. 300	2	4	4	4	4	No visual defects	Single stem, vertical	Canopy reads as one	Part of a larger group along Southern Road	F	>40	B2	3.6
