BS 5837:2012 Tree Survey

Banbury 200 Site, Southam Road, Banbury, OX16 3AE

Issued: October 2021

Delta-Simons Project No. 21-1553.02

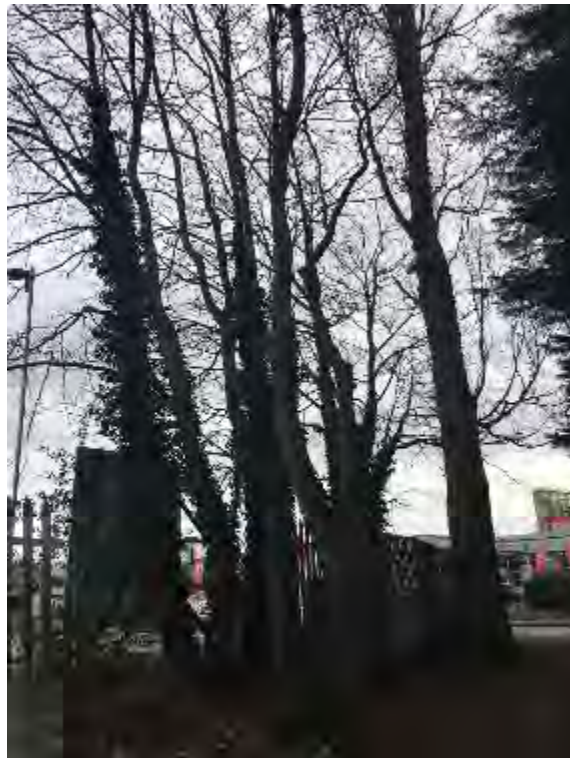
Photograph 4 – T4

T4	Sycamore	<i>Acer pseudoplatanus</i>	SM	14	S	325	8	3	3	3	3	No visual defects	Single stem, slight lean to north and bifurcates at 2 m	Canopy previously lifted to 8 m, sparse	Close to boundary fence and borders footpath	P	20-40	C2	3.9	
T5	Lombardy poplar	<i>Populus nigra</i> 'Italica'	M	25	S	875	14	3	2	2	2	No visual defects but growing close to footpath and boundary fence	Single stem, vertical	Compact, narrow canopy	Close to boundary fence and borders footpath	F	>40	B2	10.5	
T6	Lombardy poplar	<i>Populus nigra</i> 'Italica'	M	25	S	1300	6	3	3	3	4	No visual defects, growing close to footpath to south and new gabion basket to north	Single stem, vertical	Compact, narrow canopy	Ivy previously severed at 2 m	F	>40	B2	15.0	
T7	Lombardy poplar	<i>Populus nigra</i> 'Italica'	M	25	S	1050	6	3	3	3	4	No visual defects, growing close to footpath to south and new gabion basket to north	Single stem, vertical	Compact, narrow canopy	Previously crown lifted to 6 m to south	F	>40	B2	12.6

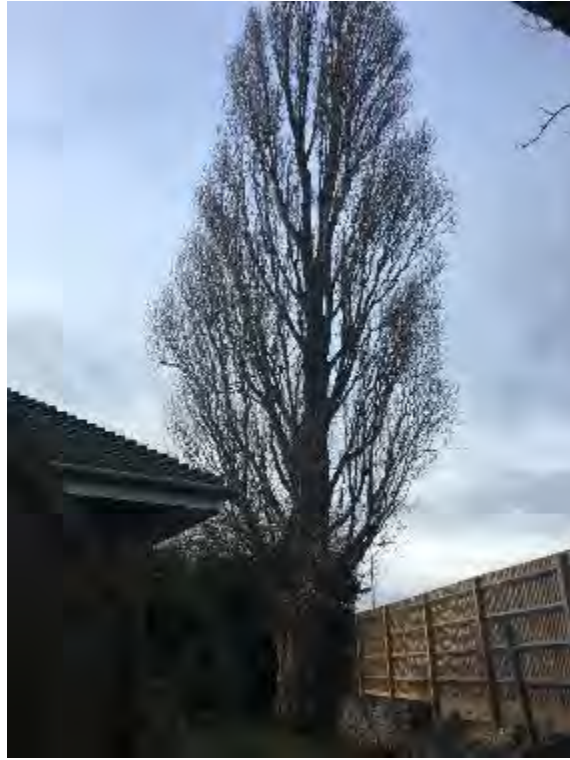
Photograph 7 – T8

T8	Lombardy poplar	<i>Populus nigra</i> 'Italica'	M	25	S	1350	4	5	5	5	4	No visual defects, growing close to footpath to south and new gabion basket to north	Single stem, vertical	Compact, narrow canopy	Previously ivy clad but severed at 2 m	F	>40	B2	15.0	
TG9	Hawthorn Field maple Holly Cherry Rowan Ash Elder	<i>Crataegus monogyna</i> <i>Acer campestre</i> <i>Ilex aquifolium</i> <i>Prunus</i> sp. <i>Sorbus aucuparia</i> <i>Fraxinus excelsior</i> <i>Sambucus nigra</i>	Y/ SM	Av. 6	S / M S	Av. 250	1	2	2	2	2	No visual defects but in places ivy covers the ground limiting visibility	Single and multi-stemmed specimens, most are vertical but a minority lean north	Canopy reads as one, heavy ivy cladding and coverage throughout	Occasional larger specimens present, self-set immature trees amongst group	F	20-40	B2	3.0	Sever and remove ivy
T10	Ash	<i>Fraxinus excelsior</i>	SM	15	S	625	5	6	5	5	4	No visual defects	Single stem, vertical. Leans north-east.	Rounded, balanced canopy	Damage present on stem from ground to 1 m creating cavity and fungal growth present.	P	<20	C2	7.5

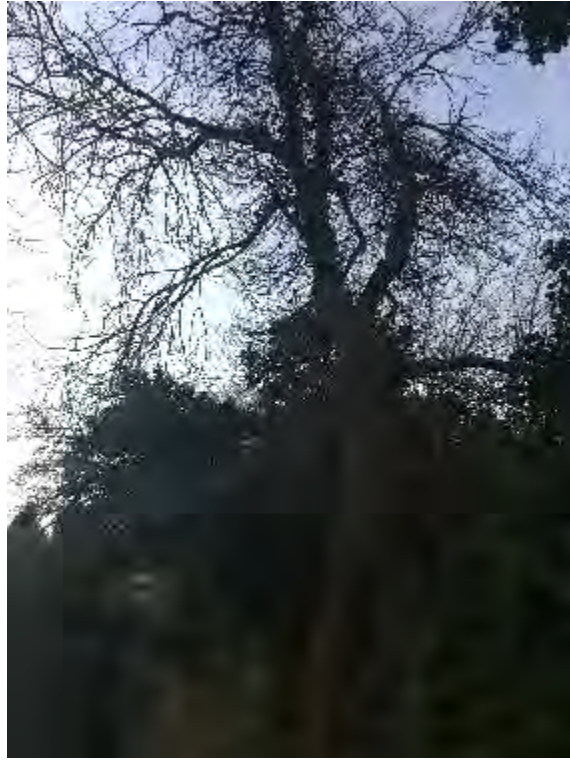
Photograph 9 – T10

Both T38 and T39 to the west are both less prominent in the landscape than T40-T45, T38 due to its position on a lower embankment and height of only 8 m and T39 due to its limited canopy spread. Whilst standing at 15 m, T10 was in a poor condition with damage at the base and fungal growth present such that its long-term viability is anticipated to be limited. At 14 m T4 has limited prominence due to its elevation and limited canopy becoming lost amongst the adjacent group and surrounding trees.

All on-Site trees appear to be in fair condition, other than T34 which is growing in a poor position at the edge of a building, and T39 which supported a sparse canopy. Off-Site to the south, T10 featured damage towards the base of the stem creating a cavity such that it was also assessed as being in a poor condition.

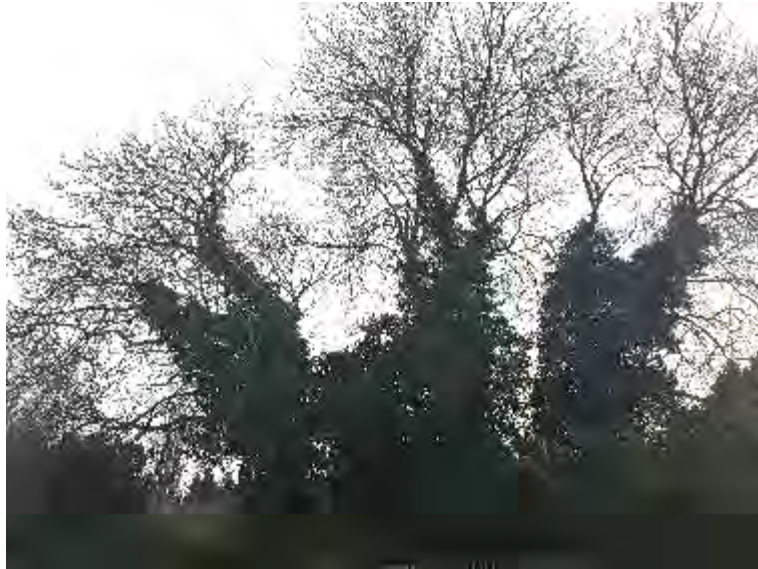
Photograph 10 – TG11

TG11	Ash	<i>Fraxinus excelsior</i>	SM	16	S / M S	Av. 600	4	8	8	8	8	No visual defects but growing close to adjacent path	Western tree, single stem leans west. Central bifurcated and base and eastern tree leans north-east	Previously crown lifted to 4 m	Ivy previously severed to 3 m on eastern stem. Central tree largest at 600 x 2 DBH. Scattered deadwood at base.	F	20-40	B2	7.2	
T12	Ash	<i>Fraxinus excelsior</i>	M	18	M S	Est. 700 x 3	4	8	8	8	8	No visual defects but growing close to adjacent path	Trifurcated at base, vertical	Balanced canopy, scattered deadwood and ivy cladding present	Thick ivy cladding. Scattered deadwood at base.	F	20-40	B2	14.4	
T13	Field maple	<i>Acer campestre</i>	SM	10	M S	Est. 400 x2, 300 x2	2	5	5	5	5	No visual defects	Multi-stemmed below 1 m, vertical	Spreading crown, balanced	Northern tree in group of smaller trees	F	20-40	B2	8.4	
TG14	Yew Willow Ash	<i>Taxus baccata</i> <i>Salix</i> sp. <i>Fraxinus excelsior</i>	Y	6	S / M S	Est. Av. 75	1	1	1	1	1	Not visible amongst scrub	Yew multi-stemmed, willow single stems	Canopies limited due to surrounding bramble scrub		F	20-40	C2	0.9

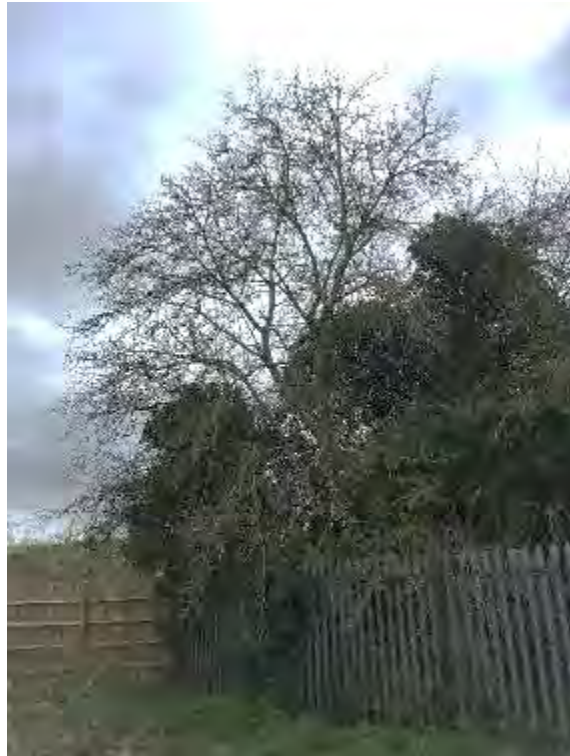
Photograph 12 – T13

According to aerial photographs, the Site has been used for industrial purposes for at least the previous 16 years. Recent works have taken place to install a new boundary fence which extends close to T43 and T13 and there is the potential that this has caused disturbance within the RPA of both trees to create the post holes.

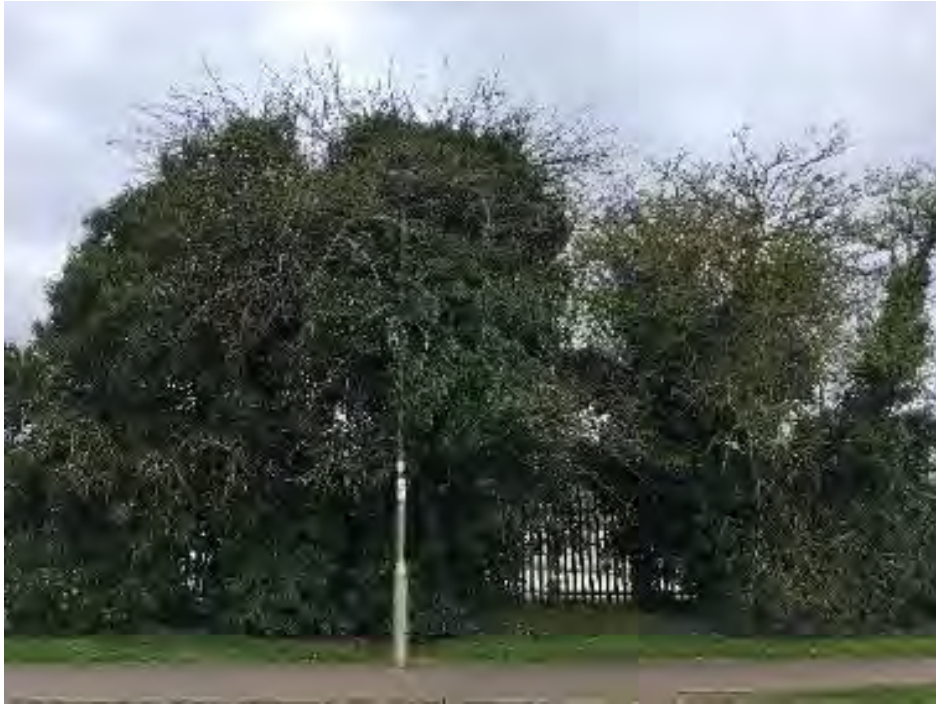
Photograph 19 – TG20

TG20	Elder Cherry	<i>Sambucus nigra</i> <i>Prunus sp.</i>	SM	8	S	Est. 300	0	3	3	3	3	No visual defects	Not visible amongst ivy but anticipated to be single stems, vertical	Canopy reads as one, heavily congested with ivy	Located in grass verge at edge of residential estate	F	20-40	C2	3.6	
T21	Maple	<i>Acer sp.</i>	SM	14	S	550	5	6	6	6	6	Raised roots noted surrounding tree and raised tarmac to east	Single stem, vertical	Rounded, balanced canopy. Previously crown lifted to 5 m to east.	Street tree	F	>40	B2	6.6	
T22	Silver birch	<i>Betula pendula</i>	SM	18	S	450	6	5	5	5	5	No visual defects	Single stem, vertical	Rounded, balanced canopy. Previously lifted to south to 4 m.		F	20-40	B2	5.4	
T23	False acacia	<i>Robinia pseudoacacia</i>	SM	18	S	450	5	5	5	4	4	No visual defects	Single stem, vertical. Epicormic growth at base.	Rounded, balanced canopy	Split on previously removed branch at 3 m to east. Tag 003258	F	>40	B2	5.4

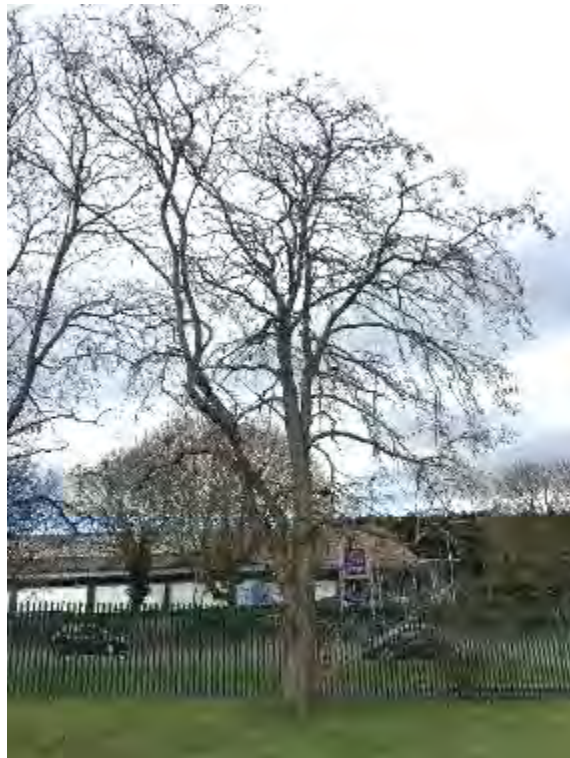
Photograph 22 – T24

T24	False acacia	<i>Robinia pseudoacacia</i>	SM	18	S	Est. 600	4	5	5	5	5	Raised root to north-west with mower damage	Single stem, vertical	Rounded, balanced canopy	Tag 003257	F	>40	B2	7.2	
TG25	Maple	<i>Acer sp.</i>	SM	14	S	Av. 425	4	5	5	5	5	Minor surface roots	Single stems, vertical	Rounded, balanced canopies	Roadside trees	F	>40	B2	5.1	
TG26	Cherry London plane	<i>Prunus sp.</i> <i>Platanus x hispanica</i>	SM	Av. 14	S /	Av. 475	3	5	5	5	5	Minor surface roots	Mostly single stems,	Rounded, balanced canopies	Southern most cherry fallen north, still living	F/ P	>40	B2	5.7	Remove fallen tree

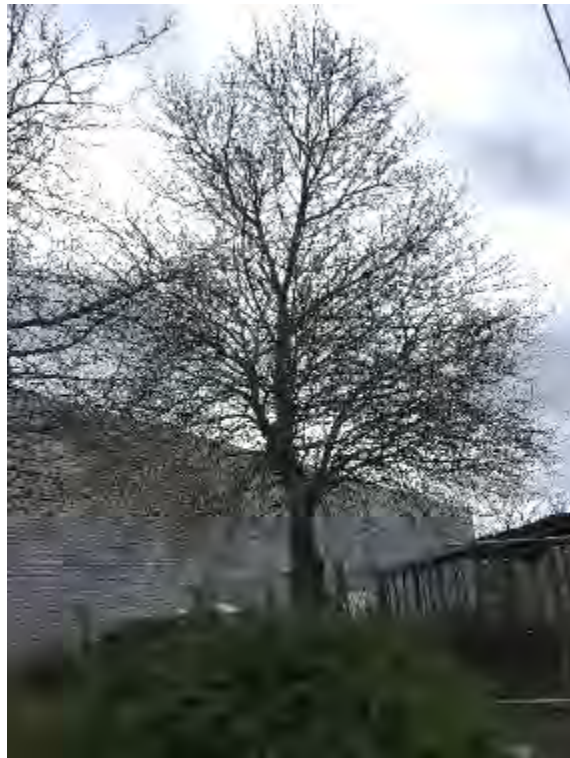
Photograph 30 – T36

T36	Sycamore	<i>Acer pseudoplatanus</i>	Y	14	S	375	4	4	4	3	5	No visual defects	Single stem, vertical	Rounded, balanced canopy. Previously crown lifted to 4 m.	Limited canopy due to T1 and T3. Tree tag 003287	F	>40	B2	4.5
T37	London plane	<i>Platanus x hispanica</i>	SM	14	S	600	3	7	7	7	7	No visual defects	Single stem, vertical	Rounded, balanced canopy, previously crown lifted to 4 m to east	Thin ivy cladding on main stem, negligible BRP	F	>40	B2	7.2
T38	Field maple	<i>Acer campestre</i>	Y	8	S	325	3	3	3	3	3	Exposed surface roots, particularly to the east	Single stem, vertical	Rounded, balanced canopy	Tree tag 003295	F	20-40	C2	3.9
T39	Ash	<i>Fraxinus excelsior</i>	Y	8	S	150	4	3	2	1	2	No visual defects	Single stem, vertical	Sparse canopy	Tree tag 003296	P	20-40	C2	1.8
T40	Norway maple	<i>Acer platanoides</i>	Y	8	S	275	3	4	4	4	4	Surface roots present on all aspects	Single stem, vertical	Rounded, balanced canopy	Tree tag 003297	F	20-40	B2	3.3
