Home Farm, Access Track and Barn, Arboricultural Impact Assessment

Stage 1 and 2 Arboricultural Report

Charlton on Otmoor, Kidlington

855863

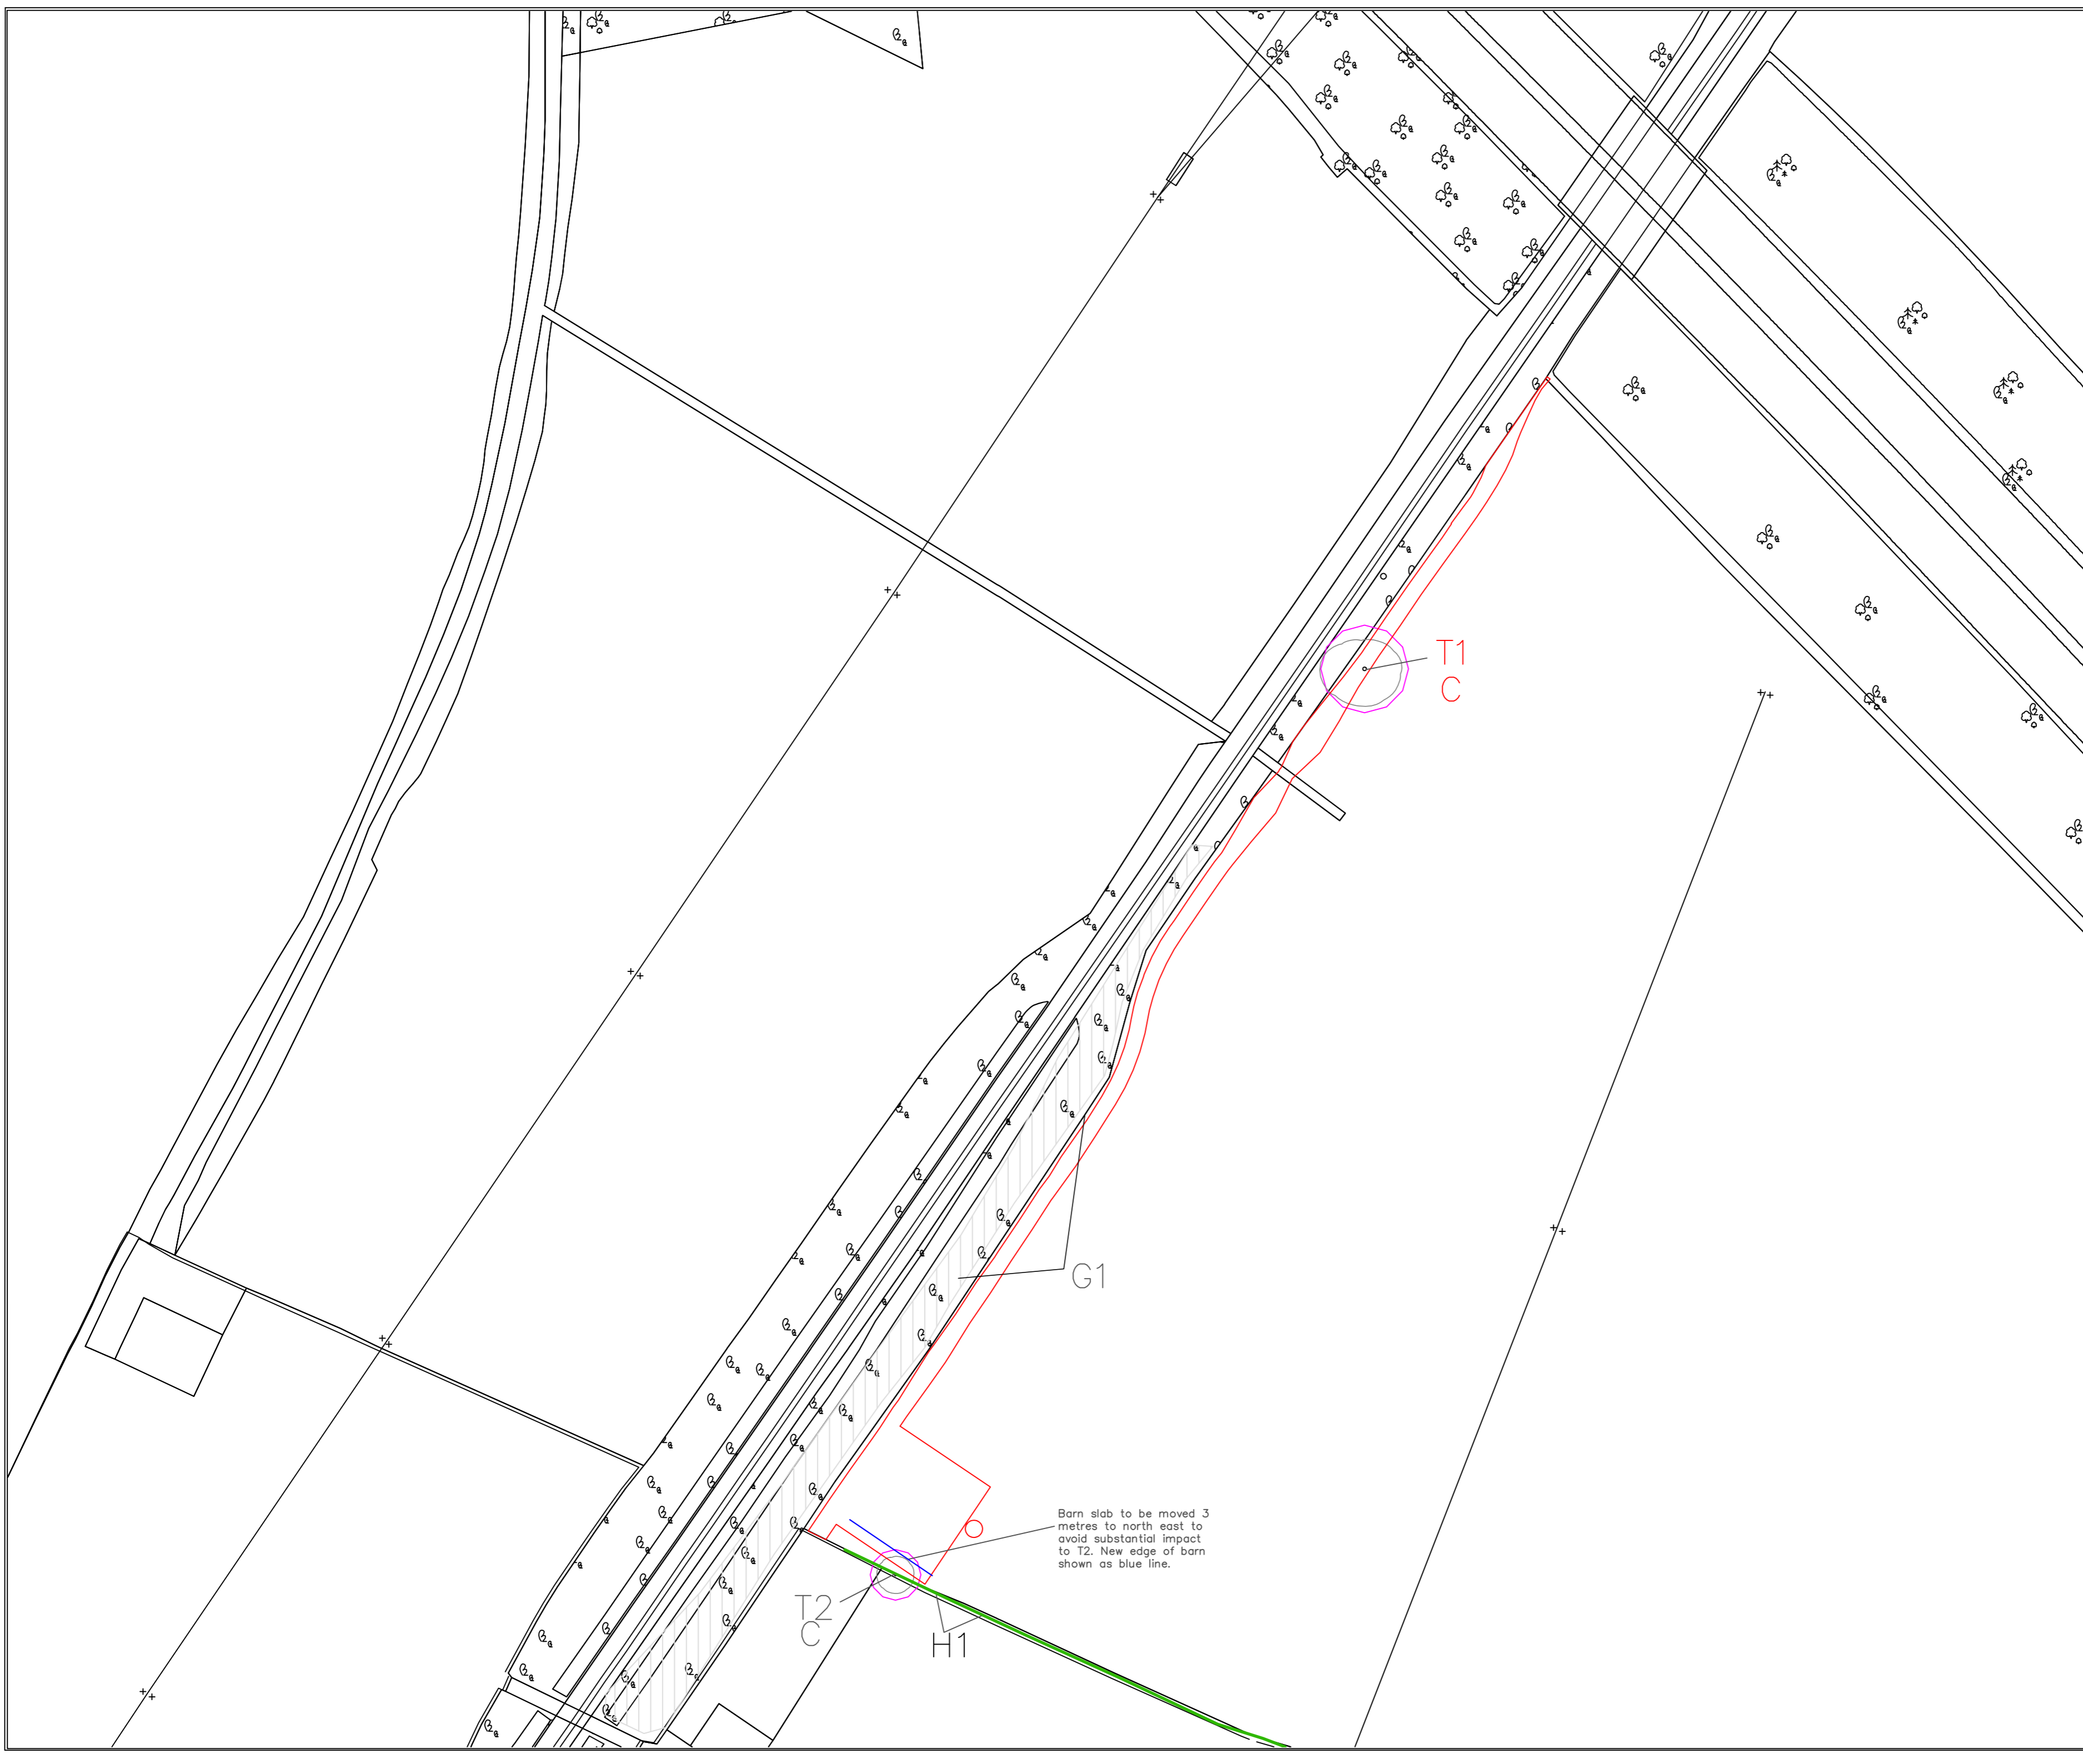
8 **FIGURE 1** **TREE REMOVALS PLAN**

Tree T1, a structurally-poor mature Ash, has a large open basal cavity at its base that extends to around 1.6 metres. Sounding with mallet indicates that decay is also present higher up the stem, to around 2.4 metres. The decay causing fungi, *Inonotus hispidus*, was also noted on structural branches which increases the likelihood for premature branch failure.

Tree T2, a mature Pear in a hedgerow, was seen to be in poor physiological condition and its crown apex displayed signs of retrenchment through dieback.

The track route passes over the Root Protection Area (RPA) of Tree T1 and the slab base for the barn will lie within the RPA of tree T2 by 1 metre at its north east extent. No pruning is required to facilitate the proposals.

Tree T1 will require removal and T2 will be impacted slightly by the construction. As both trees offer a limited long term potential this is not seen as being of significant detriment to the landscape.

The tree works required (tree removals) should be carried out before construction begins and be undertaken by a competent arboricultural contractor⁴ in accordance with BS3998:2010 Tree work – Recommendations⁵.
