Chancel Cottage

PLANNING AND DESIGN AND ACCESS STATEMENT

08th July 2015

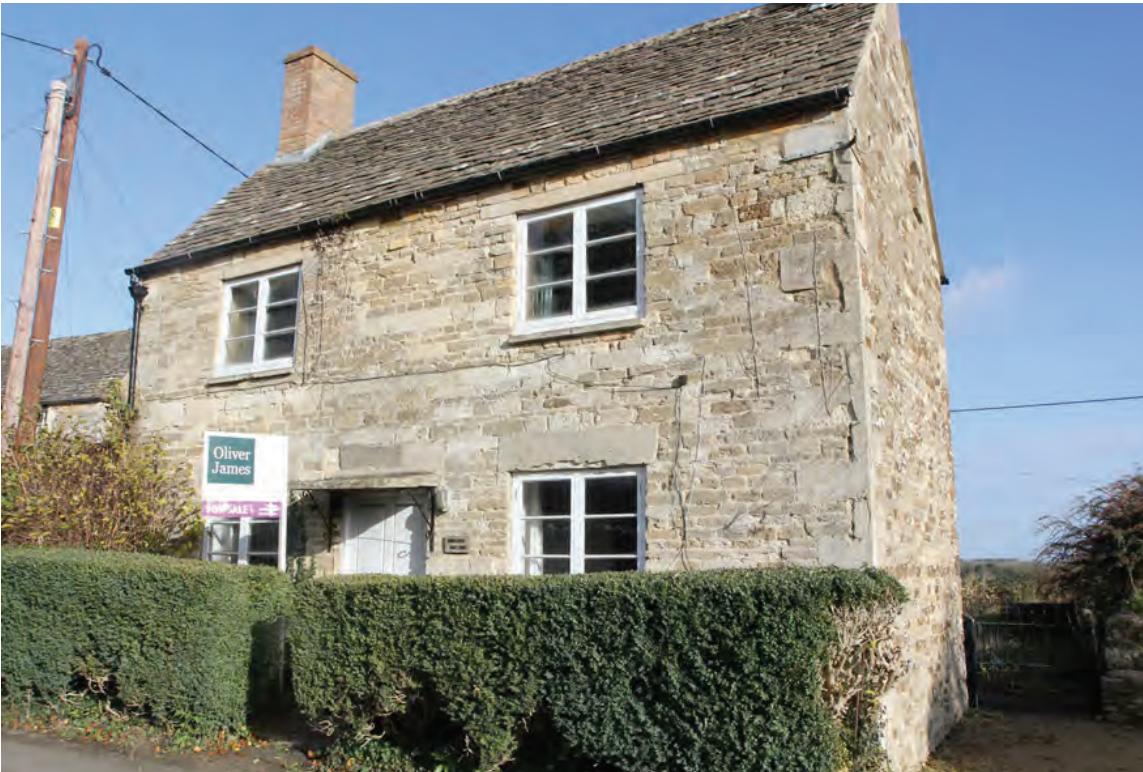
Fig.15 - Front facade

The wall is coursed limestone with ashlar dressing, which is affected by ivy and vegetation growing either side of the doorway and causing damp internally. There are many open joints to the wall, particularly beneath and between the windows and beneath the eaves. The overhaul of the stonework and repointing is required. There is rot occurring to the lower rail to the door and to the weatherboard.

There has been outward movement to roof, which has caused the eaves to bow. The addition of restraint to the roof is required. The quoin stones on the south side are affected by some movement to the outer face of the wall to the east gable.

There is some slippage to the slates beneath the ridge and around the chimneys and recovering is required. Both end stacks are in brick with a lead lining. There are open joints around the lining from the west slope to the chimney to the east, clearly repairs are required. There are several missing small bricks to this chimney and slates missing under the flashing. Overhaul and repointing is required to the stack.

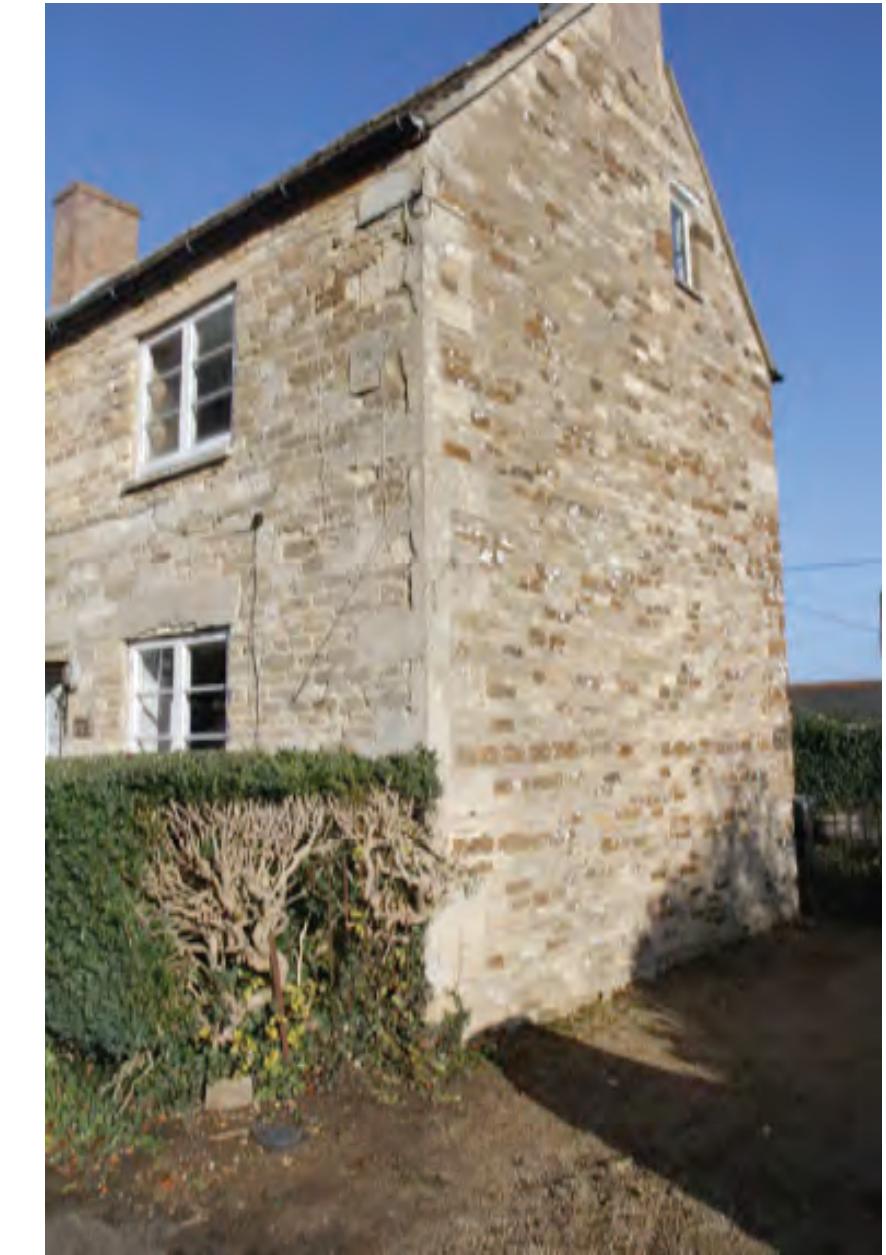
Fig.16 - South gable

The south gable to the main range is in limestone rubble and ironstone, there are open joints to the corner to the west and at ground level, which require urgent repointing.

At high level there is the single light metal window, general overhaul of this is required together with re-puttying. The cement dubbing has broken away allowing the mortar to ingress behind the flashing, which is causing the damp internally.

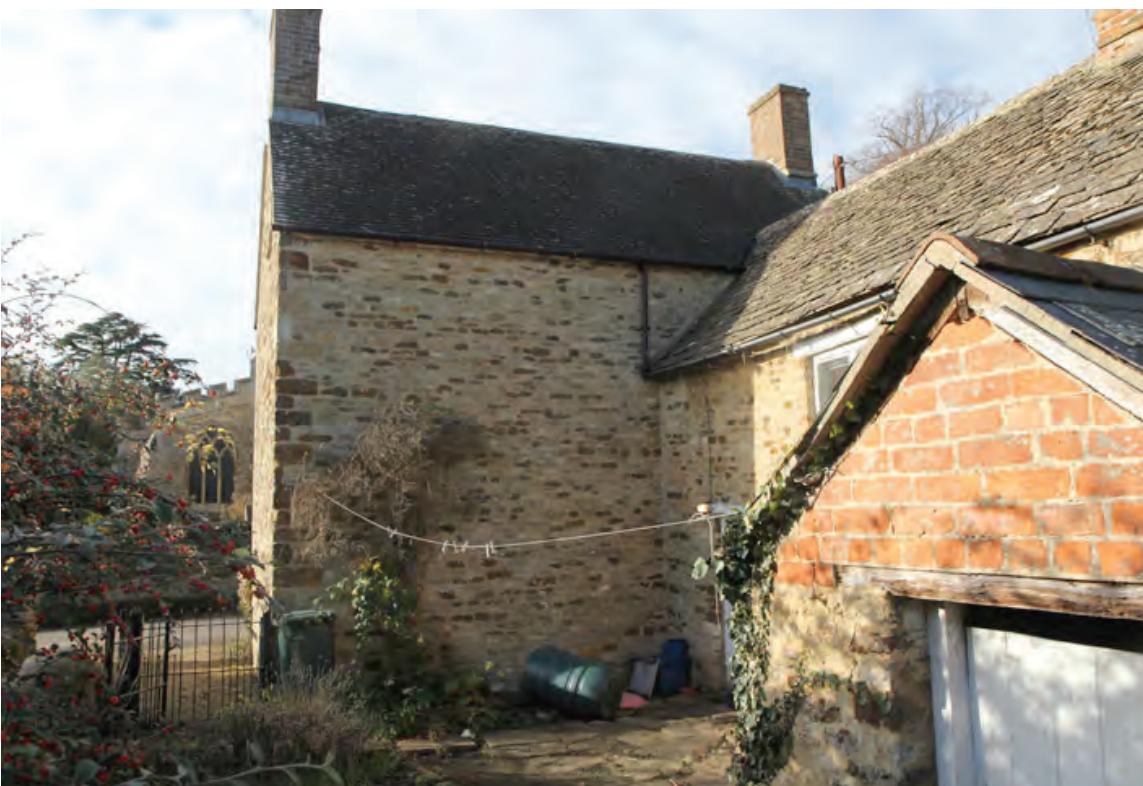
Fig.17 - East elevation to front section

The roof drainage is formed with a fascia and plastic gutter and downpipe, which discharges into the gutter extending along the outbuilding. As noted previously, there is brickwork cracking to the chimney to the south and general repair is required together with the replacement of the flashing. Attention is required to the flashing to the chimney to the west.

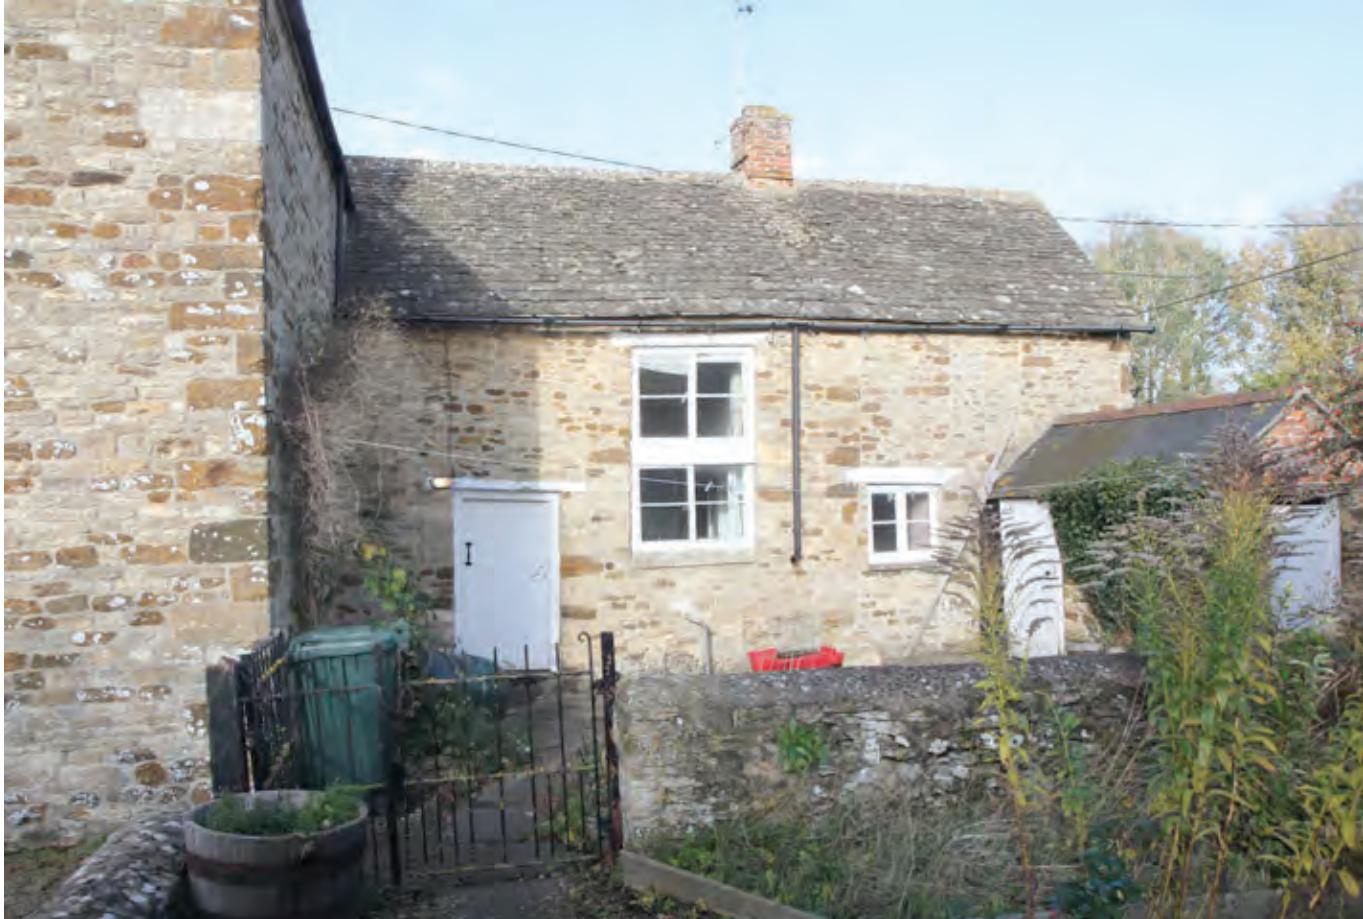
Fig.18 - South elevation to rear wing

The elevation is a mixture of limestone and ironstone, which has been flush pointed and requires overhaul and repointing. There has been outward pressure from the roof causing movement cracks to the main building and beneath eaves. The movement has occurred to the centre of the wall where the window has distorted. There is also damage to the stonework to the junction with the gable wall to the bathroom section. The main building has been repointed in a hard cement mortar, which is coming away. The general tying in and repointing is required along with an investigation made into the ground conditions in this area to assess the cause of a substantial bow to the wall.

The boarded entrance door is in poor condition. There has been some rot to the lower members of the frame, which has been replaced in the past. Overhaul, repair and redecoration is required.

Past repairs to the kitchen window, that have been pieced into the sill, are decaying. Over the replacement metal opening light is a timber lintol, to which there is settlement. The general overhaul and repair is required.

There is a plastic gutter on rise and fall brackets which used to discharge into a now removed rainwater pipe. Improvement of the drainage system here is urgently required.

The roof is formed in stone slates in diminishing courses, which is in poor condition; recovering is required. To the ridge there is a brick chimney to which the brickwork is spalling and the pointing is poor. The general overhaul of this is required.

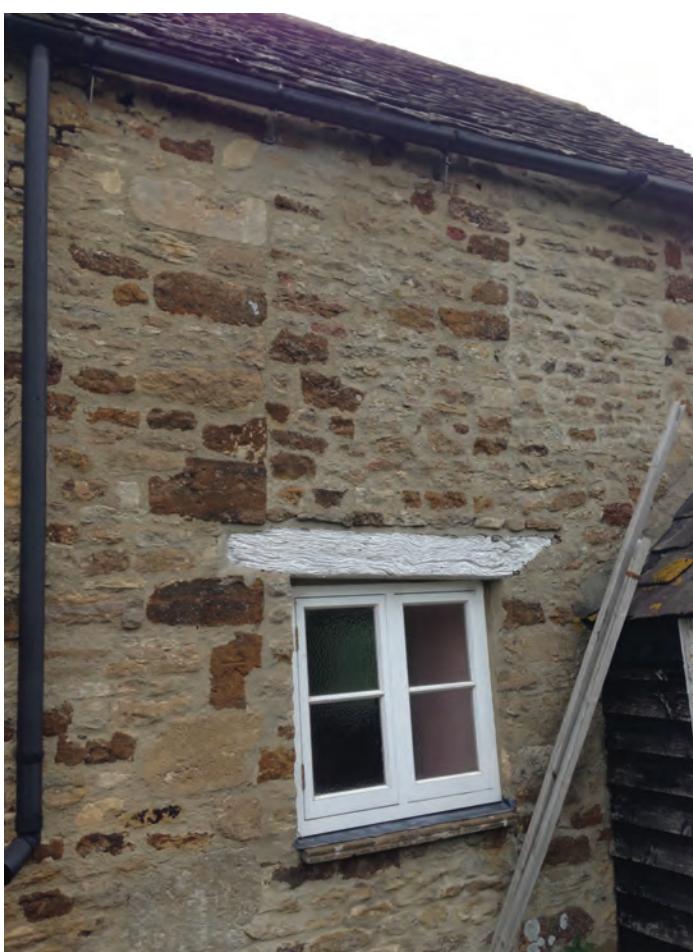
Fig.20 - Line down stonework

Toward the east of the south elevation is a clear line between the stonework (fig.20) that suggests the wall may have been either rebuilt or is a later addition.

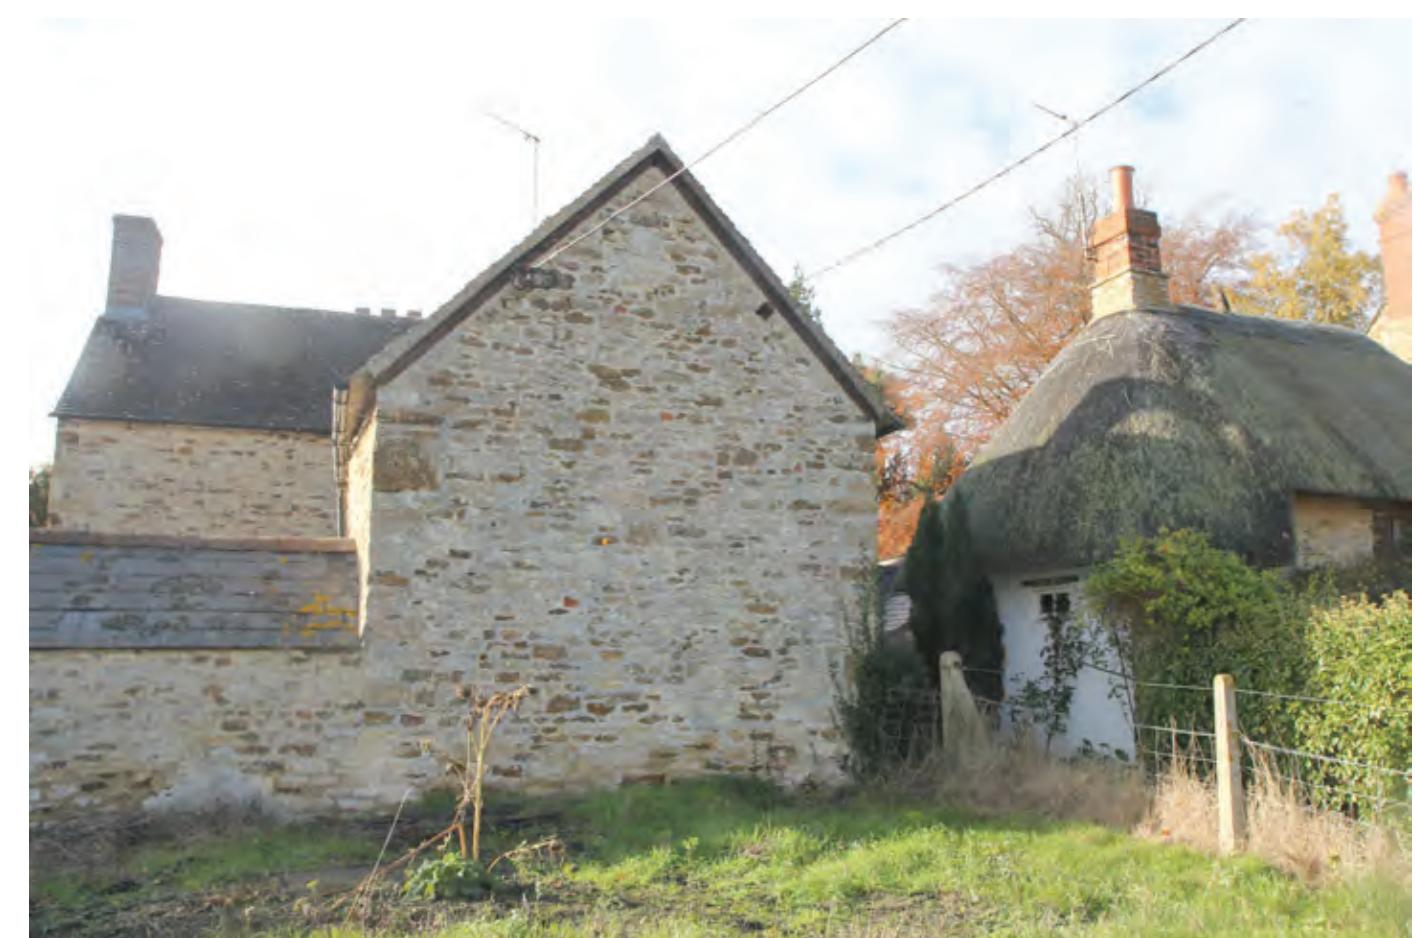
Fig.21 - East gable

The stone gable has considerable opening joints and movement cracks which extend down the centre of the wall to both corners. General repointing is required and overhaul to the gable complete and local replacement of stonework. The incoming electrical mains is fixed to the purlin end, which is clearly not helping the condition of the movement of the gable.

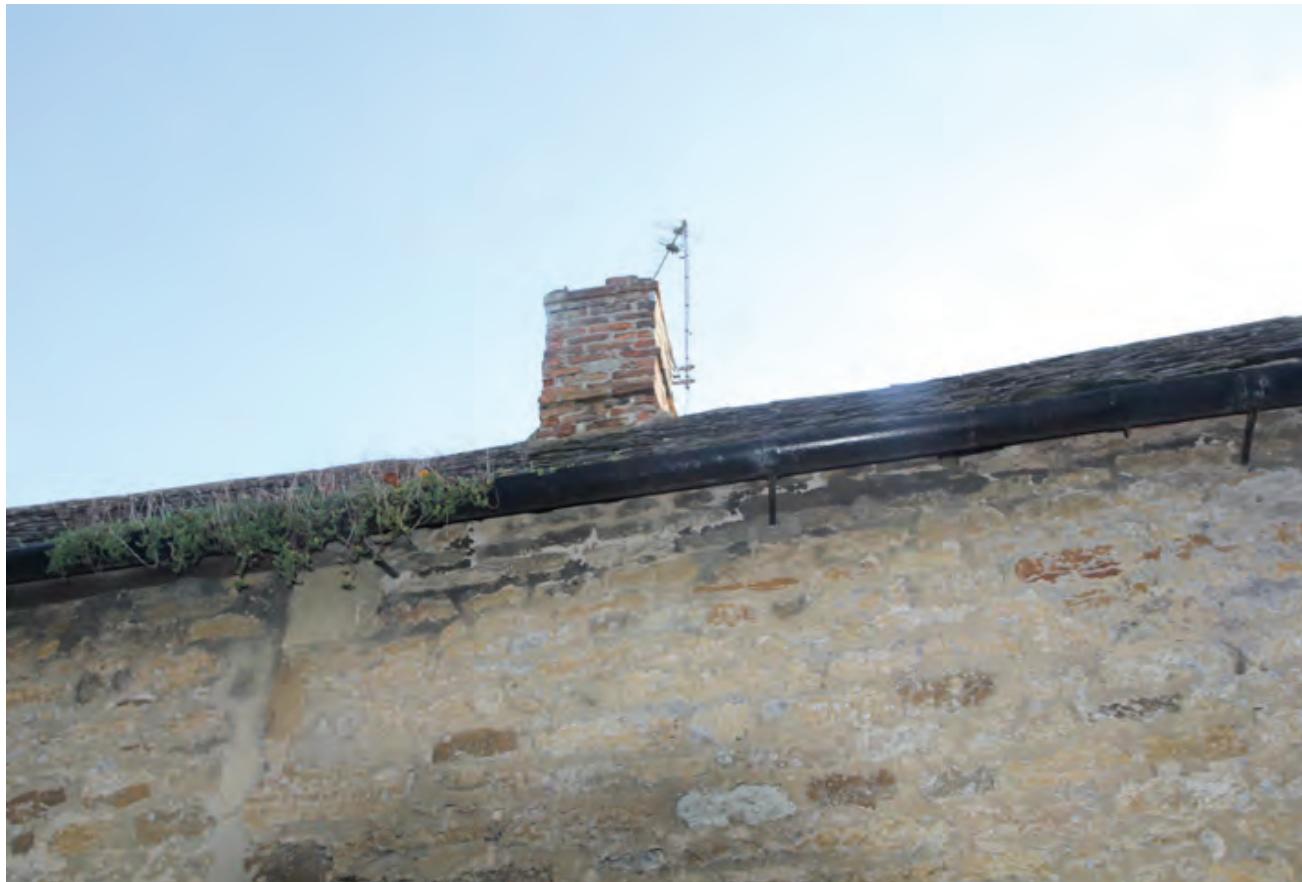
Fig.22 - North elevation to rear wing - joint between the extension

There are movement cracks evident to the bathroom, the general making good and repointing is required. Overhaul and redecoration is required to the timber 2-light casement window and the timber lintol, which is affected by furniture beetle. To the kitchen section again general repointing is required. There is an open joint, which has been pointed in a hard cement mortar between the extension and the main gable; this requires repointing. There is an aluminium gutter on rise and fall brackets, which is blocked, the general cleaning out of this is urgently required. The roof is in stone slates, which are in poor condition, and the general recovering is required. As noted previously, the chimney stack is in poor condition and the overhaul and replacement of brickwork generally is required.

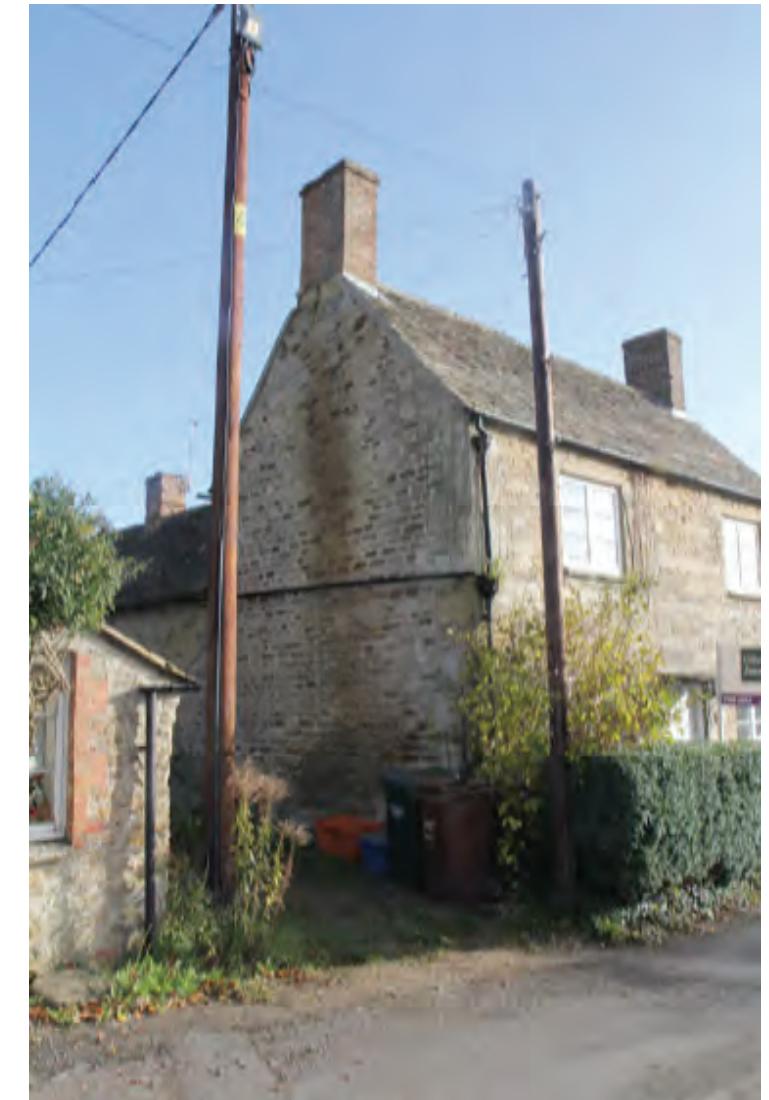
Fig.23 - North gable front section

There has been some movement to the stone here, particularly to the corner to the west. The general repointing here is required together with the removal of vegetation. The chimney stack has decayed stonework beneath the brick chimney stack, replacement of this and general repointing is required to an area of approximately 30 sq metres. Extending across the elevation is the aluminium gutter, which discharges into the copper grating to the front elevation. The replacement of this is required in conjunction with improvement of the system

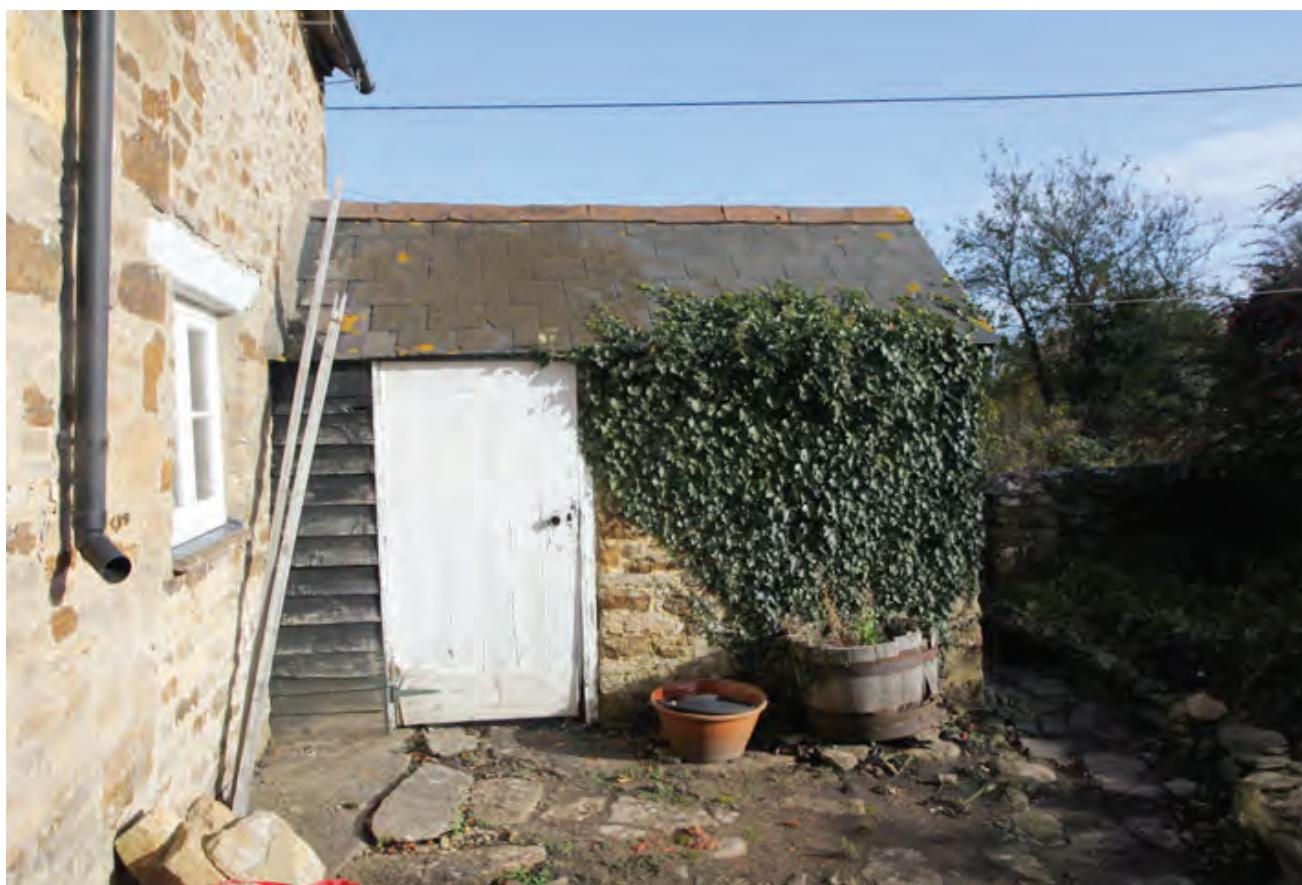
Fig.24 - Stores

The store are a mix of timber boarding, brick, and stone; and in generally poor condition. Repointing is required as well as the addition of a gutter and replacement of timber lintols. Our proposed works seek to remove the stores and reuse the stone in the new extension.

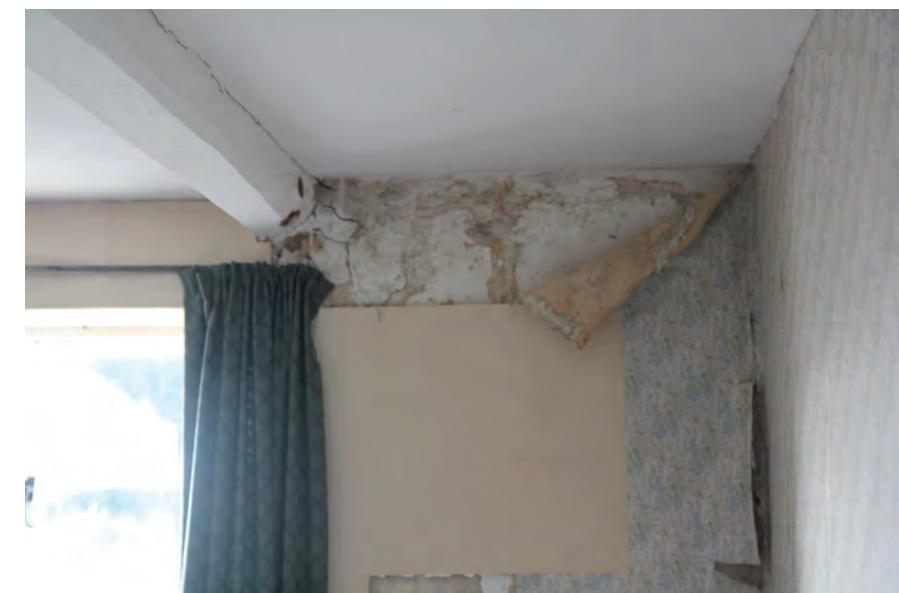
Fig.25 - Bedroom 1

The walls are plastered and papered and the decorations are in poor condition. The walls are affected by damp due to poor pointing externally and water is ingressing at windows causing plaster to become debonded. Walls are moving outwards due to the outward thrust and the tying in of this is required.

The floors have considerable sag where settlement has occurred. The movement is thought to relate to settlement caused by the ground water conditions being affected by the faulty rainwater disposal system.

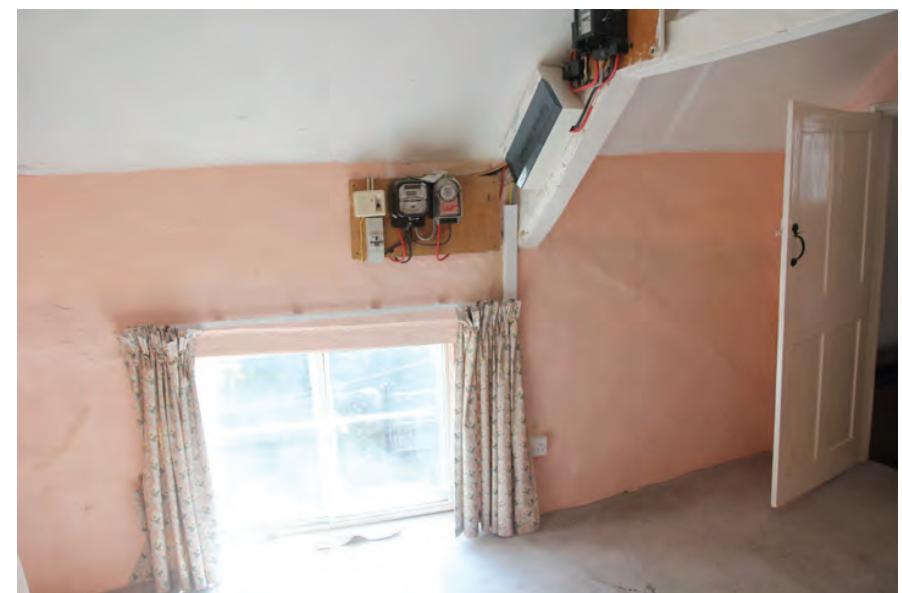
The system is generally poorly installed, with surface mounted wiring that is untidy and detracts from the building.

Fig.26 - Bedroom 2 - electrical incoming mains and distribution boards

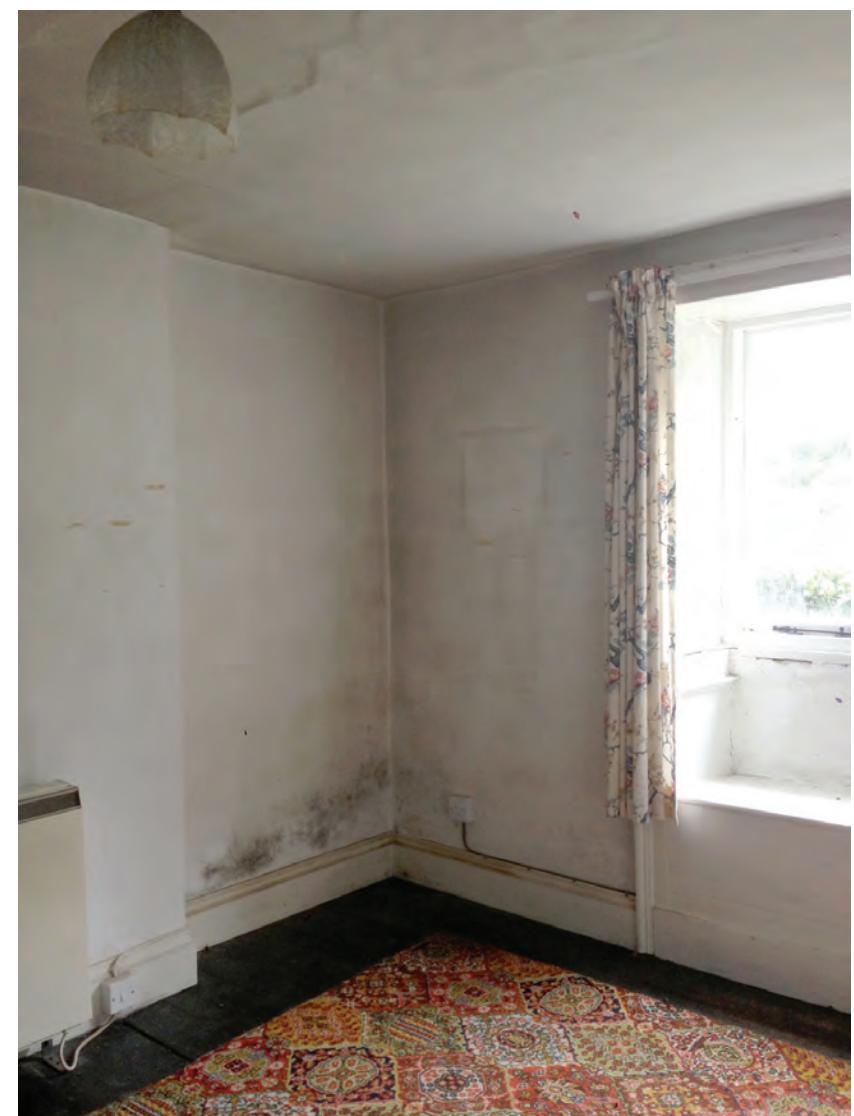
The ground floor suffers from the same problems as the first: Chiefly, high levels of damp, poor quality recent decorations, and movement to walls caused by the outward thrust.

Fig.27 - Dining room - damp

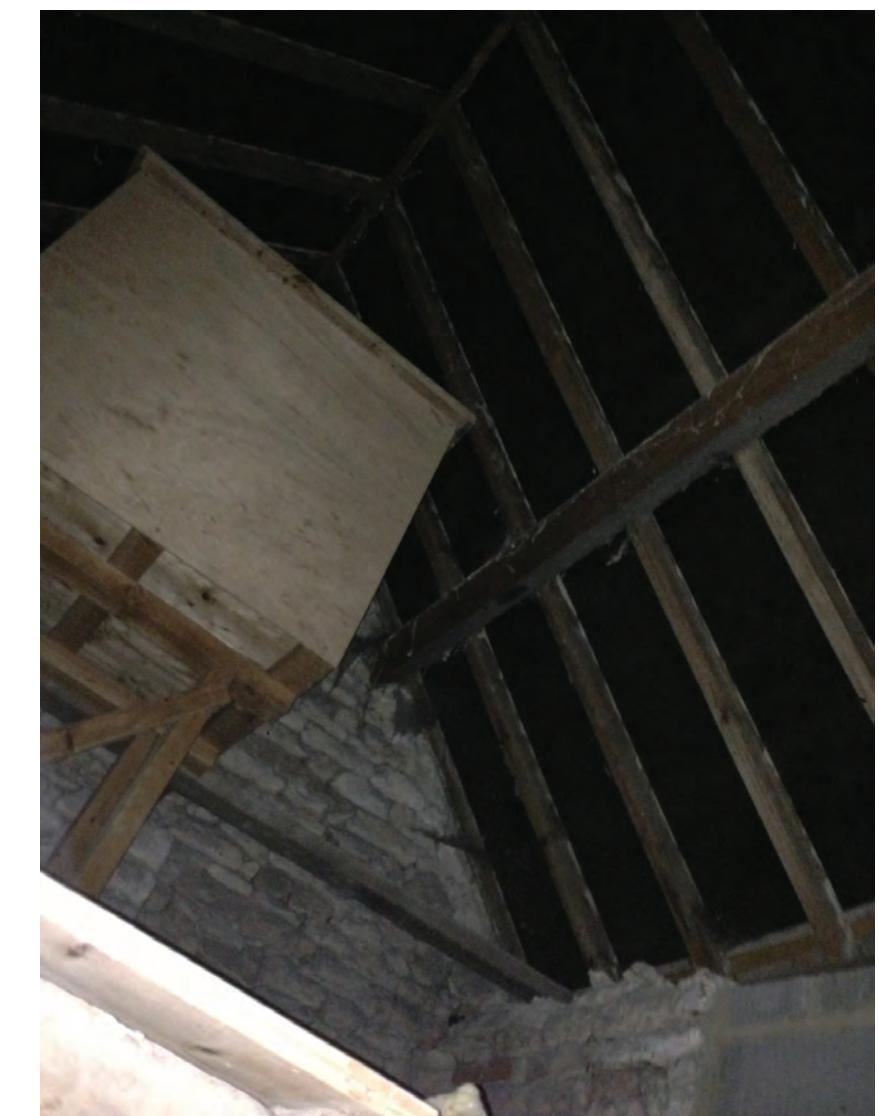
Fig.28 - Bathroom roof space

There are newer looking joists and rafters in the roof space above the bathroom that houses the water tank, again this indicates that the eastern end of the building may have been partially rebuilt or be a later addition.
