Chancel Cottage

PLANNING AND DESIGN AND ACCESS STATEMENT

15th December 2016

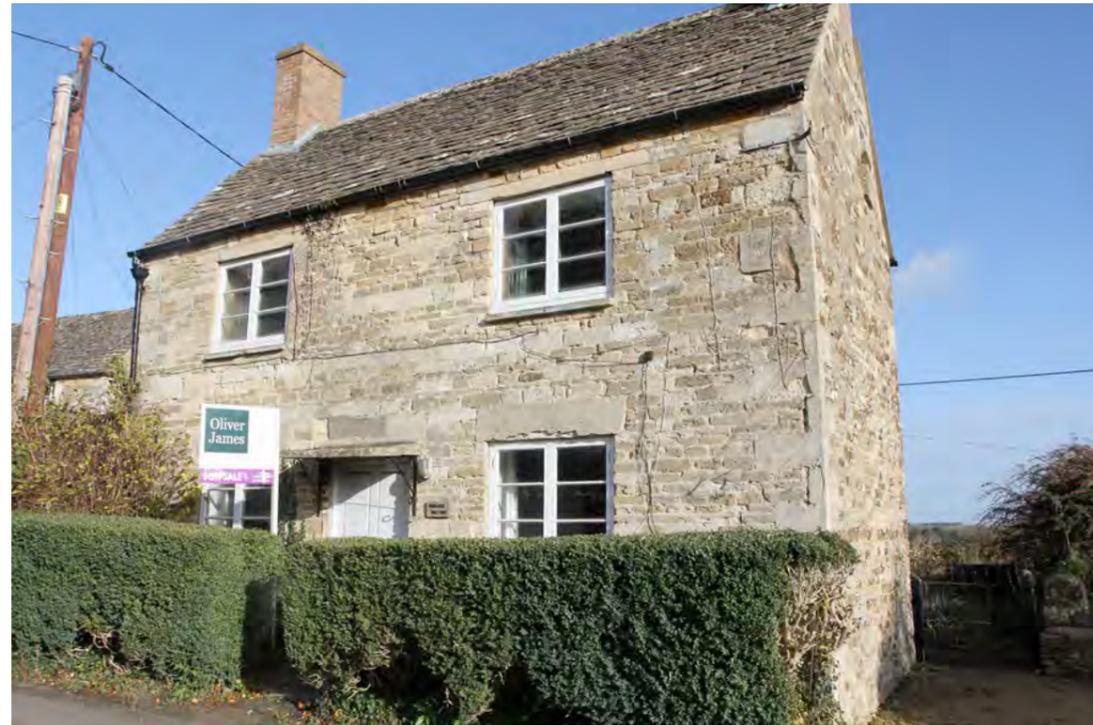
Fig.15 - Front facade

The wall is coursed limestone with ashlar dressing, which is affected by ivy and vegetation growing either side of the doorway and causing damp internally. There are many open joints to the wall, particularly beneath and between the windows and beneath the eaves. The overhaul of the stonework and repointing is required. There is rot occurring to the lower rail to the door and to the weatherboard.

There has been outward movement to roof, which has caused the eaves to bow. The addition of restraint to the roof is required. The quoin stones on the south side are affected by some movement to the outer face of the wall to the east gable.

There is some slippage to the slates beneath the ridge and around the chimneys and recovering is required. Both end stacks are in brick with a lead lining. There are open joints around the lining from the west slope to the chimney to the east, clearly repairs are required. There are several missing small bricks to this chimney and slates missing under the flashing. Overhaul and repointing is required to the stack.

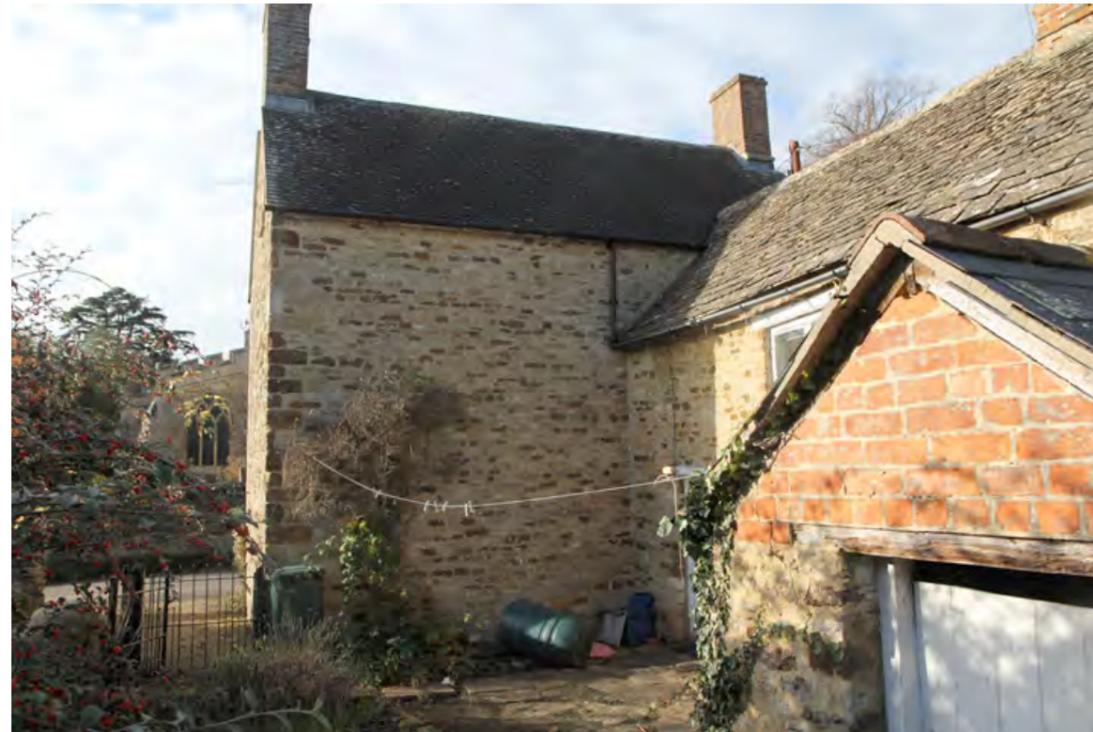
Fig.17 - East elevation to front section

The roof drainage is formed with a fascia and plastic gutter and downpipe, which discharges into the gutter extending along the outbuilding. As noted previously, there is brickwork cracking to the chimney to the south and general repair is required together with the replacement of the flashing. Attention is required to the flashing to the chimney to the west.

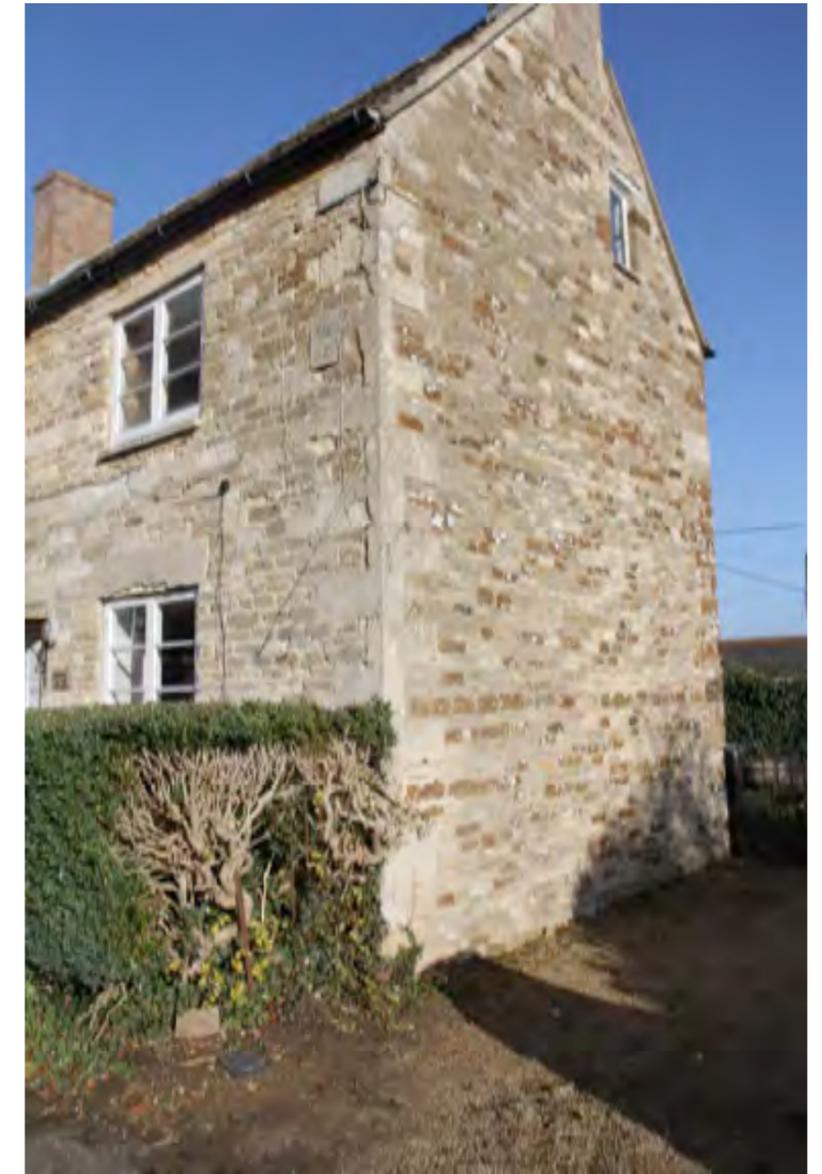
Fig.16 - South gable

The south gable to the main range is in limestone rubble and ironstone, there are open joints to the corner to the west and at ground level, which require urgent repointing.

At high level there is the single light metal window, general overhaul of this is required together with re-puttying. The cement dubbing has broken away allowing the mortar to ingress behind the flashing, which is causing the damp internally.

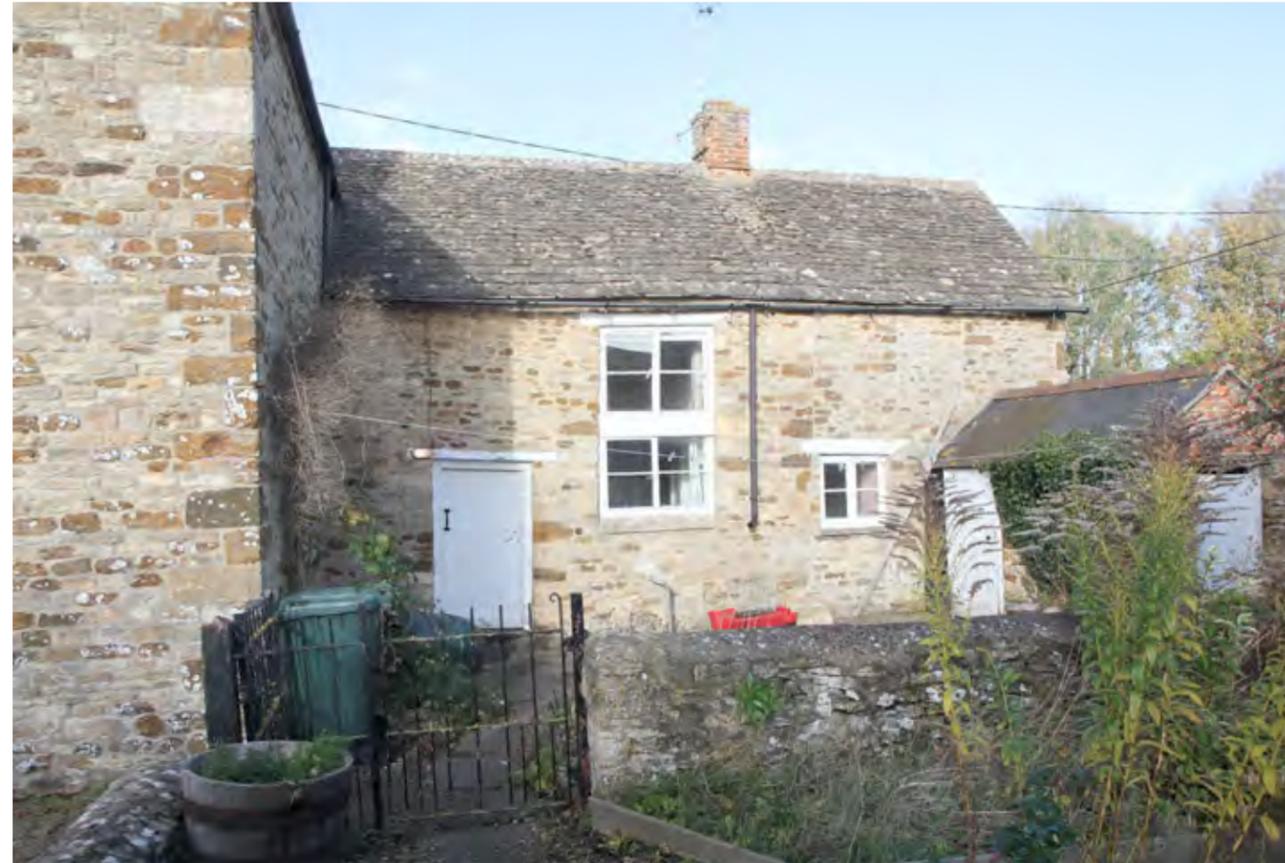
Fig.18 - South elevation to rear wing

The elevation is a mixture of limestone and ironstone, which has been flush pointed and requires overhaul and repointing. There has been outward pressure from the roof causing movement cracks to the main building and beneath eaves. The movement has occurred to the centre of the wall where the window has distorted. There is also damage to the stonework to the junction with the gable wall to the bathroom section. The main building has been repointed in a hard cement mortar, which is coming away. The general tying in and repointing is required along with an investigation made into the ground conditions in this area to assess the cause of a substantial bow to the wall.

The boarded entrance door is in poor condition. There has been some rot to the lower members of the frame, which has been replaced in the past. Overhaul, repair and redecoration is required.

Past repairs to the kitchen window, that have been pieced into the cill, are decaying. Over the replacement metal opening light is a timber lintol, to which there is settlement. The general overhaul and repair is required.

There is a plastic gutter on rise and fall brackets which used to discharge into a now removed rainwater pipe. Improvement of the drainage system here is urgently required.

The roof is formed in stone slates in diminishing courses, which is in poor condition; recovering is required. To the ridge there is a brick chimney to which the brickwork is spalling and the pointing is poor. The general overhaul of this is required.

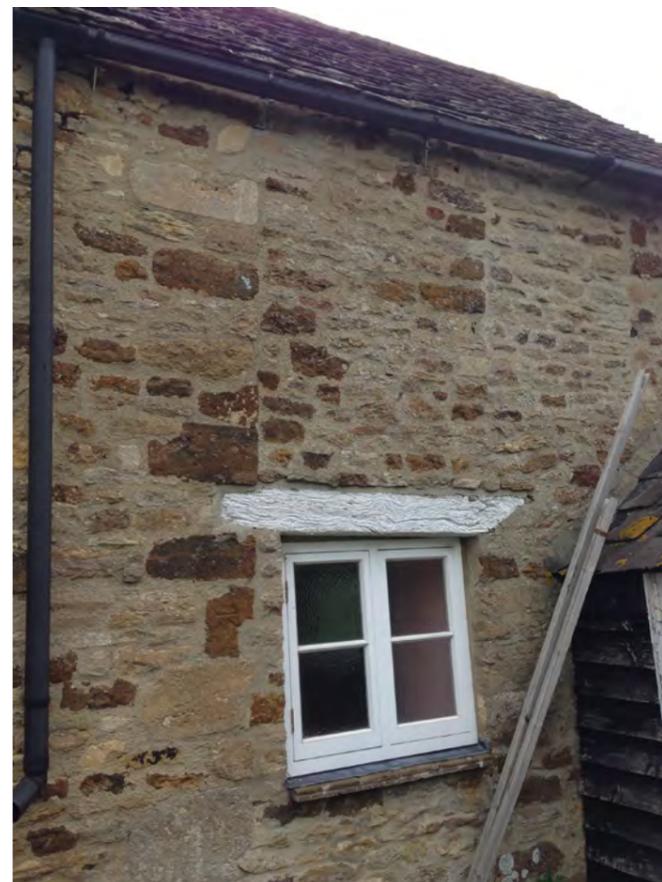
Fig.20 - Line down stonework

Toward the east of the south elevation is a clear line between the stonework (fig.20) that suggests the wall may have been either rebuilt or is a later addition.

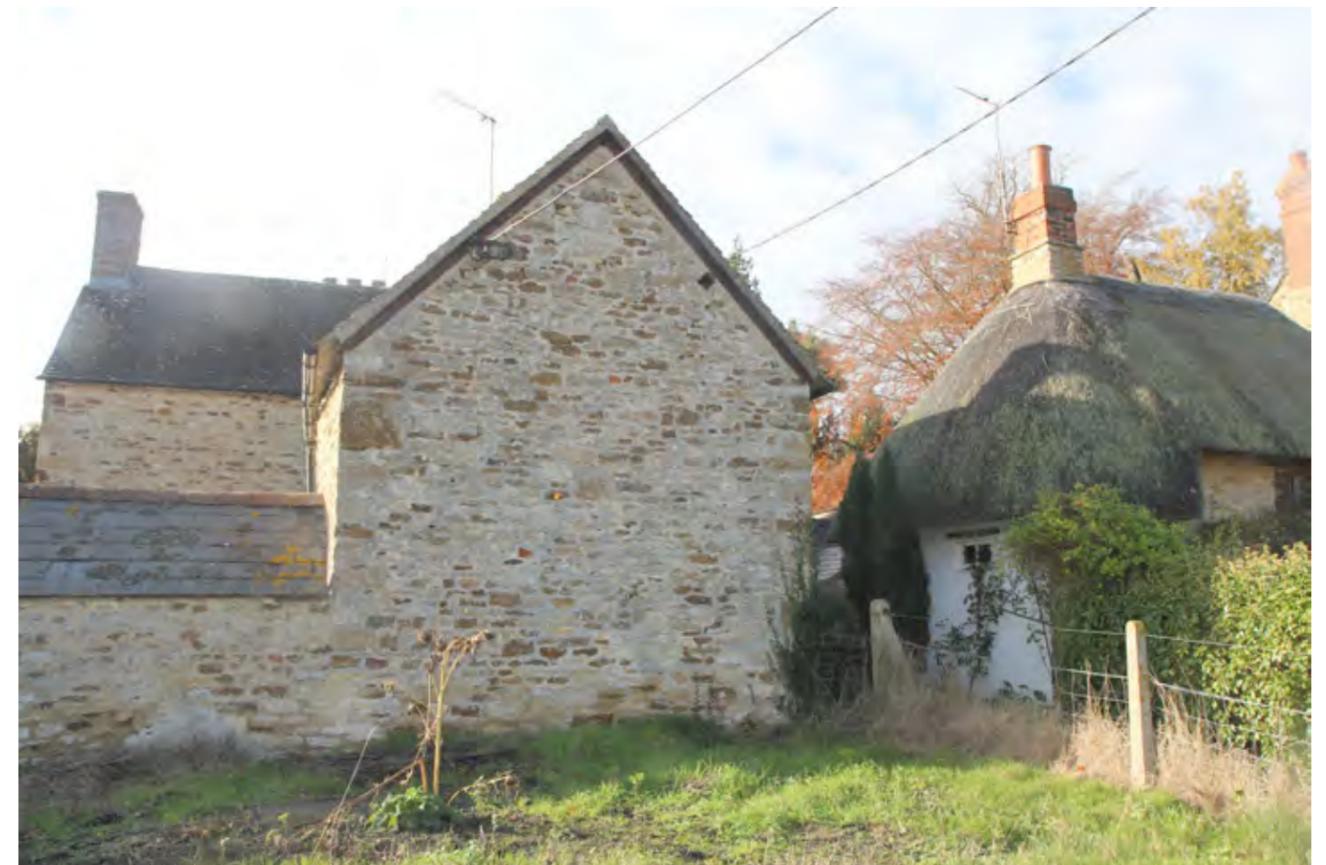
Fig.21 - East gable

The stone gable has considerable opening joints and movement cracks which extend down the centre of the wall to both corners. General repointing is required and overhaul to the gable complete and local replacement of stonework. The incoming electrical mains is fixed to the purlin end, which is clearly not helping the condition of the movement of the gable.

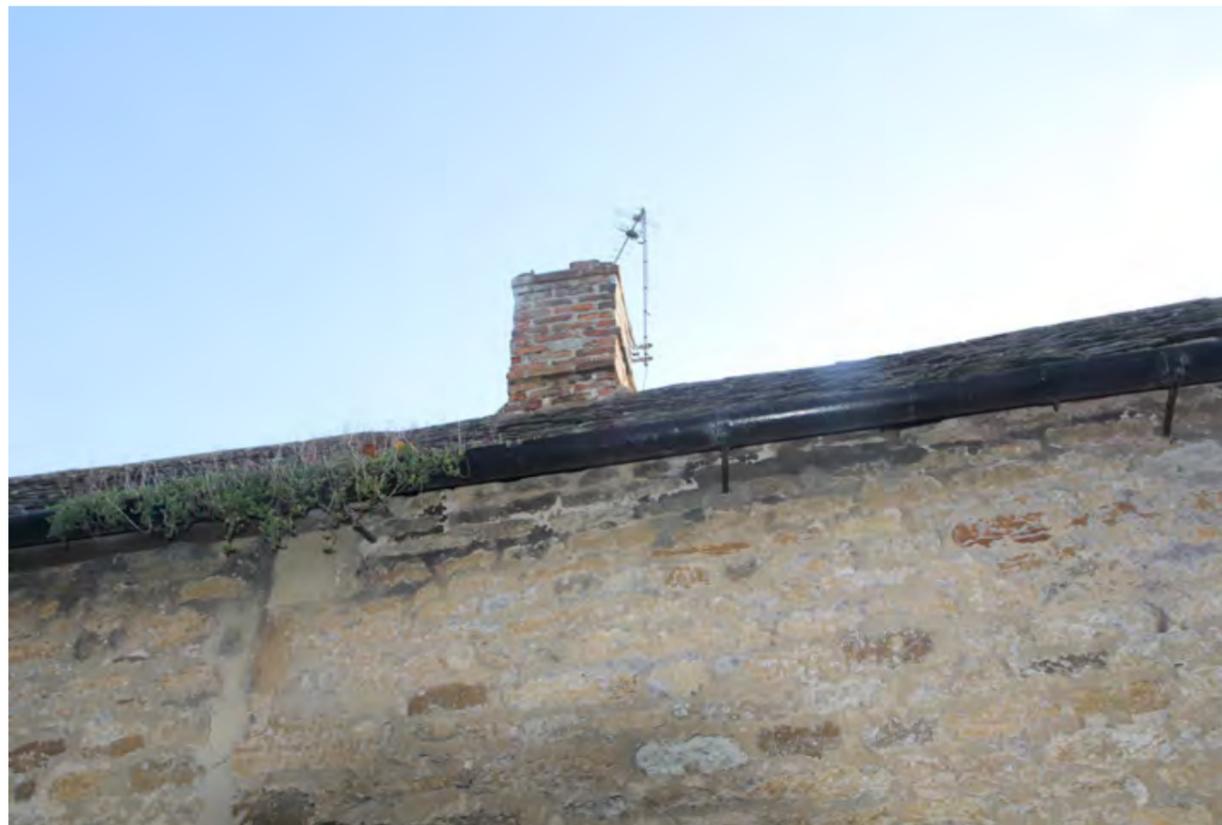
Fig.22 - North elevation to rear wing - joint between the extension

There are movement cracks evident to the bathroom, the general making good and repointing is required. Overhaul and redecoration is required to the timber 2-light casement window and the timber lintol, which is affected by furniture beetle. To the kitchen section again general repointing is required. There is an open joint, which has been pointed in a hard cement mortar between the extension and the main gable; this requires repointing. There is an aluminium gutter on rise and fall brackets, which is blocked, the general cleaning out of this is urgently required. The roof is in stone slates, which are in poor condition, and the general recovering is required. As noted previously, the chimney stack is in poor condition and the overhaul and replacement of brickwork generally is required.

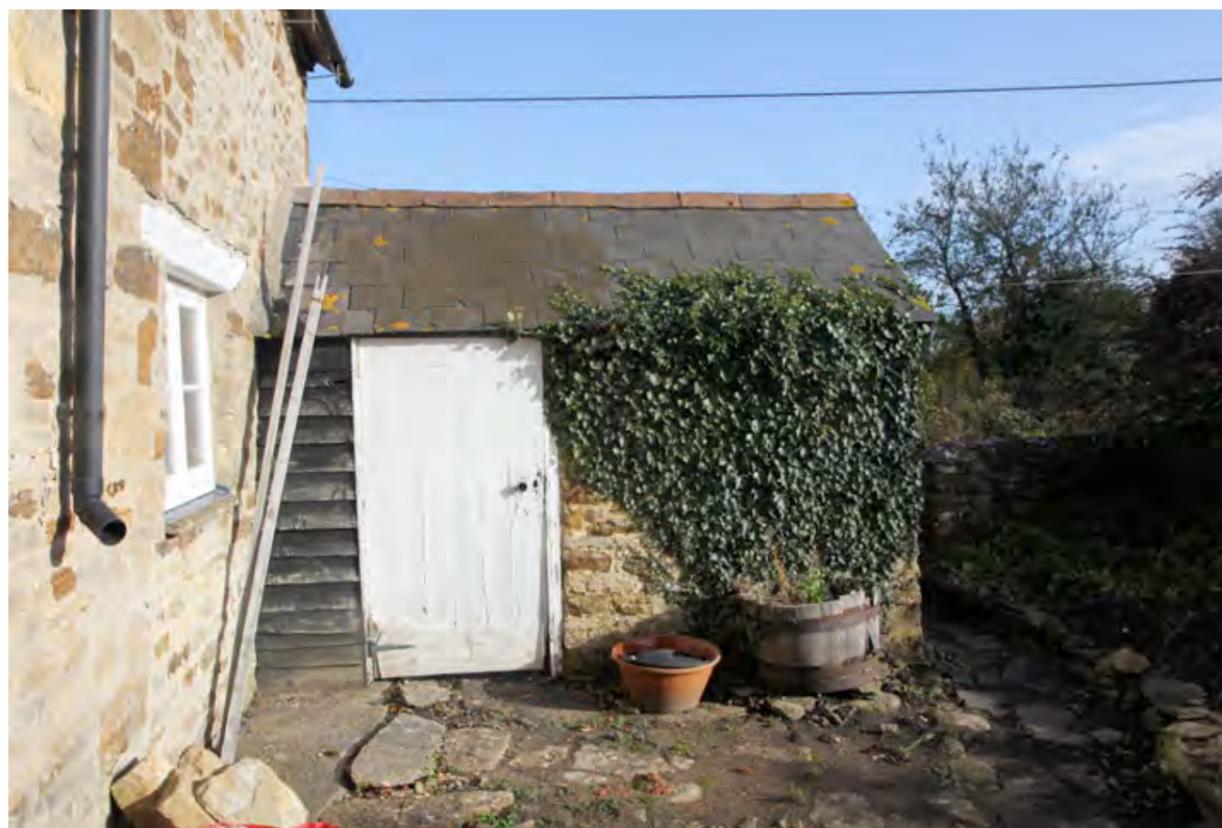
Fig.24 - Stores

The store are a mix of timber boarding, brick, and stone; and in generally poor condition. Repointing is required as well as the addition of a gutter and replacement of timber lintols. Our proposed works seek to remove the stores and reuse the stone in the new extension.

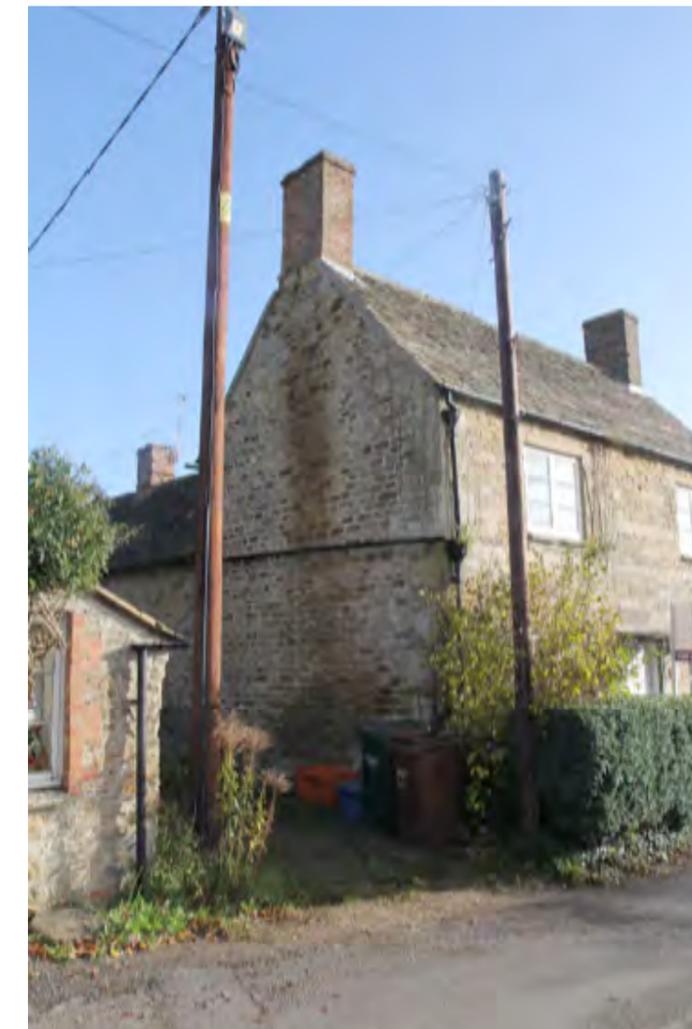
Fig.23 - North gable front section

There has been some movement to the stone here, particularly to the corner to the west. The general repointing here is required together with the removal of vegetation. The chimney stack has decayed stonework beneath the brick chimney stack, replacement of this and general repointing is required to an area of approximately 30 sq metres. Extending across the elevation is the aluminium gutter, which discharges into the copper grating to the front elevation. The replacement of this is required in conjunction with improvement of the system

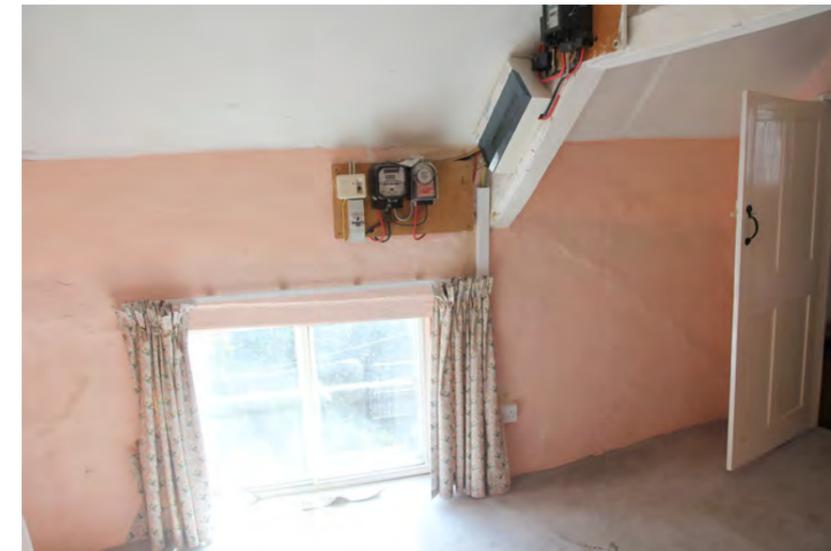
Fig.26 - Bedroom 2 - electrical incoming mains and distribution boards

The system is generally poorly installed, with surface mounted wiring that is untidy and detracts from the building.

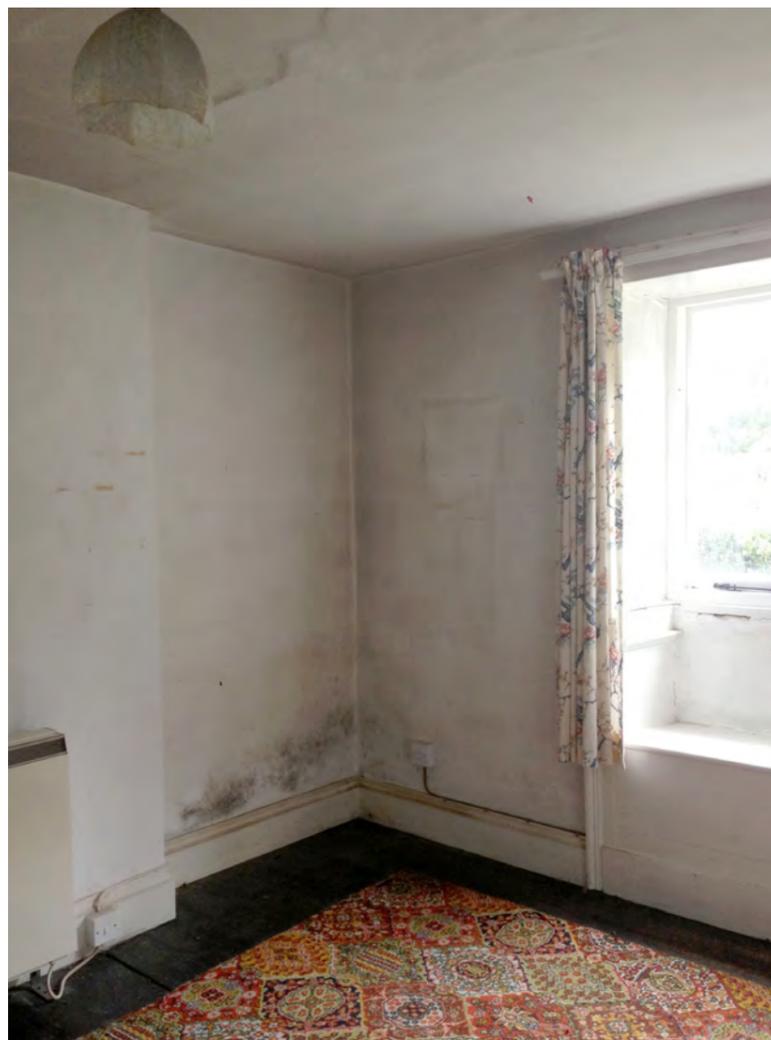
Fig.27 - Dining room - damp

The ground floor suffers from the same problems as the first: Chiefly, high levels of damp, poor quality recent decorations, and movement to walls caused by the outward thrust.

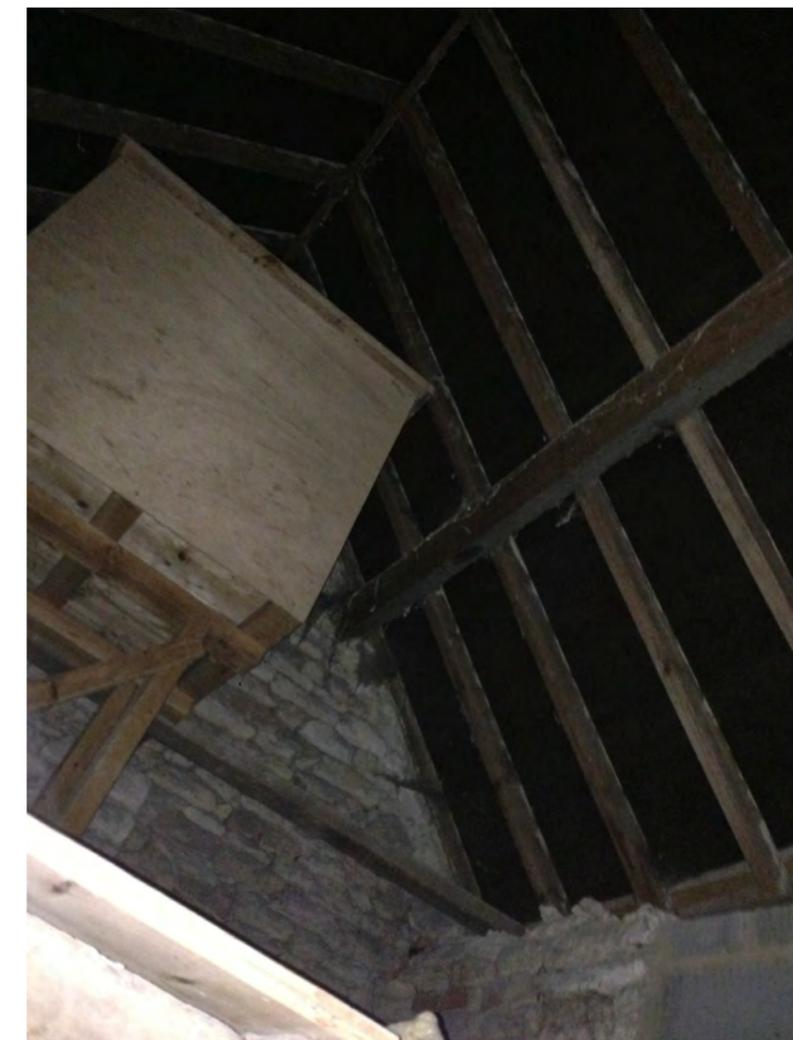
Fig.28 - Bathroom roof space

There are newer looking joists and rafters in the roof space above the bathroom that houses the water tank, again this indicates that the eastern end of the building may have been partially rebuilt or be a later addition.
