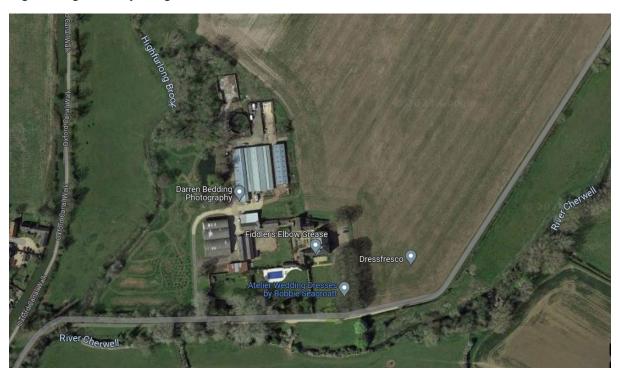
Highfurlong Book adjoining River Cherwell

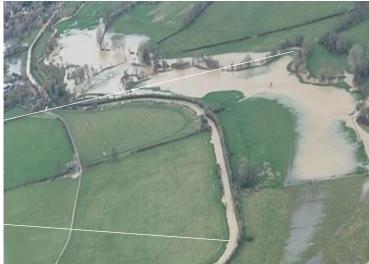
Flooding south of Cropredy, towpath is unpassable.

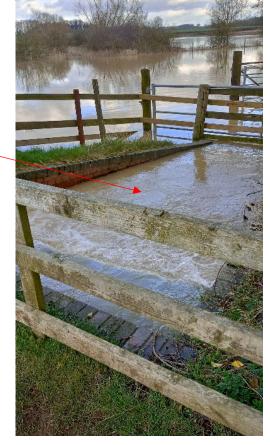
A. Canal spillway running, flooding Highfurlong Brook and surrounding fields. (one of many spillways)

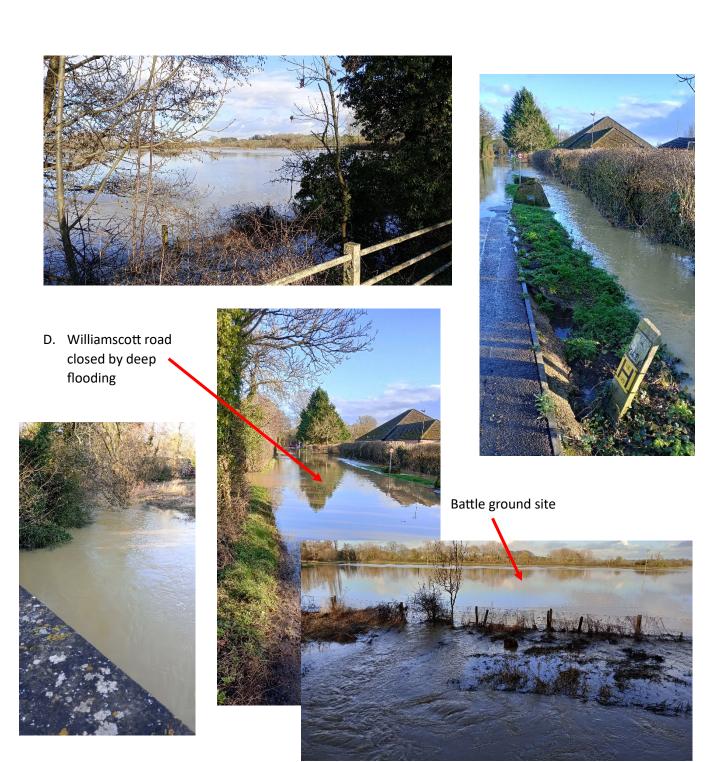
C. Proposed site of new development

- E. Route and flow direction of Highfurlong Brook (and associated flood)
- F. Route and flow direction of River cherwell (and associated flood)

G. East of lock keepers cottage (where the River and the brook run together)

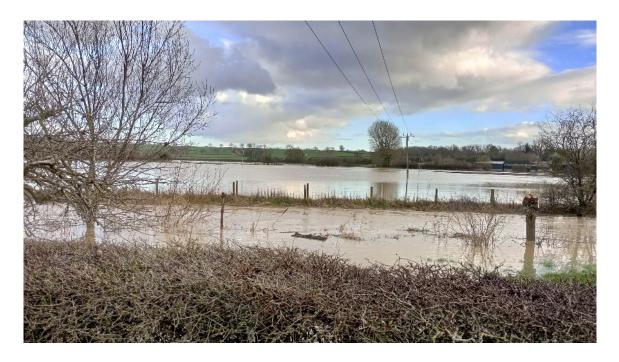
Canal at maximum capacity
