ARBORICULTURAL REPORT

To **BS5837:2012** at:

Land at
Berry Hill Road,
Adderbury,
Banbury,
Oxfordshire

Reference: *AWA1949*

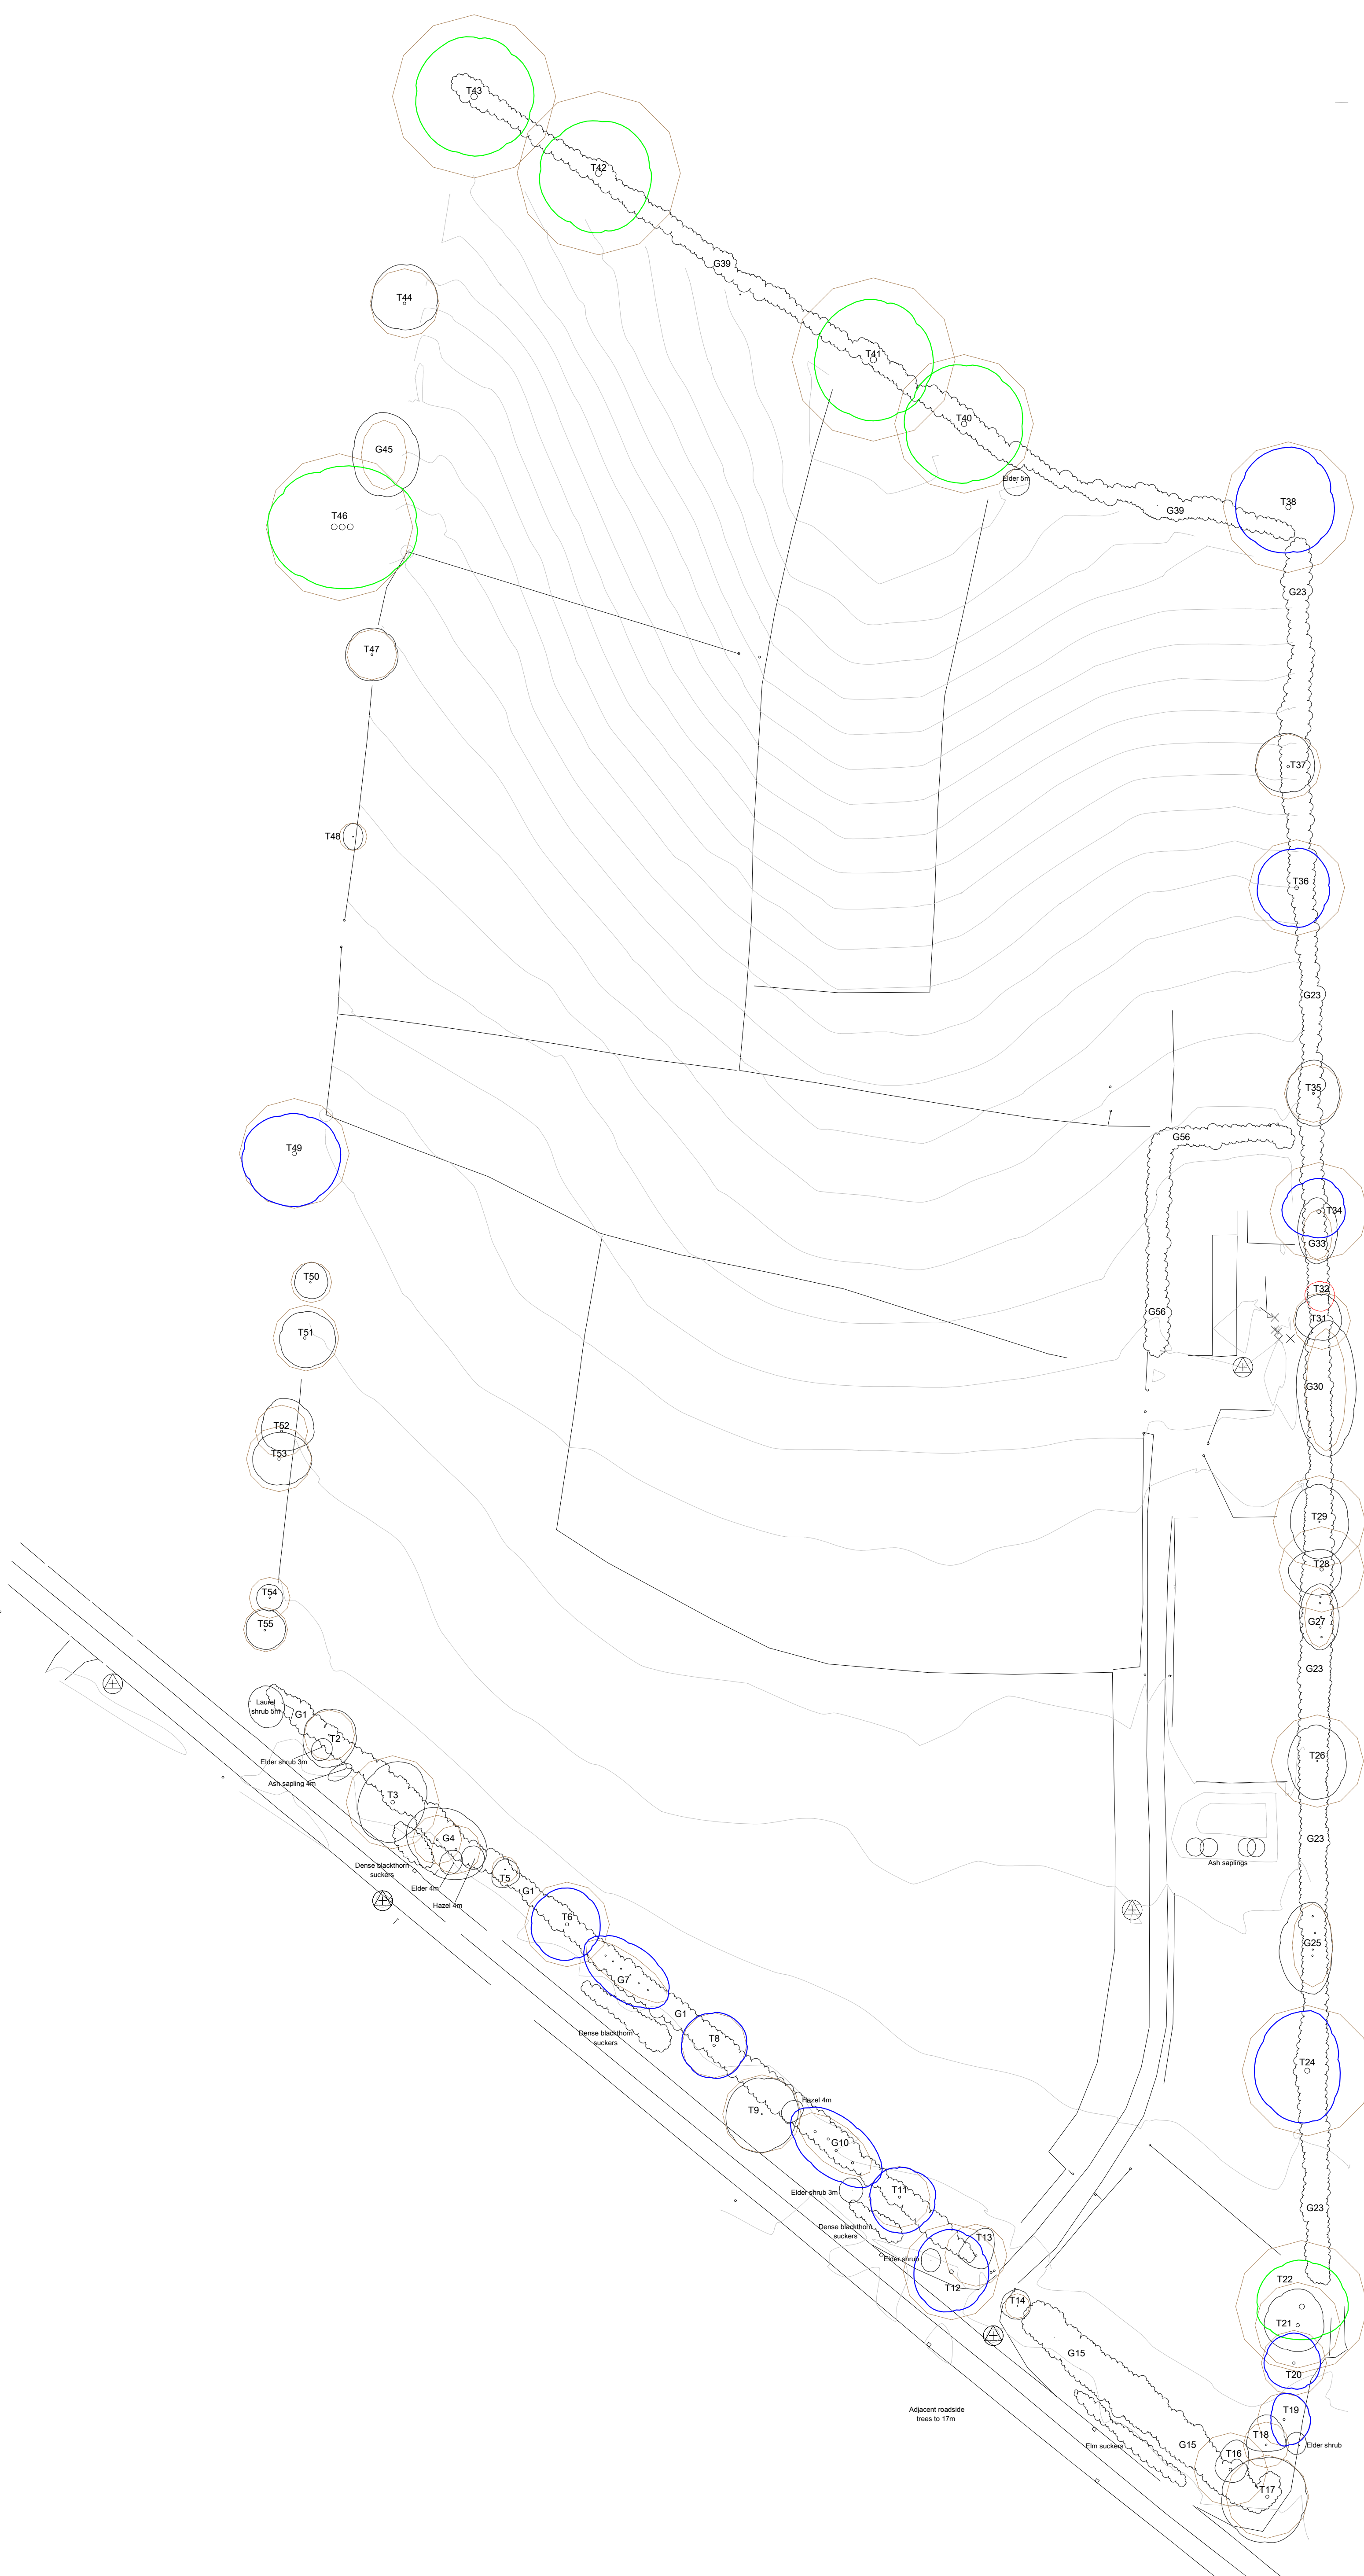
Appendix 5:
Tree Constraints Plan
 Berry Hill Rd, Adderbury
 Ref: AWA1949

- 3.2.13 The tree Root Protection Area (RPA) is detailed on the Tree Constraints Plan at Appendix 5. The RPA for each tree has been plotted as a polygon centred on the base of the stem. Due to the presence of roads, structures, topography (and past tree management) the RPA is likely to be a simplified representation of the tree roots actual morphology and disposition.

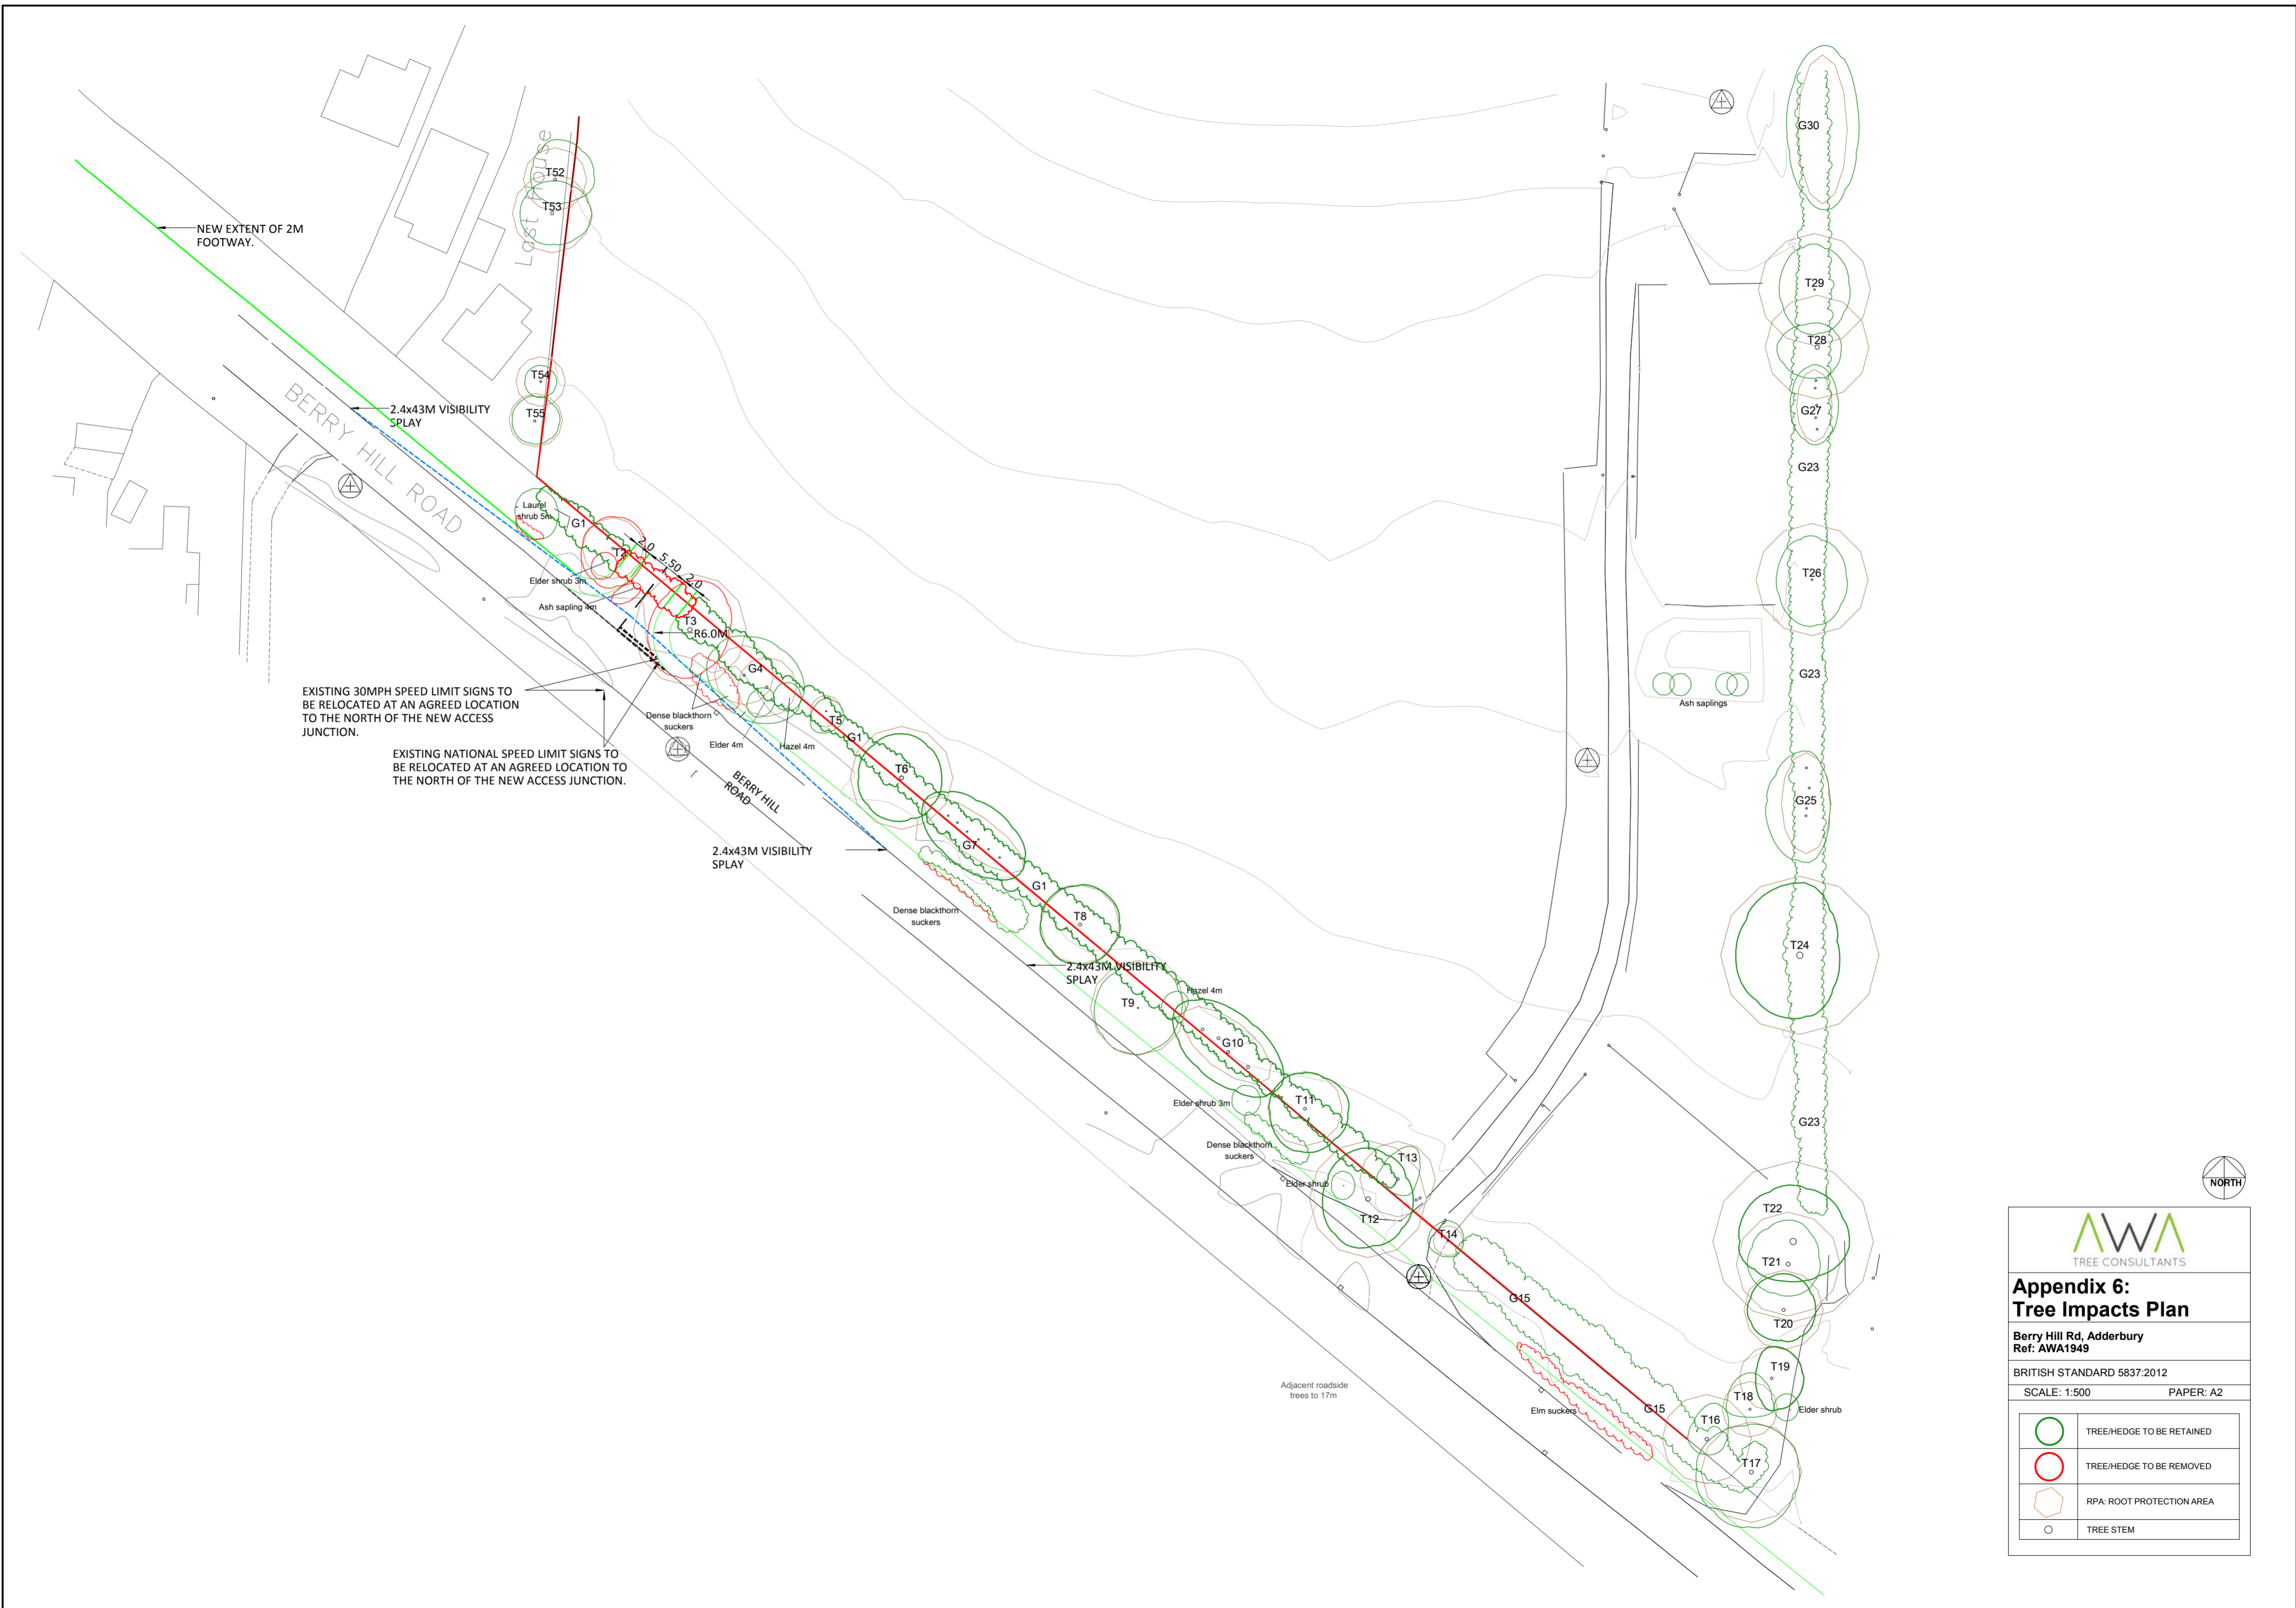
**Appendix 6:
Tree Impacts Plan**

- 4.2.1 From assessing the new development proposals, no significant trees will require removal to facilitate the new access arrangement. One Maple (T2) and one Horse Chestnut (T3) and one section of the unmanaged hedge group (Hawthorn G1), will require removal as they are situated in the footprint of the structure or their retention and protection throughout the development is not suitable.

- 4.2.2 The individual Maple T2 and Horse Chestnut T3, that require removal, are of low value, retention category 'C' and their removal will have little negative arboricultural impact at the wider site.

- 4.2.3 The removal of a 10m section of the unmanaged hedge group G1 will only have a minor negative arboricultural impact. The proposed removal of the section of G1 will have minimal impact on the overall integrity of the wider group feature. The landscape value, visual amenity and screening value of the wider group will not be lost because of the proposed new access point.

EXISTING 30MPH SPEED LIMIT SIGNS TO BE RELOCATED AT AN AGREED LOCATION TO THE NORTH OF THE NEW ACCESS JUNCTION.

EXISTING NATIONAL SPEED LIMIT SIGNS TO BE RELOCATED AT AN AGREED LOCATION TO THE NORTH OF THE NEW ACCESS JUNCTION.
