**St. George's Catholic Church,
Round Close Road, Adderbury, Oxfordshire**

Protected Species Survey Report

November 2015

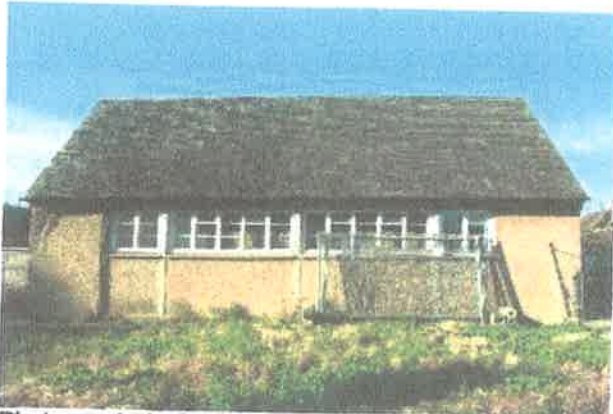
Photograph 1. St George's Church viewed from the east.

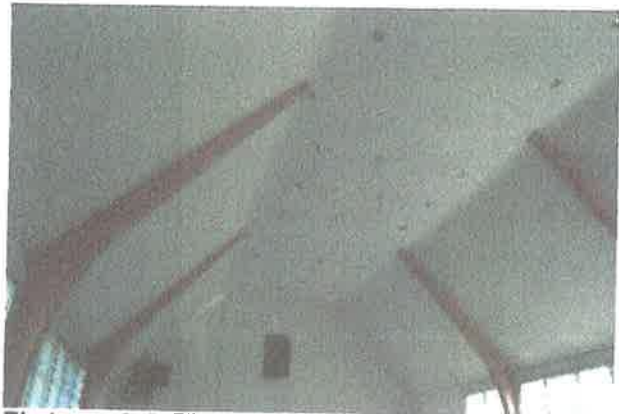
Photograph 2. The interior space of the church.

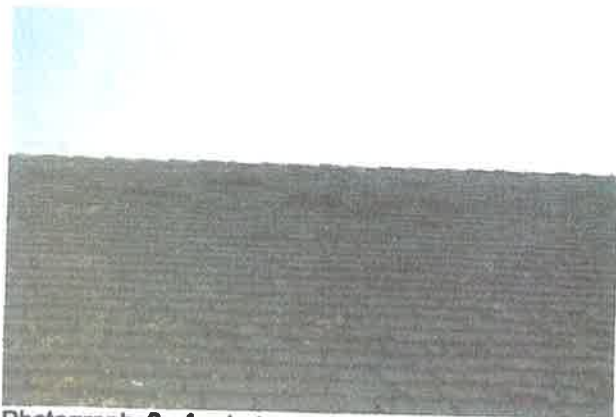
The building is in a good state of repair, with no cracks or gaps observed within the exterior render. The wooden bargeboards are tight fitting. The sloping soffit boards fitted to the eaves on either side of the building are also tight fitting. A number of wooden shingles have become very warped, but these do not appear to create any potential shelter for bats within the fabric of the roof.

Photograph 3. A photograph showing some of the lifted wooden shingles.

Demolition works should proceed in a careful and controlled manner. Contractors should be briefed with regard to the fact that individual bats can often exploit very small crevices as roost sites (such as gaps in beneath wooden shingles and beneath wooden soffits) and that bats can move between roost sites on a regular basis.

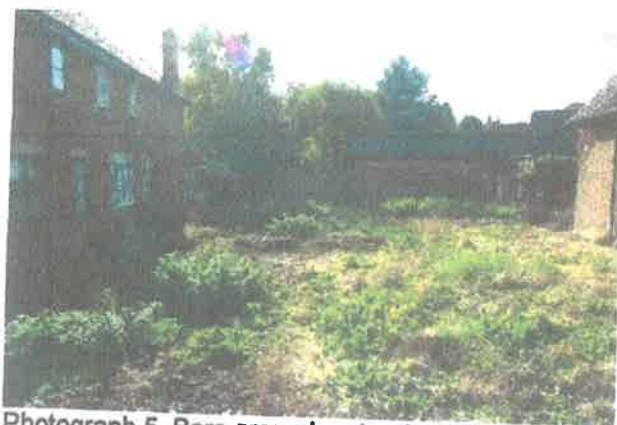
The ruderal vegetation is typical of disturbed, urban habitats and waste ground and is of negligible ecological value.

Photograph 5. Bare ground and ruderal vegetation.

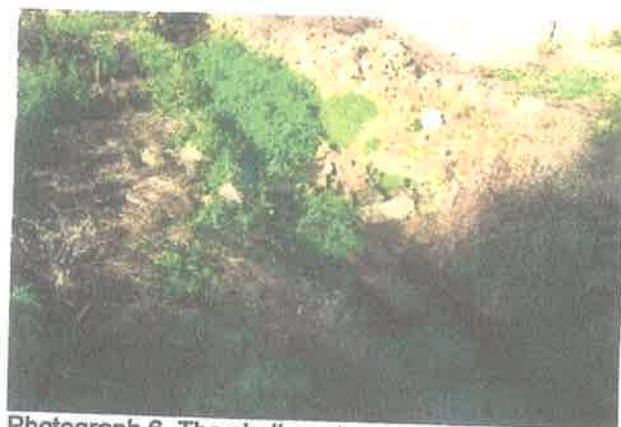
A small stream is present to the southern side of the site. It flows above ground for a short section of its length (approximately 10m) before being culverted beneath adjacent properties. The stream appears to have good water quality and is of 20cm depth at its deepest point, with a bed of rubble and soil. The only aquatic vegetation found within the stream is fool's watercress *Apium nodiflorum*. The banks are shallow and the watercourse has an approximate width of 80cm.

The stream is considered to be an important ecological feature within the context of the site. This is due to the fact that the stream provides habitat for aquatic plants and aquatic invertebrates. The stream is not suitable habitat for otters *Lutra lutra* or water voles *Arvicola amphibius*.

Photograph 6. The shallow stream.

During works to culvert the stream it should be protected from run-off and pollution in accordance with the Pollution Prevention Guidelines from the Environment Agency.
