Arboricultural Statement

Portway Bridleway, Upper Heyford

On behalf Heyford Park Estates Ltd

11th June 2018

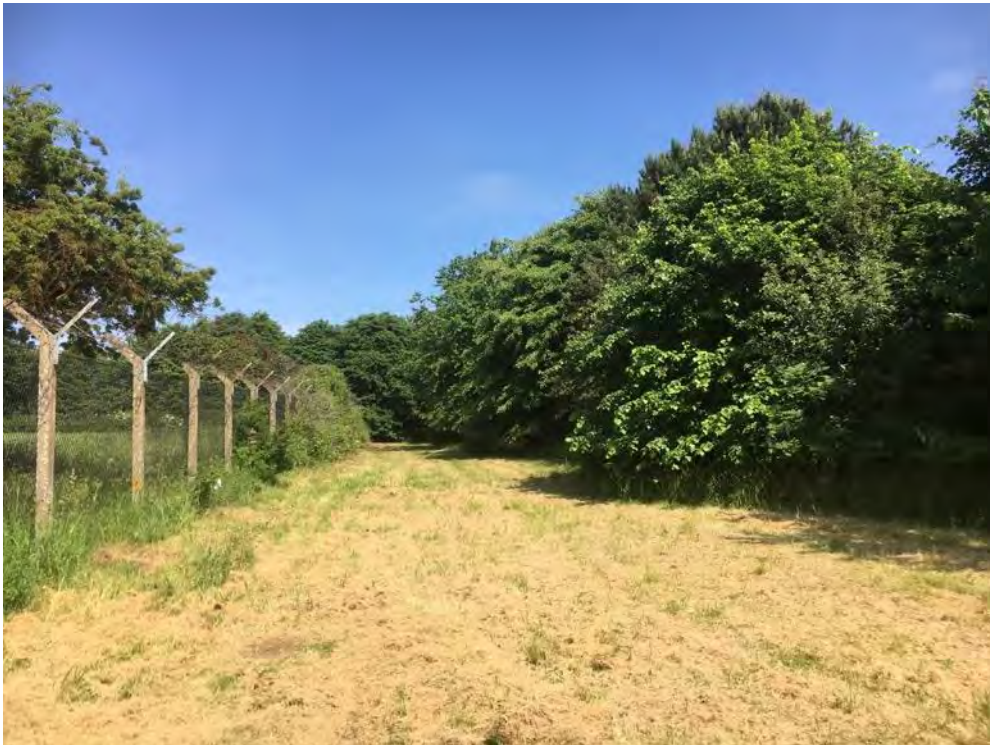
Photoview 1: View looking east towards G1024 in the background. To the right of frame is G1023 and left of frame existing chain-link fence to be replaced with 1.5m wooden post and rail.

north of G1023 without requiring any tree removal. The current gap between the canopy edge and perimeter fence is approximately 7m, although this does drop to approximately 5m in some locations. In this context, some minor canopy pruning in the form of a lateral reduction will need to be undertaken along the northern side of G1023 where required to ensure at least a 0.5m clearance of the proposed chain link to allow for its erection. It is considered that this would be acceptable from an arboricultural perspective and unlikely to give rise to significant effects on the trees within the group.

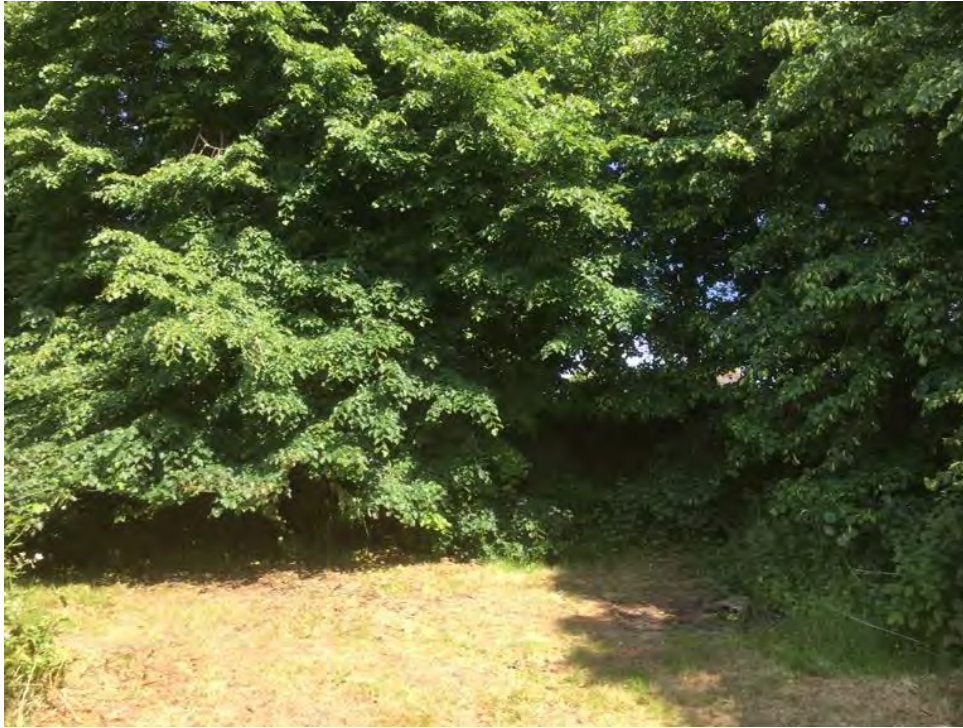
Photoview 4: View looking east towards G1024 where the new southern chain-link fence alignment and access to the earth embankment is proposed.

- 6.12 The proposed new chain-link fence is shown to cut through G1024 in two locations. This is to enable public access to the top of the embankment, which is immediately to the east of the canopy spread of G1024, to allow public views across the flying fields. The alignment of the fencing through G1024 is likely to require a small number of stems to be removed and canopy pruning to enable construction and clearance of fencing (see Photoview 5) Given the nature of proposals there is flexibility to align the fencing around existing trees and avoid stem removal as far as possible.

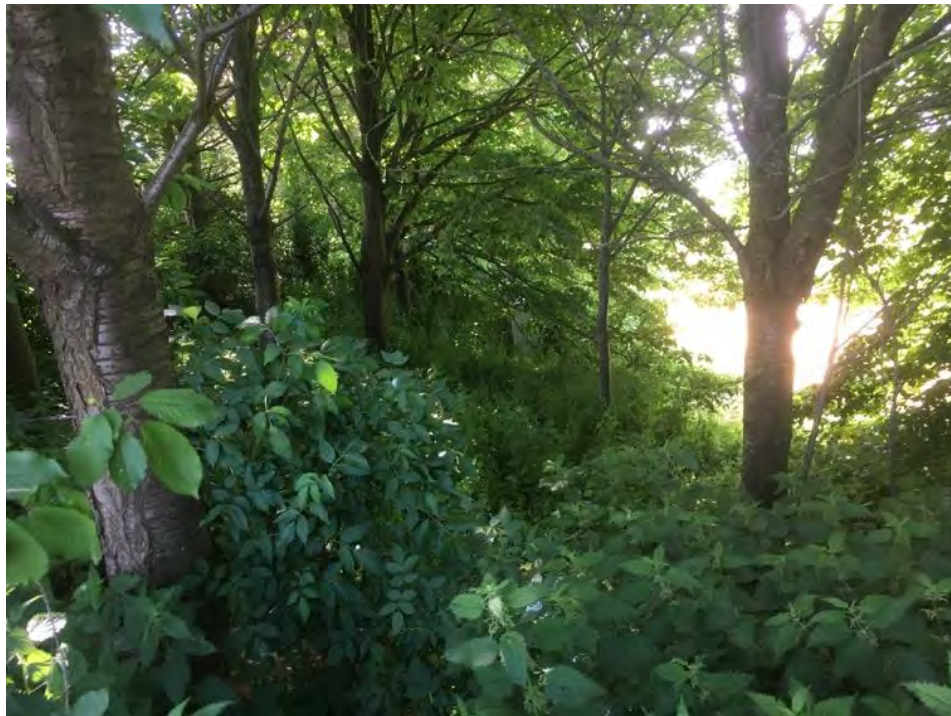
Photoview 5: View looking west from the earth embankment along the proposed alignment of the southern chain-link fence within G1024 towards the location of viewpoint 4 outside of the group beyond.

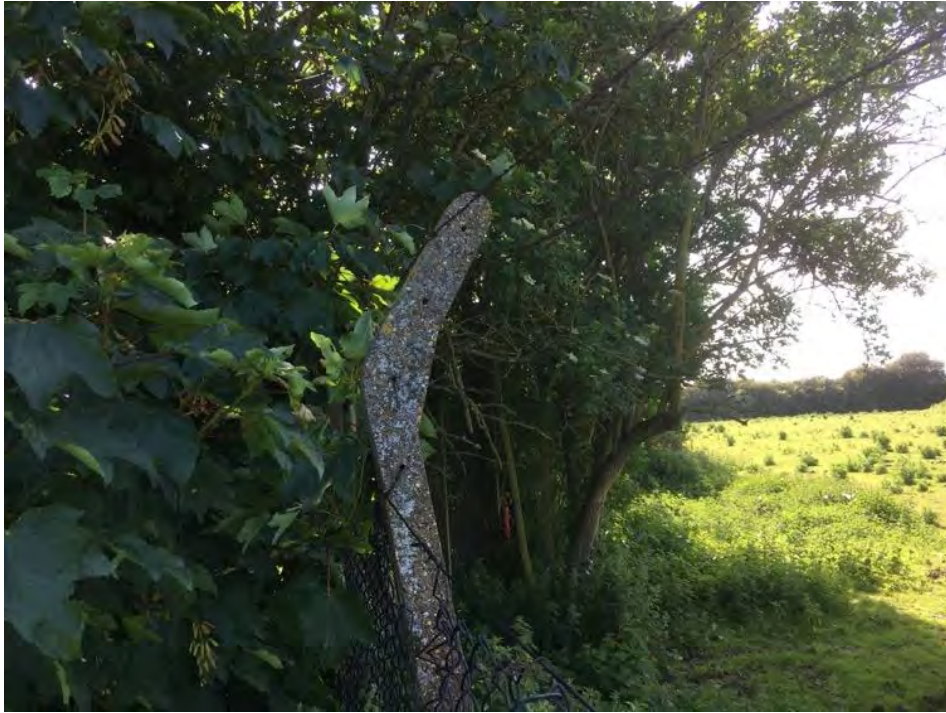
Photoview 6: View looking west from the eastern side of H1018 towards the elder bush growing in front of the proposed connection to the existing bridleway at the southern part of the site.

to be removed. In addition, existing elder stems to the front of the existing fencing (see photoview 6) will require removal.

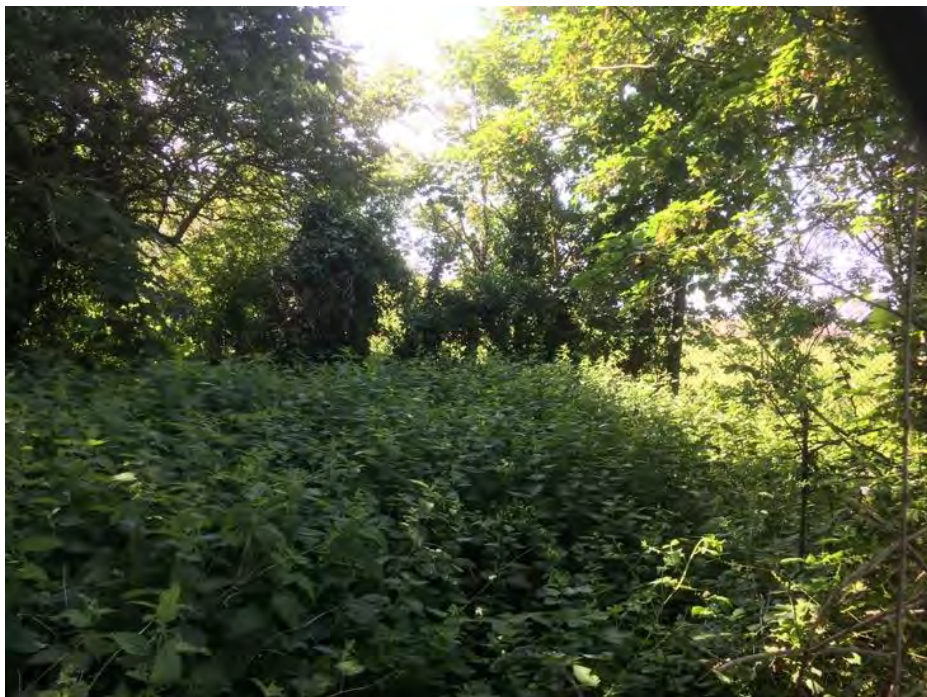
Photoview 7: View looking north west within H1018. The proposed bridleway connection point can be seen in the lighter area to the right of frame.

- 6.15 As shown in photoview 7 trees within H1018 are located on the boundaries of the bridleway and existing chain-link fencing. There is a multi-stemmed sycamore shown in photoview 8 on the eastern aide of H1018. The proposed new chain-link fencing is to connect with existing fencing in this location. It is likely some lower canopy pruning could be required as part of the construction process, however the tree would not need to be removed.

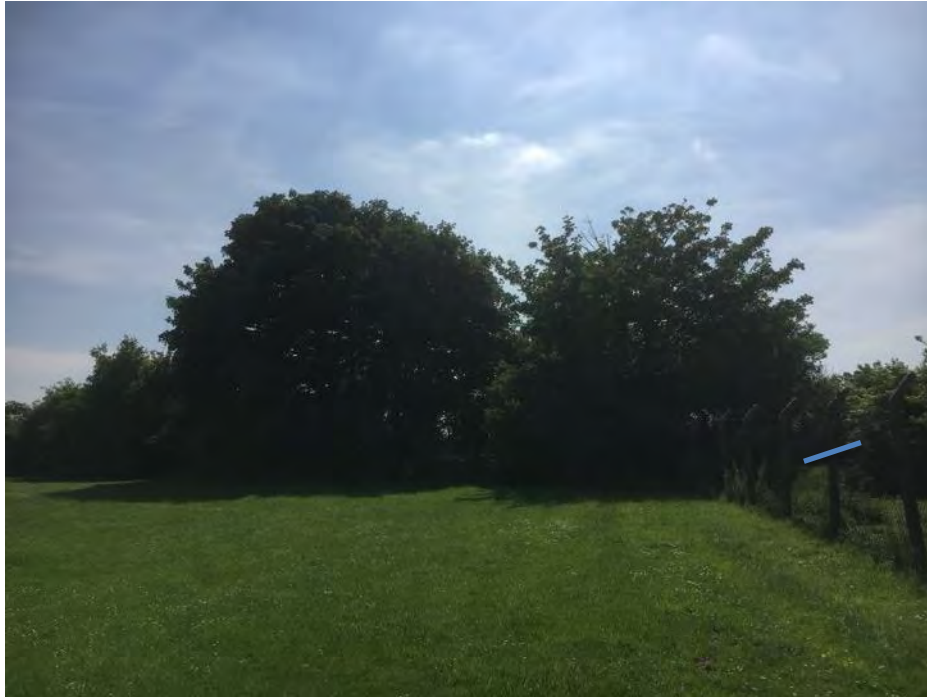
Photoview 8: View looking south west towards the eastern edge of the northern end of H1018. The tree visible to the right of frame is an early/mature to mature sycamore growing along the existing chain-link fence line. The proposed connection to the existing bridleway will come in just west of the northern side of this tree, indicated by the blue line.
