# Claydon Marina

Follow-up report – Revision 3

858429

**Title:** Claydon Marina – follow-up report

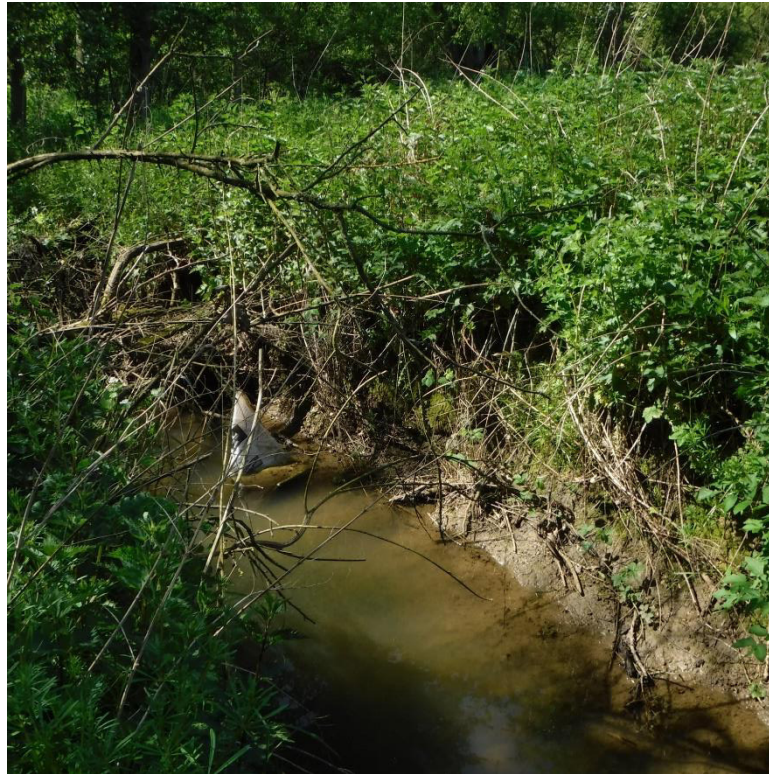
At the upstream extent of the survey area (SP 45788 51385) the brook meanders through an area of woodland within the North Claydon Disused Railway Local Wildlife Site (LWS). This section is characterised by shallow water depth (c.5-20 cm depth), a silted, clay substrate and slow, or imperceptible flow; primarily a result of impoundment from several coarse woody debris (CWD) dams within the brook (Figure1). A surface film was noted at several impounded areas. Some small sections of very shallow run or riffle habitat with a silted pebble / gravel substrate were noted. The brook flows into a shallow culvert c.25 m long under Boddington Road before continuing downstream adjacent to the proposed development area.

**Figure 1 - Typical habitat (shallow glide) upstream of the proposed development**

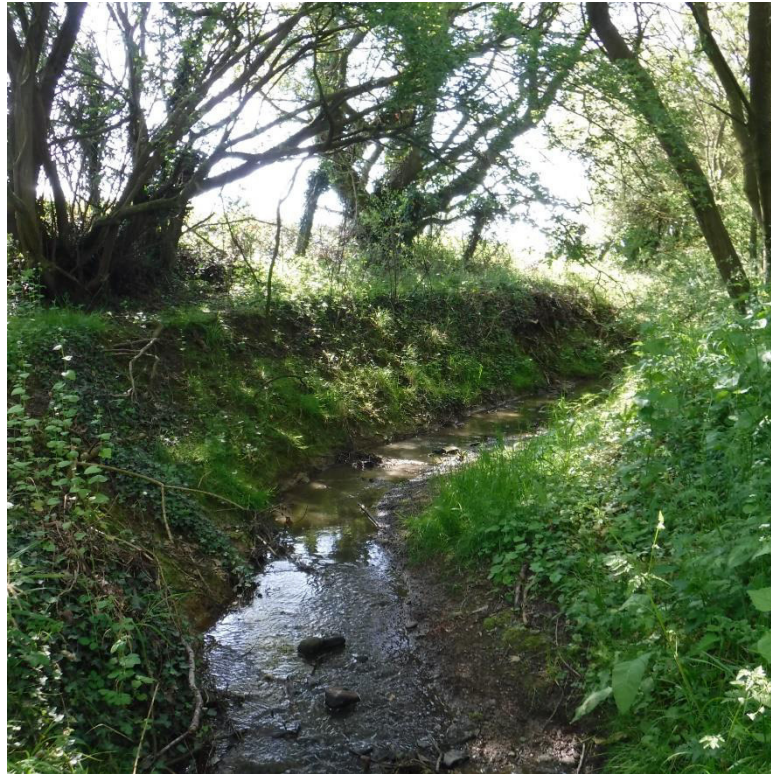
The channel downstream of the culvert is similar to the upstream channel with shallow areas of slow flowing glide or no perceptible flow. Short sections of shallow run or riffle were noted, particularly alongside depositional features such as side or point bars. Several CWD dams were present creating short impoundments of deeper (c.20 cm) glide. The development includes plans for a small headwall within this section (outfall from the proposed clubhouse sewage treatment plant) approximately 250 m downstream of the culvert. The habitat around the proposed headwall location is a mixture of shallow glide and shallow run (<10 cm depth) over a mixed substrate of clay and silted pebble and gravel. The proposed headwall location is on the RHB which is tall, steep and vegetated (Figure.2).

**Figure 2 – Facing upstream looking at the approximate proposed headwall location**

- Headwall installation – disturbance to the banks and bed of the brook should be minimised as much as practicable. Having an ecological clerk of works (ECoW) on site during headwall installation would be advisable to assess the exact placement locations for protected species (such as water vole & white-clawed crayfish) and provide advice to minimise disturbance to the watercourse.

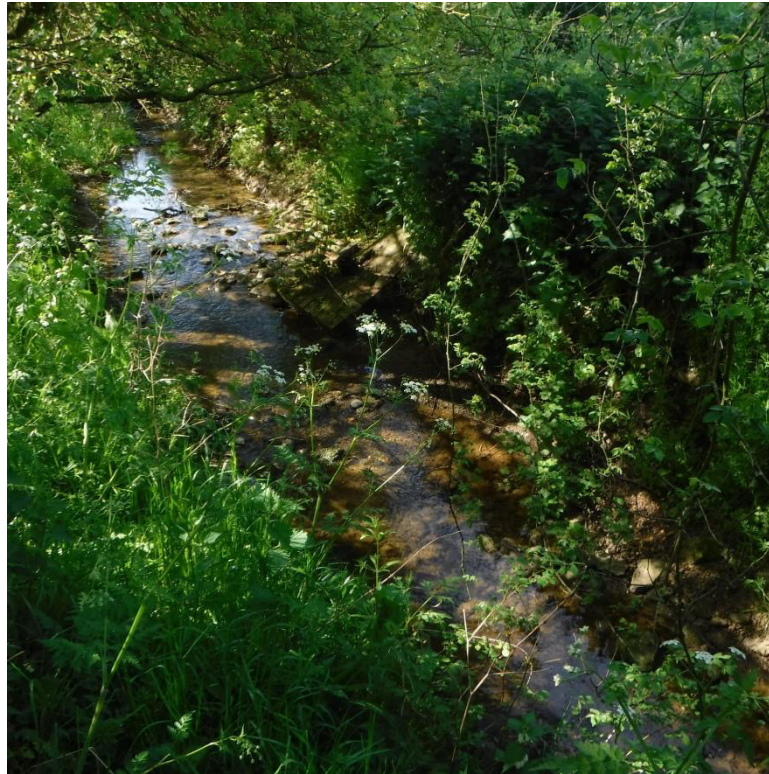
A short distance downstream of the proposed headwall location the channel has been historically re-aligned for c.400 m, presumably during construction of the now defunct railway, of which little visible evidence still exists except for old fencing. Access is poor along much of this reach being inhibited by dense riparian vegetation. Sufficient gaps existed to permit a survey to be undertaken. Habitat does not vary significantly in this reach from that present upstream being predominantly a mix of shallow glide and very shallow run over a mix of clay and silted pebble / gravel substrates (Figure.3).

**Figure 3 - Shallow run habitat within historic straightened section**

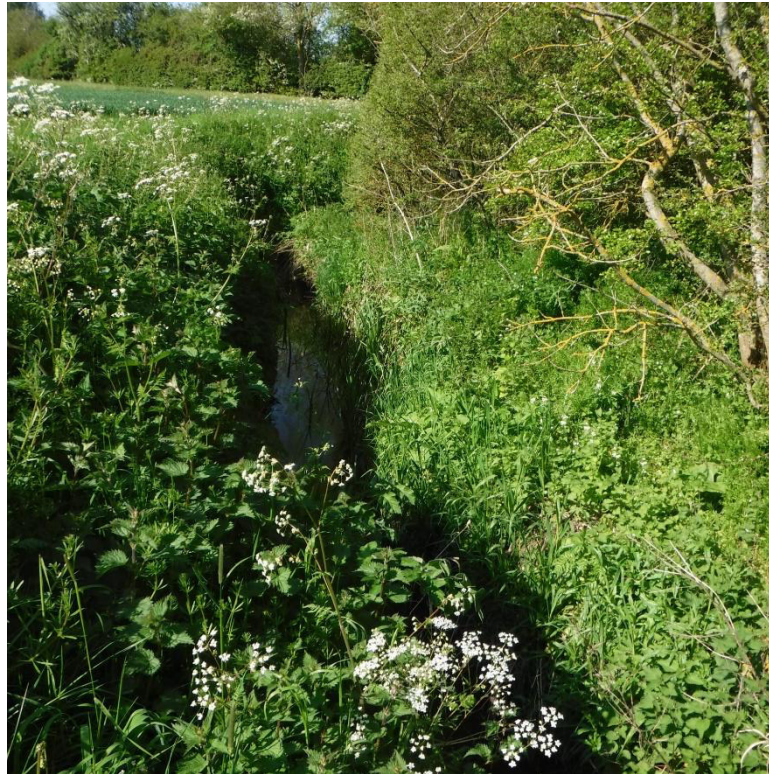
As the brook exits the culvert it flows through an over-deepened section with the RHB being particularly steep and overgrown (Figure 4). Flows are sluggish throughout this section mainly comprising shallow glide (c.10 – 30 cm depth). This section represents the first part of the survey reach outside of wooded areas and as such shading is significantly reduced allowing emergent macrophyte species to grow within the channel. This section may provide potential water vole (*Arvicola amphibious*) habitat.

**Figure 4 - Facing upstream - over-deepened section with glide habitat**

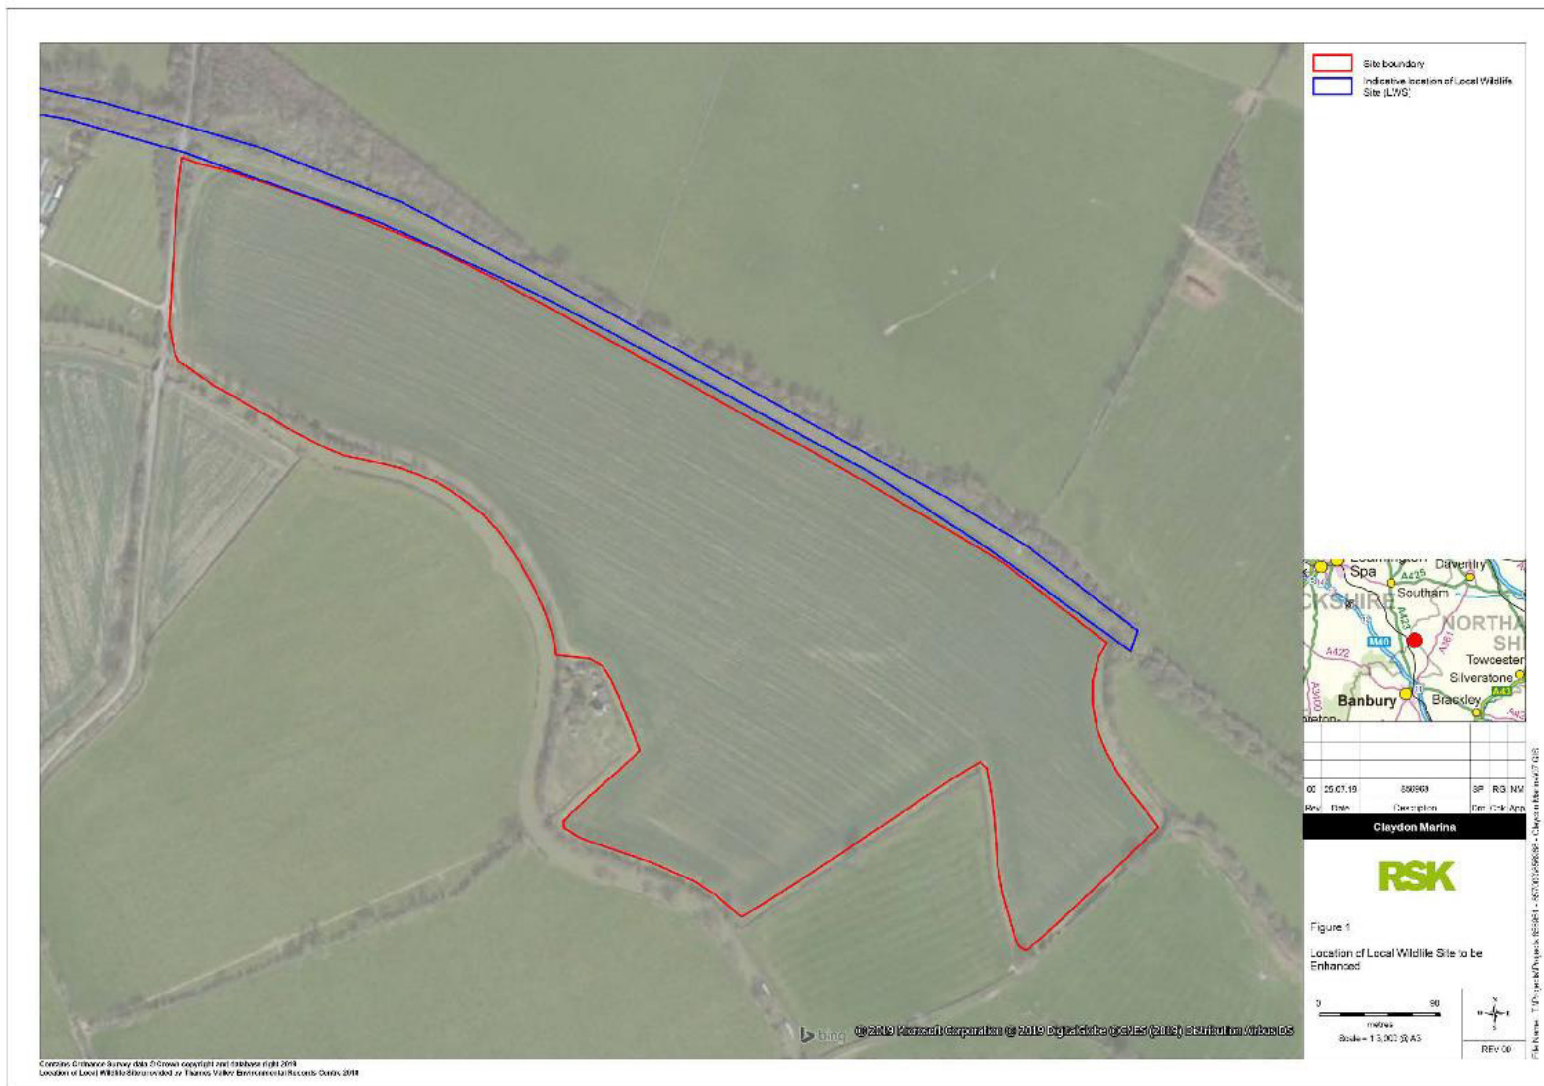
The North Claydon Disused Railway local wildlife site is located along the northern boundary of the development (Figure 1), encompassing the now little used agricultural access track and part of the arable field and the woodland corridor through which Wormleighton Brook flows. The LWS is known to contain areas of scrub and rough wet grassland<sup>6</sup> with the section along the development boundary composed predominately of rough grassland. Scrub is noted by the Thames Valley Environmental Record Centre (TVERC) as an uncommon habitat throughout much of Oxfordshire<sup>5</sup>, and current proposals plan to incorporate scrub habitat within the development site which will include at least three woody species, no weeds or invasive species and will have a good age range and a well-developed edge<sup>7</sup>.

Figure 1 shows the location of the local wildlife site (LWS) to be enhanced as part of the proposed development. As stated the LWS is outside of the development boundary and the proposed enhancements relate to improving connectivity and strategic creation of habitat opportunities. As these factors are not included in the current version of the biodiversity calculator, it has been deemed inappropriate to use the calculator to assess the potential biodiversity gain from the LWS habitat improvements.

Following discussions between RSK and SBRice Ltd the developer has agreed to plant and manage the LWS strip in a manner which improves connectivity of the LWS to the surrounding habitats including those proposed within the development site. RSK propose that hedgerow / woody scrub species are planted along the existing hedge / fence line to increase the scrub habitat within the LWS and provide an additional buffer against disturbance of the river corridor. Across the remainder of the LWS strip between the proposed hedge to the north and existing development boundary to the south wildflower planting is proposed.
