Appendices

Appendix A: Historic Windows

Windows – incomplete set of photos			
Windows Exterior	Windows Interior - Add	Historic/modern	Location

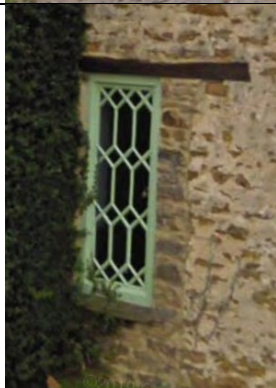
Historic but not original, timber, not sure if it has timber glazing bars or metal T-bars	No 7 – North West Elevation (front) GF north cell

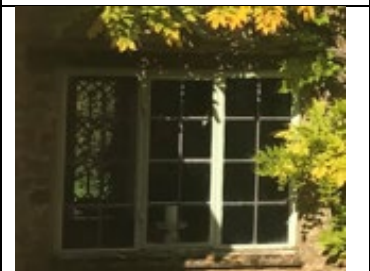
<p>Historic Lead comes</p>	<p>No 8 – North West Elevation (front) 1F south of No8 cottage</p>

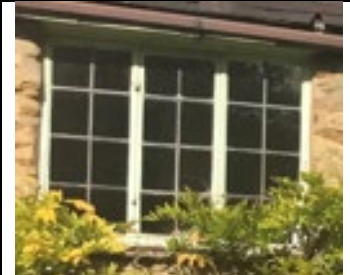
<p>Historic Lead comes</p>	<p>No 7 – South East Elevation (rear) GF north</p>

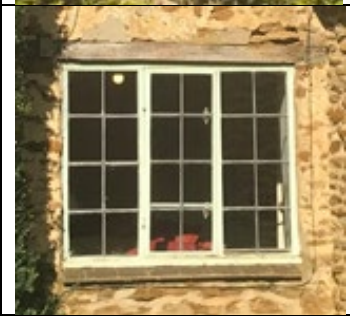
<p>Historic Lead comes</p>	<p>No 7 – South East Elevation (rear) 1F north</p>

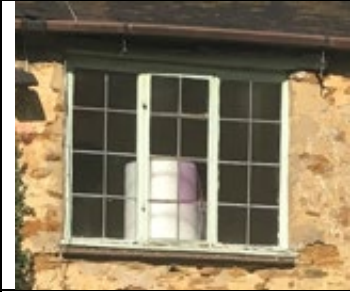
<p>Historic Lead comes</p>	<p>No 7 – South East Elevation (rear) GF south</p>

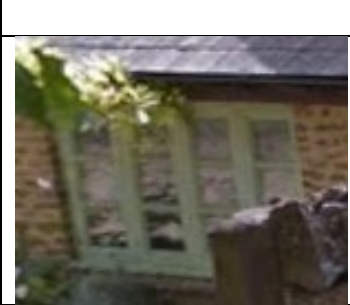
<p>Historic Lead comes</p>	<p>No 7 – South East Elevation (rear) 1F south</p>

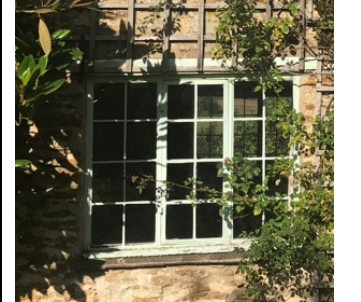
<p>Modern 2009 Lead comes</p>	<p>Porch North East Elevation – 2 side lights</p>

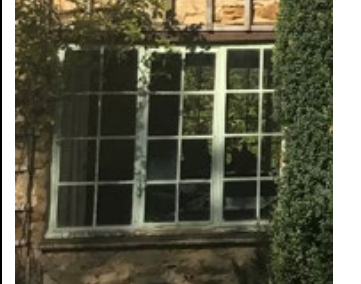
<p>Historic Are the glazing bars lead comes or metal T-sections</p>	<p>No 8 - GF South East elevation 1F south (rear)</p>

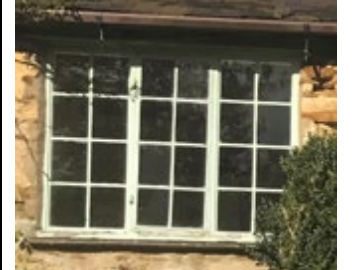
<p>Historic Are the glazing bars lead comes or metal T-sections</p>	<p>No 8 - GF South East elevation GF north (rear)</p>

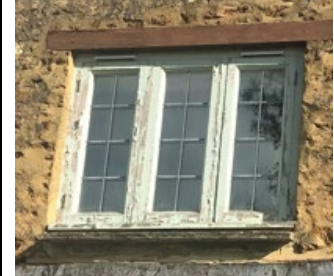
<p>Historic Are the glazing bars lead comes or metal T-sections</p>	<p>No 8 - GF South East elevation 1F north (rear)</p>
