**Application Site:**

7 The Colony, Colony Road, Sibford Gower OX15 5RY

**Proposals:**

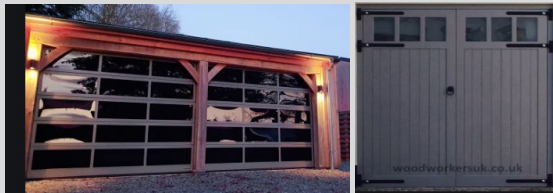
New garage doors. This was approved as an open shed/car port. The proposals look to insert glazed panelled doors behind the timber post as an up and over door. The pattern and material is not sympathetic to the setting and would look more like a car showroom (below left). If they are intent on enclosing the bays then traditional painted boarded garage doors which are side hung would be more appropriate. A traditional flush door could accommodate windows at the top. An example is below right (ignore the hinge positions).

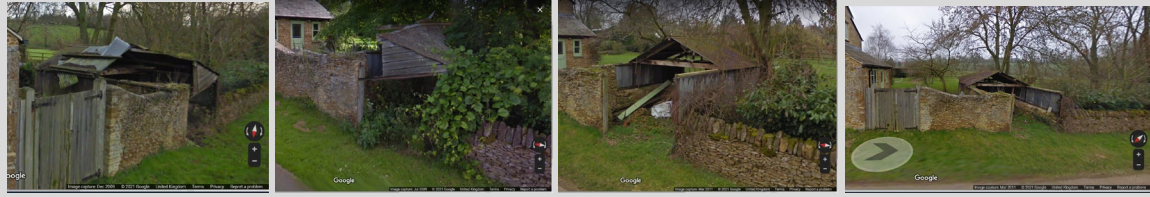
Whilst there are remnants of corrugated iron or tin, the structure is not the original form. Looking at the masonry and the historic plans, it seems likely this was a possible pigsty.

The proposal is not sensitive in scale or material. The land is lower at this point as the road falls to the south. The proposed eaves are considerably higher than the existing eaves and higher still than the earlier structure. I would not support this increase in scale as a building in this position should be modest and not detract from the simplicity of the pair of Quaker’s cottages. A modest replacement single storey structure would be supported, the proposal is too high and the glazed gable could dominate the setting. The taller part of the wall has been extended, as seen by the vertical joint, I would not object to this continuing to meet the lower stone boundary wall. A waney-edged timber cladding could be built on top of the lower masonry walls. Alternatively the masonry walls could be increased in height to a low single storey, it may be possible to include a discreet clerestory between the eaves and the top of the wall to avoid raising the height of the stone boundary wall or cross wall (see Fig 23 in <https://historicengland.org.uk/images-books/publications/adapting-traditional-farm-buildings/heag158-adapting-traditional-farm-buildings/>). Whilst there may be scope for the rear elevation to have glazing, this should be mindful of the possible impact on the surrounding countryside and light spill, the gable could be very visible from the bridleway to the south. The impact of any glazing could be reduced by

projecting the roof beyond the glazing, or timber louvred screens could be added. The existing roof itself is of low pitch and this might lend itself to a traditional corrugated roof that one might see on a farm outbuilding, these roofs are also good for rain harvesting. Alternatively we would not object to a natural slate roof to match the house.
