PROJECT: BARTLETT COTTAGE, SIBFORD GOWERS, OS 15 5RY

## 4.0 Proposed Works

### 4.01 Restoration Works - Roof Works & Chimneys

With reference to Allcott Residential Building Survey (Level 3) conducted on 2 SEP 2020 and the accompanying plans.

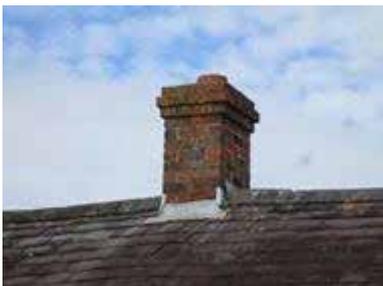
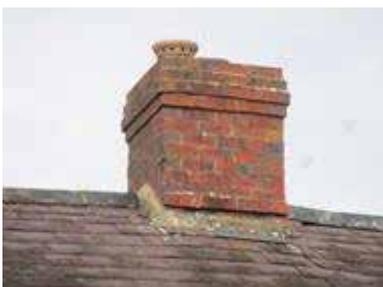
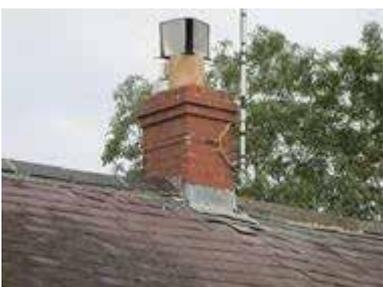
1 It was identified by the surveyor that there are light deterioration to the three chimney stacks.

Existing Chimney Stack - Left

Existing Chimney Stack - Central

Existing Chimney Stack - Right

The proposed restoration works includes the re-pointing of the brick mortar, redressing of lead flashing, replacement of cracked chimney pot works required to the existing chimney stacks

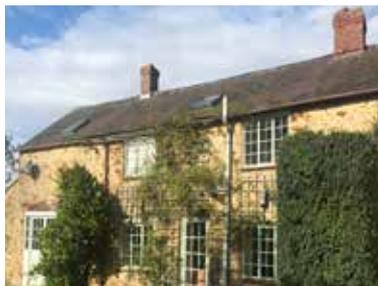
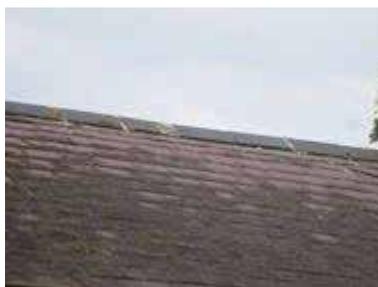
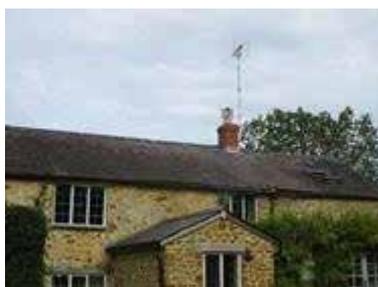
2 It was identified by the surveyor that there is undulation to the ridge tiles due to deterioration of the mortar pointing.

Existing roof ridge - left side

Existing roof ridge

Existing roof ridge - right side

The proposed restoration works includes the re-pointing and re-bedding of the ridge tiles.

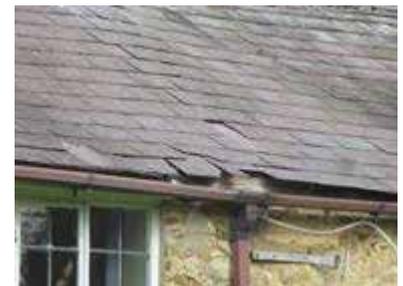
3 The existing roof is covered in slate tiles, there are slipped and damaged tiles.

Damaged and slipped slate tiles

The proposed restoration works includes the reinstatement of slipped tiles and replacement of damaged tiles with matching slate tiles.

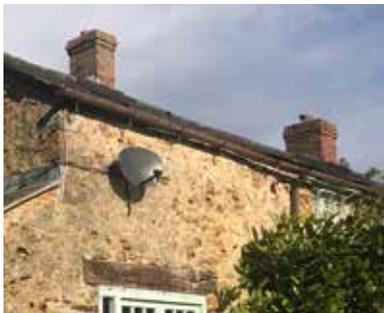
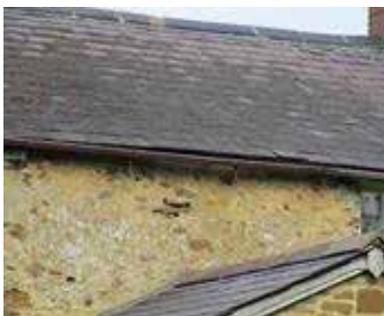
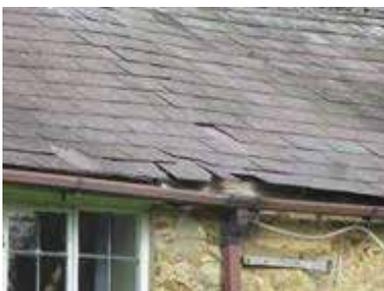
The existing gutters are mix of brown PVC and metal in a simple profile supported off metal brackets. Some of the gutters are in a poor state and pulling away and separated from the roof slate. Some of the existing timber fascias are in a poor state. The proposed restoration work is to replace all the existing with new conservation painted ( colour to match window frames ) metal gutter and down pipe system ( in a sympathetic “deep round” profile ). Existing fascias will be replaced with painted timber fascias. Other work include the incorporation of a felt support tray which will bridge the gap between the roof slates and the gutter to prevent ongoing saturation at the junction between the roof tile and adjacent building elements.

Existing Gutters

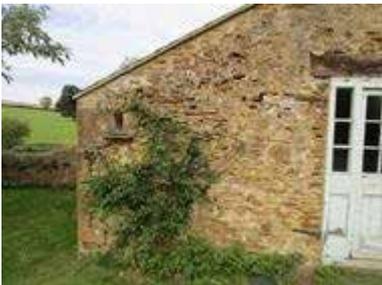
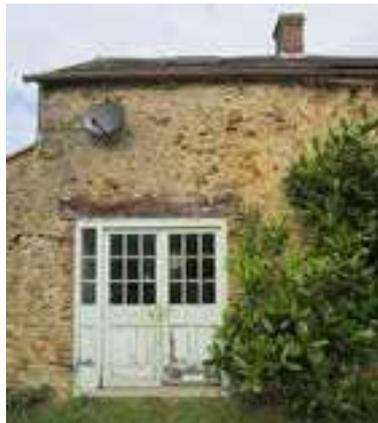
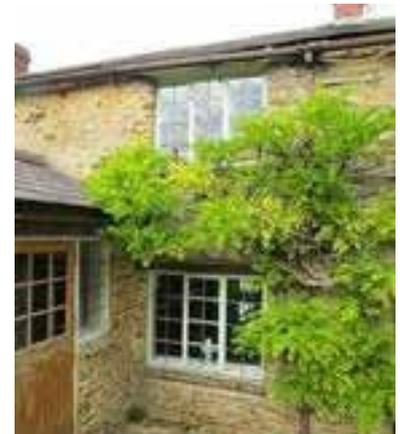
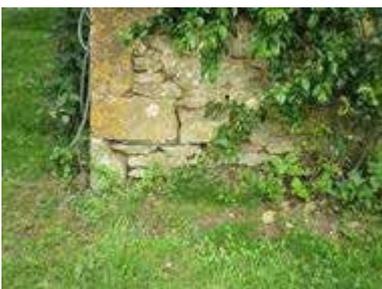
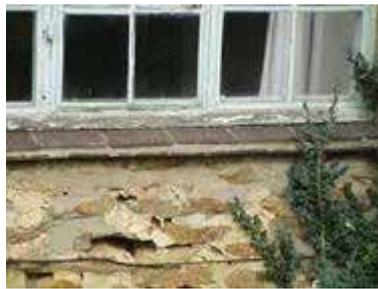
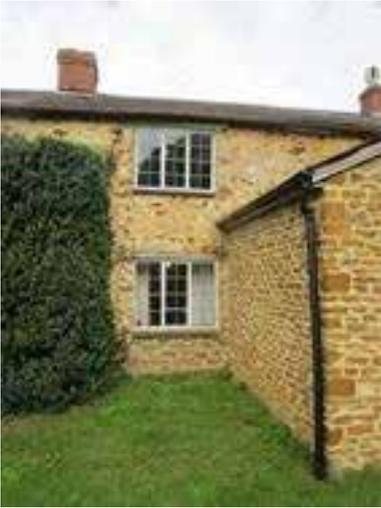
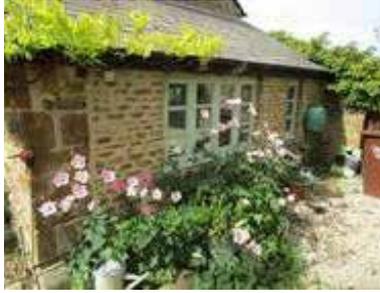
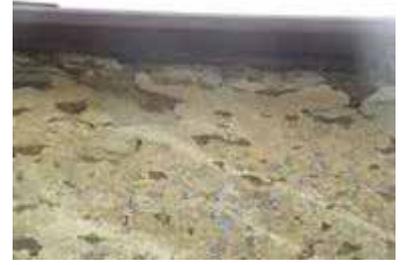
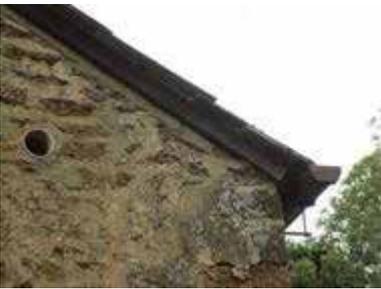
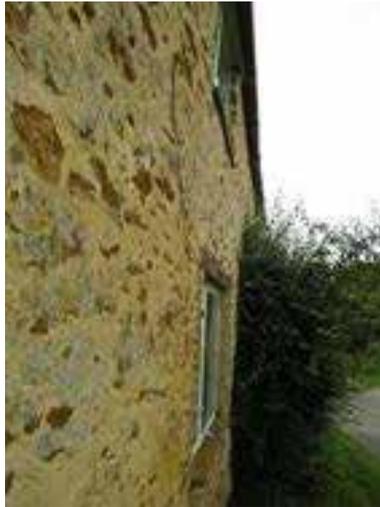
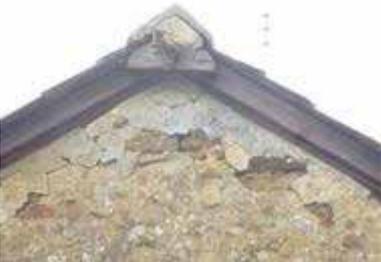
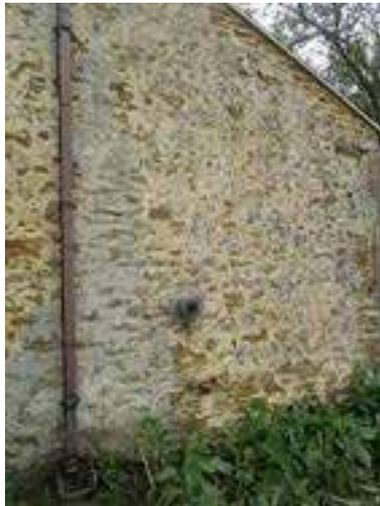
It was identified by the surveyor that there are significant erosion of and poorly applied mortar pointing to the south east elevation in various locations which includes but not exclusive to:

- The stone wall of single storey extension to the far left
- The stone wall outside of the "Games Room"
- The stone wall right of the entrance porch
- The stone wall left of the entrance porch
- The stone wall to north east elevation - top right between rafter an sloped roof
- The stone wall to north east elevation - gable
- The stone wall to north west elevation - at low level
- The stone wall to north west elevation - right hand of the right hand chimney stack
- The stone wall to north west elevation - far right - wall to "garden room"
- The stone wall to garage

The proposed restoration works includes the re-pointing of the stone mortar using a lime based mortar by qualified and specialist stone mason.

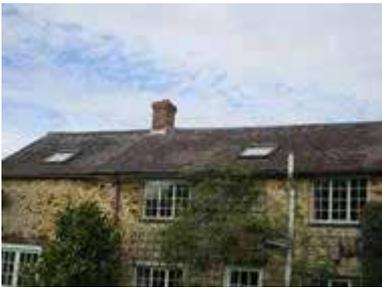
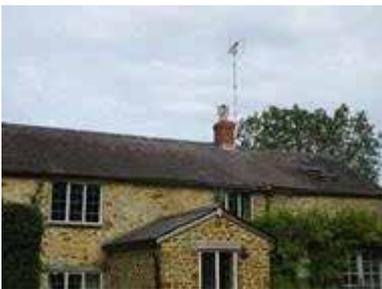
1 The existing 3nos roof lights are of some age, and the proposal is to replace them with new “conservation” roof lights ( double glazed ) to fit into the existing openings.

Existing South East Roof lights - left side

Existing South East Roof lights - right side

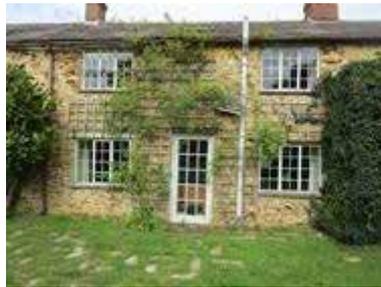
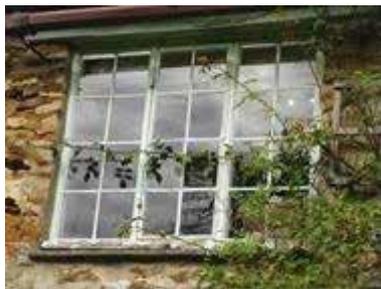
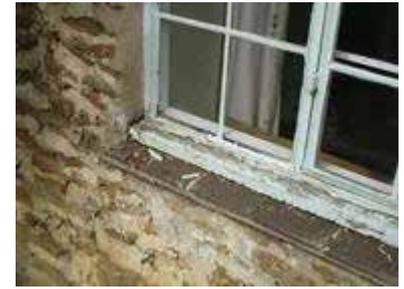
2 Inspection of the windows both at ground and first floor levels between the central stack and the left hand stack identified evidence of rot and decay. The windows have metal Crittall inserts which themselves were showing signs of corrosion particularly at cill level.

Existing South East 1st Fl Window -  
between central stack and left hand stack

Existing South East Windows - Crittall style

Existing South East 1st Fl Window - cill

The proposal is to replace with new double-glazed metal frame windows to match the existing with slim mullions and metal glazing bars, set in a fixed timber surround frame.

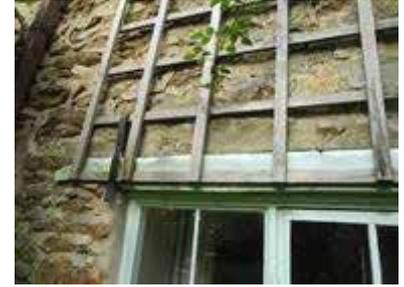
3 The lintel above the first floor left hand window has clearly suffered with decay in the past. The repair carried out previously appears basic.

Existing South East 1st Fl Window - lintel

The proposal is to replace the existing timber lintel with matching new timber lintel. A structural engineer will be appointed to size and proposed specification.

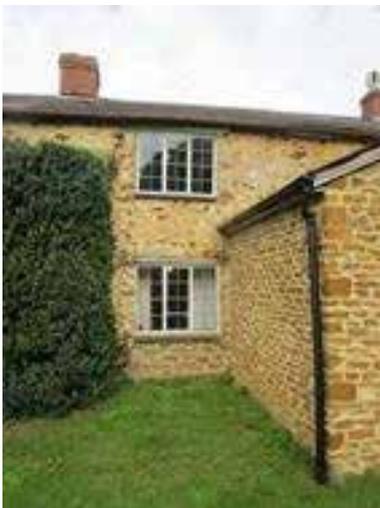
5 Timber windows to the left hand side of the entrance porch are in a substantially dilapidated state and will benefit from replacement. There is some cracking above the ground floor window to the left hand side of the entrance porch. The lintel above the first floor window to the left hand side of the entrance porch is in a dilapidated state. The proposal is to replace with new double-glazed metal frame windows to match the existing with slim mullions and metal glazing bars, set in a fixed timber surround frame. The proposal is to replace the existing timber lintels with matching new timber lintels. A structural engineer will be appointed to size and propose the specification.

Existing South East Windows - left of porch

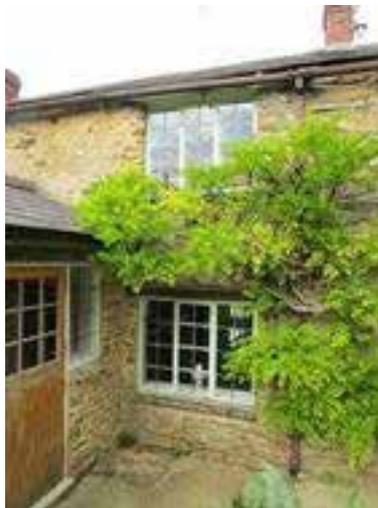
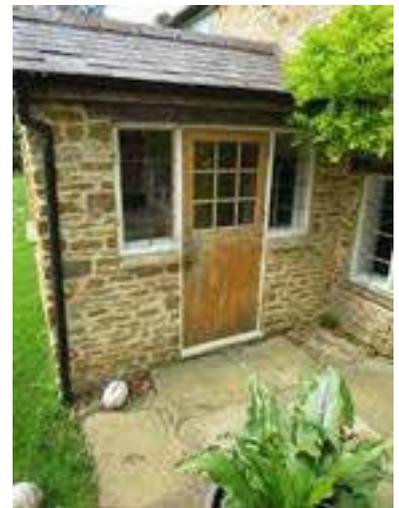
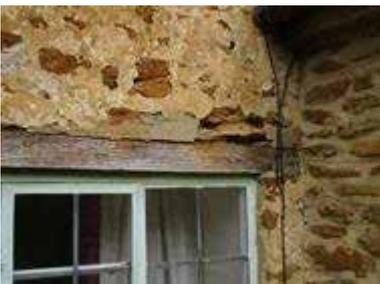
4 Timber windows to the right hand side of the entrance porch both at ground and first floor levels are in a dilapidated state. The proposal is to replace with new double-glazed metal frame windows to match the existing with slim mullions and metal glazing bars, set in a fixed timber surround frame.

Existing South East Windows - right of porch

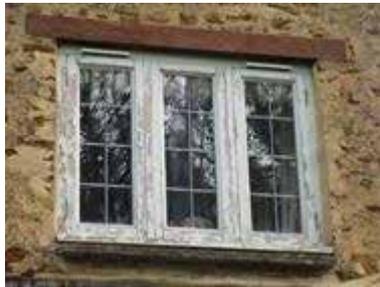
6 The timber window at first floor level is in a dilapidated state. The proposal is to replace with new double-glazed metal frame windows to match the existing with slim mullions and metal glazing bars, set in a fixed timber surround frame.

Existing South West Elevation - 1st fl window

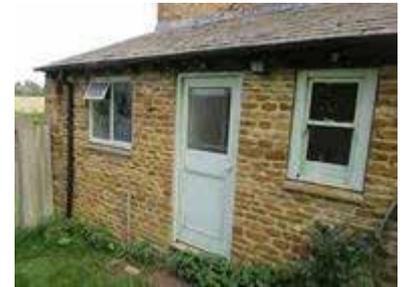
7 The ground floor windows are in a dilapidated state. The proposal is to replace with new double-glazed metal frame windows to match the existing with slim mullions and metal glazing bars, set in a fixed timber surround frame.

Existing South West Elevation - ground fl windows

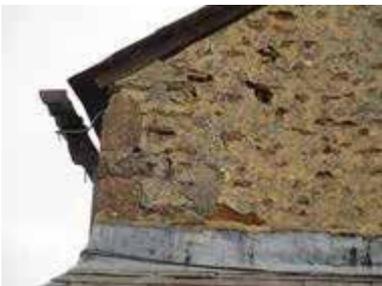
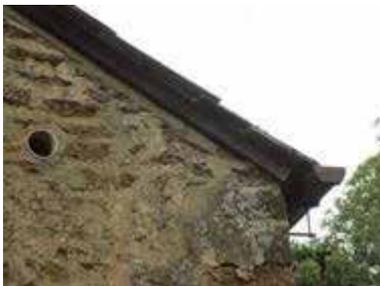
8 There is some slight cracking to the left and right hand sides of this elevation at the lowest point of the roof line most likely as result of light roof spread. As part of re-pointing works , crack stitching is proposed in order to tie the stone quoins to the main stone wall.

Existing South West Elevation - roof right

Existing South West Elevation - roof left

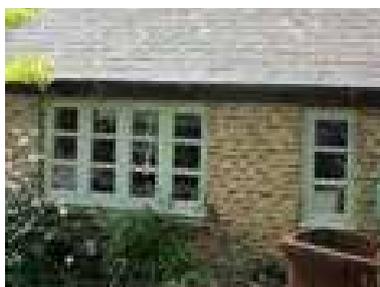
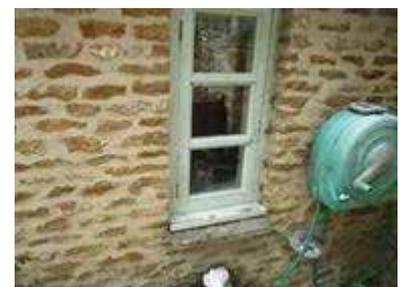
8 The windows are in a dilapidated state. The proposal is to replace with new double-glazed metal frame windows to match the existing with slim mullions and metal glazing bars, set in a fixed timber surround frame matching to existing.

Existing North East Elevation - windows

Existing North East Elevation - window left

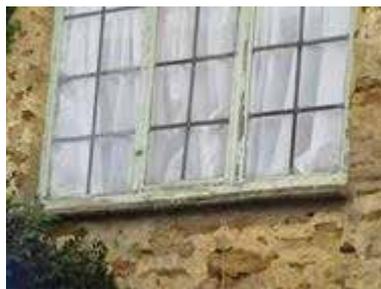
9 The timber window at ground and first floor level are in a dilapidated state. The proposal is to replace with new double-glazed metal frame windows to match the existing with slim mullions and metal glazing bars, set in a fixed timber surround frame.

Existing North West Elevation - general state of windows

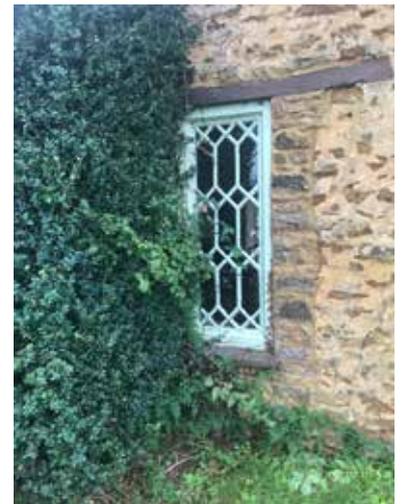
Existing North West Elevation - window with honeycomb glazing

11 The ground floor window with honeycomb glazing will be retained and refurbished.

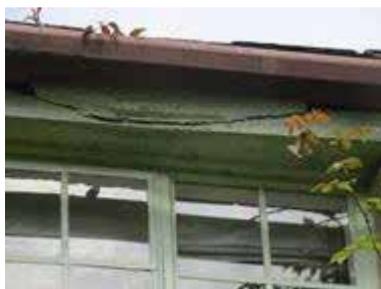
10 The lintels above the first floor windows have clearly suffered with some decay and deterioration over the life of the building however in large part they appear original and at this stage no failure is noted. However where more significant deterioration is noted particularly to the right hand side of this elevation.

Existing North West Elevation - 1st Fl Windows - lintels

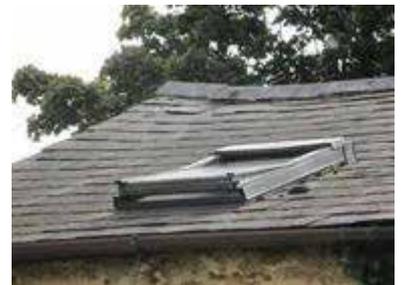
Existing North West Elevation - roof lights

12 The existing 2nos roof lights are of some age, and the proposal is to replace them with new "conservation" roof lights ( double glazed ) to fit into the existing openings.

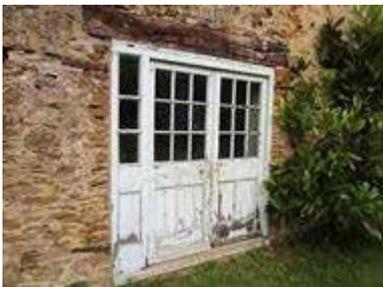
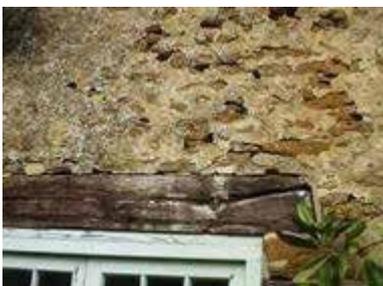
1 The existing pair of timber doors to the “games room” are in substantially dilapidated state. The timber lintel above the left hand doors is clearly of some significant age. It is showing signs of decay which is exacerbated as a result of the deterioration of pointing at the junction between the timber lintel and the stonework. There is some evidence of slight diagonal cracking to suggest some deflection as a result of the deterioration of the lintel.

Existing door to Games Room

Existing timber lintel to Games Room door

The proposal is to replace with new double-glazed metal frame doors to match the existing with slim mullions and metal glazing bars, set in a fixed timber surround frame. The existing timber lintel ( subject to further inspection by structural engineer ) to be maintained. The mortar pointing will be renewed to its perimeter and the timber treated with appropriate protective treatment.

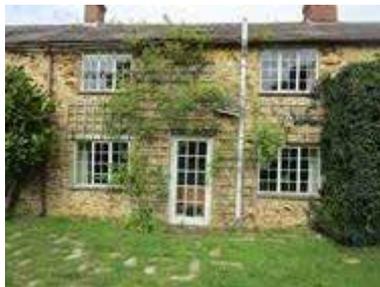
2 The pedestrian access door left of the central stack is in a dilapidated state.

Existing pedestrian access door left of central stack

The proposal is to replace with new double-glazed metal frame doors to match the existing with slim mullions and metal glazing bars, set in a fixed timber surround frame.

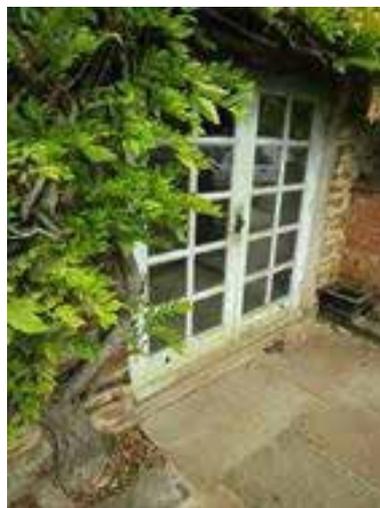
3 The existing double doors to the right hand side of this elevation are in a dilapidated state.

Existing double doors to right of this elevation

The proposal is to replace with new double-glazed metal frame doors to match the existing with slim mullions and metal glazing bars, set in a fixed timber surround frame.

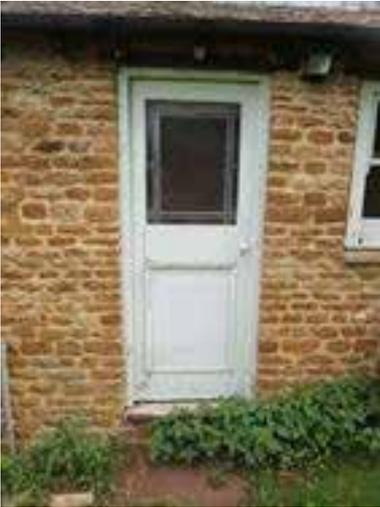
- 4 The pedestrian access door is in a dilapidated state. The proposal is to replace with new timber panel door with 2 stone external steps

Existing pedestrian access door

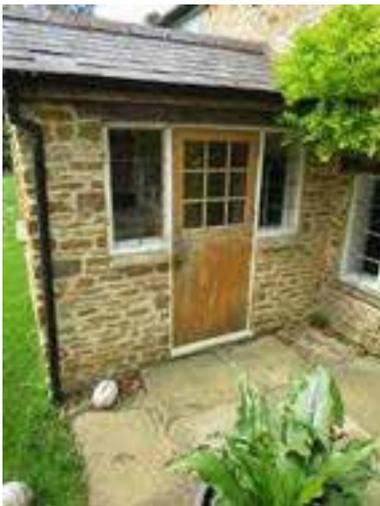
- 5 The existing "stable" style side entrance door is in a poor state. The proposal is to replace with new timber panelled door.

Existing "stable" style side entrance door

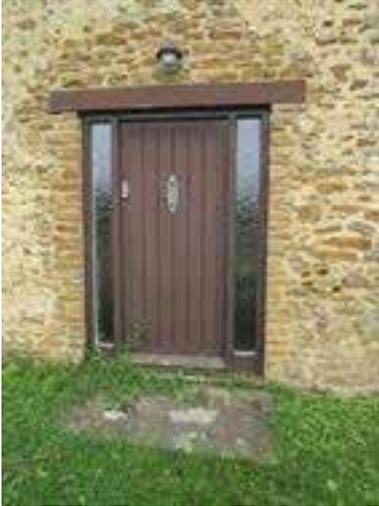
6 The existing main entrance is showing signs of deterioration. The proposal is to replace with new timber panelled door, style will be in keeping with the house

Existing main entrance door

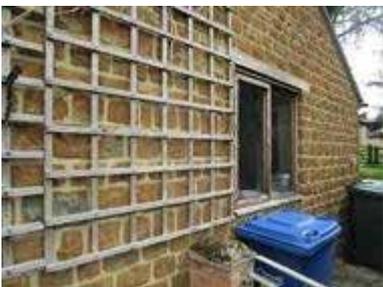
The existing south west facing window is in a dilapidated state. The proposal is to replace with new double-glazed metal frame window to match the existing with slim mullions and metal glazing bars, set in a fixed timber surround frame.

Existing south east facing window of garage
