ARBORICULTURAL IMPACT ASSESSMENT

SITE REF Banbury Oil Depot

ISSUE DATE 17.03.2021 **SEED REF** [1159-AIA-V1-A]

CLIENT The Motor Fuel Group Ltd

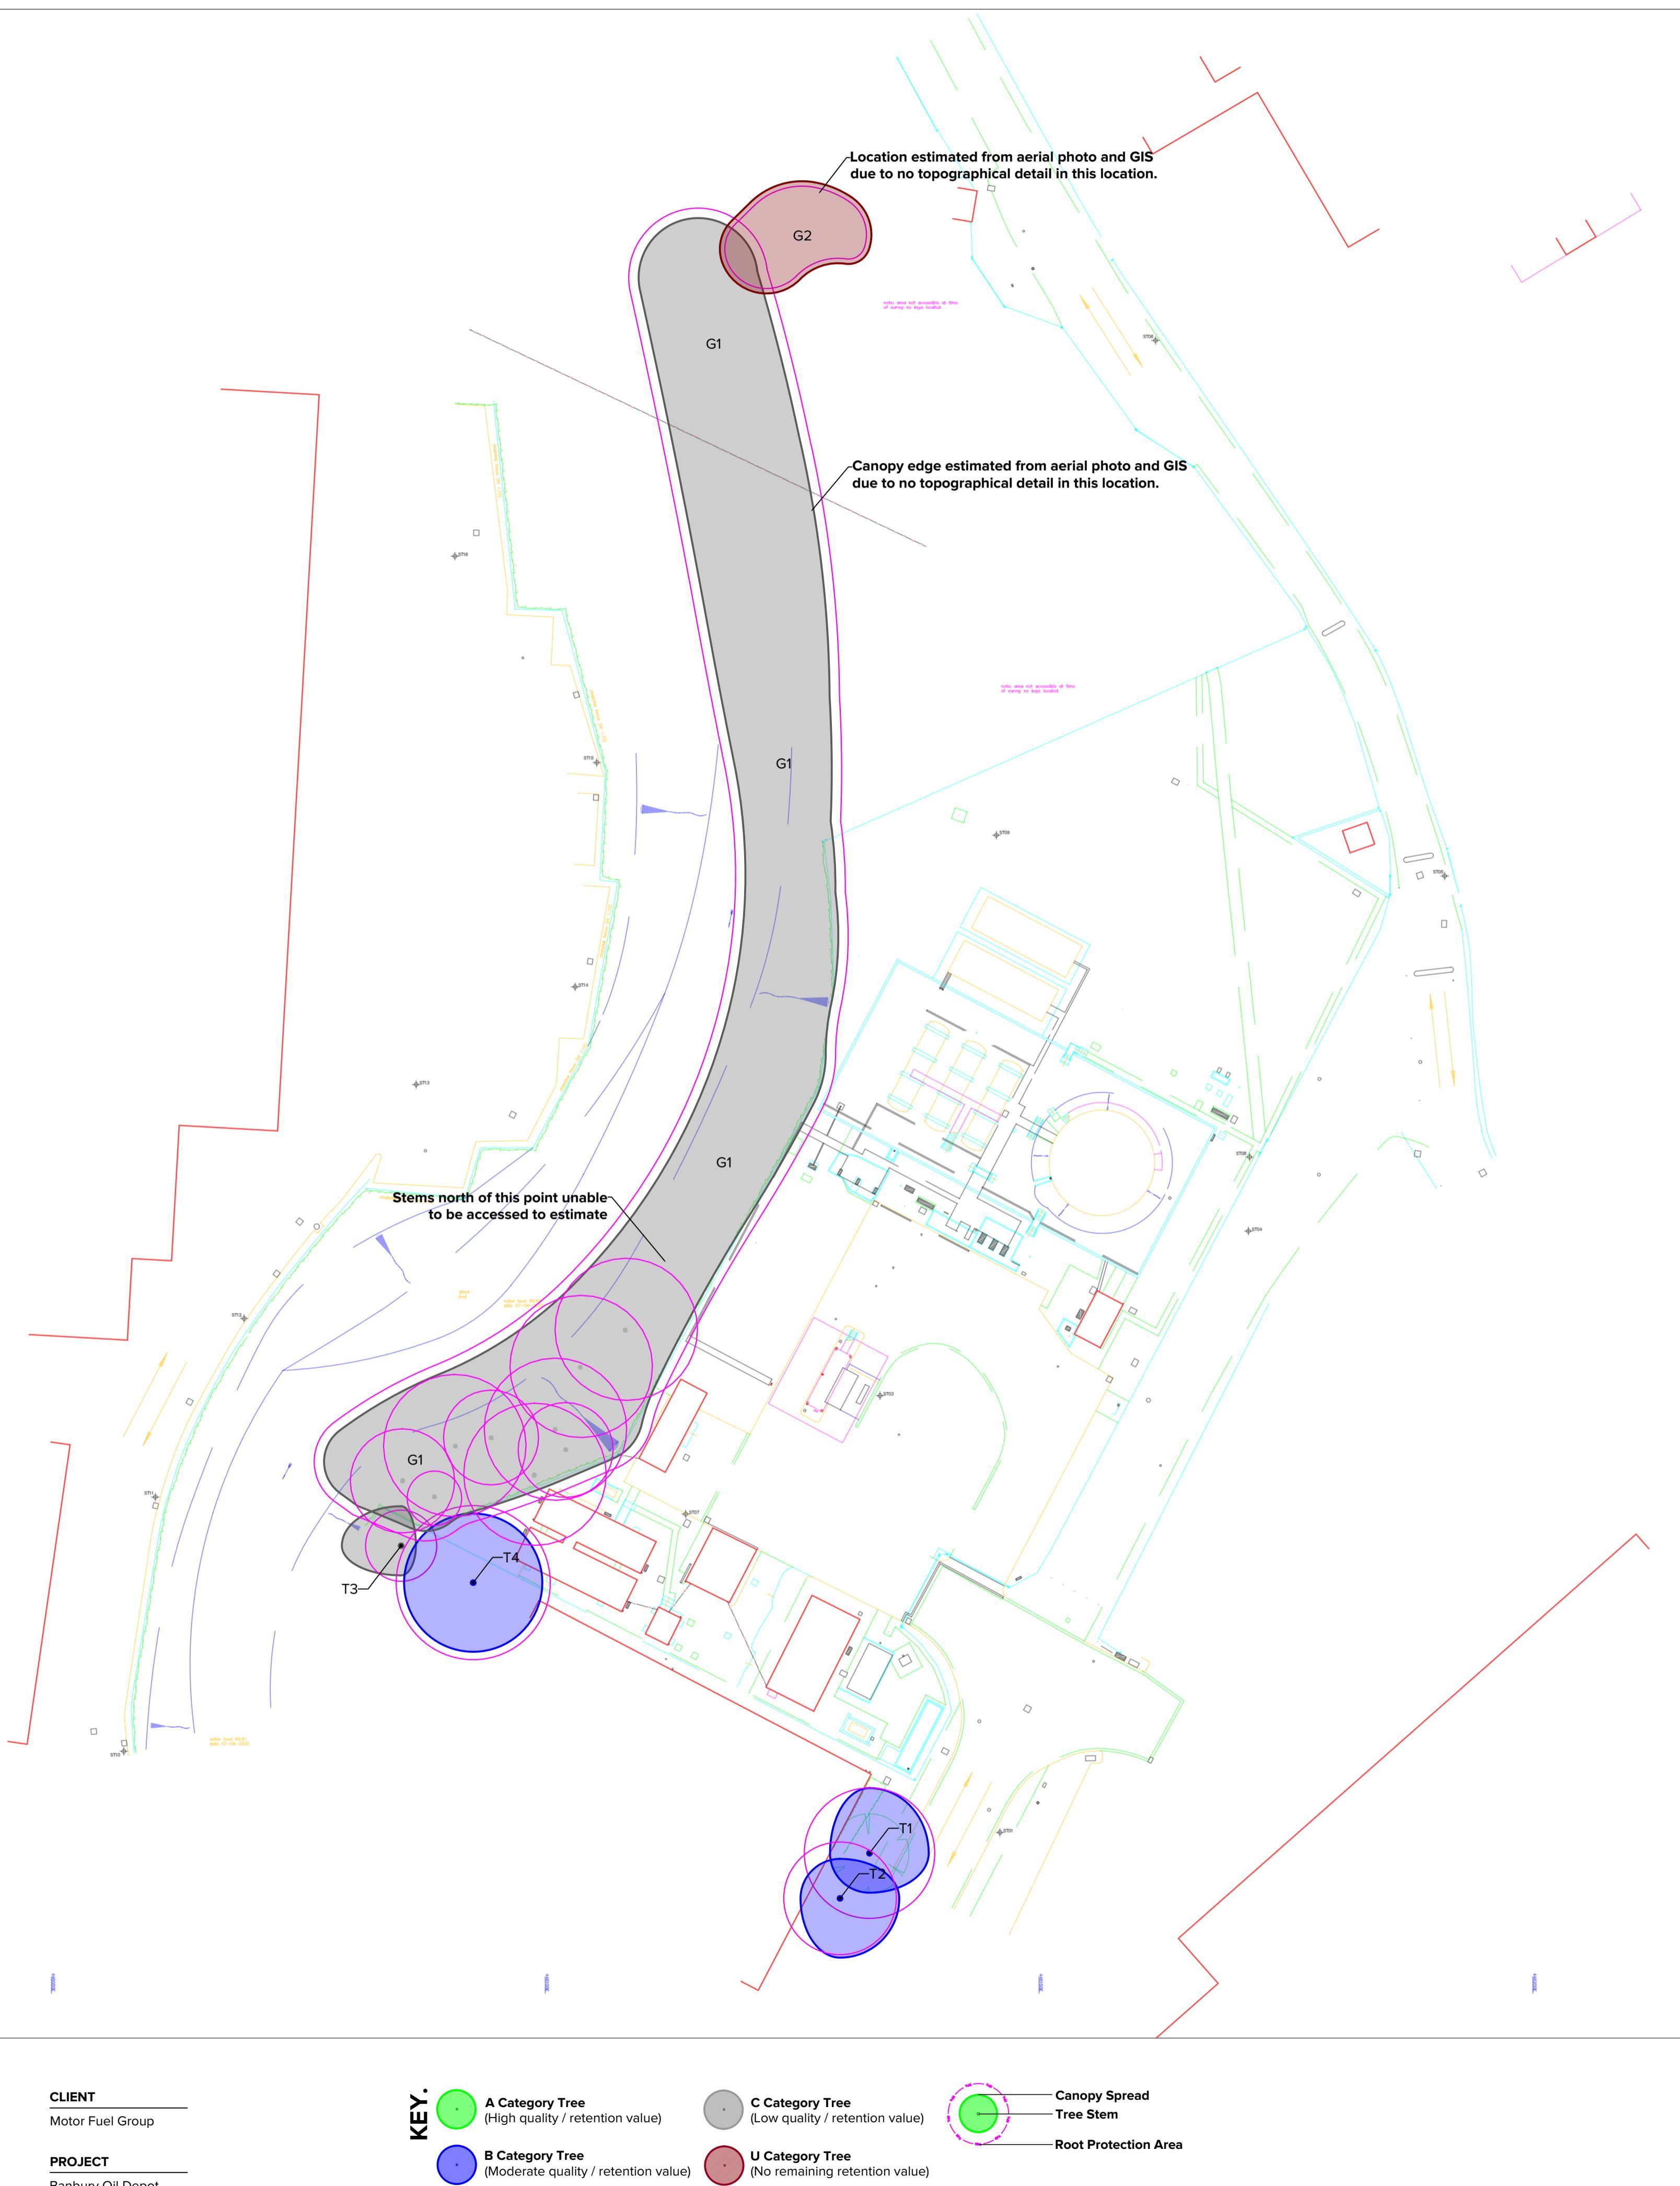
TREE CONSTRAINTS PLAN

The survey recorded a total of 4no. individual trees and 2no. groups of trees. Full details are provided within the Tree Schedule at Appendix 2. The location of each tree and their associated constraints including canopy spread and Root Protection Areas (RPA) are illustrated on the Tree Constraints Plan (DWG 001 Rev A at Appendix 3).

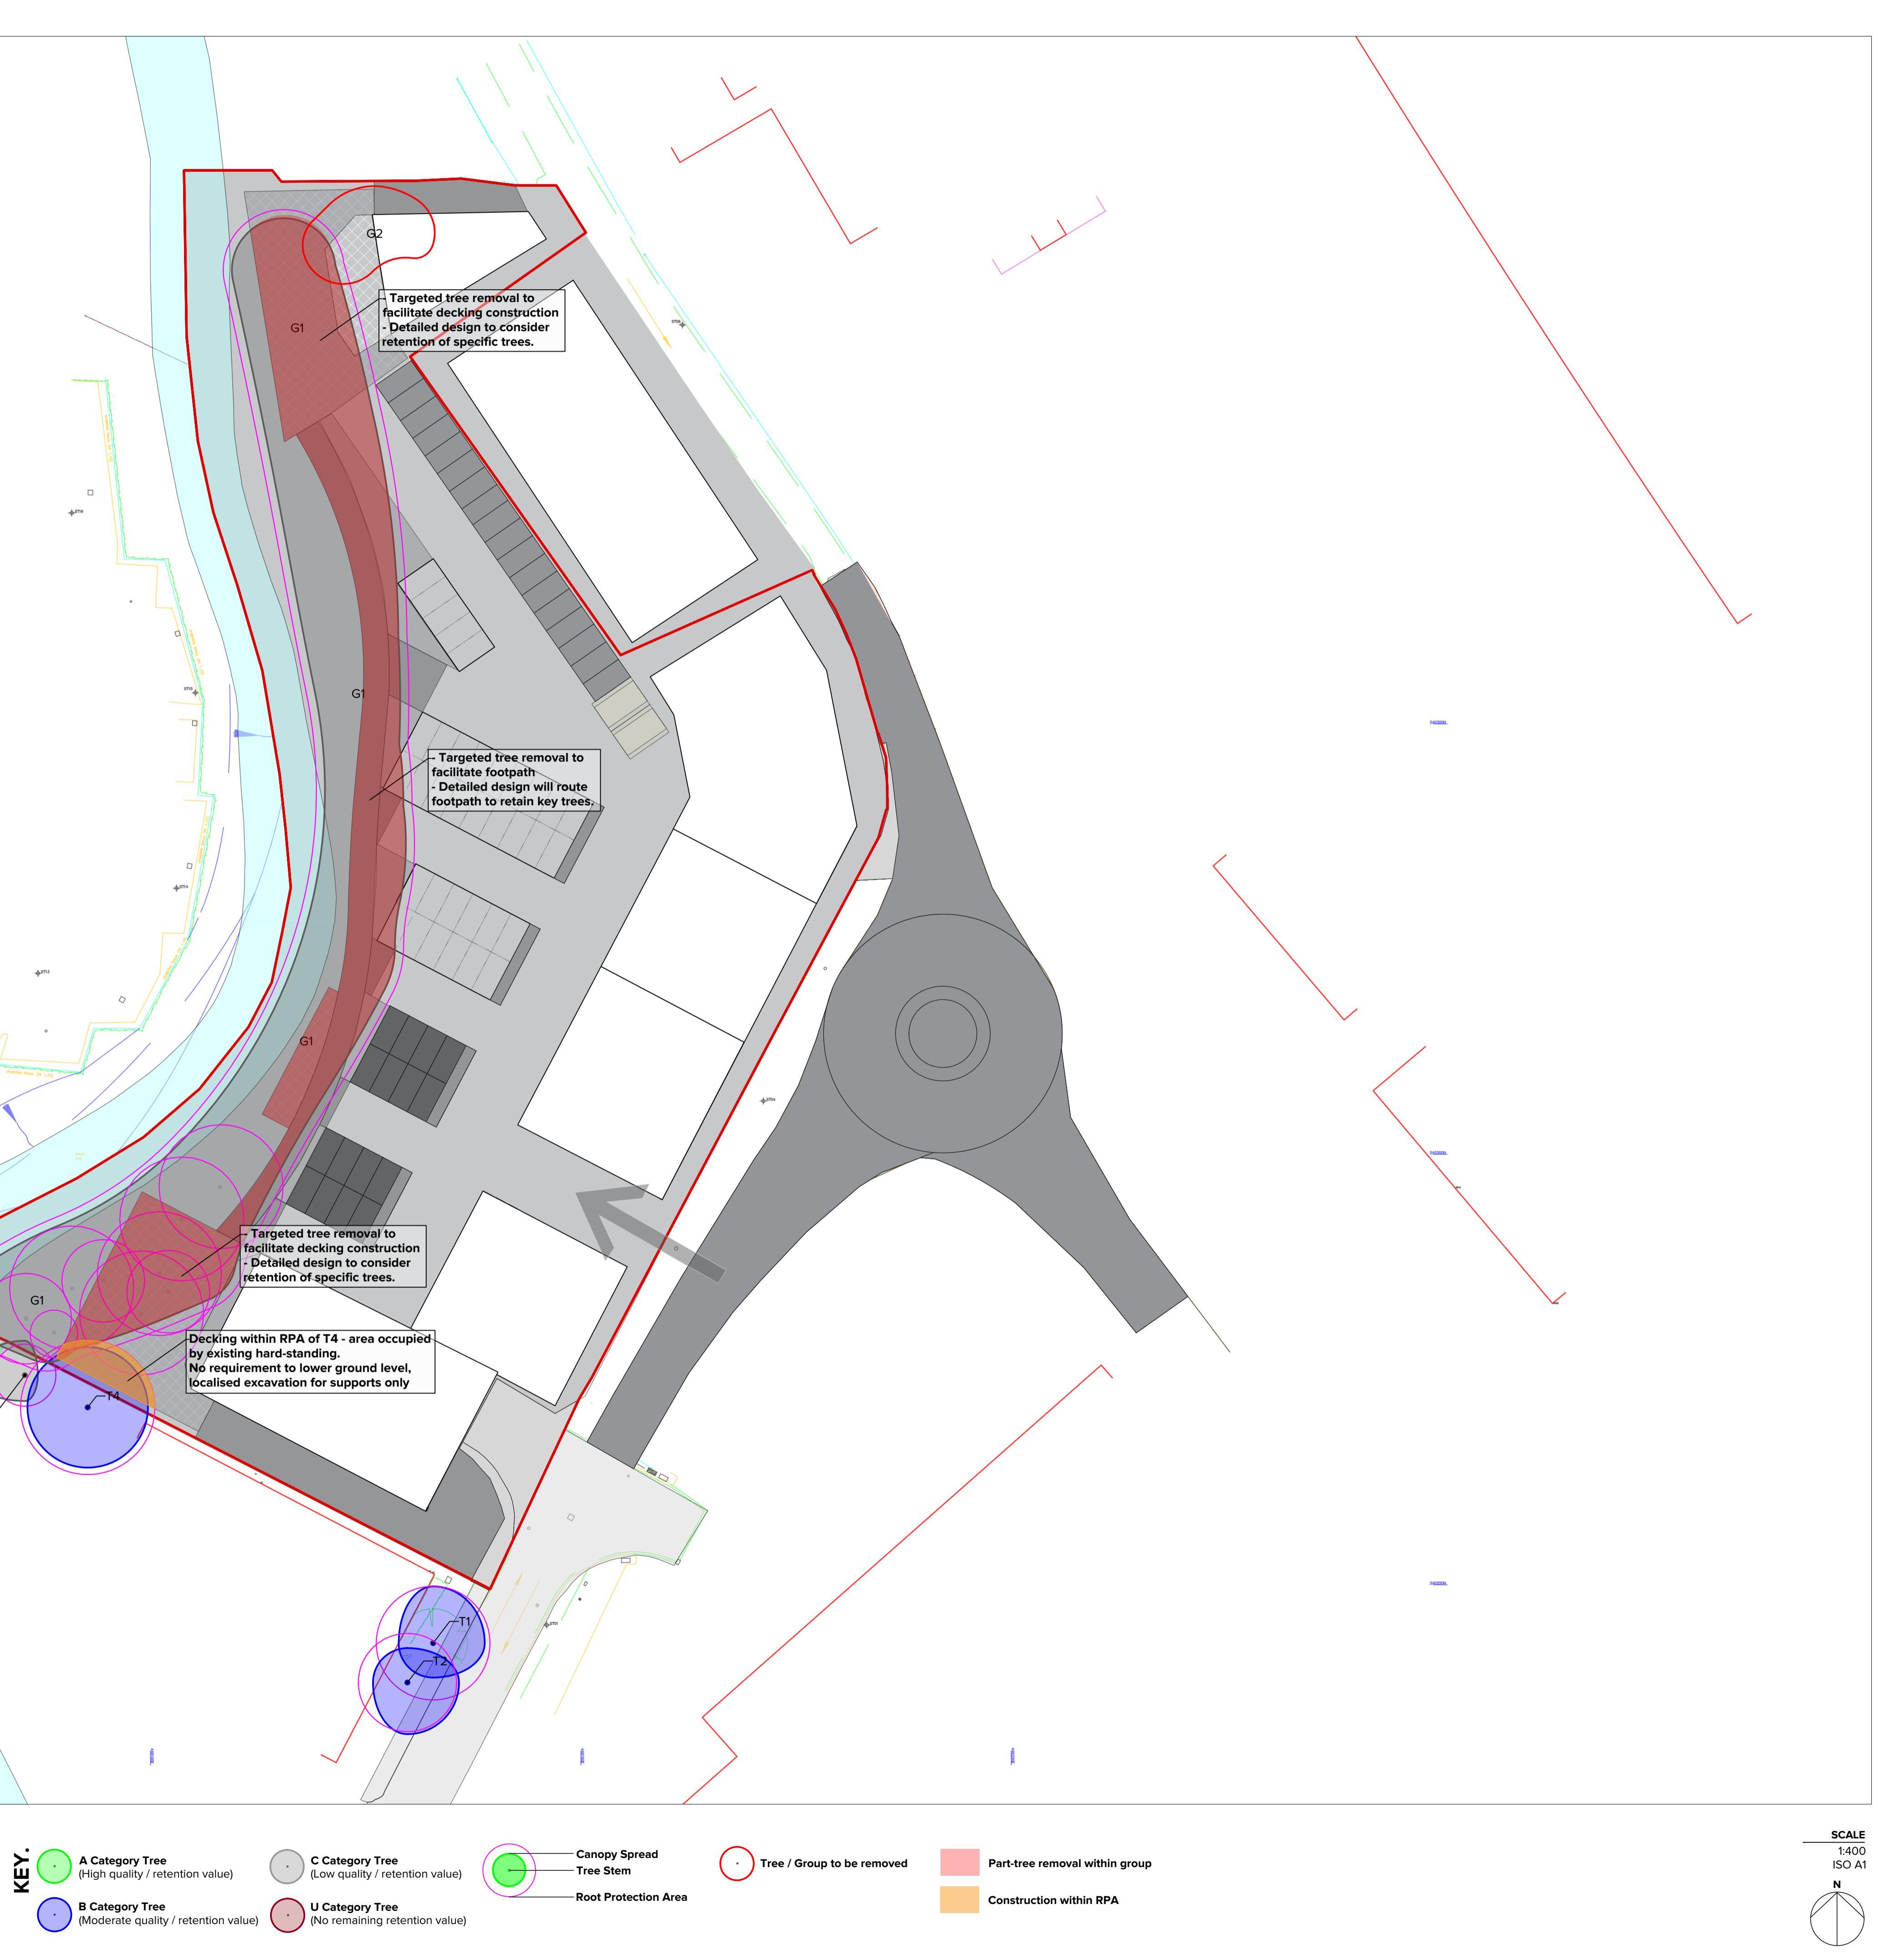
ARBORICULTURAL IMPACT PLAN

The impact has been assessed based upon the Illustrative Masterplan (edge Urban Design – Ref: 255_P03-Masterplan). The impact of the Proposed Development is illustrated on the Arboricultural Impact Plan (DWG 002 Rev A at Appendix 3).

The Proposed Development would require the part-removal of 1no category C group (G1).

G1 (mixed group) is a dense group on the river embankment. Visually the group is dominated by larger multistemmed crack willow which are becoming prone to failure at the unions. The dense understorey of the group is comprised of wild cherry, common hawthorn and elder.

There will be a requirement for part-removal of G1 to facilitate the installation of the riverside walkway and riverside walkway platforms. The illustrative masterplan gives a broad indication of this layout, however, detailed design for any subsequent Reserved Matters application should consider the location of key trees for retention. The decking design allows for retention of key trees within the footprint of the decked area by cutting out sections around trees.

G2 (sycamore) is a category U group of self-seeded regeneration growing through an area of broken hardsurfacing. This group should be removed in the interests of good management irrespective of development proposals.

To construct the Proposed Development will be new incursions within the RPAs of several trees within G1 for the proposed riverside walkway and decking.

There will be a requirement to remove existing hard-surfacing within the RPA of T4 (wild cherry) to facilitate the proposed riverside decking. The level of the existing RPA incursion will not be increased and removing hard-surfacing to replace with decking would be likely to improve the rooting environment around T4.

G1 will require extensive management to retain trees within the revised context of a residential development and it is likely that the group will require thinning and larger willows should be pollarded to enable long-term retention. Where need to be removed, new planting should be included to improve species and structural diversity.

The construction will be low-impact and all can be achieved by construction above-ground with decking and walkway supported by localised excavations for supports and the use of a cellular Tree Root Protection System (such as Wrekin ProtectaWeb) to reduce the likelihood of ground compaction within RPAs.

Detailed design as part of any Reserved Matters application should allow for the retention of key trees within G1, in order to retain the tree-lined riverside feature. Pro-active management including thinning and enrichment planting within G1 will ensure the group provides long-term value to any Proposed Development.
