GEO-ENVIRONMENTAL DESK STUDY

Land West of Yarnton

70048642-R01 REV 4 SEPTEMBER 2021

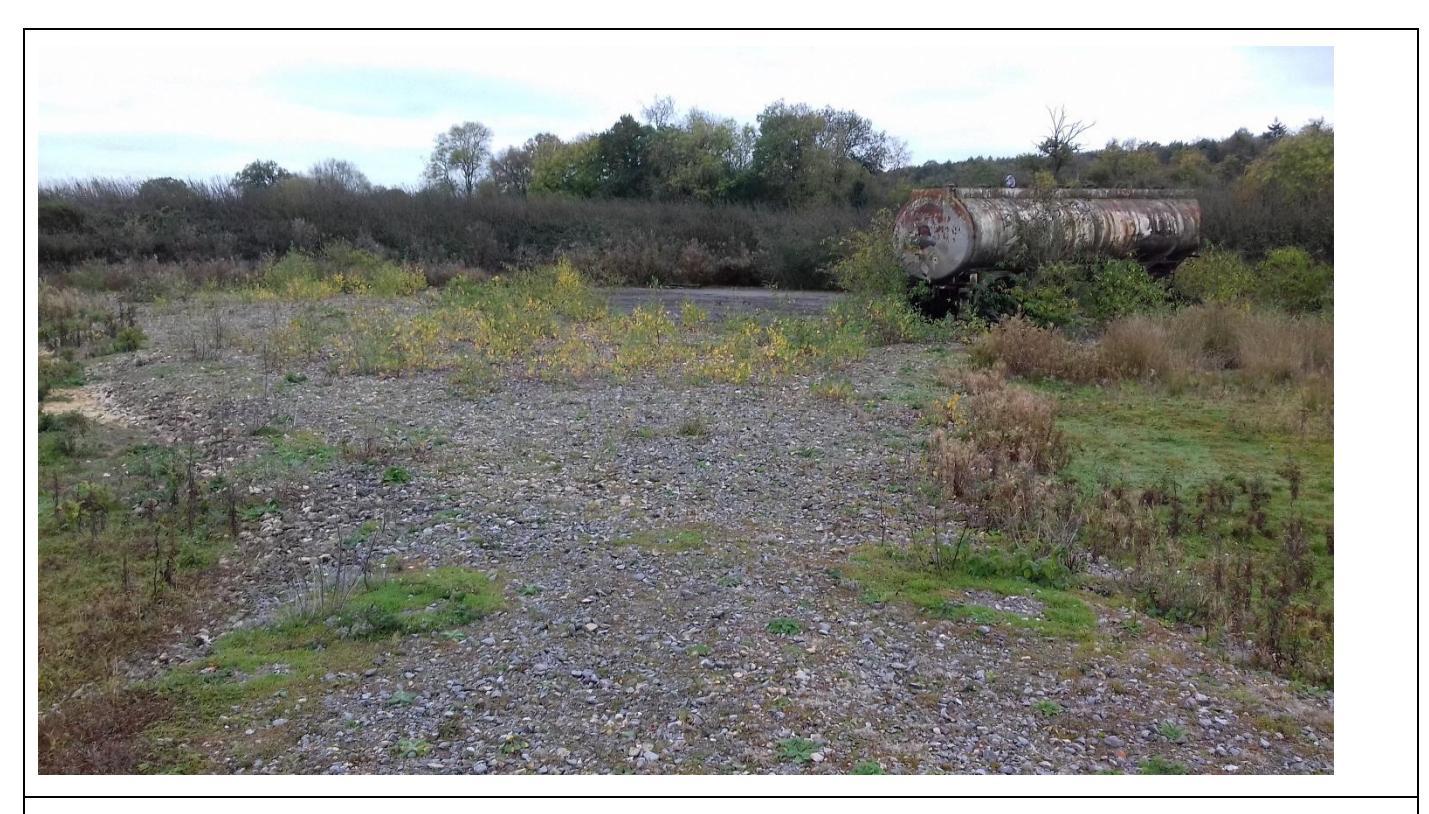
| Field Number | Notes |
|---|---|
| 1 | Comprised a mix of hardstanding, tarmac and soft landscaping at surface. Bordered by vegetated embankments on three sides with gated access to Spring Hill Road. Embankments are formed of unknown material. A water tanker was located in this field alongside a blue plastic water pipe visible at surface. Topographically flat. |

Field 1- Hardstanding in the foreground with tarmac surface in the background and soft ground to the right. Tanker is marked as containing water.

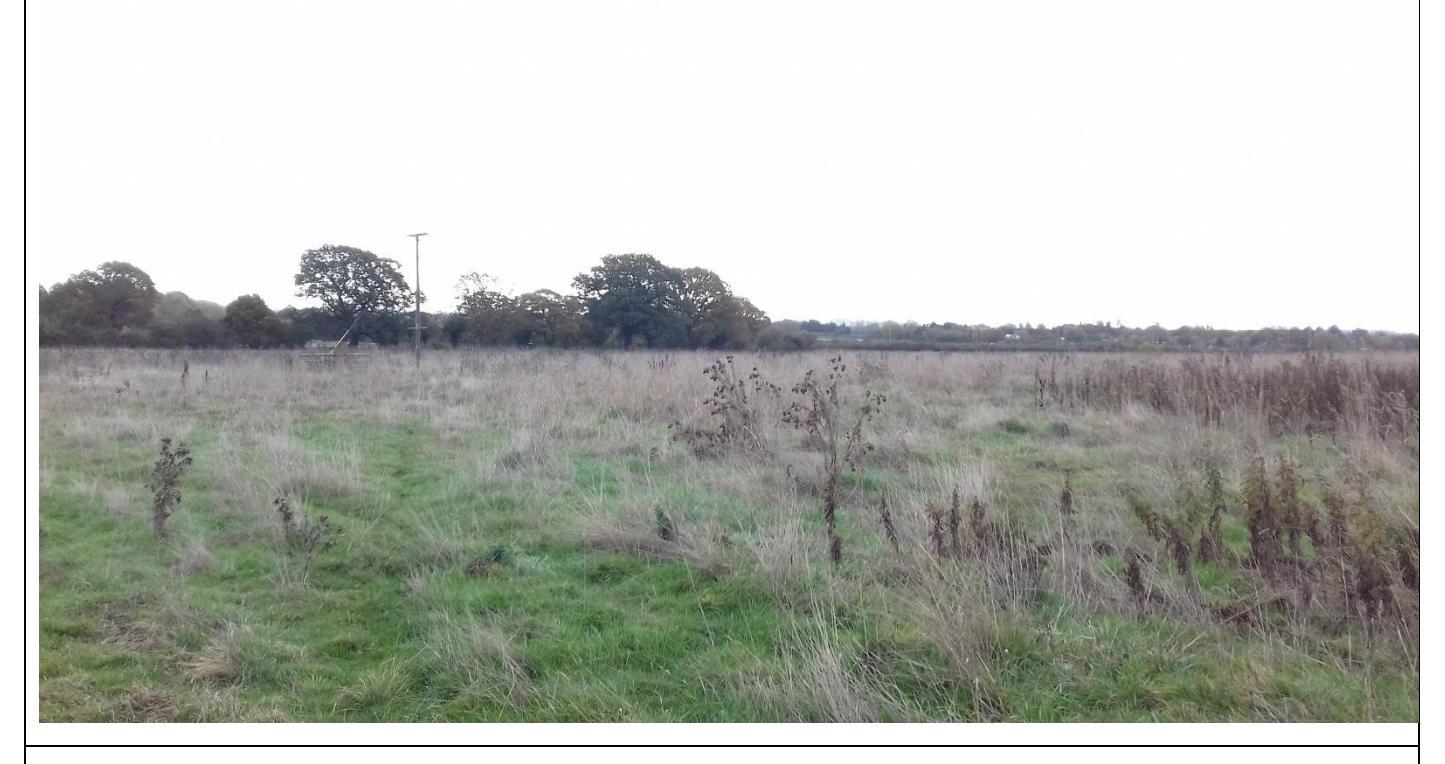
| Field Number | Notes |
|---|---|
| 2 | Vegetated field with a public footpath cutting through. Low voltage electricity pylons overhead. Generally, topographically flat. |

Field 2- Looking east towards A44. Low voltage electricity pylons can be seen.

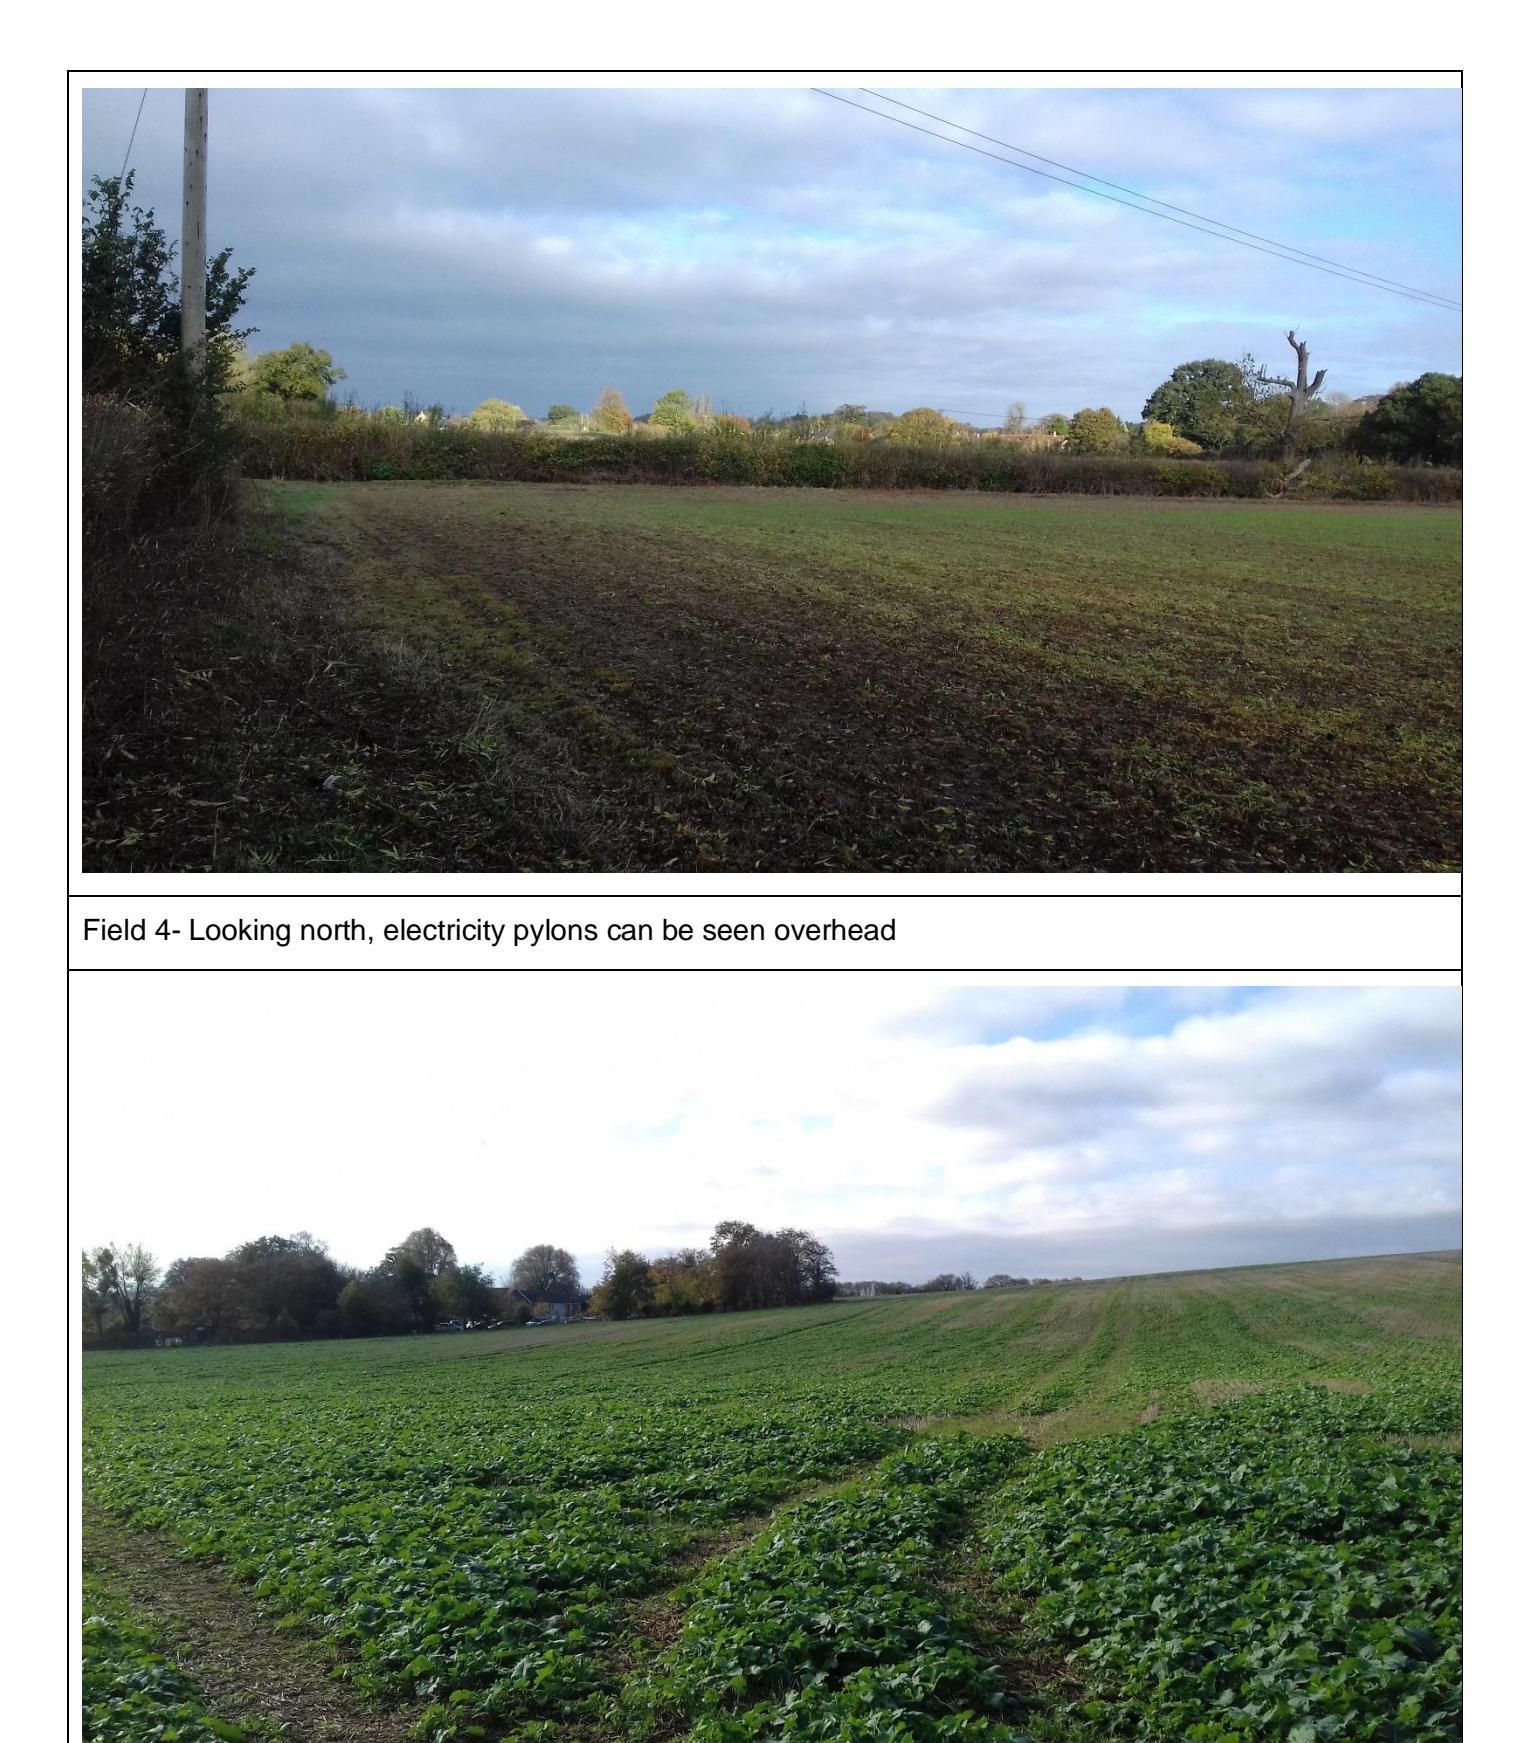
Field 11- Looking west

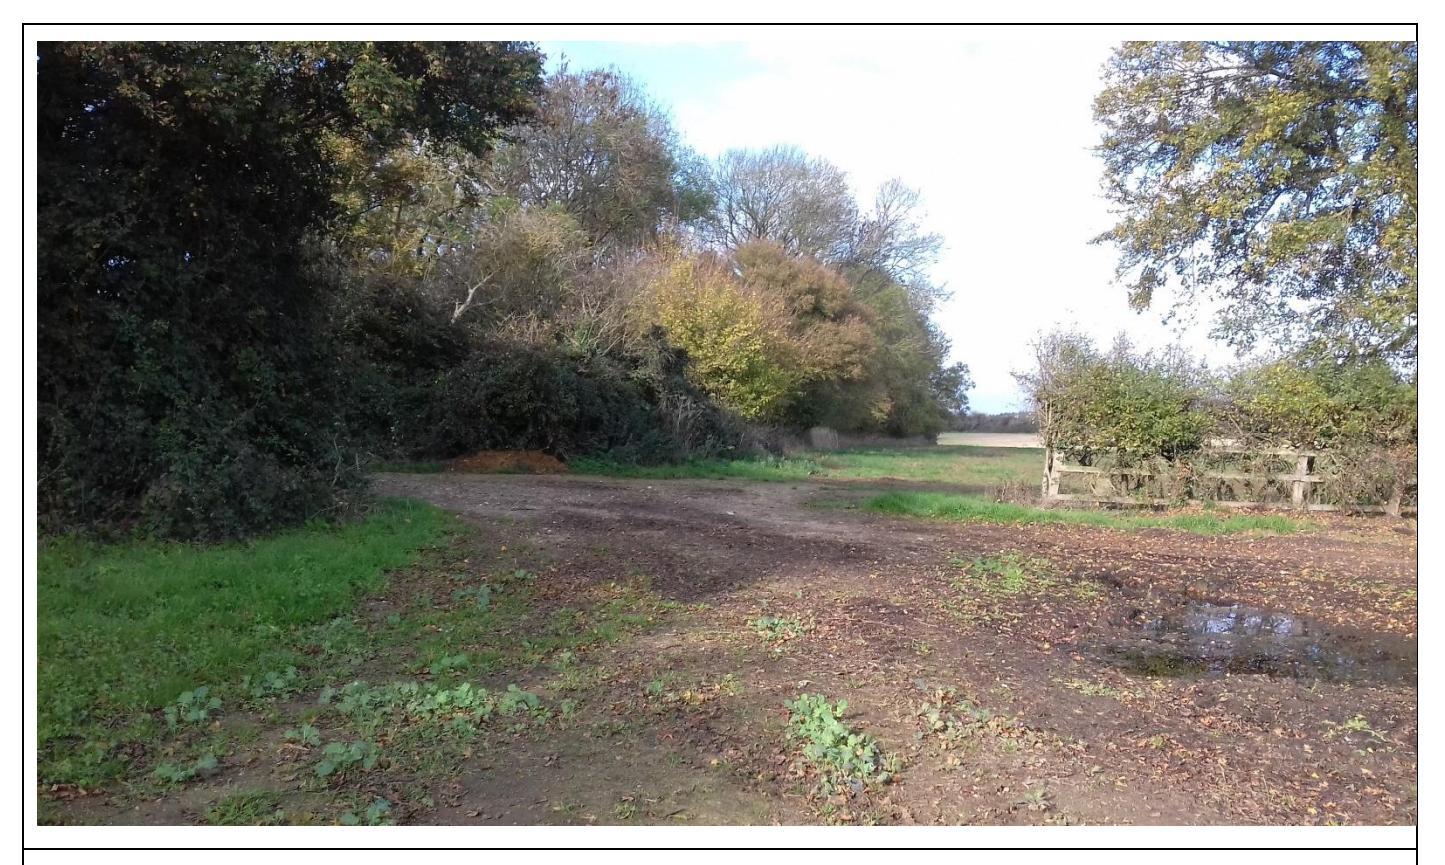
| Field Number | Notes |
|---|---|
| 11 | Field containing arable crops (likely cabbage). Topographic high point in the centre of the field. Hardcore visible at surface at western boundary between Field 9 and 11. |

Field 11- Area of hardcore in the northwest corner of Field 11, looking to the north (towards Field 9)

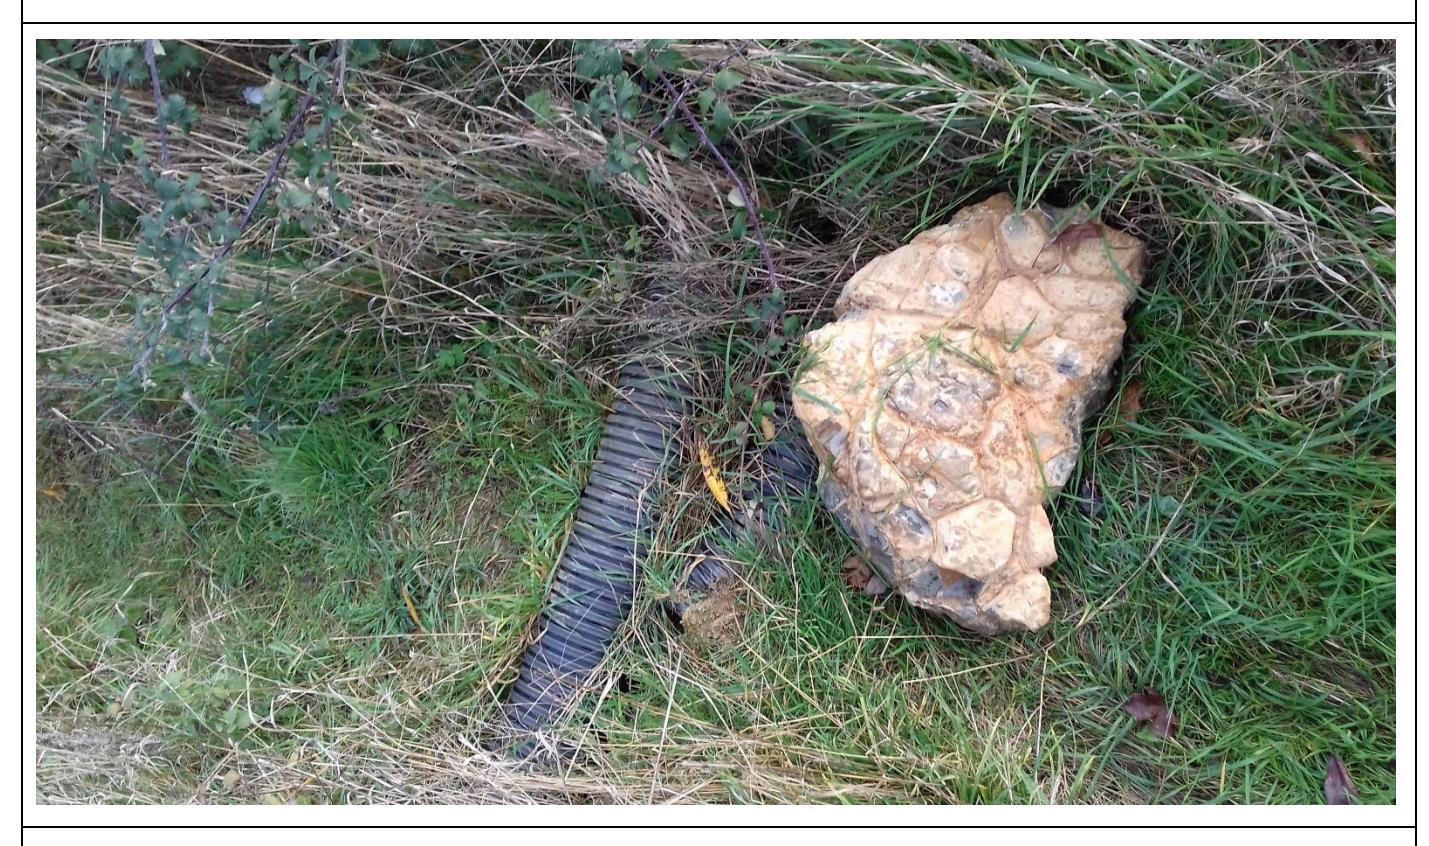
| Field Number | Notes |
|---|---|
| 9 | Ploughed field, young vegetation present at time of walkover. Topographic undulation across field. Low voltage pylons along north of site. Hardcore visible at surface at western boundary between Field 9 and 11. |

Field 9- Visible drainage in boundary

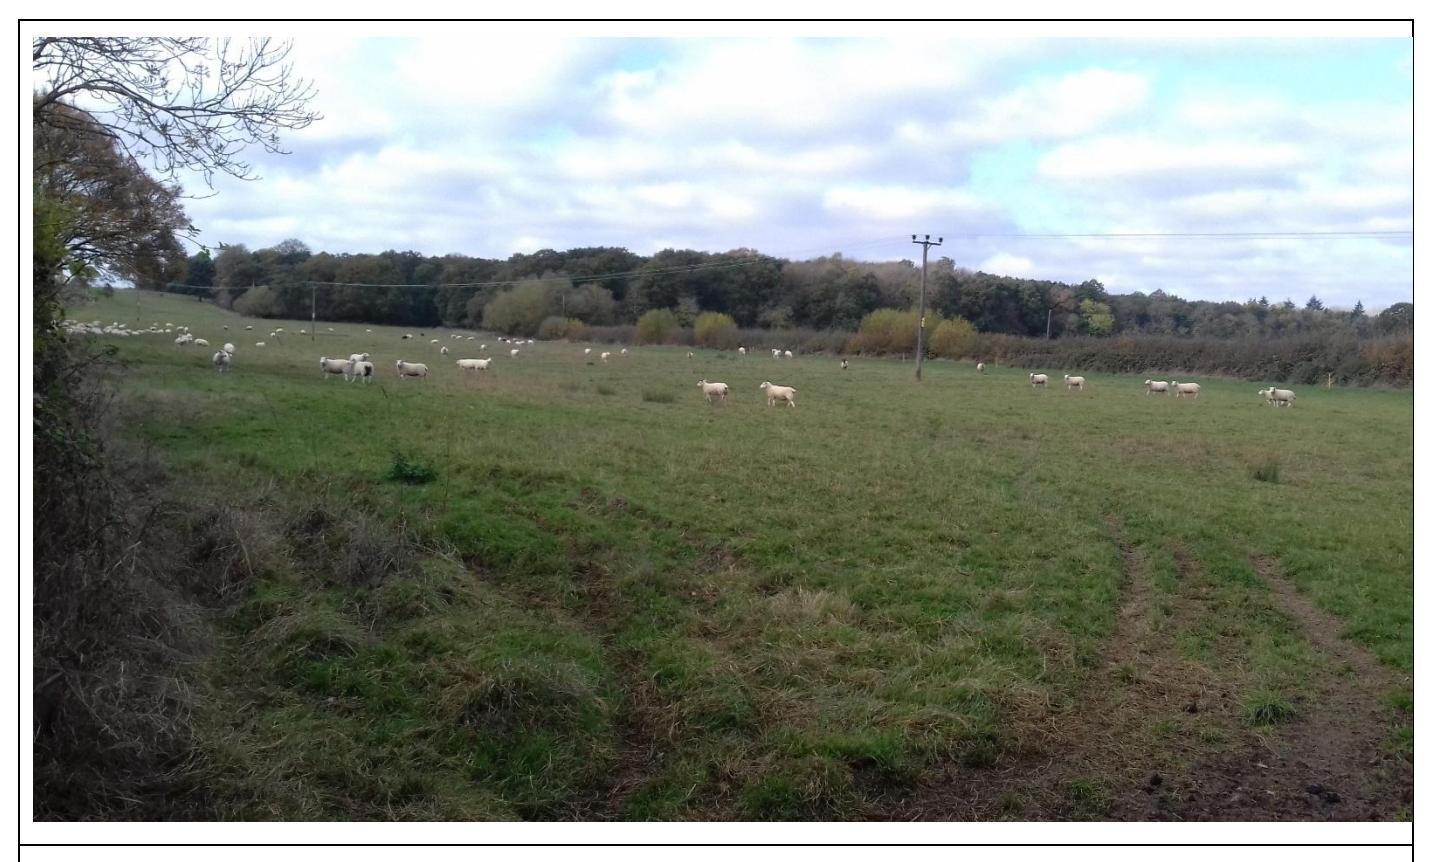
| Field Number | Notes |
|---|---|
| 6 | Vegetated field livestock field (sheep). Low voltage pylons overhead. Topographic rise to the west. |

Field 6- Livestock field with electricity pylons

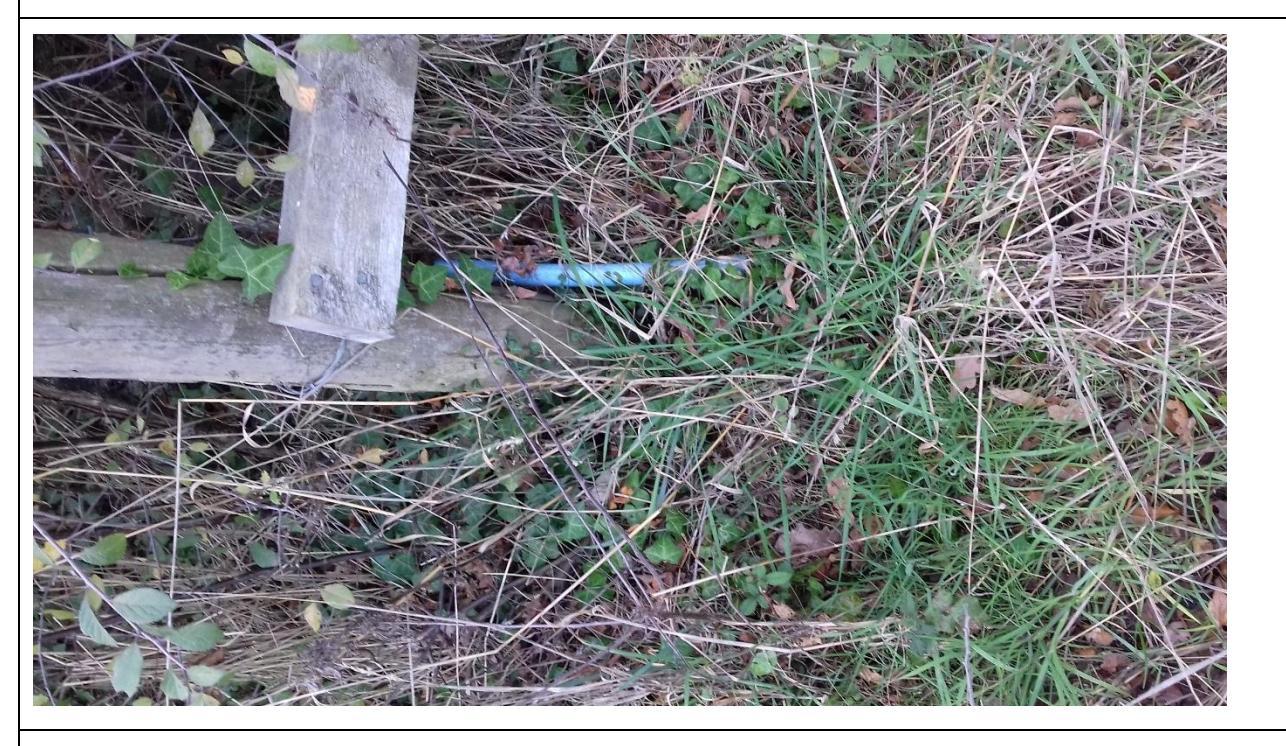
Boundaries between fields were generally demarked by tree lines and barbed wire fences. At a number of locations blue plastic water pipes were noted on the ground surface between fields. Black plastic drainage pipes were also noted at a number of locations. Overhead electricity pylons cross several fields (as detailed above).

Field 5- Water pipe visible at boundary
