**Arboricultural Impact Assessment:
Jacobs Douwe Egberts, Ruscote Avenue, Banbury – Site 2**

Document reference: 614-21, Revision 0

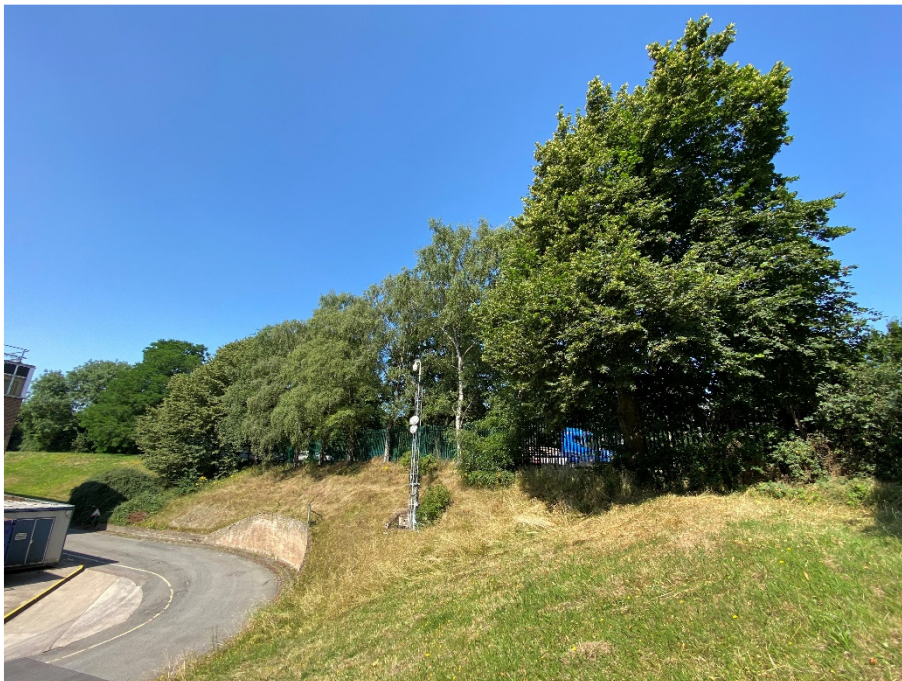
Photograph 1: Boundary trees on top of embankment viewed from the east.

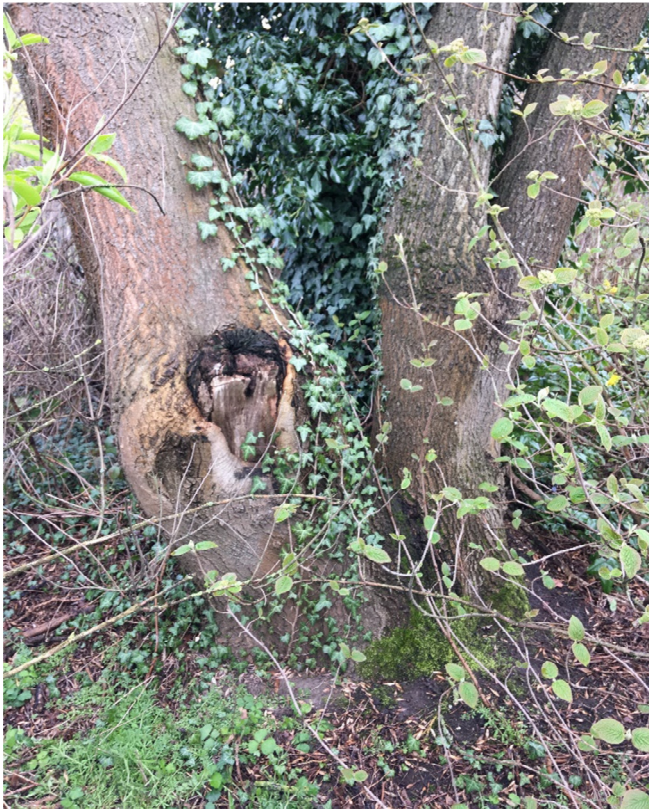
- 2.7 Tree 8 is coppice regeneration from a previously felled ash tree and grows amongst an outgrown shrubbery surveyed as group G9, for which the arboricultural elements are mainly restricted to younger self-sown trees of mediocre only form.

Photograph 2: Showing coppiced base of ash tree 8 (photograph taken in May 2019 when more visible).

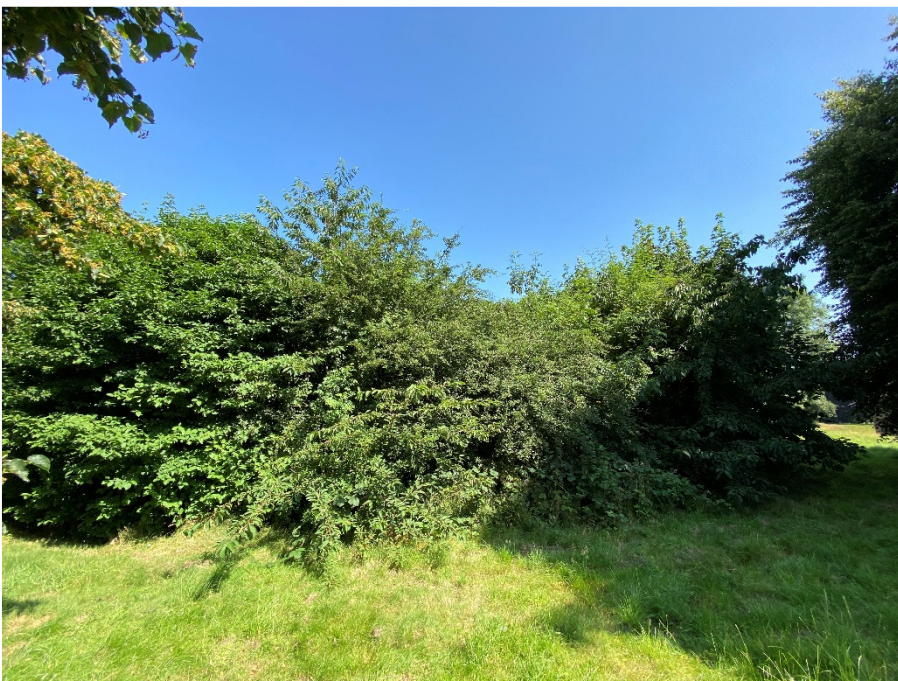
Photograph 3: Part of group G9 viewed from the south.

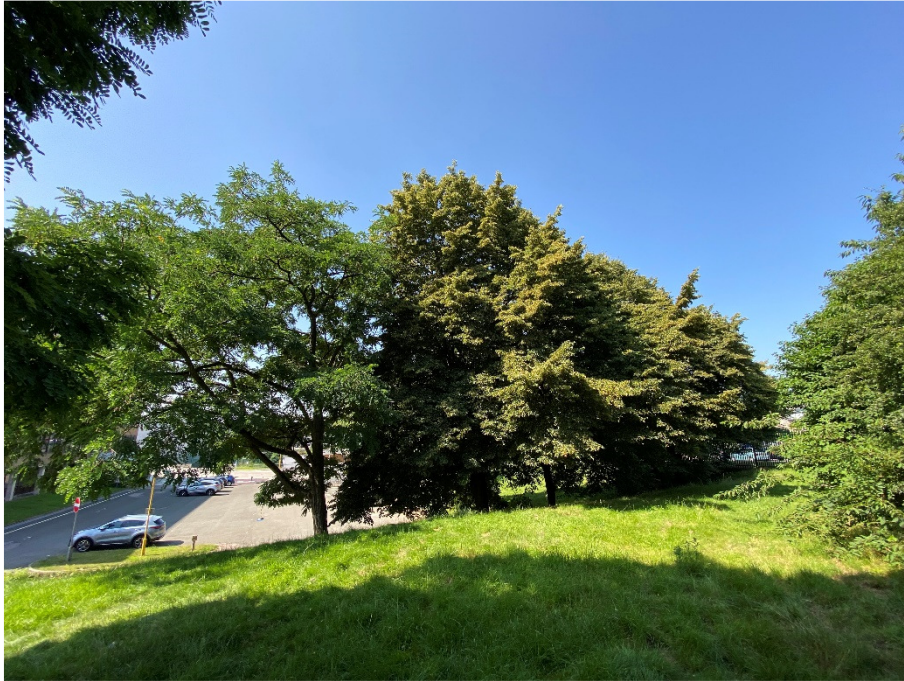
- 2.8 Trees 10 to 19 have a collective impact growing upon either the sloping embankments or the upper level of the landscaping mound.

Photograph 4: Showing trees 10 to 12 viewed from the north.

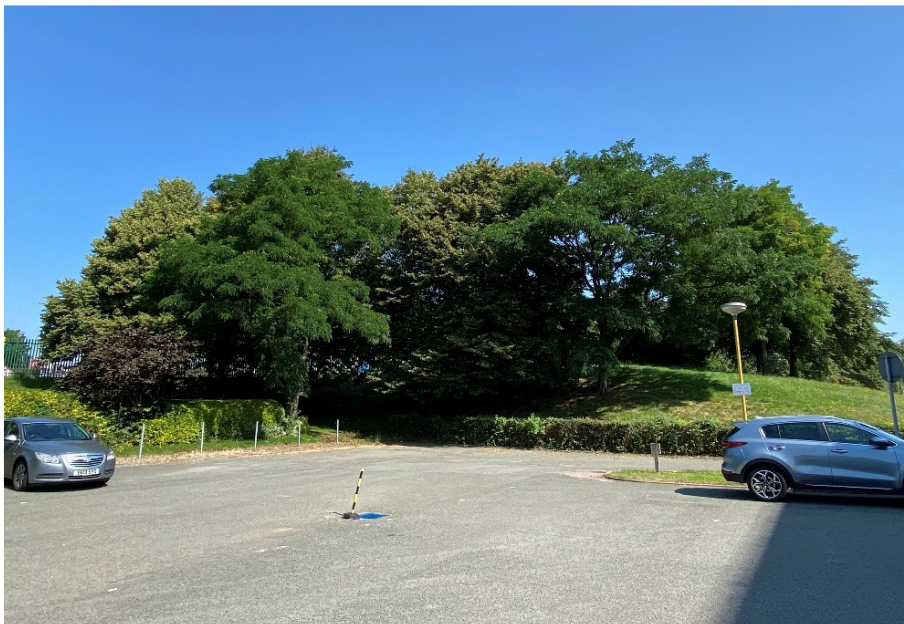
Photograph 5: Showing trees 10 to 19 inclusive viewed from the south.

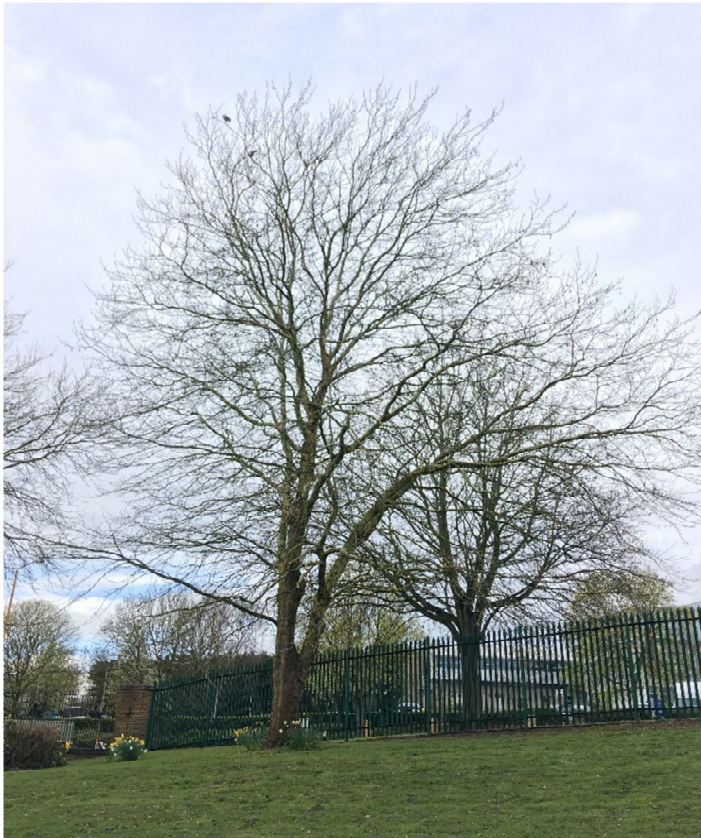
- 2.9 Tree 20 is a prominent frontage, high value London plane tree that has co-evolved with Norway maple tree G growing in the public verge.

Photograph 6: London plane tree 20 viewed from the south east with Norway maple tree G visible in the background (photograph taken in May 2019).

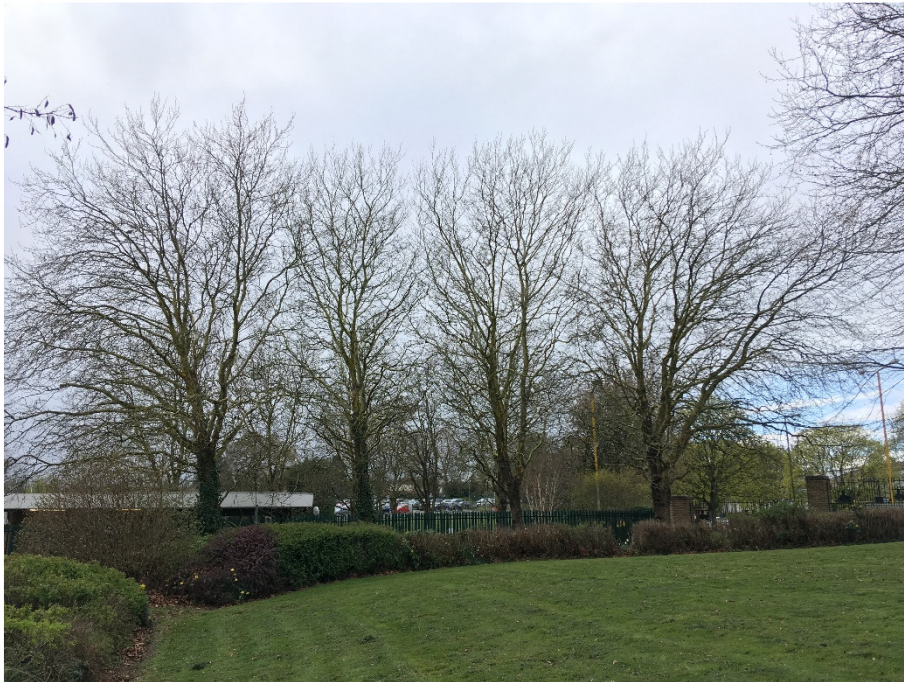
2.10 Plane trees 21 to 24 inclusive form one half of an avenue feature to either side of the main access into the site with the security lodge in the centre. The north western tree, tree 21, is the best developed and grows in the most conspicuous location.

Photograph 7: Plane trees 21 to 24 viewed from the east (photograph taken in May 2019).

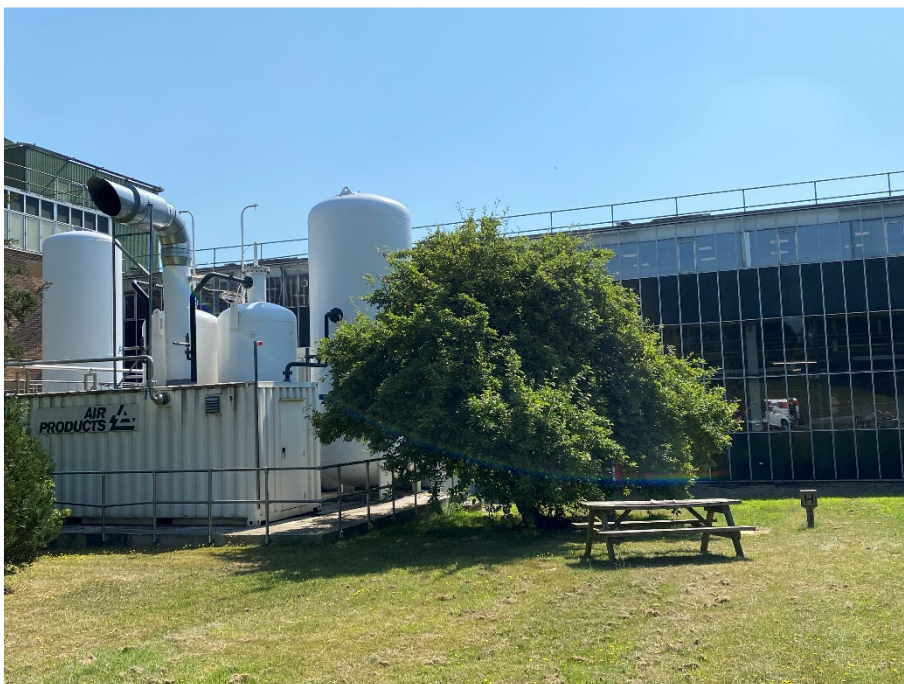
2.11 Apple tree 26 and group G27, formed from cypress and yew, are located within the amenity space set back slightly within the factory footprint close to the nitrogen production plant.

Photograph 8: Apple 26 viewed from the west.

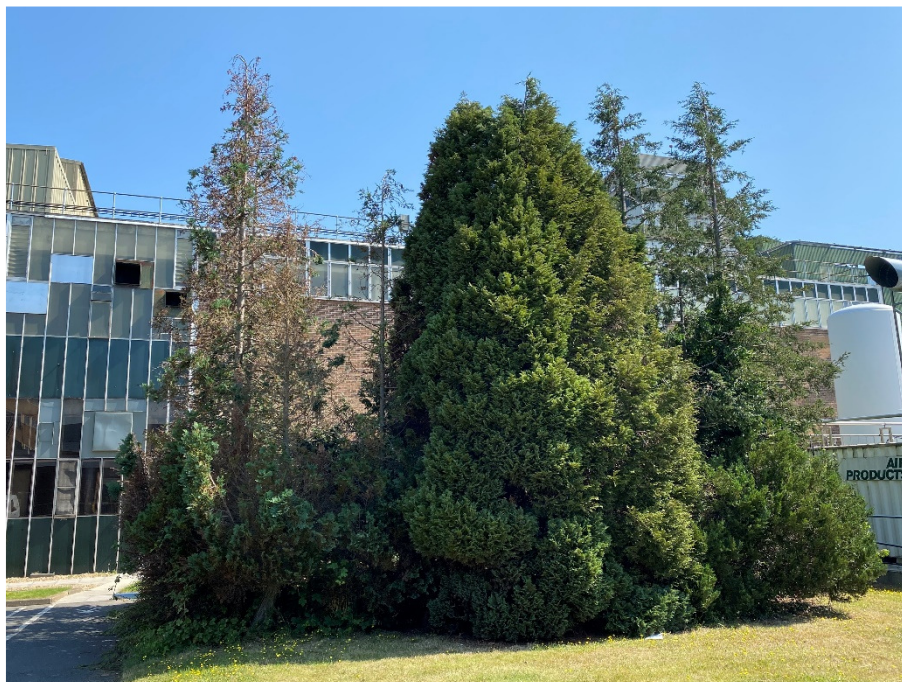
Photograph 9: Group G27 showing the declining trees within.
