BB Trees Ltd
Tree and Woodland Consultancy
ben@bbtrees.co.uk
www.bbtrees.co.uk

**Arboricultural Impact Assessment:
Redevelopment at Jacobs Douwe Egberts, Ruscote Avenue, Banbury – Site 3**

Document reference: 615-21, Revision 0

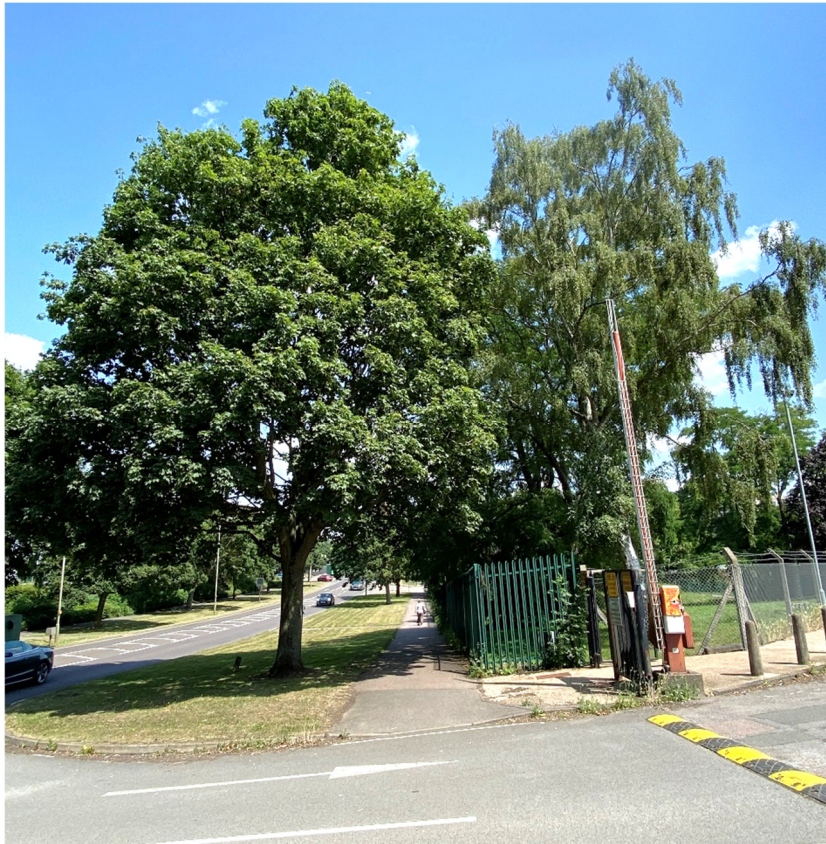
Photograph 1: Birch tree 1 to the righthand side of highway tree A

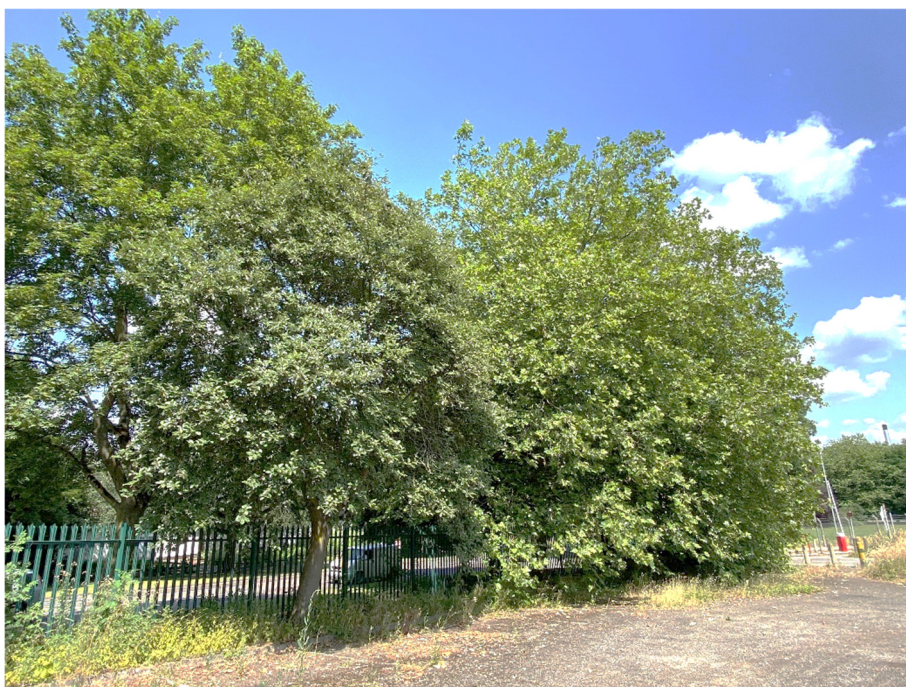
Photograph 2: Looking towards Swedish whitebeam tree 4 with London plane trees 2 and 3 to the right.

3	London plane <i>Platanus x hispanica</i>	17	510	N 6 E 5 S 8 W 7	3.5 S	0 SE	EM	A	B	The second of a pair of frontage plane trees. Near-to-surface roots causing heave in footway to north west. Minor deadwood within crown. Minor plane anthracnose. Monitor footway heave. Undertake ramp repair as necessary. It would be acceptable on arboricultural grounds to crown lift to give 3.5m clearance all round. Remove dead and defective branches.	>40	A (2)

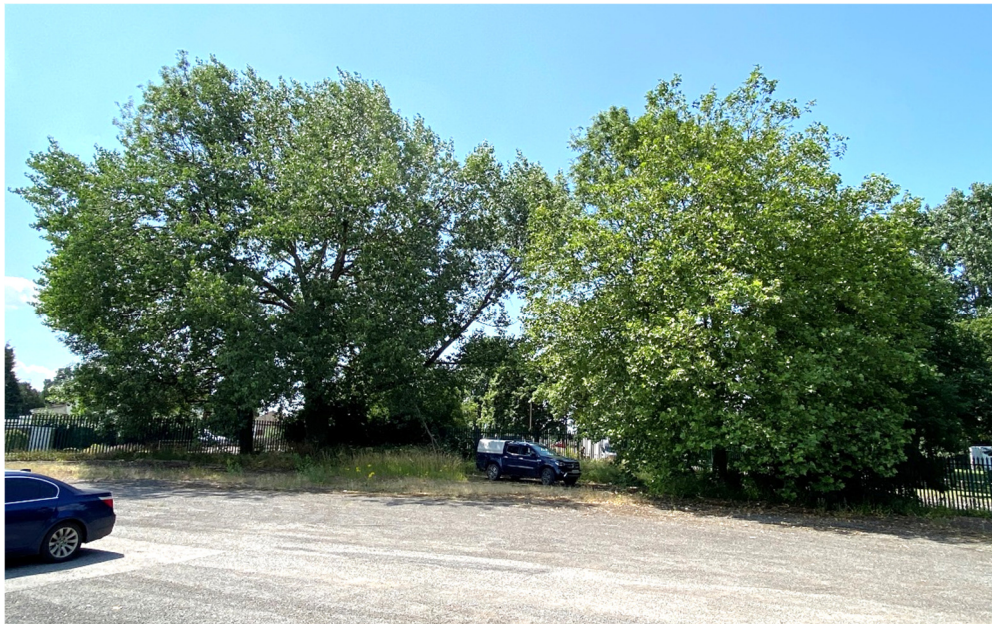
Photograph 3: Showing dominant poplar tree 7 (left) and London plane tree 5 (right) from within the site.

- 3.4 The retaining wall alignment results in a minor incursion within the root protection area of poplar tree 7 (affecting around 20 m² out of a total of 480 m²). This poplar tree is of Category C value. On arboricultural grounds, it has been recommended to substantially reduce the crown of this tree (post-pruning height of around 15m and a remaining radial crown spread of around 7m). Given the low value and limited longevity of this tree, the proposed construction is acceptable in this instance.

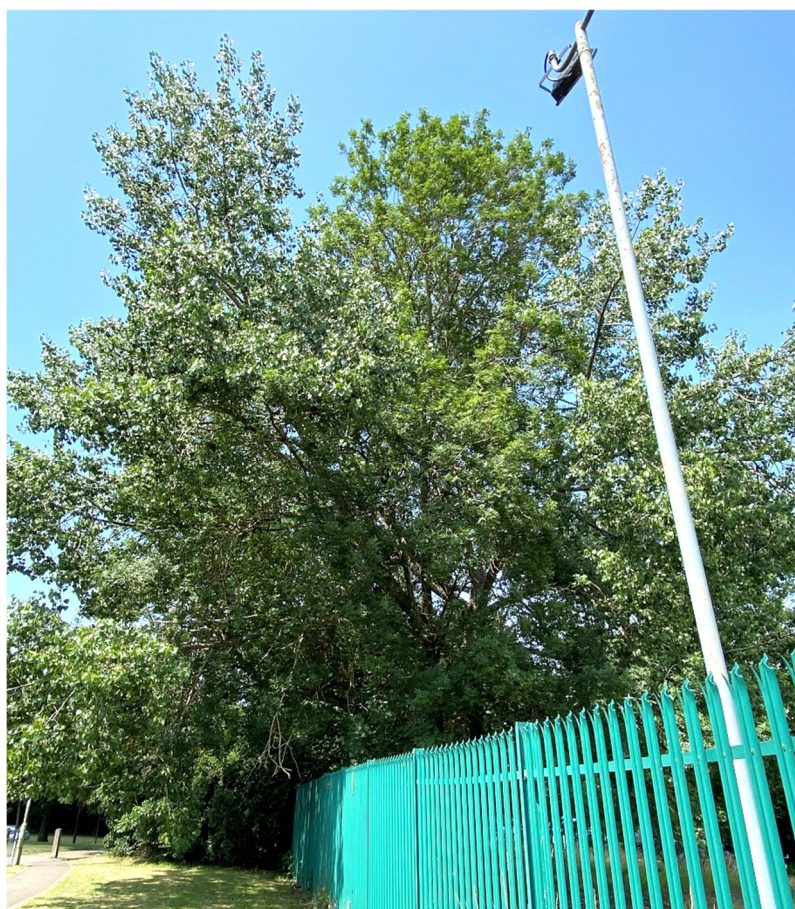
Photograph 4: Narrow leaved ash tree 8 grows through the crown of poplar tree 7.

- 5.3 Poplar tree 7 and, by implication ash tree 8, require crown reduction pruning. These are assessed as low value trees and the need for such pruning is independent of any construction activity. The proposed retaining structure results in a modest incursion within the root protection area for the larger poplar. Given the heavy reduction pruning required and within the context of the trees' value and limited longevity, this is deemed acceptable in this instance.

- A2.2 The main pruning requirements are for the crown lifting of London plane trees 2 and 5 to provide 3-4m post-pruning clearance beneath. The extent of the crown reduction pruning for poplar tree 7 (and by implication, ash tree 8) is to be further specified ahead of the works. As this stage, a post-pruning height of around 15m and a remaining radial spread of around 7m is envisaged. Any remaining dead or defective branches should be removed.

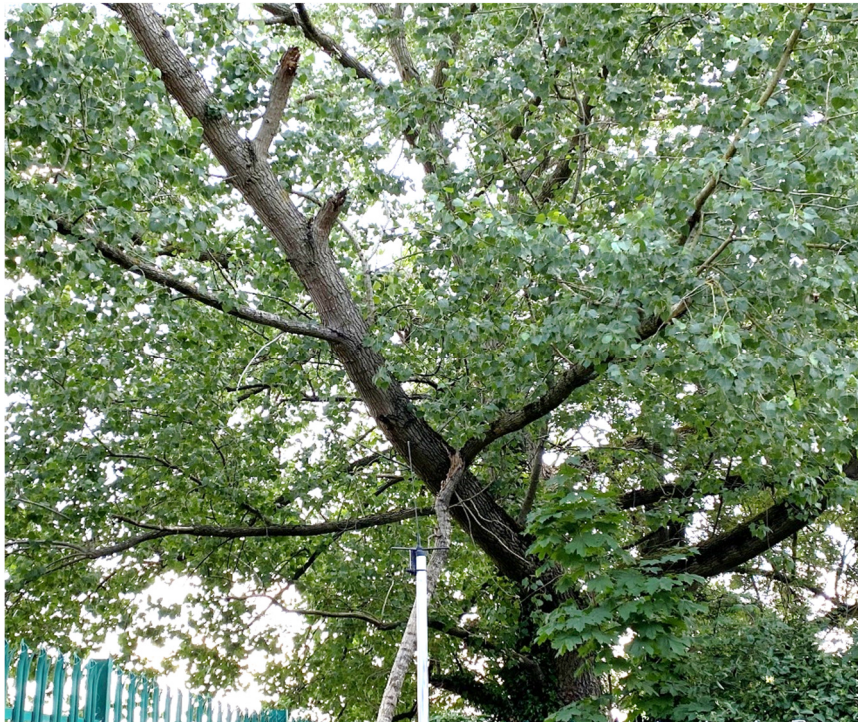
Photograph 5: Poplar tree 7 features heavy, end-weighted primary limbs with recent secondary branch shedding evident.

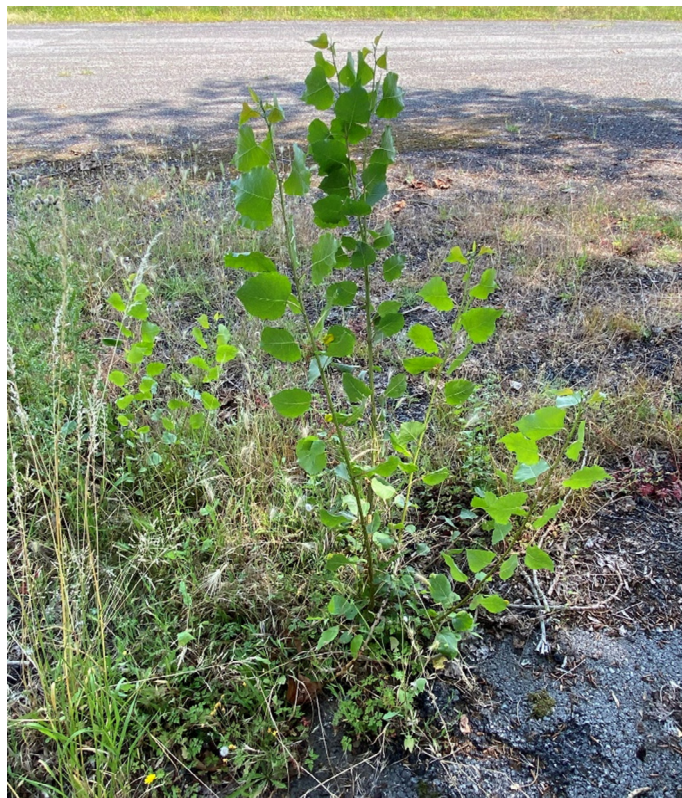
Photograph 6: Poplar root-suckers have recently come up through the car park surface.

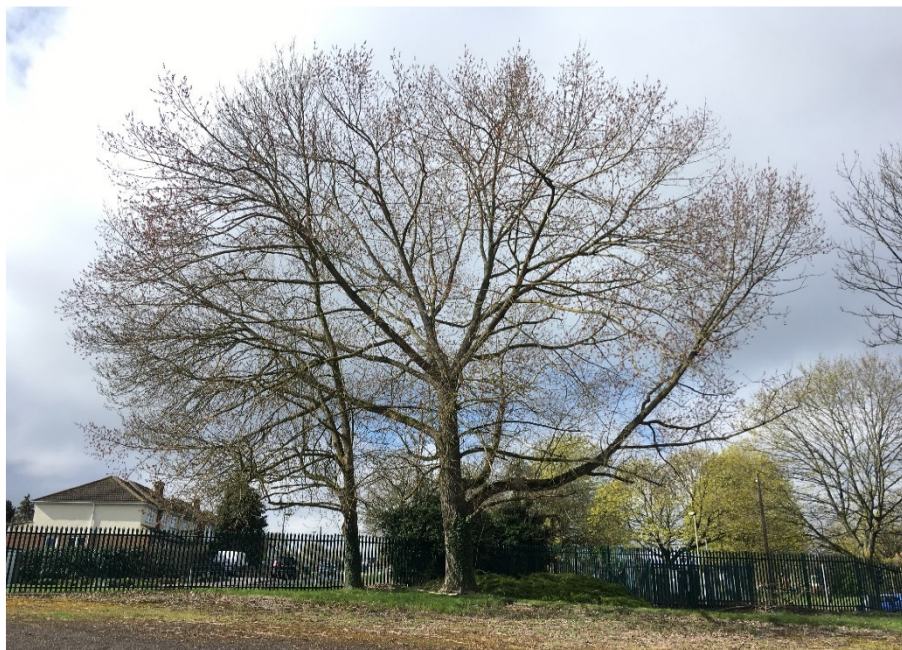
Photograph 7: Poplar tree 7 and ash tree 8 in 2019, better showing their structure whilst not in leaf.

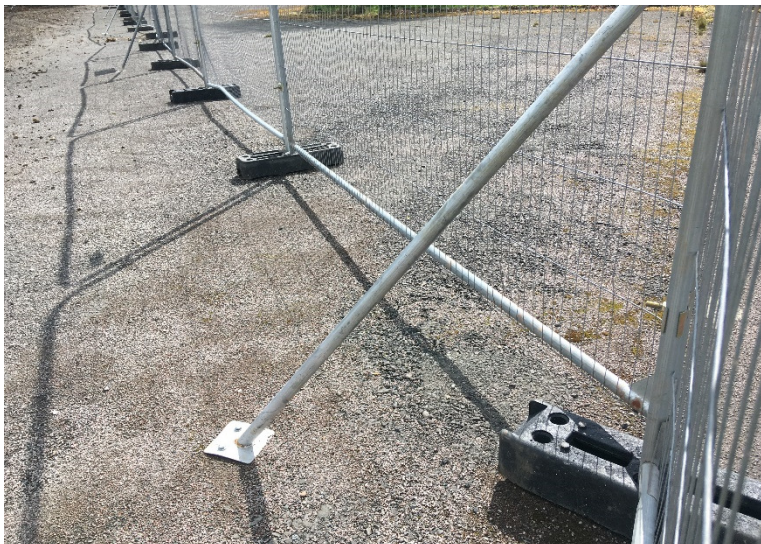
Photograph 8: Example of barrier securely fixed into existing hardstanding.

4.6 Where the barrier is to be erected on top of existing hardstanding (pending it being uplifted), rubber block foot-blocks may be used, subject to adequate diagonal bracing, such as current barriers found on site.

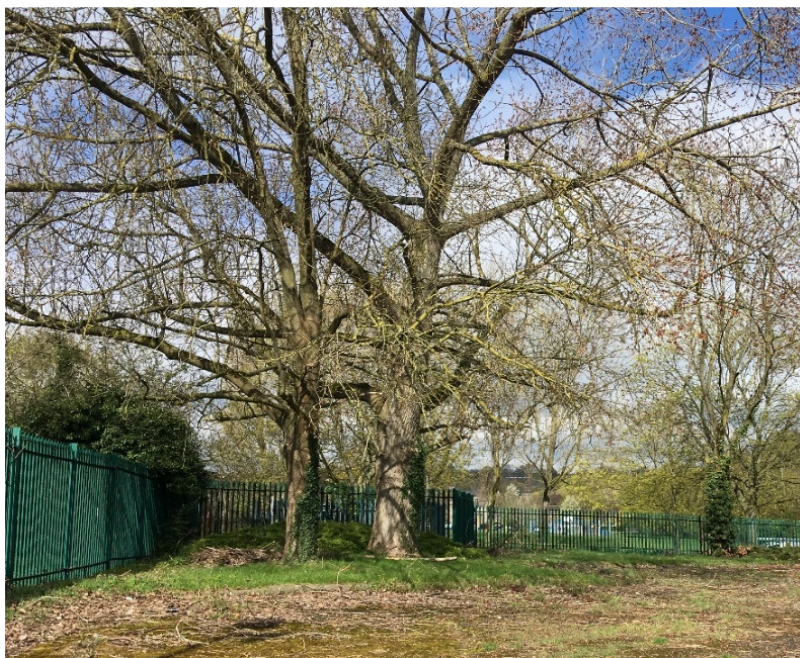
Photograph 9: Showing current fence alignment adjacent to trees 7 and 8 (image dated 2019 showing the trees when not in leaf).

- A2.14 A section of acoustic fence is proposed to be erected adjacent to the boundary with Nursery Drive, which will run close to retained trees 7 and 8. Although the fence specification is subject to final design, it has been detailed as being 2m tall and of wooden construction. The alignment is such that it will likely replace the existing palisade fence running around the boundary.

- A2.15 Given the modest height and wind-loading upon the fence, it appears unlikely that much larger post footing will be required than is the case with the extant fence. Ahead of the works, the new fence specification shall be subject to arboricultural review.
- A2.16 Where nearest the two retained trees, potential post location shall be subject to trial excavation. If tree roots greater than 25mm diameter are encountered, then support post locations shall be altered to avoid such roots and a bespoke section of fence panel constructed to suit. Within the root protection areas, any post footing holes shall employ an impervious liner, to protect the soil and roots from harmful leachate ahead of the concrete/postcrete curing.
