Ref: LAS_368
Date: 04.05.2022

Site: POS Airfield Park, Phase 2, Heyford Park

Arboricultural Statement

Project:
Upper Heyford Phase 2 Open Space

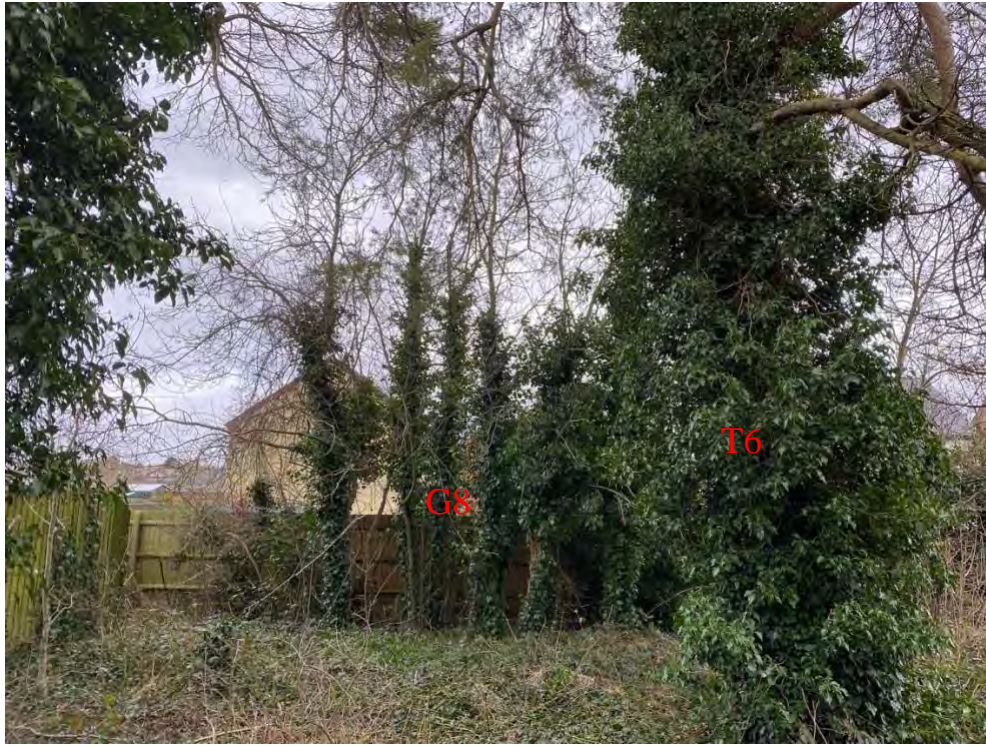
On the eastern boundary of the site is self-set multiple young to semi mature ash stems (G8) with fragmented ash, hawthorn, ivy and elm scrub (G5).

Photo 1: View looking east towards G8.

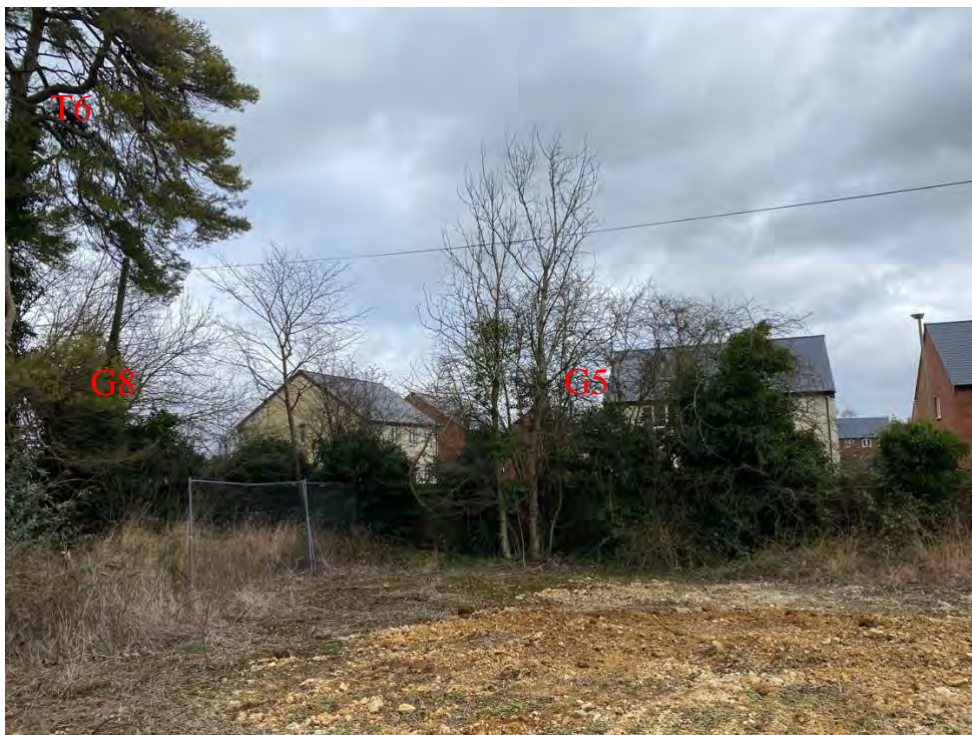
Photo 2: View looking east towards G5.

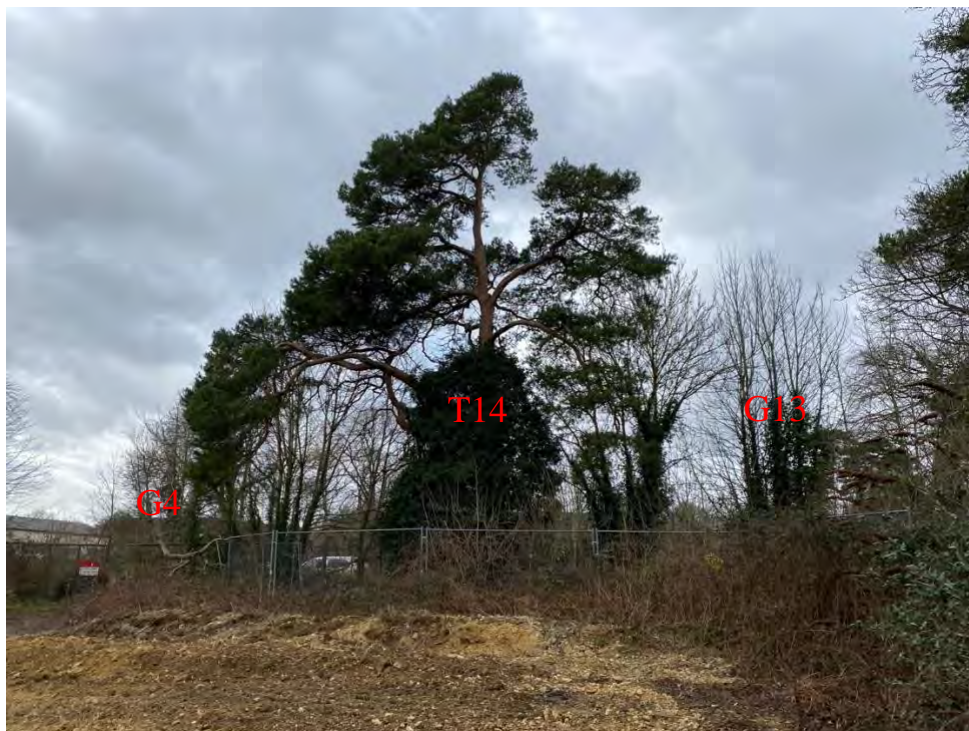
T14 will need to be removed due to its location in the footprint to the 5 aside pitch. It is also noted that the previously approved POS plan (see appendix 1) does not show T14 as a retained tree. But due to its location in the footprint to the 5 aside pitch as well as the alignment of the proposed drainage run, T14 would need to be removed if implementing the previously approved plans.

Photo 3: View west towards T14.

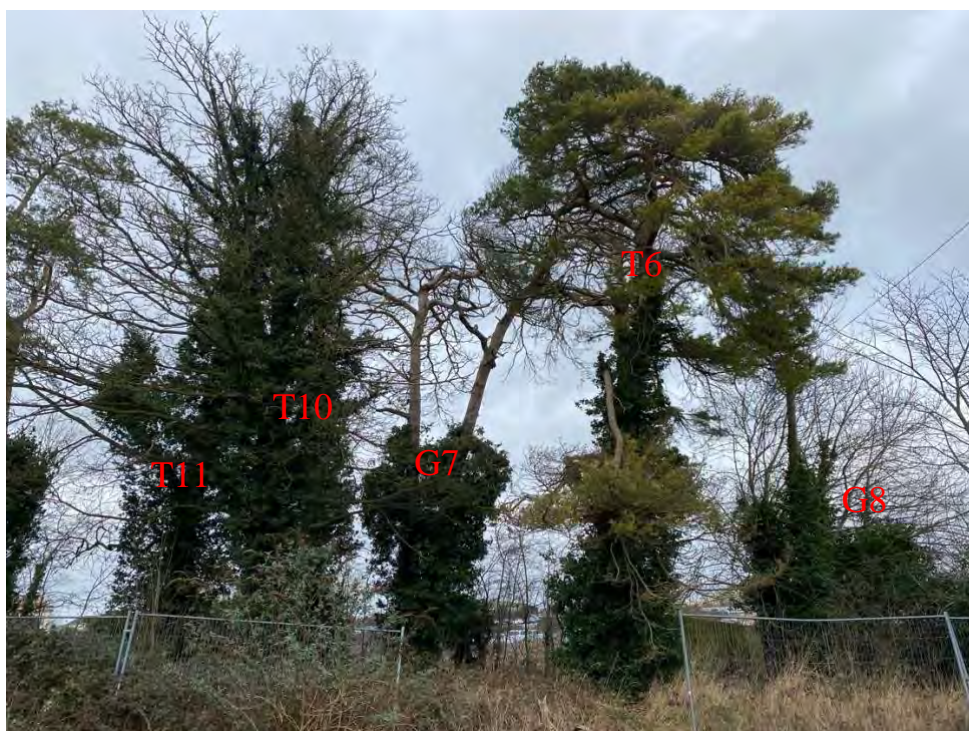
In terms of impact of the loss of T6, G7, T9, T10, T11 and T12 it is important to note the current condition of these trees. G7 comprises two pine trees, both of which are dead therefore removal would be recommended regardless of proposals. T9 and T11 are both mature ash trees with very thin crowns, poor structural condition and appear to be in irreversible decline. These again would be recommended for removal regardless of development. T10 is a heavily ivy clad sycamore with thinning crown. It is assessed as low quality therefore should not be viewed as a constraint to development. Given its condition, it is considered that it could be replaced with new tree planting. T6 and T12 are mature pine that are assessed as moderate quality and generally should be retained. However, notwithstanding a requirement to remove contaminated soil from site, it is noted that the proposed drainage of the sports pitch to the existing attenuation pond passes next to the stem therefore the tree would need to be removed for this. In any case even if no development was proposed/approved, if the other trees are removed due to condition, the loss of companion shelter may reduce their long term retention value by an increased risk of storm damage and windthrow. T6 and T12 could only be retained if existing ground levels can be retained, which as discussed above it has been advised that the levels cannot be retained due to requirement to remove contaminated soil from site.

Photo 4: View looking north towards G7-T11.

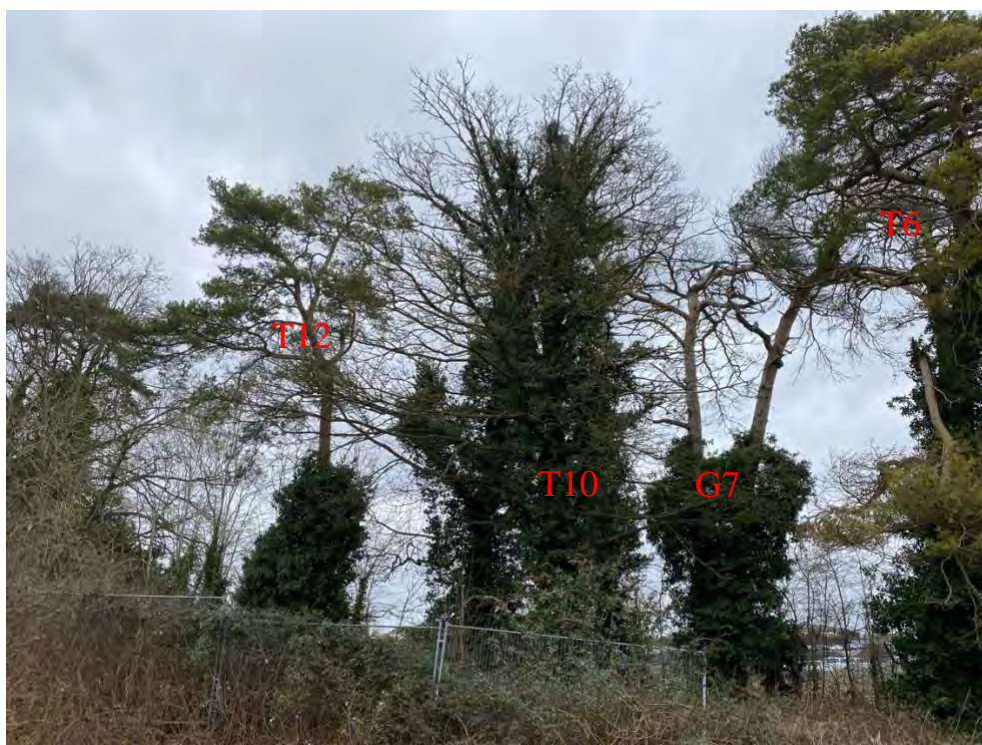
Centrally to the site (south of attenuation basin) are several mature trees. There are two mature pine (T6 and T12), two dead pine trees (G7, two ash trees (T9 and T11) which appear to be in poor condition and a mature sycamore (T10) again which appears low quality.

Photo 5: View looking north west towards T6-T12.

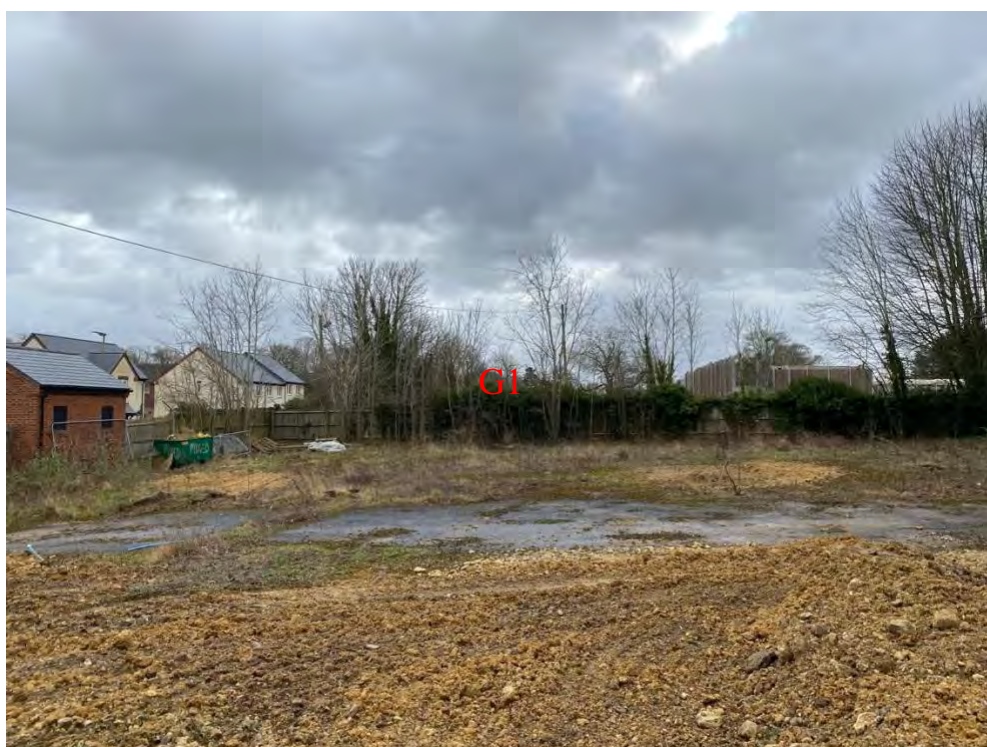
The southern boundary of the site comprises a close board fence with young self-set sycamore and ash stems growing along it (G1) that appear as pioneer growth due to lack of management.

Photo 6: View south towards G1.

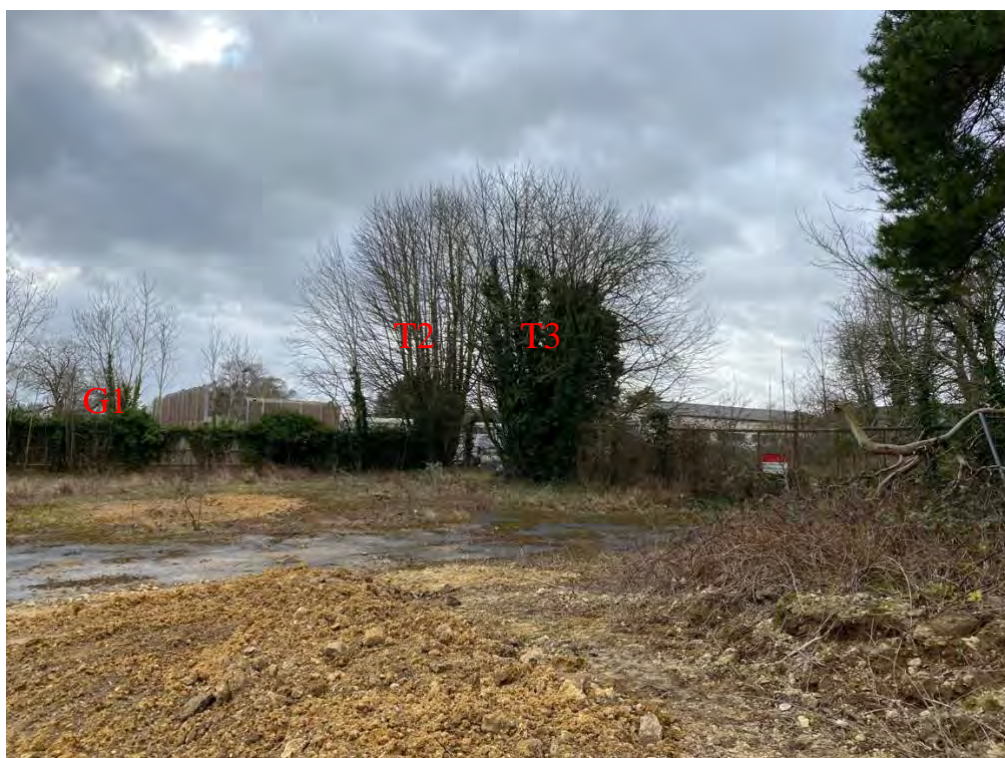
Photo 7: View south west towards G1, T2 and T3.

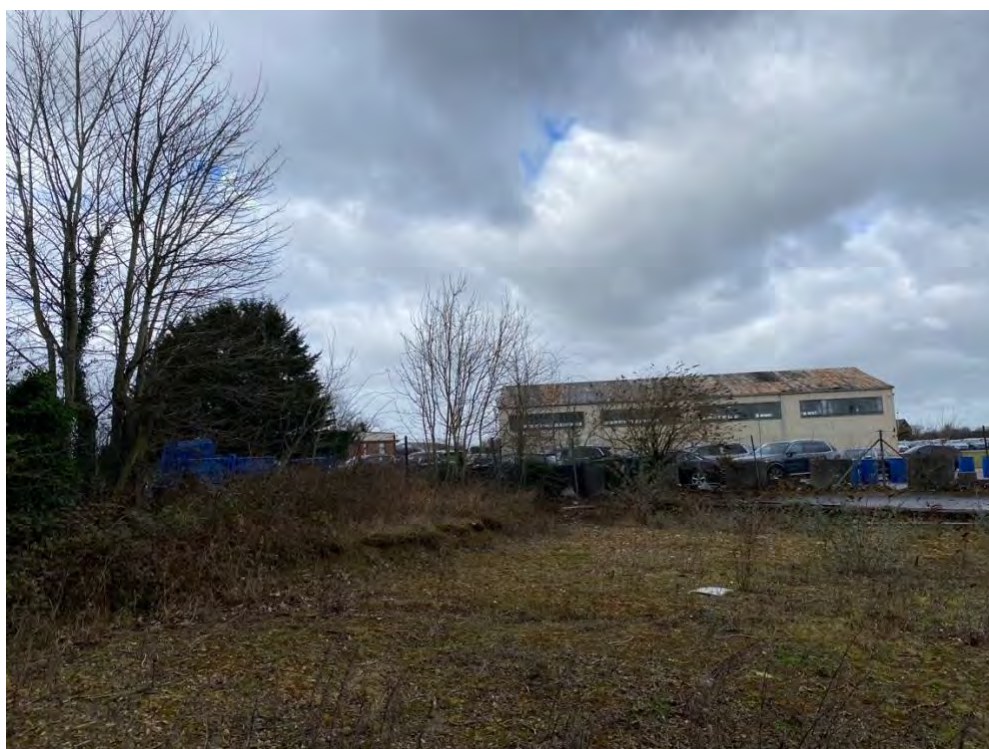
The north part of the site is free of trees. There are some off site mature trees and self-set scrub and small trees along the north-western boundary behind a chain-link fence.

Photo 8: View of off-site self-set scrub and small trees on north western boundary.

No major tree work will be required. However, to enable the removal of an existing chain-link and replacement with new close board fence, overhanging vegetation and branches from off-site trees on north-western boundary will need to be pruned back / lifted to ensure at least 1.5m clearance of the fence.

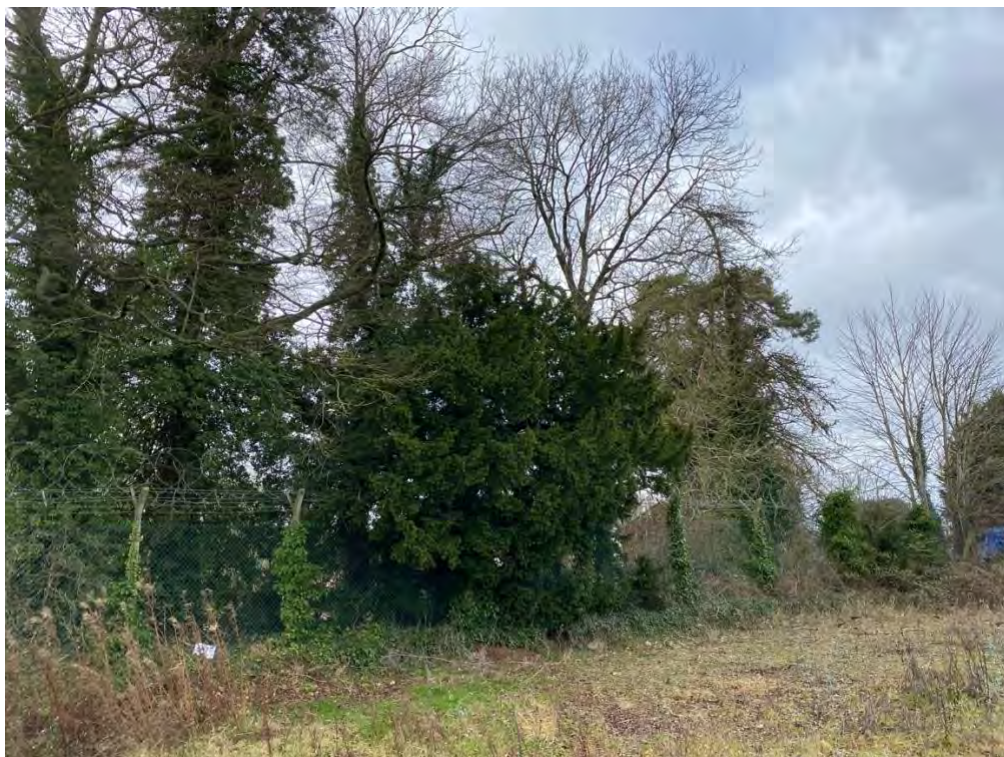
Photo 9: View west towards off site trees on western boundary (NW of G13).

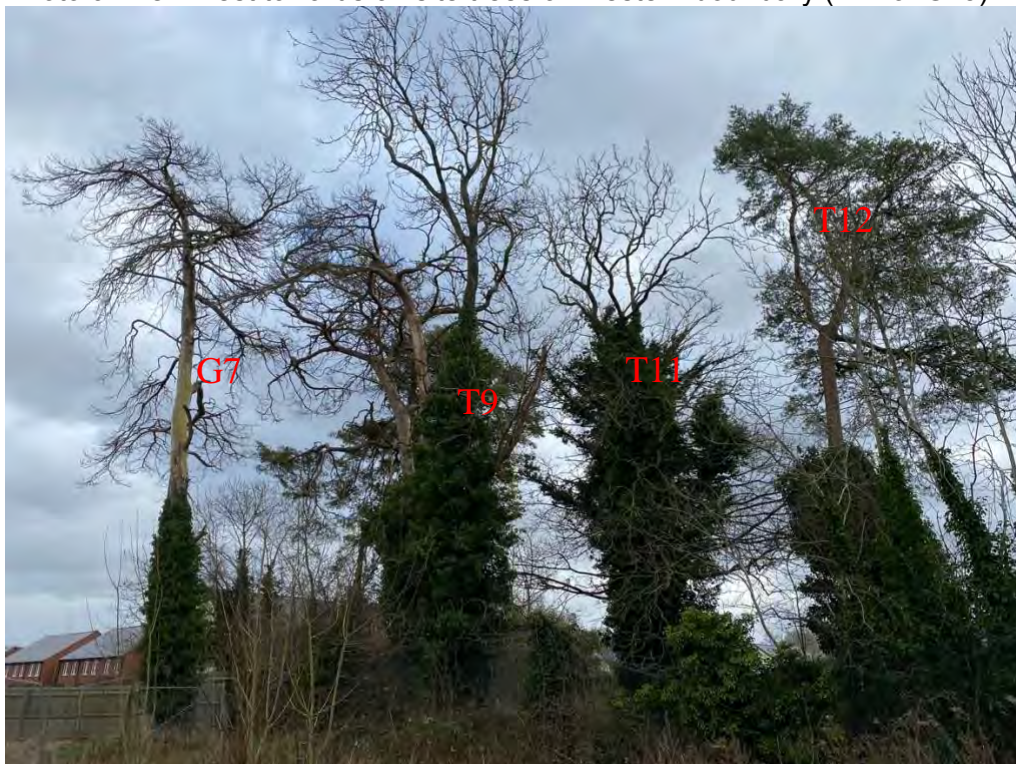
Photo 10: View south towards G7-T12.

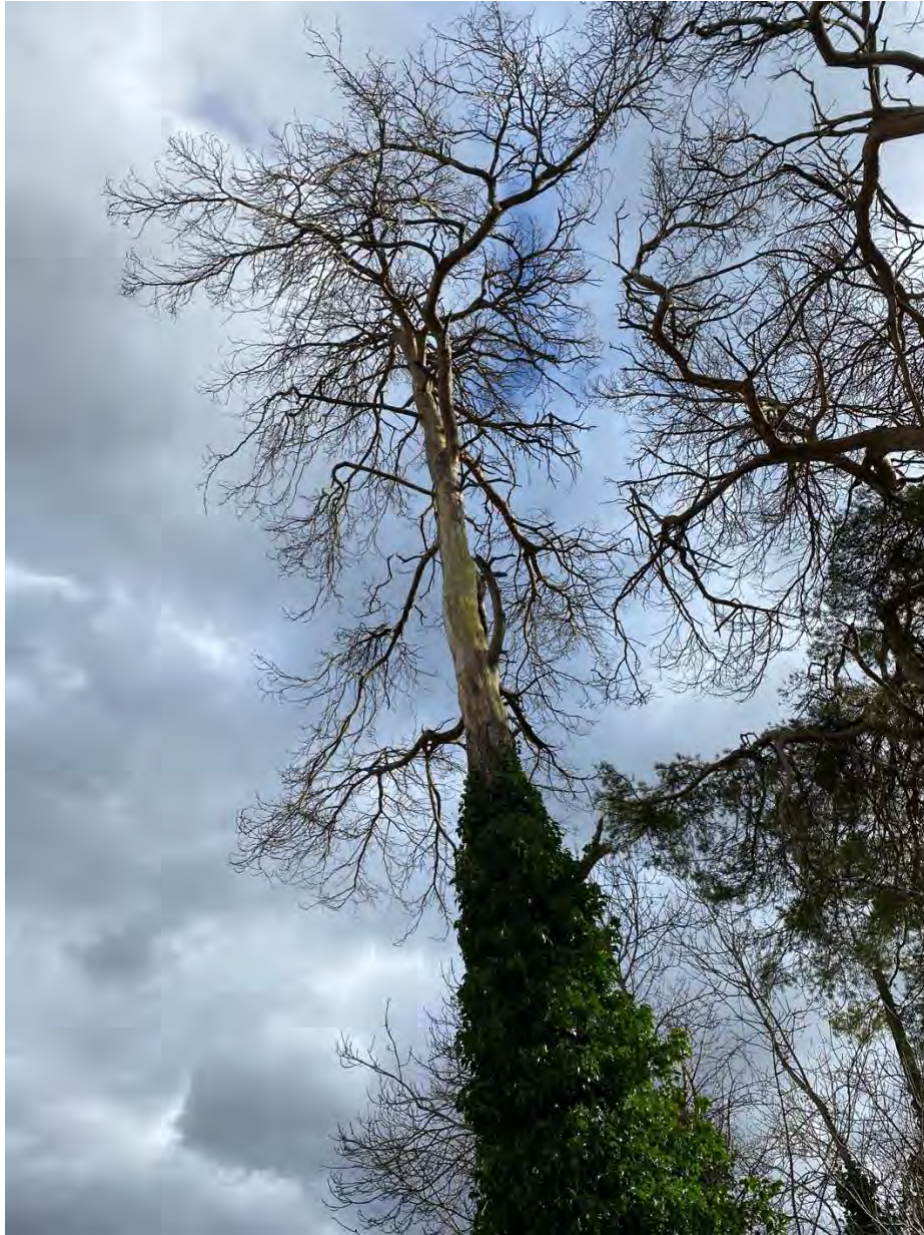
Photo 11: View of dead stem in G7.

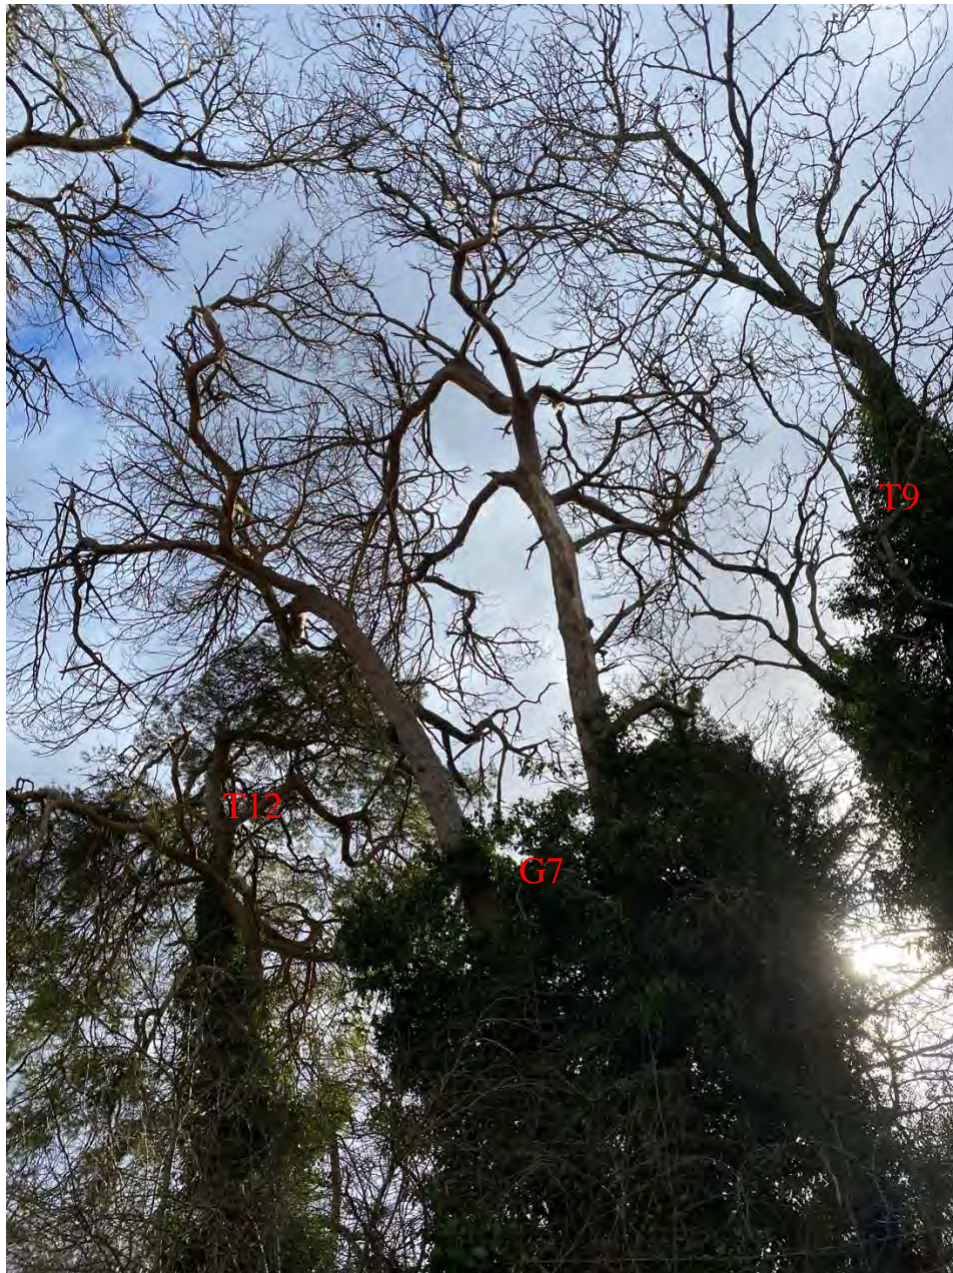
Photo 12: View of dead stems in G7.

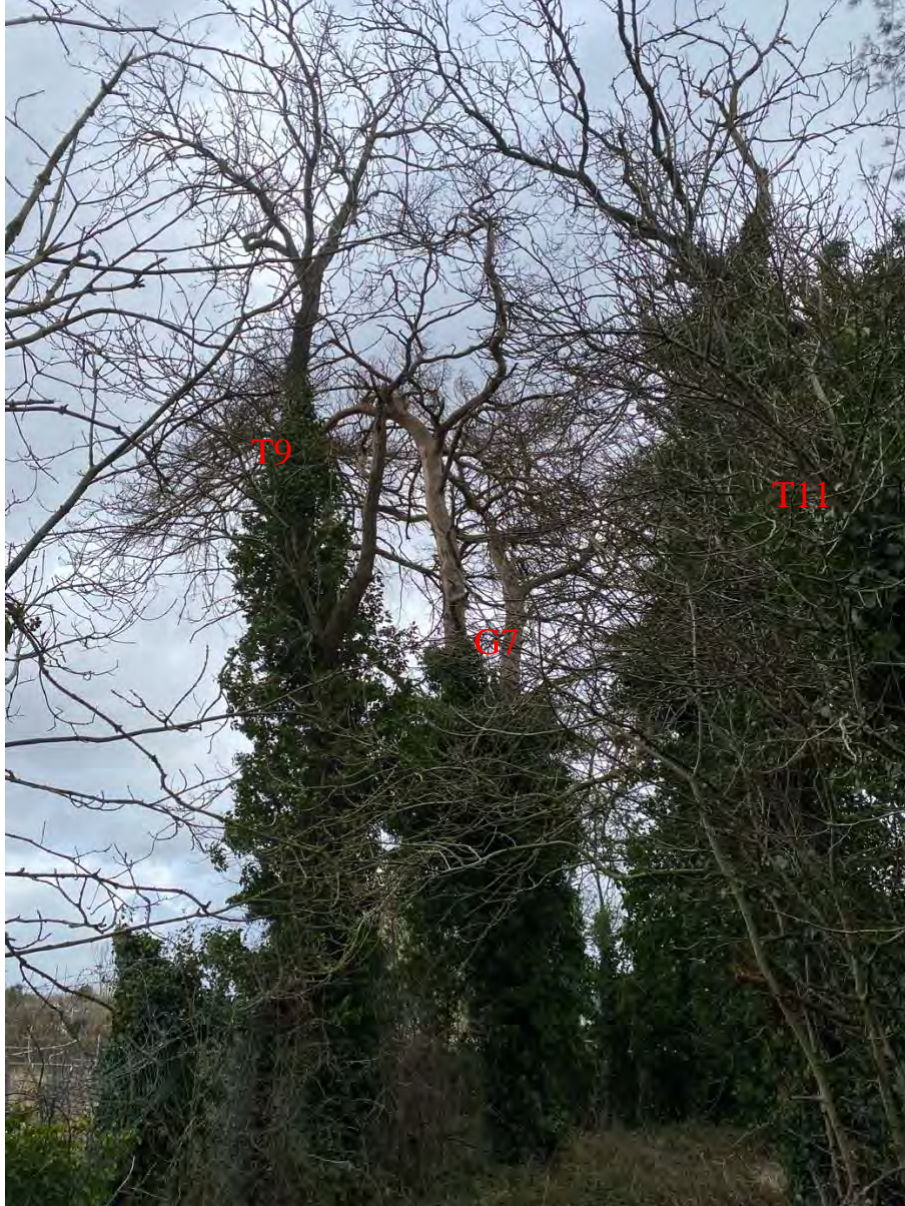
Photo 13: View east towards T9.

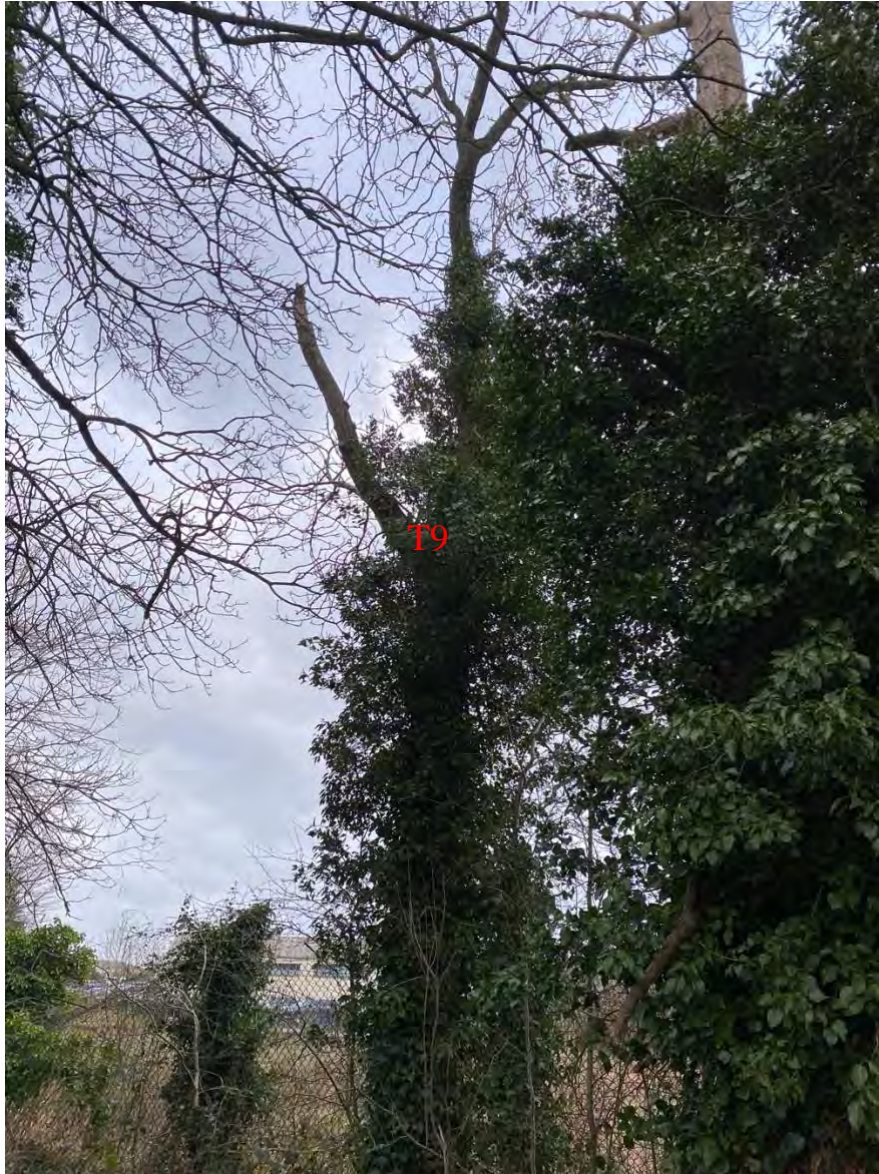
Photo 14: View of north at T9.

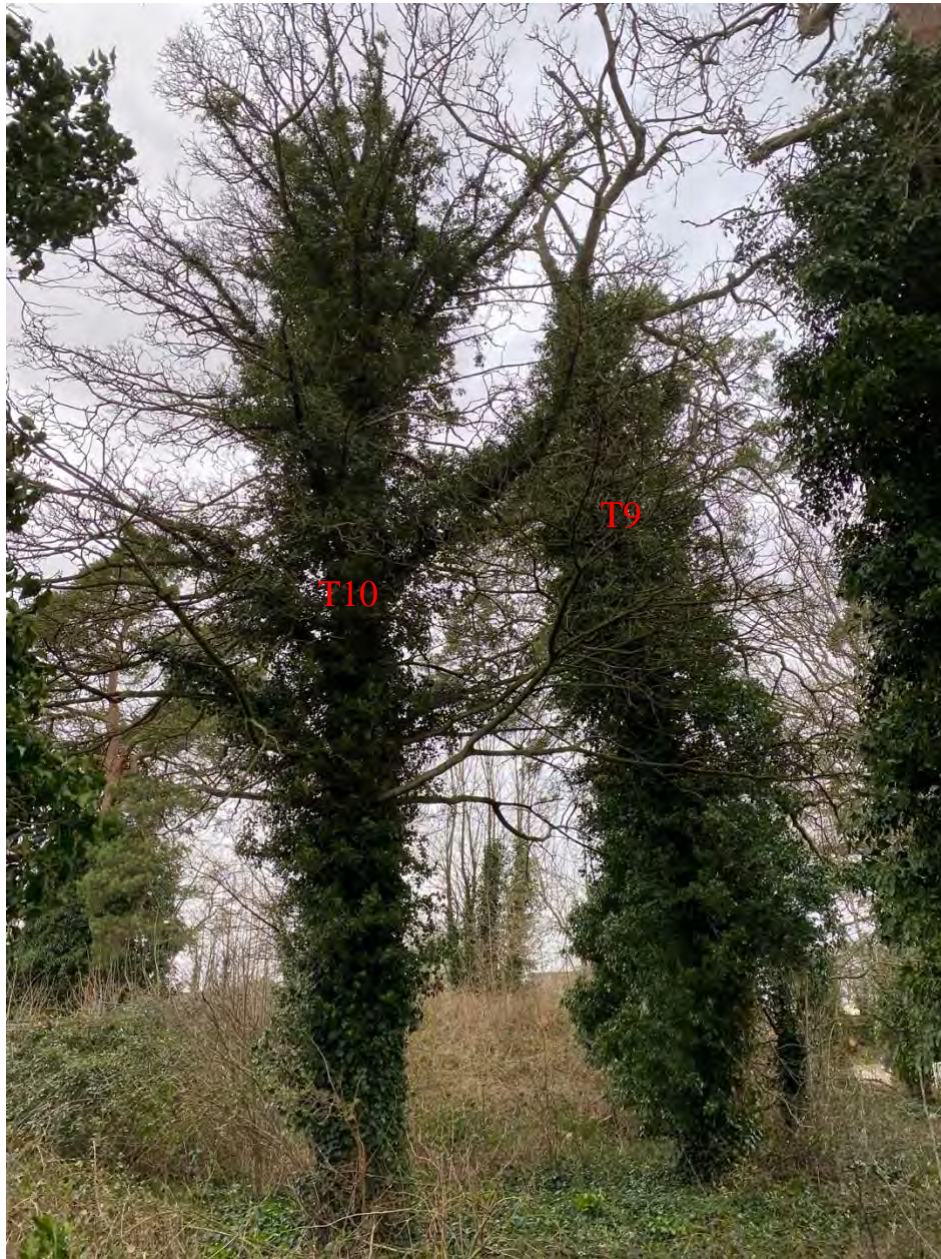
Photo 15: View west towards T10.
