Longford Park – Country Park Landscaping Amendment Commentary

By: Taylor Wimpey UK

Dated: 23/05/2022

This report is to accompany the revised landscape drawings for Longford Park. The below will identify changes and the reasons for the changes.

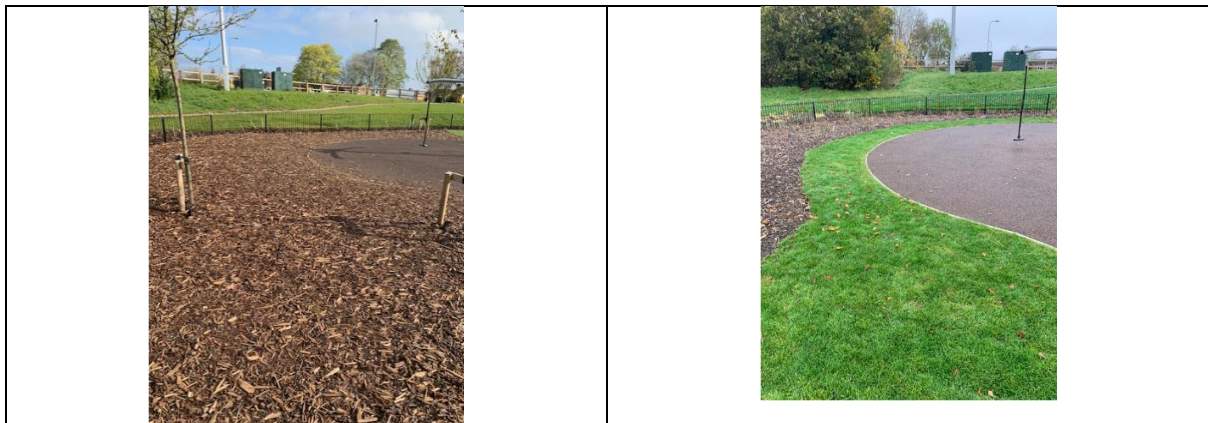
5205/ASP/CP.PP4.4 Rev H

Within the NEAP area it has become evident that the children taking the shortcuts straight through the long grass (*Miscanthus sinensis* 'Siberturm') flowerbeds or using them as run off from play equipment. We have made the decision to change some of these areas over to a turfed finish, as we felt that replanting the plants has been proved not to be a practical option due to inability to establish in this area. The other benefit of the change is offering better options on maintenance the below pictures shows the before and after turfing. We also run this by personnel from Banbury town council as the end user as they happen to be with us on a day we were looking at this area.

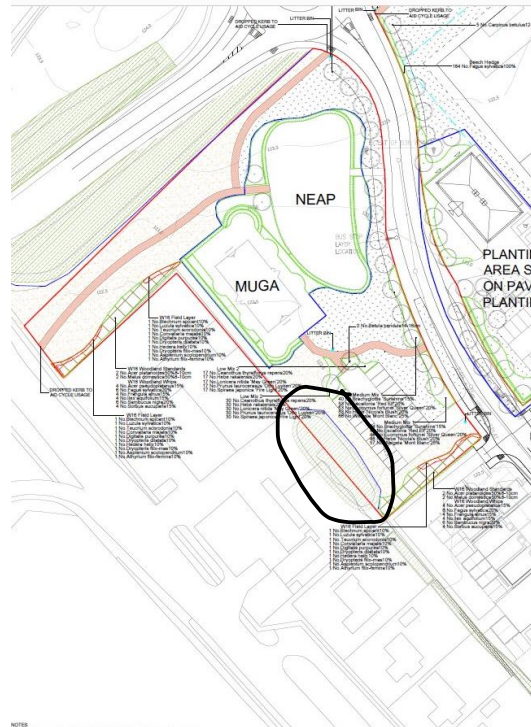
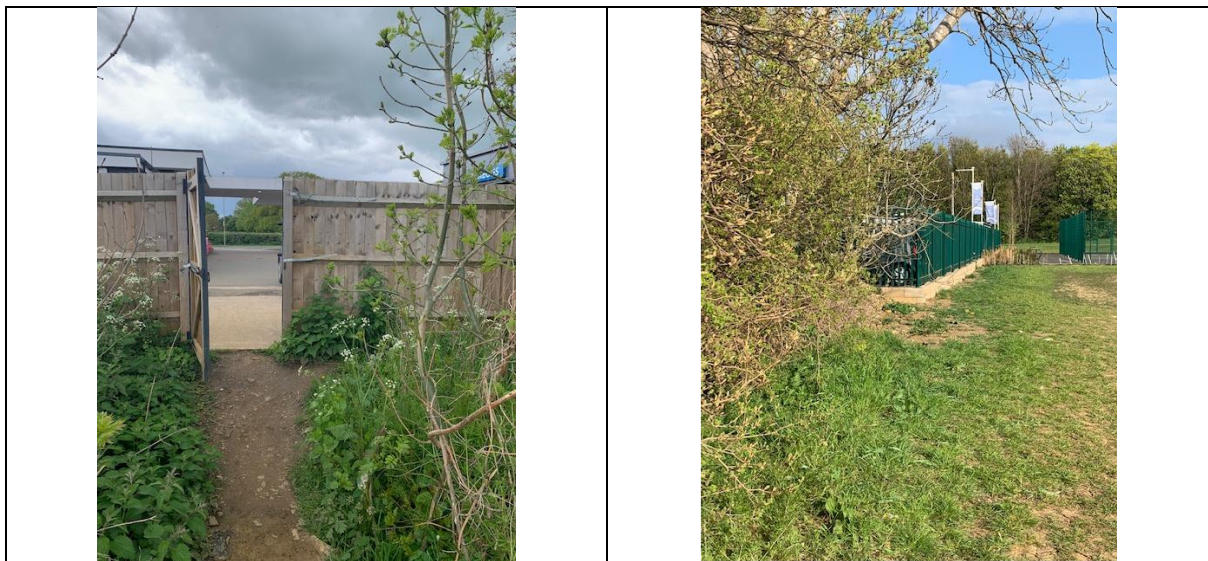
5205/CP-ASP2.4 rev Z

At some point a gate has been installed into a boundary fence as marked above which is outside our property line to allow access through to Greggs and the Garage forecourt (picture below showing gate). Though attempts have been made to prevent the general public gaining access we have been unable to restrict access as it is outside our property line. Due to where line in the grass through the MUGA and neap area to the gate made by children accessing Greggs and the garage forecourt area along with conversations with some members Cherwell District Council the conclusion was we have to install a fence, or this area would not be able to be adopted.

Through careful consideration we felt it was inappropriate to install a path which would encourage children into an unsafe area of a garage forecourt. We also conclude that a close boarded fence would not stand up to the rigours of the local population so made the decision to install a 1.8 m high metal palisade fencing with an access gate for maintaining the hedge. Which is also in keeping with the garage which runs along same boundary as below.

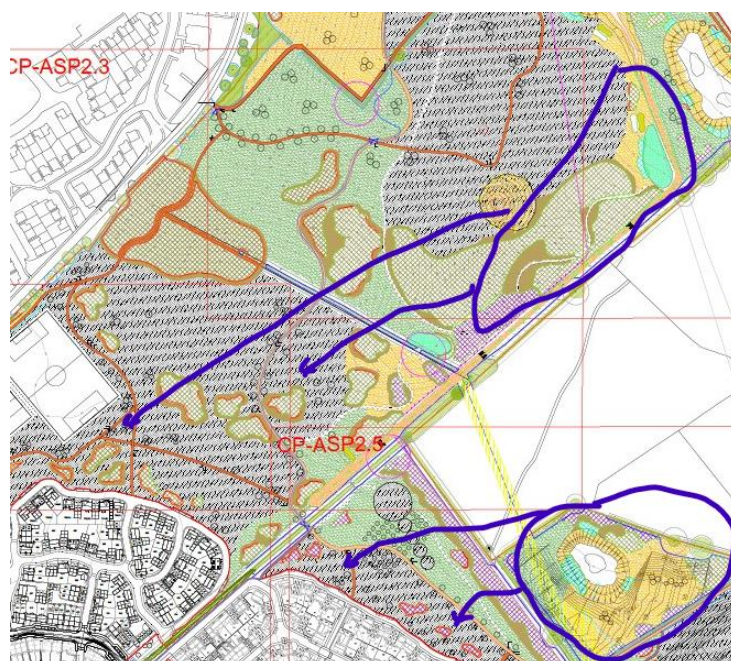
Through the period that the field layer has been installed within the country Park it has become evident that certain field layer beds have not survived where other field layer beds have had high number of plant survival.

Where the beds have not had high number of plant species surviving, are areas with low foot traffic from the general public also had higher signs of animals with in these areas.

The drawing below shows a rough area where we are moving the beds from and planting the field lays plants that have not taken. The field lays beds numbers be increased along areas with a higher footfall to the public with most of the beds being beside occupied plots and paths.

Through discussion with a member Cherwell District Council, we have concluded to move a number of the field planters to other field layer beds to increase the potential of survival and reduce the complications of future maintenance.

We feel that that this will offer better enjoyment to the public walking through the country Park rather than being in areas of low foot traffic. The other benefit of moving the field layer is that avoids maintainece problem by them being cut when grass cutting as they are surrounded by wildflowers areas.

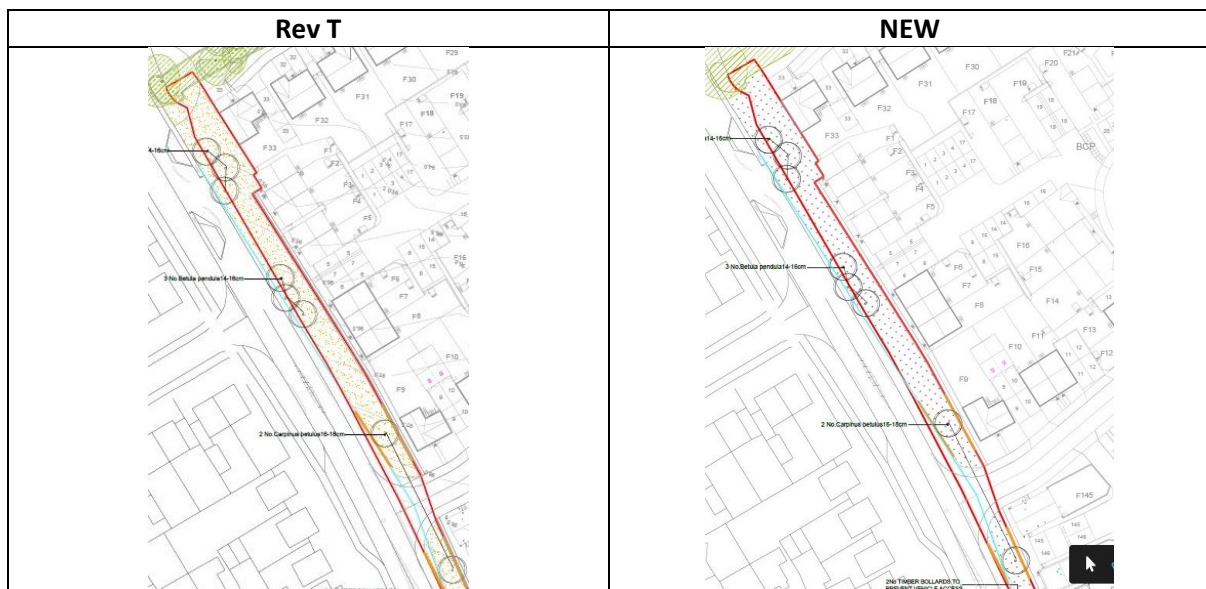
Front of site

At the front of site revision T we had wildflower grassland to be installed. At time of sales offices were open by Taylor Wimpey and Barrett's installed turf along the front of the site to allow for suitable presentation of the entrance to the site.

As we currently feel it enhances the appearance to the entrance of Longford Park phase 4 we were reluctant to change back to wildflower and have made the decision to change the drawings to turf. Which is in keeping with other developments along the Bankside Road.

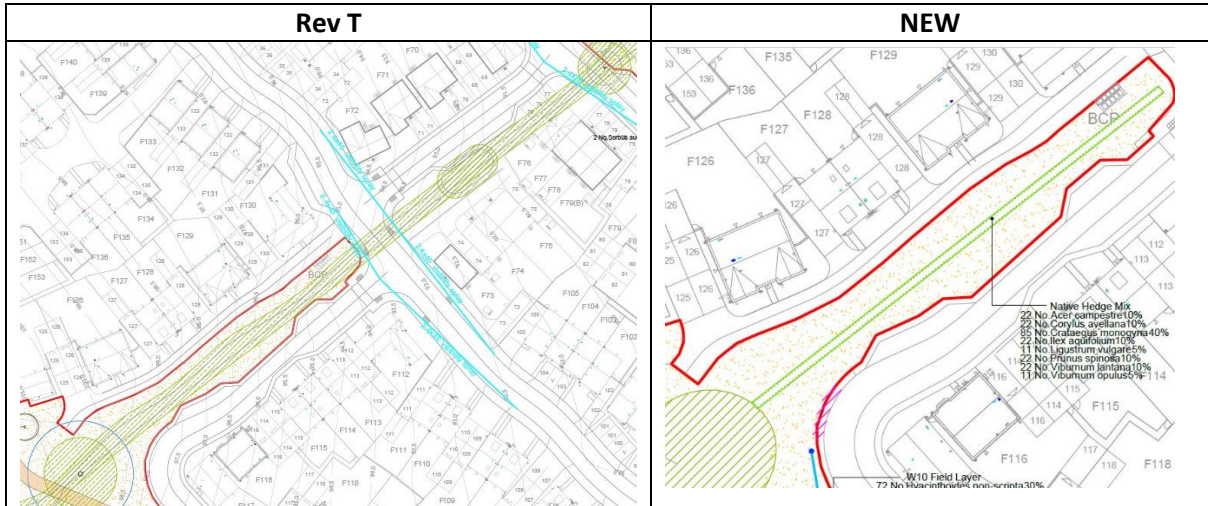
Central bank through the site

The approved drawing revision T incorrectly showed an existing hedge running right through the site including across hardstanding areas. This was incorrect and should have fully been removed at an early stage.

To help with bringing back diversity within the site and allow an enhancement of the landscaping we have corrected this area and have asked for a native hedge species to be installed within the wild grass area.

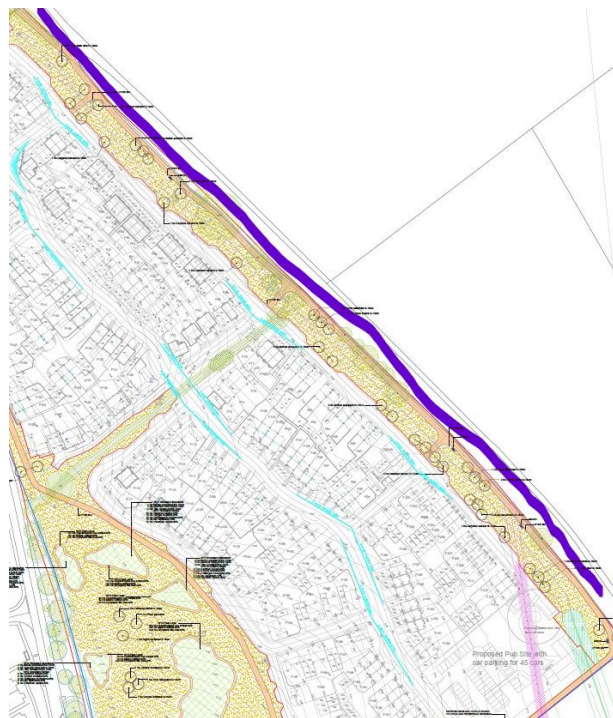
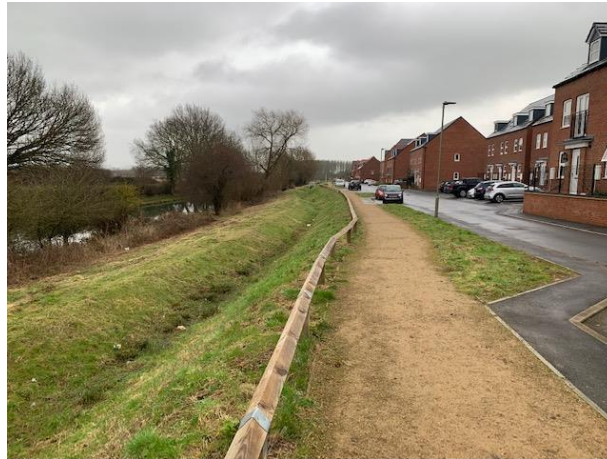
Swale

The current approved drawings revision T along the canal as marked above to be planted with wildflower seeds. Due to the banks in this area, we feel that it is unlikely that will manage to get wildflowers to take and have risk of any seeds being washed away. As the swale has been created for over a year, we have found that natural flora and fauna has taken picture bellow. So we have

liaised with relevant party at Cherwell District Council to agree a solution which will not involve us scraping back the existing vegetation to the earth. The solution we believe will help keep residents happier and keep the ecology in this area.

The solution that we have now come up with is to pod plant number of species at a suitable spacing throughout the area. We have also changed the species to be in line with the suggestions that were made from Cherwell District Council rather than install the species as listed in the wildflower mix.

By carrying this work out, we feel that we will end up with some nice wildflowers which will gradually distribute themselves through this area by natural releasing of seeds.

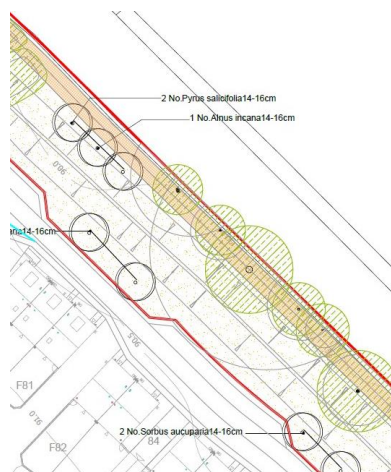
The position of the Hogging cycle path as shown on approved drawing revision T has been moved from one side of the swale near the canal to the other as shown in the above picture. Reason for moving path is that we could not achieve a 2 m path width on the that side due to number of TPO trees being located (shown bellow) along the side of the canal. The levels would have put it at risk of flooding and additional maintenance. By moving the swale and installing the knee rail we have now made to cycle path safer for children to use as we have now removed the water hazard being right beside the path.

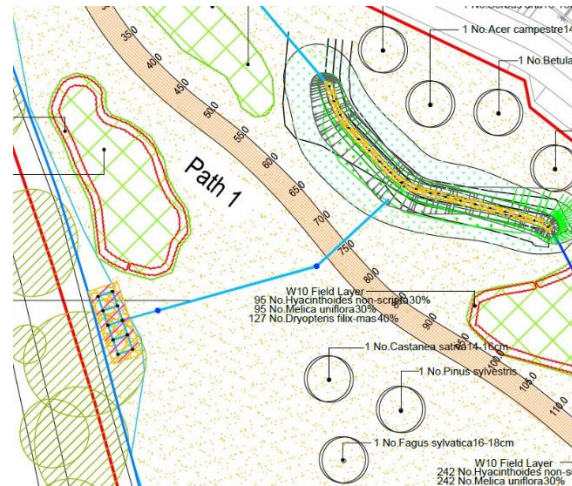
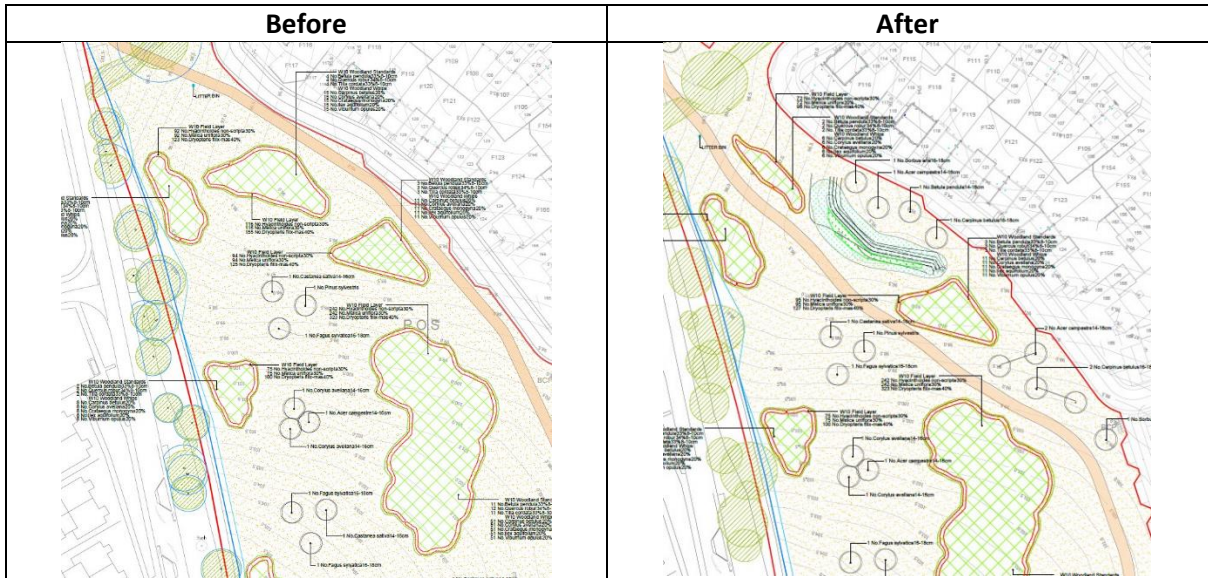
Spring

We've had to install interceptor drainage features to capture the spring water that is flowing above the ground level in the area along Bankside Road. As part of the country park profiling works, the groundworks contractor have identified a total of seven springs along this area, which were not previously identified by the various site investigations. The interceptor swale shown below is required to prevent said spring water from flowing onto the road causing a health and safety issue.

During construction of the interceptor swale our groundworks contractor identified that the spring water was also flowing laterally and breaking through the ground at the lowest point, directly at road level. As a result, they made the decision to deepen the trench beyond what was shown on the design. Whilst this should have been agreed/discussed, it has provided the necessary interception required, and we have subsequently amended our designs to maintain this functionality whilst retaining a shallow depression at the surface. The latest design also deals with an additional spring in this location.

Several alternative solutions were reviewed to deal with the spring water, which included an option to drain directly into the surface water sewer network on site. However, it was confirmed that the network did not have capacity to take any additional flows. Therefore, the only suitable solution has been to capture the flows via the interceptor swale, and then direct them to an evaporation basin sited away from any highway or homes, with an overflow solution which would ensure that any overflows would be conveyed into an existing swale within the country park before being discharged in line with our existing surface water strategy.

Due to the various springs in this area, we have also altered the locations of the planting beds to try and move them away from areas where the soil will experience waterlogging.

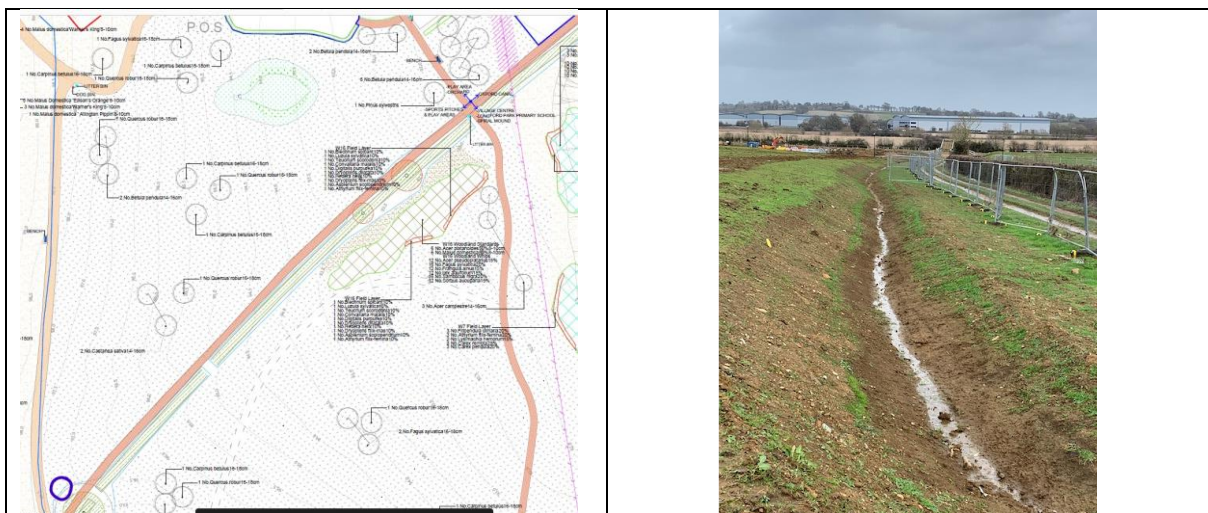
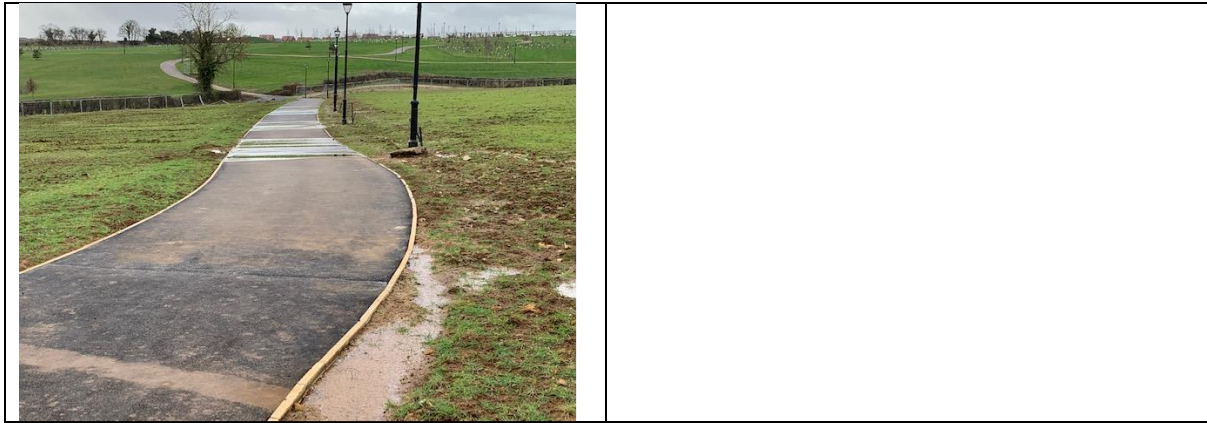
Additional drainage ditch

After profiling of the country Park and installation of the path on phase 4, another spring was identified, and highlighted of the extract below. To mitigate this, we have had to put in an additional ditch to stop additional water ending up on the farmers track and divert it down to the existing swale network, to help mitigate the farmers track having so much water on. We have also noted on recent walk around that we may need to put additional drainage in.

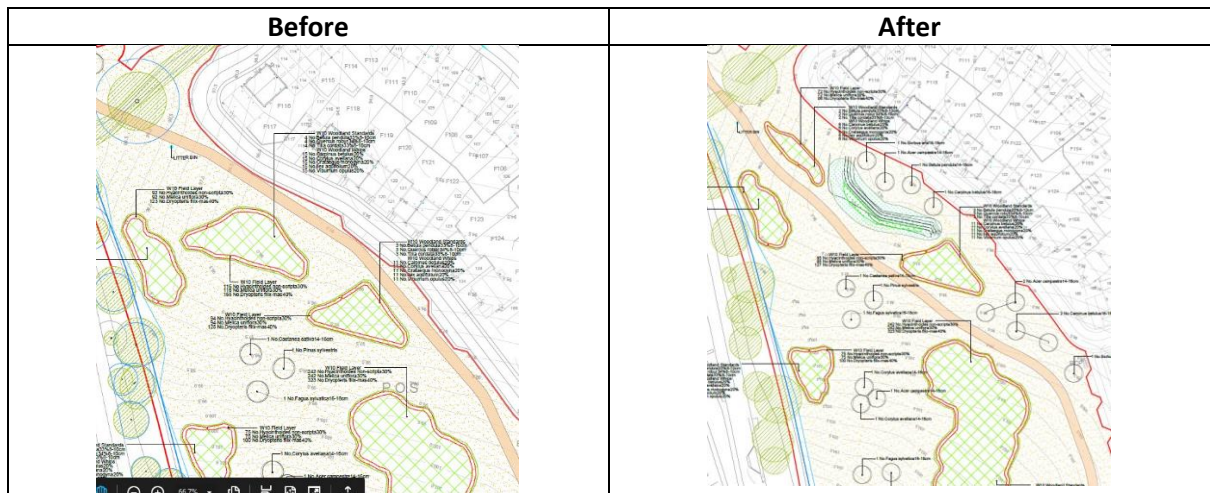
Tarmac Cycle Path

The route of the cycle path has been altered, as the original design had not taken into consideration the excessive gradients which would have been required to achieve its position on the bank, making it both unsuitable for certain pedestrian users and also posing a potential H&S risk due to the fact the steeper sections were orientated in the direction of the road. In order to meet necessary standards, both Cherwell and OCC were consulted, and the route of the path adjusted to suit feedback. This new route also avoids the root protection zone associated with the adjacent oak tree.

Though we are aware that moving the path may cause concerns from residents with regards to pedestrians overlooking the adjacent properties, we have taken the reasonable steps to mitigate this by moving some of the woodland stands to the side of the path to provide a screen. Additional trees have also been introduced in front of the interceptor swale, mentioned above, and further up the bank which we believe will provide further screening/betterment.

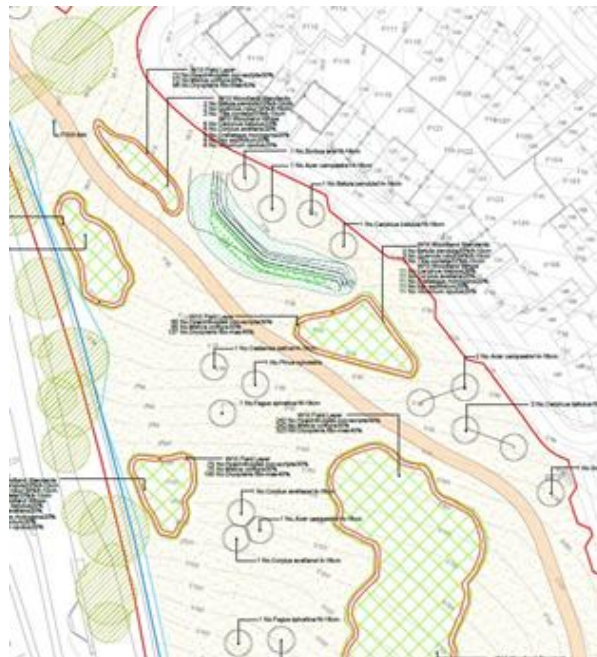
As you are aware, extensive earthworks have taken place across the entire country park. With regards to the area shown above, there are some instances whereby finished levels are slightly lower or higher than the proposed levels shown on the designs, but these small discrepancies act to cancel one another out. To confirm, less soil had been generated from Phase 4 than was originally calculated, meaning that less soil was available for profiling the area shown above and has resulted in this area being lower overall when compared to the design proposals.
